Warren

State Highway 45 and 478 – Road Safety Audit

April 26, 2017

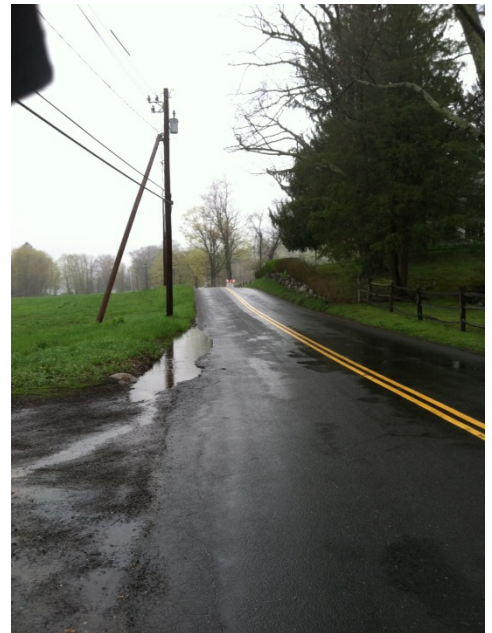
Figure 5. North Shore Road near east end

- On North Shore Road, lane widths were measured as 11-feet in each direction near the Lake Road (the east end) (Figure 5). However, only 18-feet of overall roadway width is usable due to deteriorating pavement edges.
- At a cross culvert west of Bliss Road, the overall roadway width was measured to be 19-feet, with 15 feet of drivable pavement due to deteriorated edges.
- In several locations, there is a steep drop off to

the lake immediately on the south side of the road and a steep embankment immediately on the north side of the road, leaving very little additional room for roadway widening.

- There are various fixed objects immediately adjacent to the pavement on both sides of the road, including trees, tree stumps, rock outcrops, drainage ditches and utility poles.

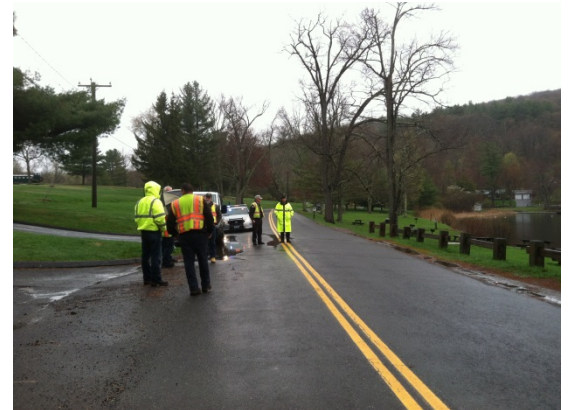
Figure 6. No crosswalk at Lake Waramaug State Park lot

- At Lake Waramaug State Park lane widths were 10-feet and 12-feet on Lake Waramaug Road.
- There is no striped crosswalk at the Lake Waramaug State Park parking lot (Figure 6).
- This section of the loop corridor is in relatively good condition, with good sight lines and reasonable roadside clearances. Parking for the park and campground is on the west side, opposite the lake. Campers and park visitors cross the road at multiple locations, but the good visibility and low traffic volumes make this a generally acceptable condition.

- Another possible location for a striped crosswalk is at the parking lot for the State Park.
- Pedestrian crossing signs should be updated to the latest retro-reflective standards.

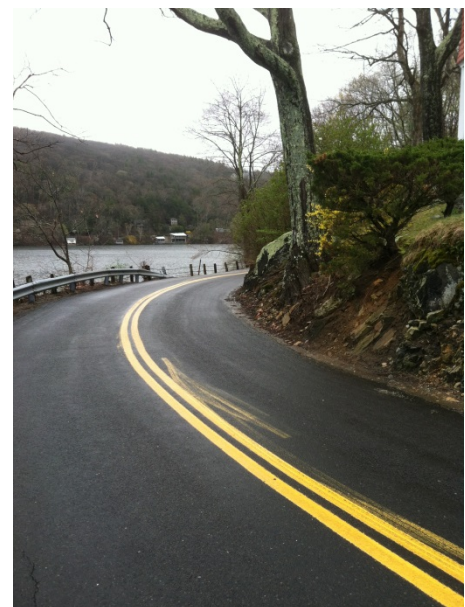
Figure 7. Tight corner, narrow lane widths, limited sight distance

- Cable guide rails throughout the corridor are in poor condition, and leaning toward the lake.
- At Loomarwick Road the lane widths on West Shore Road are 10-feet in each direction.
- There is a sharp corner on West Shore Road where sight distance is limited by a ledge (Figure 7).
 - Lane widths at the corner are 8-9-feet in each direction.
 - The guiderail at this corner is low. It is a mix of cable/timber post and metal beam rail.
 - There are no marker signs to delineate this curve.

- The ledge is deteriorating and the natural rock is loose. The adjacent stone wall supporting the roadway on the north side appears to be very old and is in poor condition.

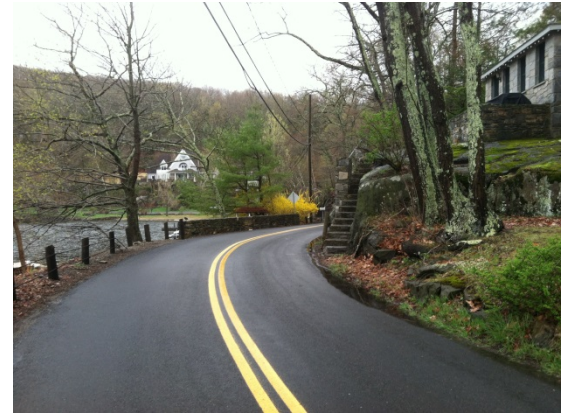
Figure 8. Second tight corner

- There is a second sharp corner on West Shore Road where sight distance is limited by a rock embankment (Figure 8).
 - Lane widths at the corner are 7-8-feet in each direction.

- There are no marker signs to delineate this curve.
 - Stairs from the house above this embankment come down to the street at this blind corner.
- Unusual open top drainage structures, some with wooden tops, are located along drainage ditches throughout the corridor (Figure 9).

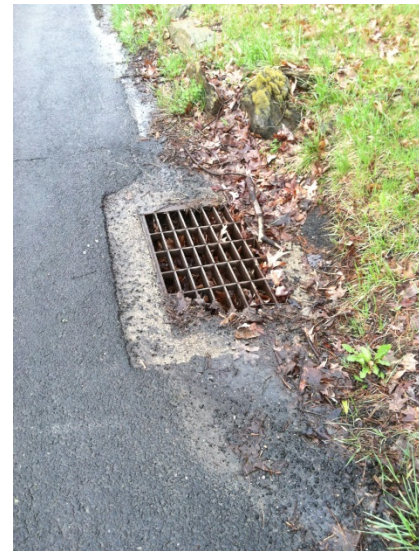
Figure 10. Non-bicycle friendly grate

- Non-bike friendly catch basin grates were observed at multiple locations (Figure 10).
- The latest retro-reflective pedestrian signs are not being used in the corridor.

1. CTDOT to replace non-bicycle friendly catch basin grates with the bicycle friendly type as part of the drainage work currently being done in the corridor.
2. Town to request that CTDOT regularly clean catch basins in the corridor.
3. Consider adding sharrows to the roads after resurfacing of the corridor is completed this year.
4. Investigate the scope of the resurfacing project scheduled for later this year to determine if failing cable guide rails will be replaced under that project.
5. Town, NHCOC and CTDOT to coordinate with each other to improve communication regarding upcoming projects.
6. Evaluate signage throughout the corridor to determine if any signs can be removed or consolidated.

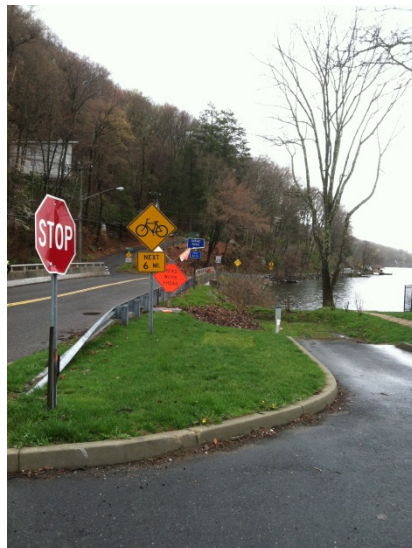
Figure 11. Dense signage

- There are many signs on West Shore Road near the intersection with East Shore Road (Figure 11).
 - Lane widths in this area are 16-feet and 14-feet.

- Dense signage was noted in the corridor.
- There are some locations where the road cannot be widened but in many areas, adding a few feet is possible.

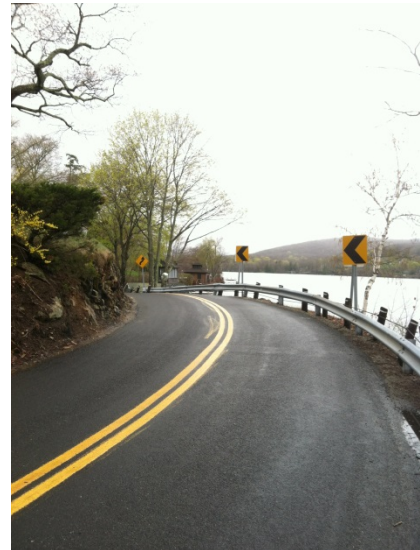
Figure 12. Tight corner

- The possibility of alternating one-way traffic with a signal at the tight corners with limited sight distance was discussed (Figure 12, Figure 13).
 - It is thought that homeowners may be in support of this concept.

- The structural integrity of walls and ledges at these corners should also be assessed.
 - There was also some discussion of the possibility of having no thru trucks due to these corners but it is thought that most truck traffic is local anyway.

1. Town to coordinate with homeowners and widen roadway where possible.
2. Consider the alternative of alternating one-way traffic at the blind corners with a signal.
3. Consider alternatives to the roadside ditches that are currently present in many sections of the corridor.

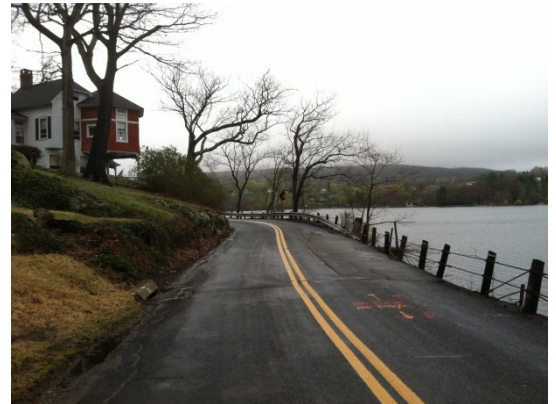
Figure 13. Tight corner, failing cable guard rail

- Cable guiderails throughout the corridor are failing (Figure 13).
 - It should be investigated whether these guiderails are being replaced during the resurfacing project this year.

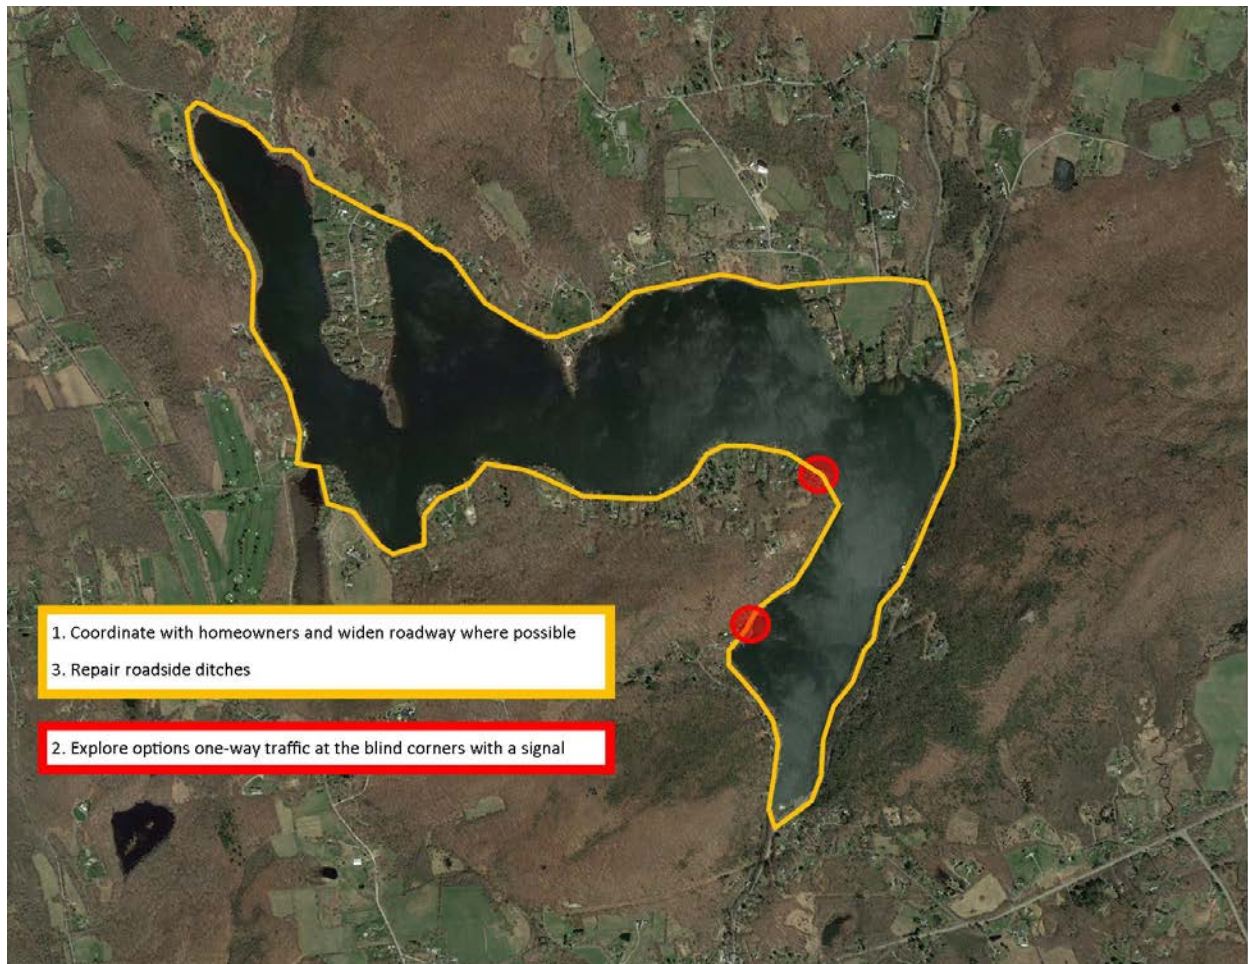
Figure 17. Long Term Recommendations

Figure 17 depicts these recommendations.
