# Watertown/ Waterbury

Bunker Hill Road - Bunker Hill Avenue – Road Safety Audit

April 18, 2017

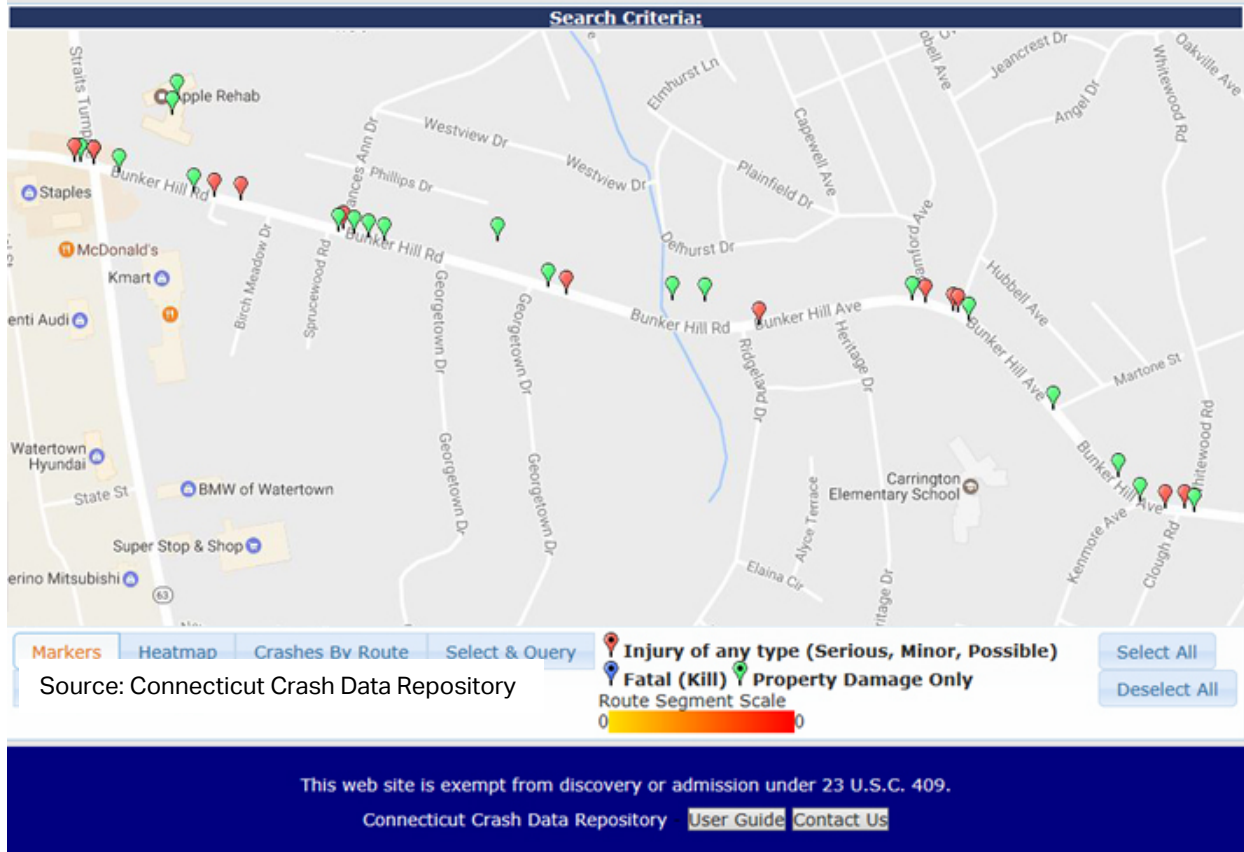
Figure 3: Crashes that Occurred in 2015 (Connecticut Crash Data Repository)

The crash types reported were primarily rear-end (Table 2). Figure 3 displays crashes that occurred in this area during 2015. The crash history for year 2015 shows that they are dispersed throughout the corridor.

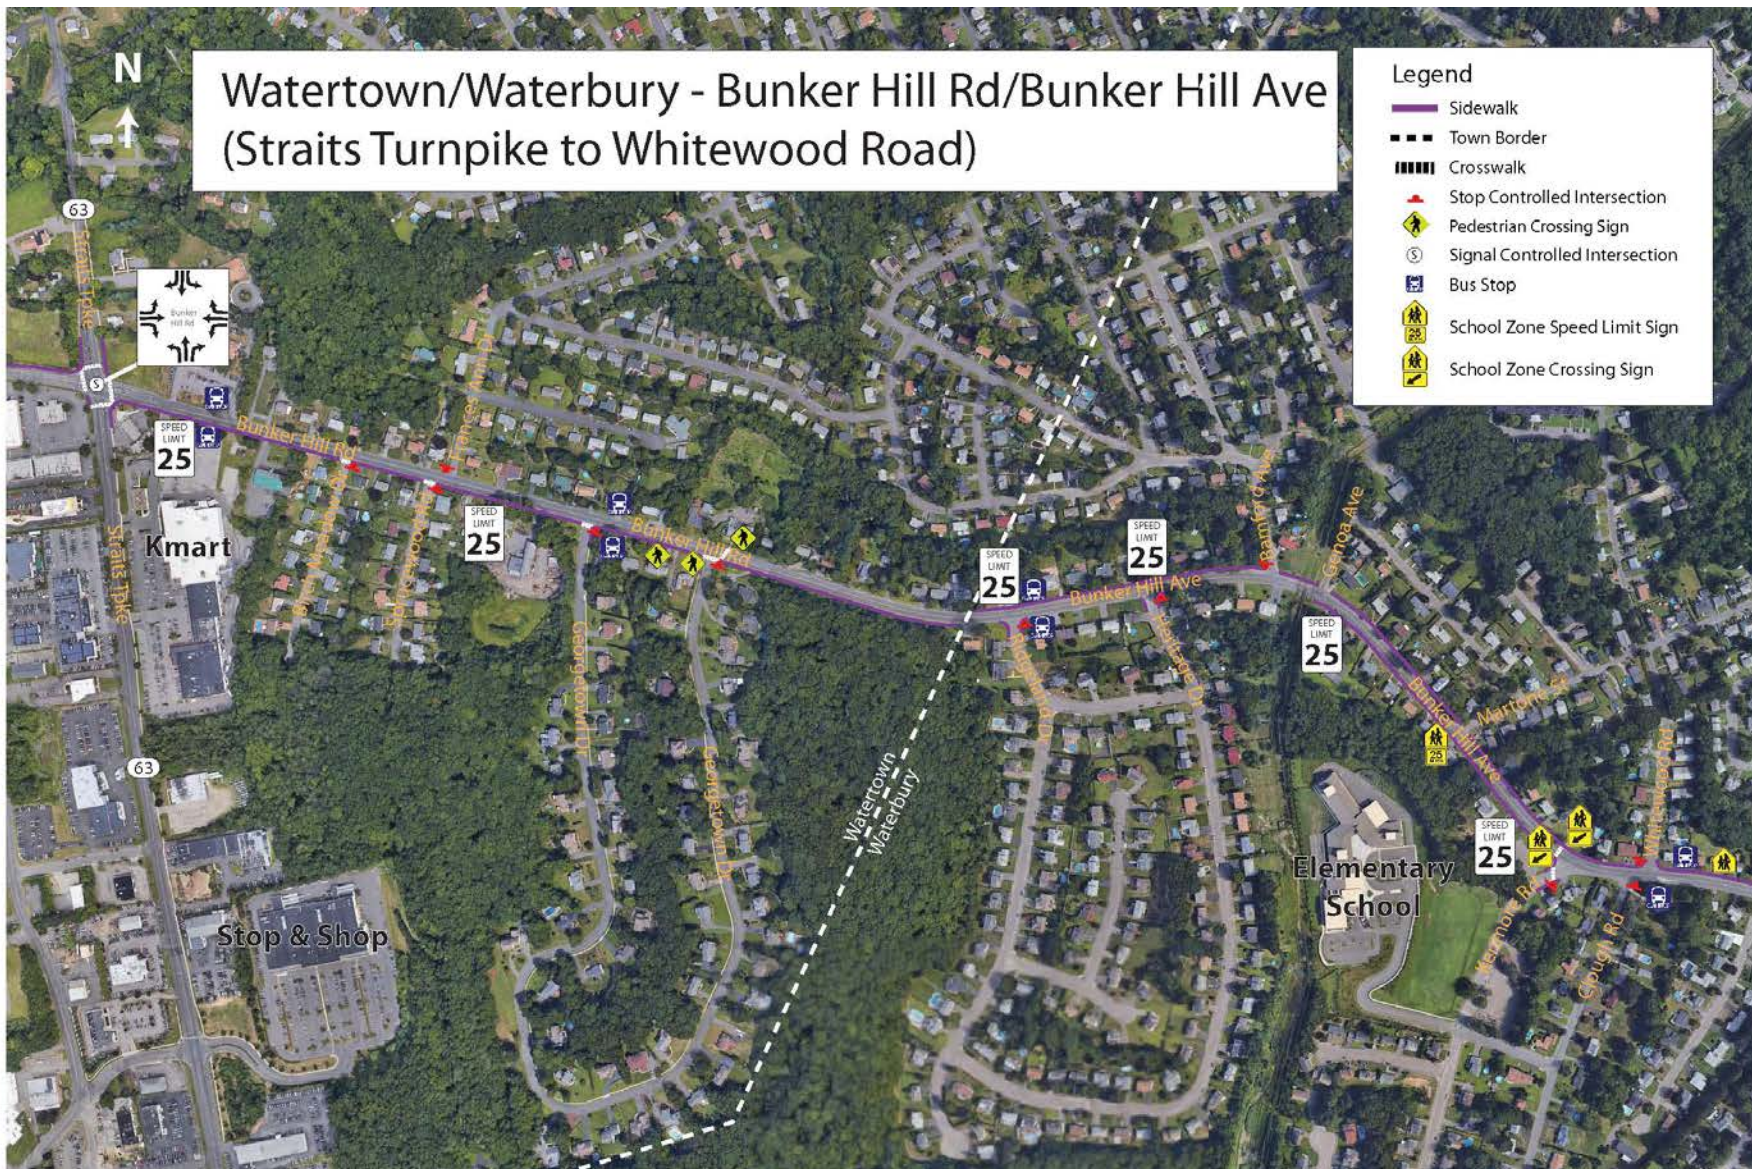
Figure 4: Bunker Hill Road Geometrics

Bunker Hill Road / Bunker Hill Avenue is a two-lane, local road with a posted speed limit of 25 MPH. Bunker Hill Road has sidewalk on the south side from the Waterbury town line to Straits Turnpike. Bunker Hill Avenue has sidewalk on the north side between the town line and Whitewood Road and on the south side between Genoa Avenue and Kenmore Road. The corridor has two midblock crosswalks at Georgetown Drive and Kenmore Road. There is one signalized intersection at the four-way junction of Straits Turnpike (Route 63) and Bunker Hill Road. The geometry of the corridor is shown in Figure 4 and described in Table 3.

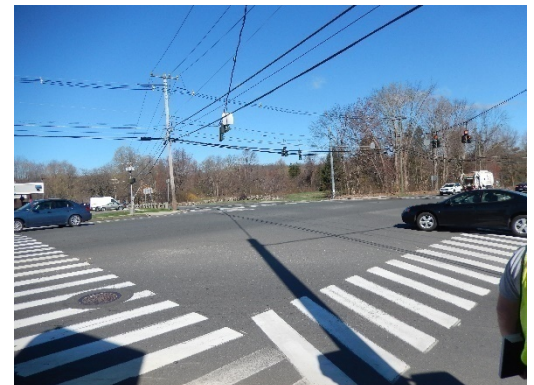
Figure 5: Straits Turnpike and Bunker Hill Road Intersection

- Bunker Hill Avenue and Straits Turnpike (Route 63) a four-way signalized intersection in the Town of Watertown.
- At this intersection, exclusive pedestrian activated signals are in operation; the eastern leg of the crossing is 83' long (Figure 5).
- Crosswalks are in good condition on all legs of

the intersection.

- Pedestrian head on the south-east corner is not properly aligned.
- Bunker Hill Ave measures 40' in overall width, east of Straits Turnpike; there is a double yellow center line only. There are no shoulder lines. (Figure 6).

5. Town of Watertown to coordinate with CTDOT District office to fix the pedestrian head at the Straits Turnpike and Bunker Hill Road intersection.
6. The Town of Watertown and City of Waterbury to coordinate with COG to conduct speed and pedestrian counts along the corridor.

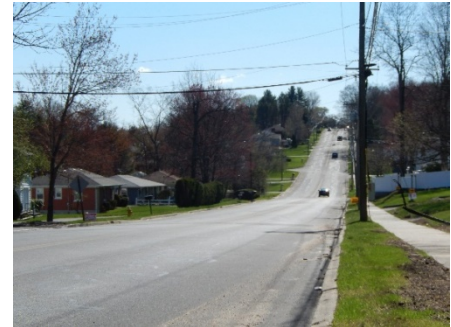
Figure 6: View of Bunker Hill Road corridor facing east

- There is adequate space to stripe a bike lane or a shoulder to if the travel lanes are narrowed to 11'.
- There is concrete sidewalk on the south side, adjacent to the eastbound travel lanes. They end at the town line.

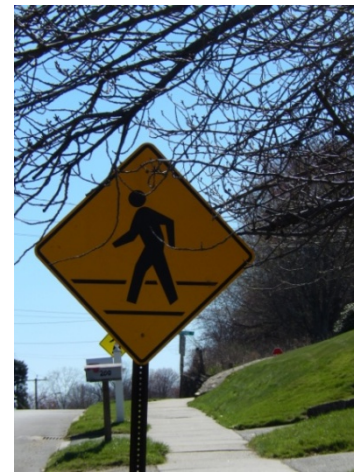
Figure 7: Pedestrian Crossing Sign

- Apple Rehab is located on the north side. There is an unorthodox pedestrian crossing sign along the westbound side just east of the entrance to the facility (Figure 7).

10. Town to reset the protruding water gate along the sidewalk in Watertown section of Bunker Hill Road.
11. Town of Watertown to remove pedestrian crossing sign at the Apple Rehab building, westbound.

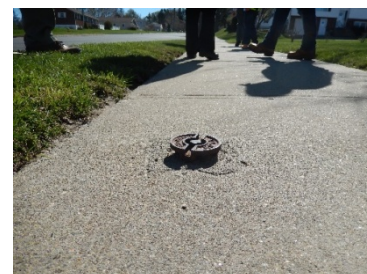
Figure 8: Utility access point obstruction

- There is a water gate that poses a tripping hazard in this section of sidewalk due to settlement (Figure 8).

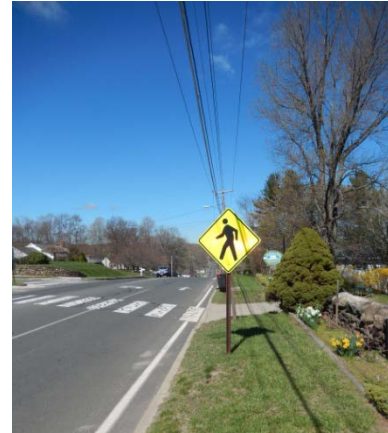
**Figure 9: Crosswalk at Pleasant View Manor**

- Georgetown Drive is a U-shaped road with two spurs intersecting Bunker Hill Road. The eastern leg intersects Bunker Hill Road in front of Pleasant View Manor. (Figure 9).

- Current pedestrian crossing signs lack the supplemental arrows to indicate the exact location of the crosswalk; the advanced warning signage along both approaches is incomplete, with no corresponding distance plaque.

9. Town to replace outdated pedestrian signs and install MUTCD compliant advanced crosswalk signage with distance indicator and down arrows for the Bunker Hill Road crosswalk in front of Pleasant View Manor (Figure 17).

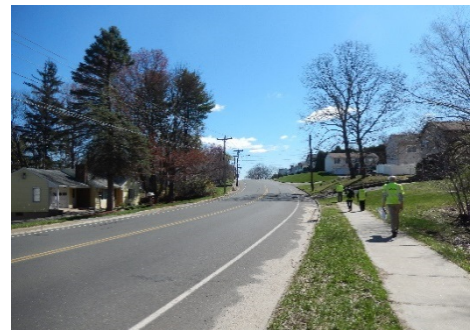
**Figure 10: Bunker Hill Road**

- Crosswalks are striped on Georgetown Drive and Bunker Hill Road (Figure 10).
- The Bunker Hill crossing has limited sight distance for vehicles approaching from both directions.

- Island in the center of the Georgetown Drive crossing separates the egress and ingress flow; exiting vehicles are restricted to turn right onto Bunker Hill Road at this intersection.

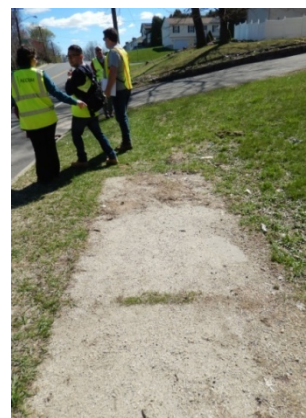
**Figure 11: Sidewalk termination in Watertown**

- East of the intersection at Ridgeland Drive, Bunker Hill Avenue (in Waterbury) widens to 45', with 6-7' shoulders along both sides.
- Sidewalk abruptly terminates on the southern side at the Waterbury/Watertown line (Figure 11).

- Sidewalk continues on the northern side of Bunker Hill Avenue in Waterbury.
- There are no pedestrian crossing features to cross Bunker Hill Road. The horizontal curvature and high travel speeds pose a hazard to walkers in this corridor.

1. Town to install a crosswalk to link the sidewalks along Bunker Hill Road and Bunker Hill Ave at current town line where sidewalks terminate and consider installing rectangular flashing pedestrian beacons at this crossing.
2. Town to determine if advanced pedestrian crossing warning signs with flashing beacons are warranted at this crossing.
3. Town to consider upgrading the crosswalk at Pleasant View Manor with the following safety features if warranted:
  - a. texturized materials;
  - b. raised crosswalk;
  - c. bump outs to narrow crossing (Figure 19); and
  - d. installing a hybrid pedestrian beacon signal.

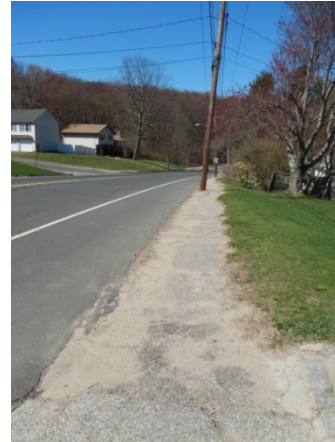
Figure 12: Sidewalk along Waterbury side

- The Waterbury segment of sidewalk is in poor condition, and constructed of bituminous asphalt. There is significant erosion and deterioration; sand deposits from the treatment of winter roads collect in the sidewalk area. (Figure 12).
- East of Genoa Avenue sidewalks are constructed along both sides of the road.
- There is no buffer between the sidewalk edge and road in the Waterbury section.
- The curb reveal is low on both sides of the corridor.
- The intersection of Kenmore Road and Bunker Hill Avenue is controlled by a side street stop sign. Signing for the school located on Kenmore Road is inconsistent. Although advanced School Zone crossing signs are posted, the eastbound sign has a 25-speed limit sign placard and the westbound sign does not. School crossing signs are posted on the west approach, but not the east.

1. Town to extend sidewalk along Bunker Hill Road east across Waterbury town line to connect to sidewalk at Genoa Avenue.
2. City to fix deteriorated sidewalk along Bunker Hill Ave in the City of Waterbury

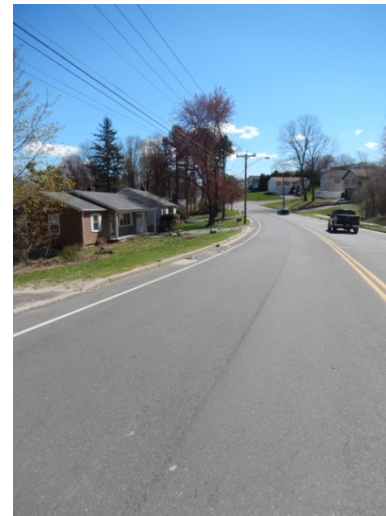
Figure 14: Current lane widths

9. The audit team would like to narrow travel lanes to 11' or 12' (Figure 14).
10. The team discussed installing rapid flashing rectangular beacons and advanced pedestrian crossing signs with beacons and distance plaques on both approaches to the crosswalk at Pleasant View Manor.

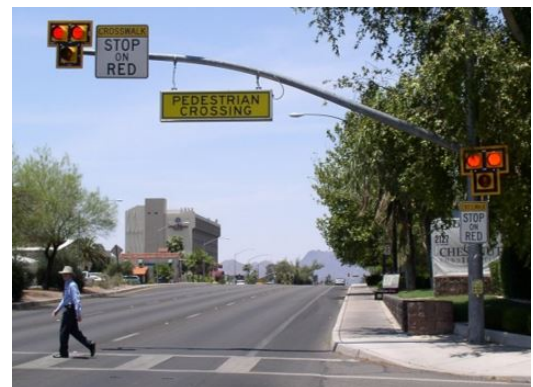
Figure 15: Hybrid Pedestrian Beacon

15. The Town to contact the COG for pedestrian counts.
16. Town to investigate the warrant for installing a HAWK signal at the current crosswalk at Pleasant View Manor and at the proposed one on Bunker Hill Avenue (Figure 15).

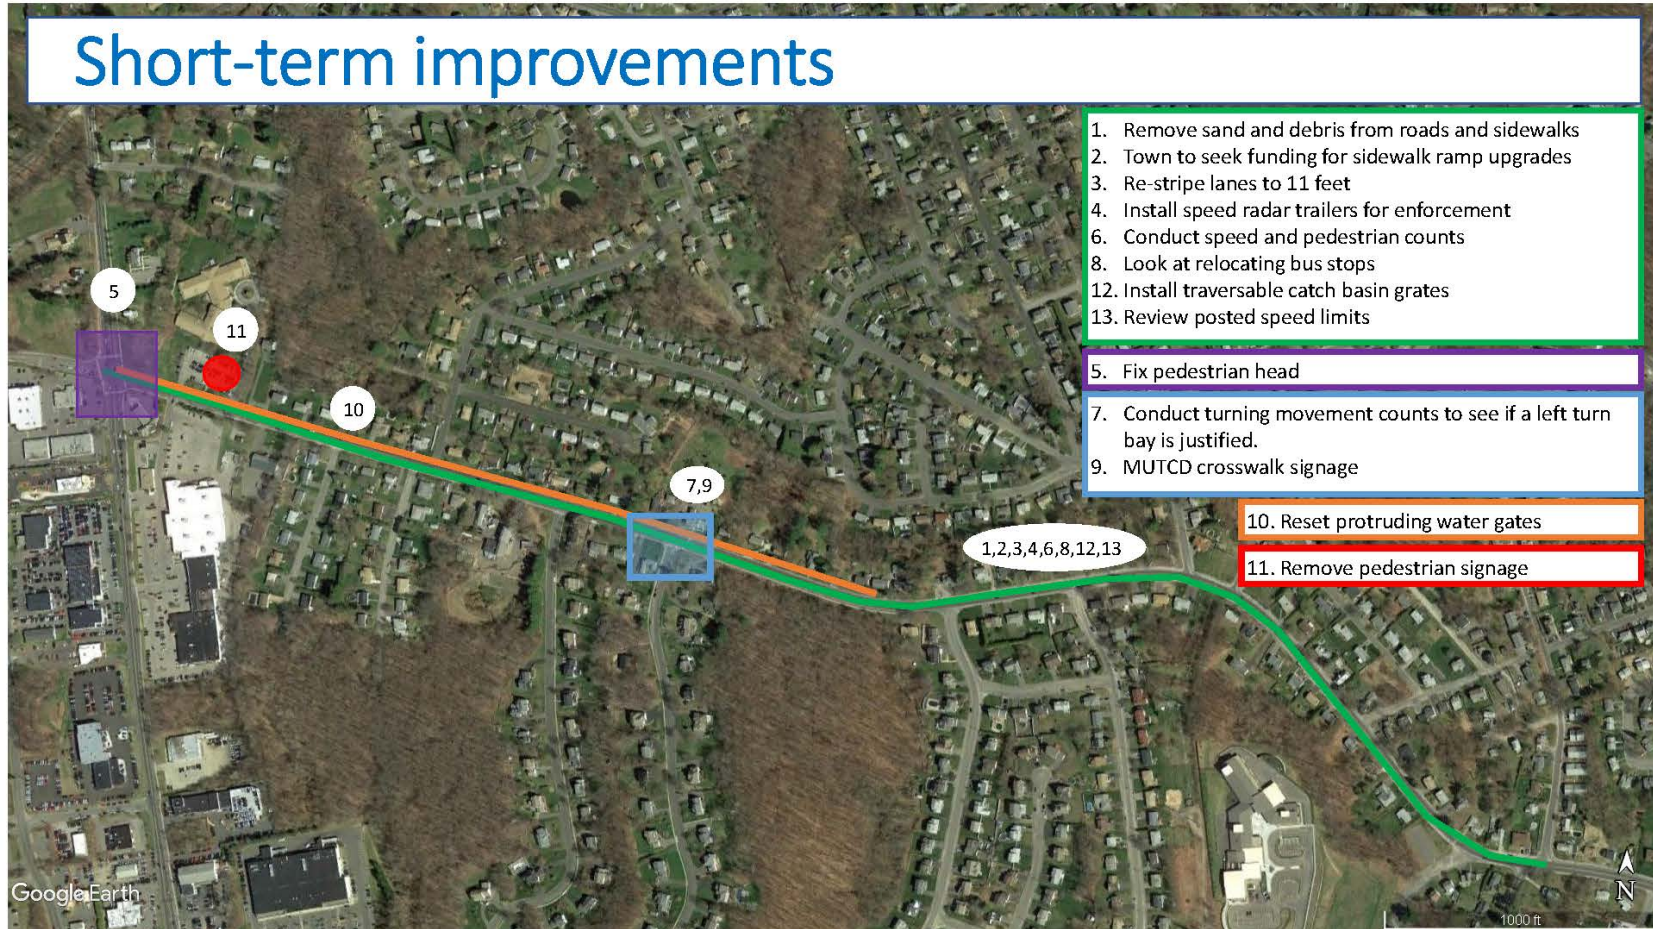
Figure 18 Short Term Recommendations

Figure 18 depicts these recommendations.

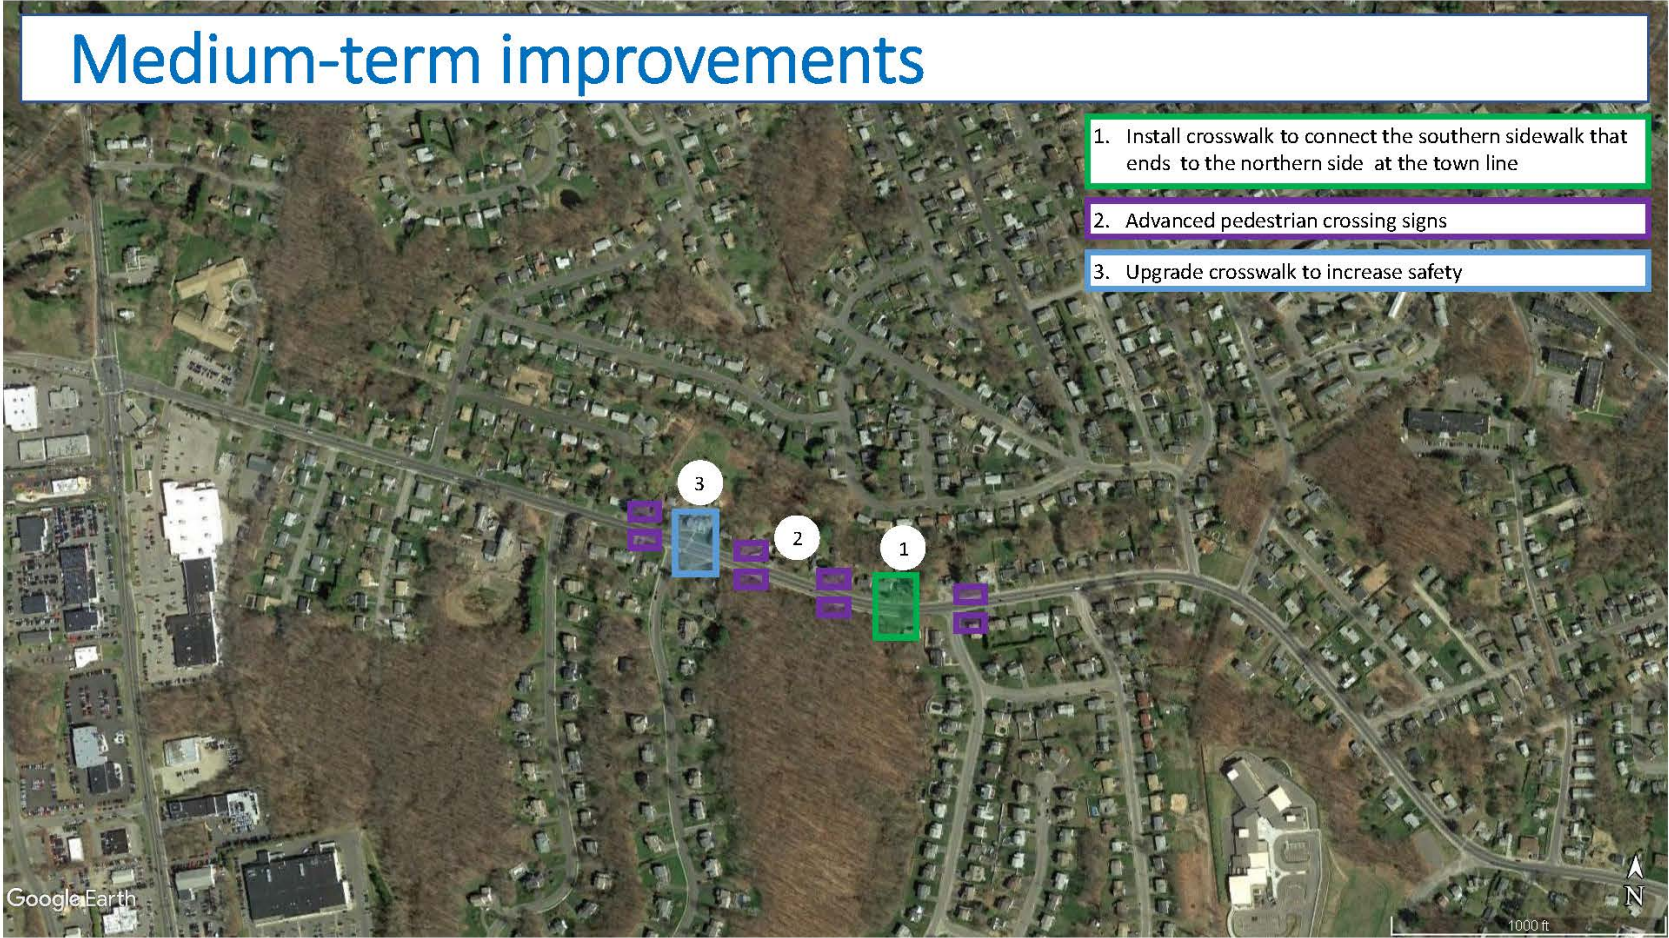
Figure 20 Mid Term Recommendations

Figure 20 depicts these recommendations.

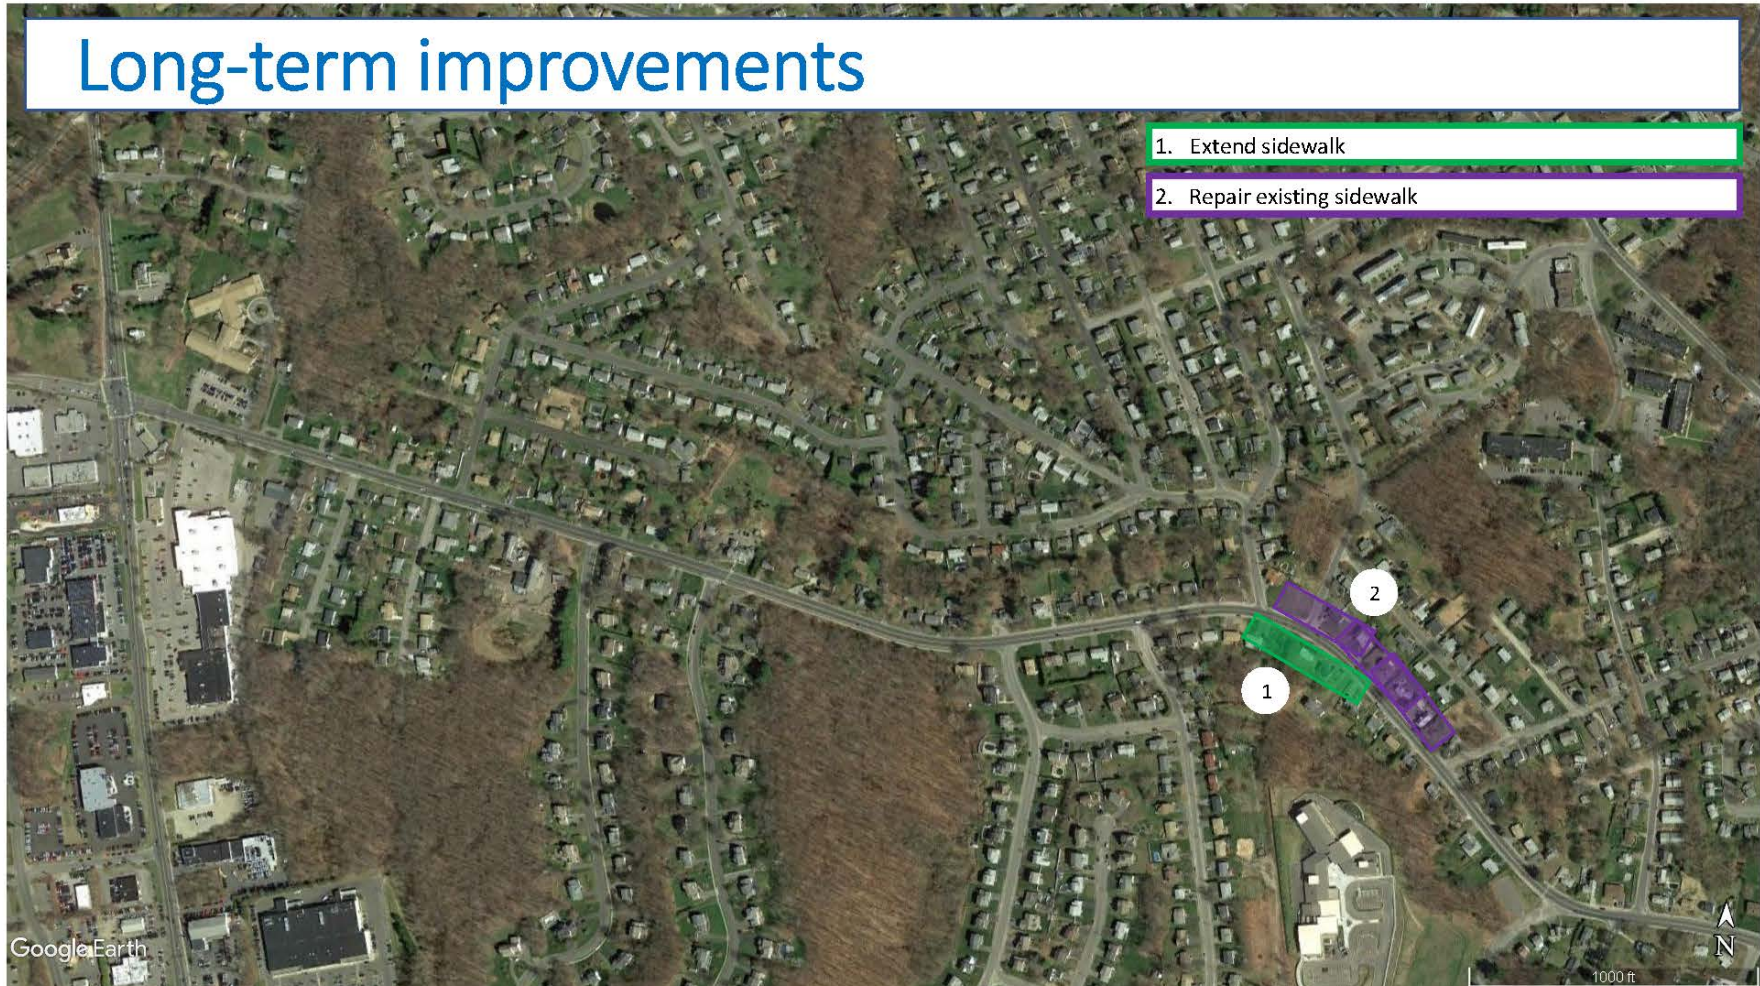
Figure 21 Long Term Recommendations

Figure 21 depicts these recommendations.
