COMMUNITY
connectivity program

Windsor Avenue (Route 159) – Road Safety Audit

April 28- 2016

AECOM

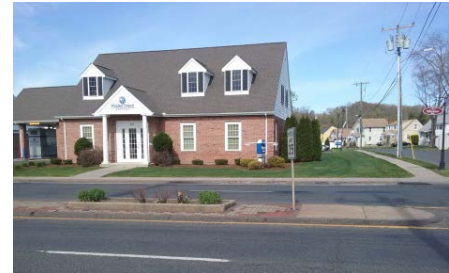
Figure 5. Center Median

- Although the roadway is state-owned, the town maintains the center medians (Figure 5).
- How will the proposed road diet impact speeds?
- The curbing is broken or missing in sections (Figure 6).

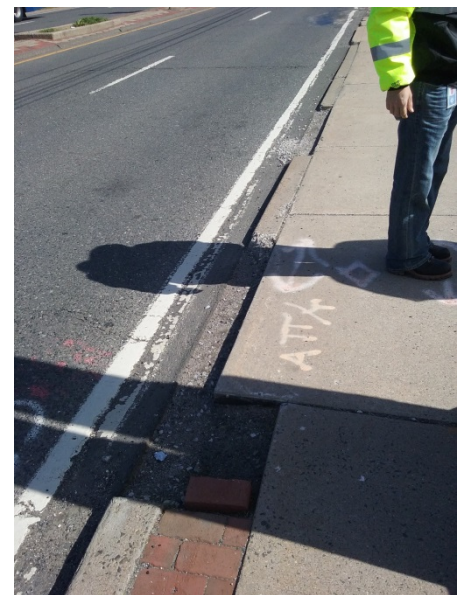
Figure 6. Broken Curbing

- Due to past repaving, most of the curbs are not 6 inches high. Many are flush or within 2 inches of the roadway.
- The median averages 8 feet wide as is desired to remain as a visual aesthetic and traffic calming element.

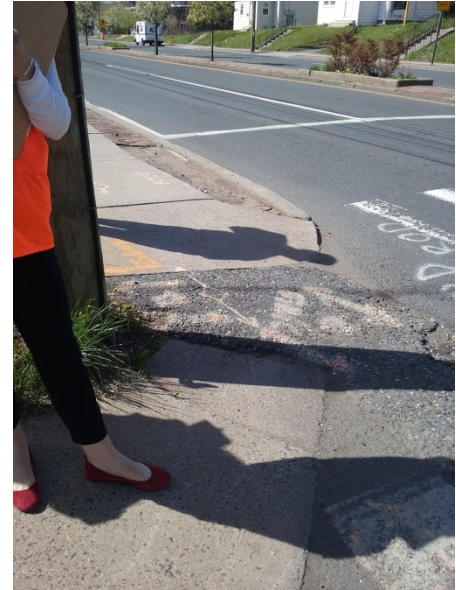
Figure 7. Narrow Sidewalk Ramp with Inadequate Landing

- Could the outside shoulders proposed with the road diet be striped as designated bike lanes?
- Many sidewalk ramps don't have tactile warning strips, are narrow and the ramps are not ADA compliant (Figure 7). There are signs that protrude into the walkway and do not have the required 7-foot of clearance (per the MUTCD).

- c. Replace sidewalk ramps and/or add detectable warning strips to ramps where needed (Figure 17).
 - d. Add a crosswalk across Deerfield Road south of Portman Street and remove the Deerfield Road crossing at Windsor Avenue to shorten the crossing distance.

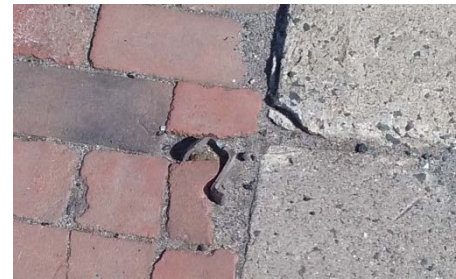
Figure 8. Sign Stub Trip Hazard

- Old sign post stubs stick out and are tripping hazards (Figure 8).
- In some locations the crosswalk paint is very faded (Figure 9).
- Pedestrian phase signals do not have count downs.

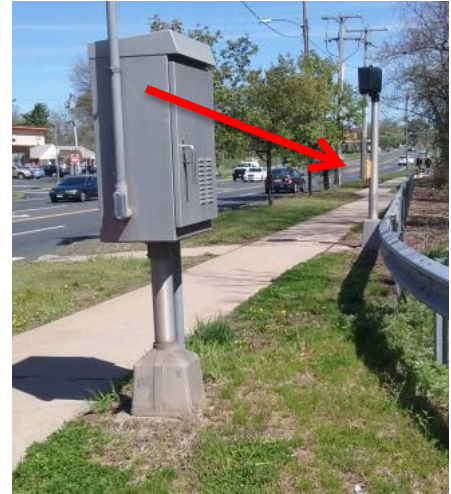
Figure 10. Pedestrian Push Button Far From Crosswalk

- The pedestrian phase push button is far from the intersection (Figure 10).
- The snow shelf under the bridge is 14 feet wide.
- There are no sidewalk lights under the overpass bridge (Figure 11).

1. Bring all ramps into compliance with current ADA standards.
2. Replace existing pedestrian signals with count down signals (Figure 20).
3. Relocate pedestrian push buttons with ADA buttons in the correct locations.
4. Conduct a traffic/concept study of corridor, including capacity, additional bicycle accommodation, pedestrian safety, land use, access management, and drainage.
5. Improve street and sidewalk lighting at the I-291 overpass.
6. Improve lighting at the pedestrian crossing at Stroh Park.

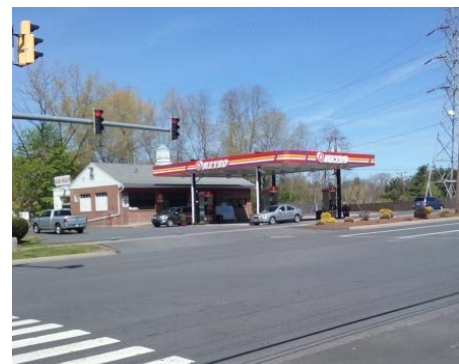
Figure 12. Uncontrolled Drive Opposite Price Rite

- There is a signal at the north drive to the Price Rite shopping plaza, and a gas station is located on the opposite side of Windsor Avenue. The gas station has two very wide driveways. The southern driveway is located within the signalized intersection zone, and the Windsor Avenue stop bar is in the center of the driveway. There are no signal indications controlling the gas station driveway. This creates confusion for vehicles entering and exiting the driveway (Figure 12).

5. All signalized crossings should have pedestrian signal heads and phasing.
6. Replace brick pavers with stamped concrete (23).
7. At the north signalized driveway for the Price Rite shopping plaza, geometric and signal modifications are needed to:

- o These improvements will require signalization modifications, median modifications and curb/driveway modifications.
8. Relocate utilities out of the sidewalk envelope.

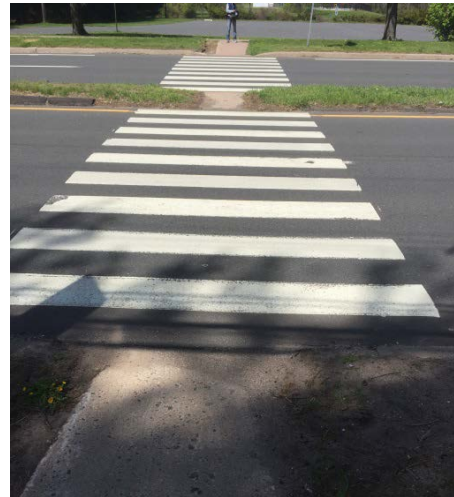
Figure 13. Mid-Block Crossing at Stroh Park

- The mid-block crossing between the large apartment complex and Stroh Park is heavily used by children in the summer. There is no sight distance issue but speeds are high, making the crossing difficult. The sidewalk ramps and median

sidewalk are narrow, with dirt encroaching and apparent drainage issues (Figure 13).

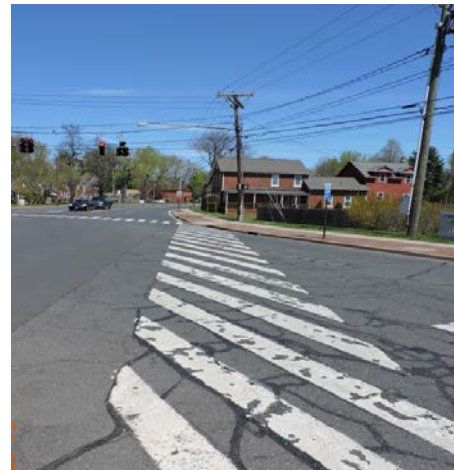
Figure 14. Long, Skewed Crossing at Deerfield Road

- Rood Avenue has no pedestrian push button to cross even though it is a signalized crossing with a crosswalk.
- The crossing across Deerfield Road is long and skewed.
- There is not enough time to complete the crossing on Deerfield Road.
- Vehicles can turn right on red from Deerfield Road even though it is a shallow angle. To see oncoming traffic they must pull into the crosswalk (Figure 14).

- 4. Evaluate the Deerfield Road intersection to improve geometry.
 - 5. Relocate loop detectors that are in the cross walk at Rood Avenue (Figure 18).
 - 6. Work with CTDOT to allow active speed detectors to be placed on state roads.

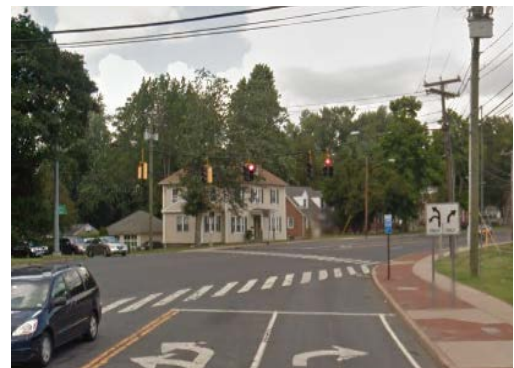
Figure 15. Deerfield Road "No Turn On Red" Approach

- a. Adjust signage height to meet the required seven (7) feet standard.
- b. Consolidate signs, where possible, to reduce visual clutter.
- c. Relocate all signs out of the pedestrian way.
- d. Replace worn-out signs with reflective signs.
- e. Remove or cut down old sign stubs so that they are flush with the pavement.
- f. Establish "No Turn on Red" and install appropriate signing for Deerfield Road turning onto Windsor Avenue (Figure 15).
