COMMUNITY
connectivity program

Woodbridge Business District – Road Safety Audit

July 15, 2016

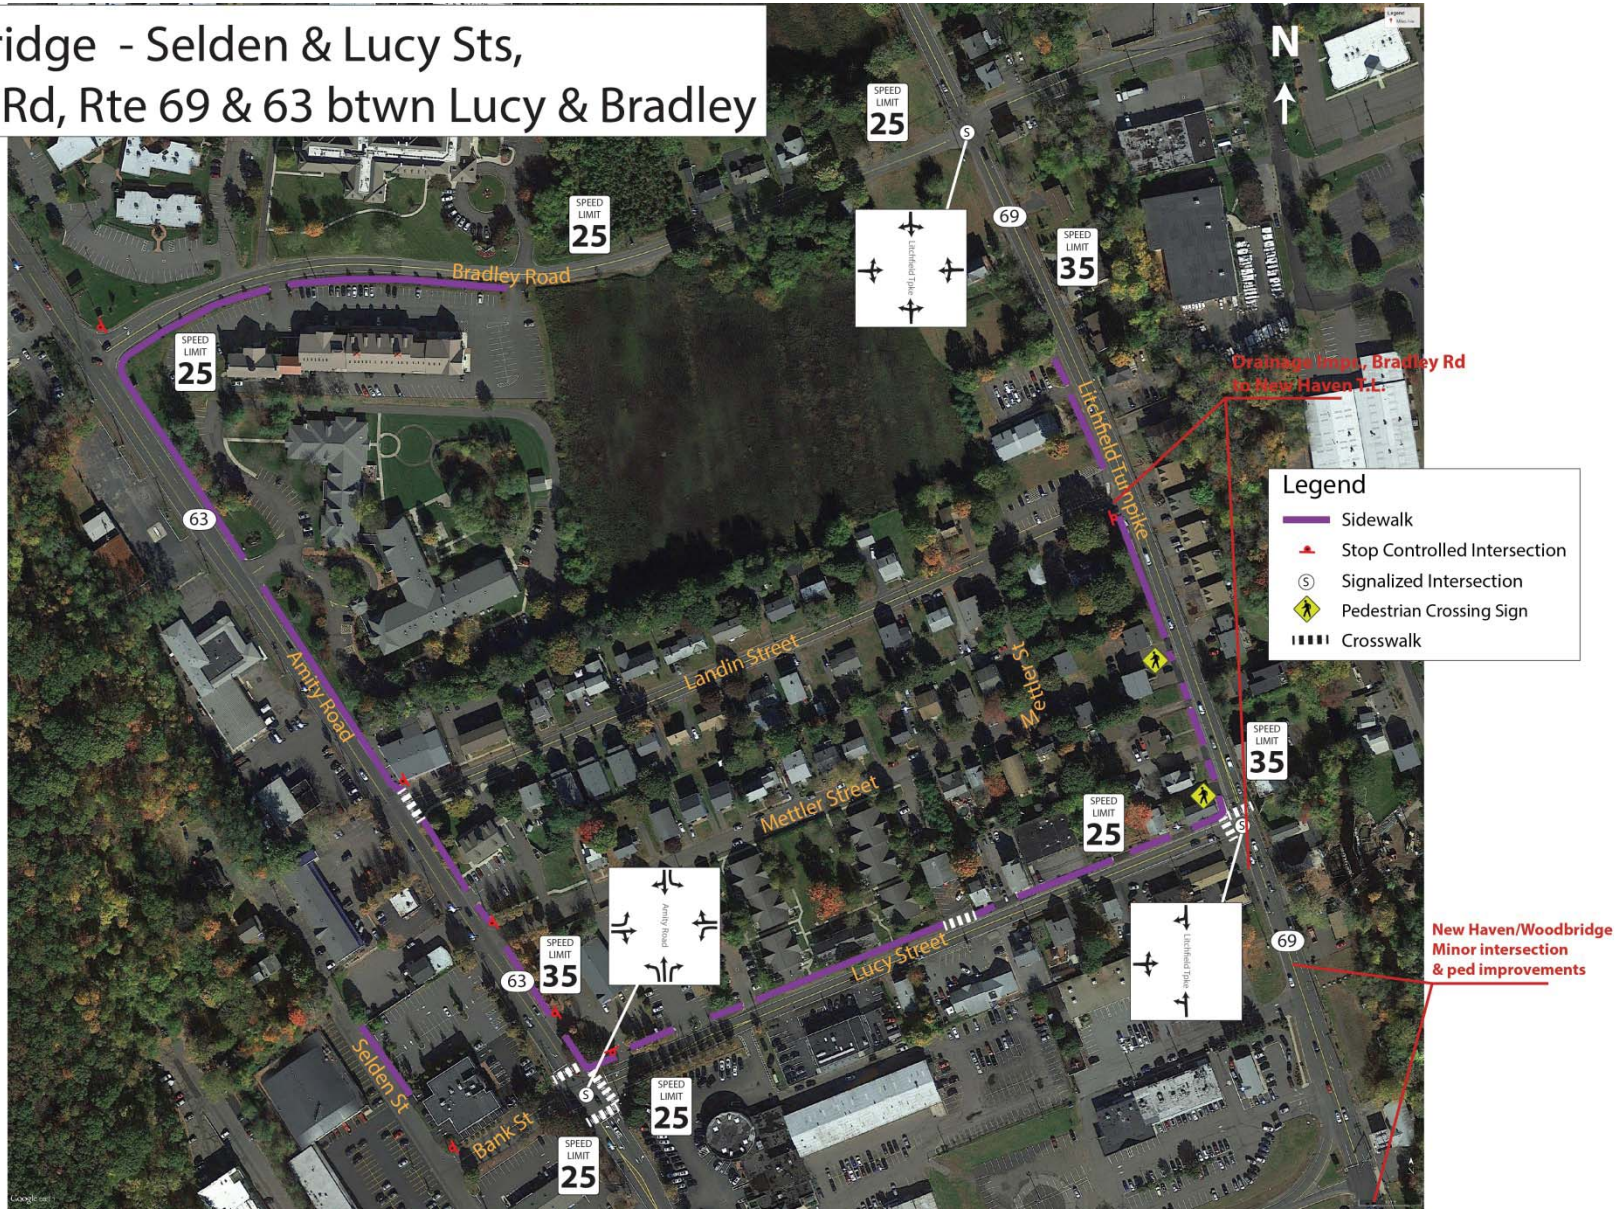
Figure 4. Woodbridge Business District Roadway Geometrics

Roadway geometrics for the audit corridor roadways and intersections are shown in Figure 4. An inventory of corridor streets is provided in Table 3.

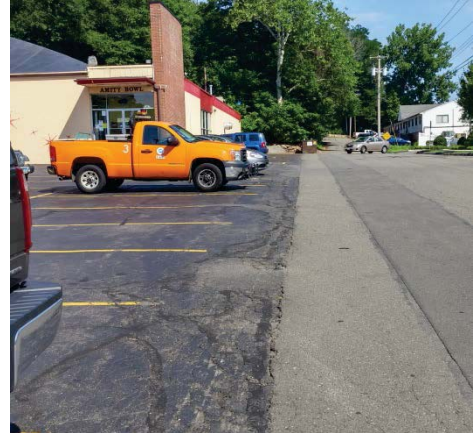
Figure 5. No Driveway Curb Cut

- There is no defined exit or entrance to Selden Plaza. Vehicles can enter or exit anywhere along Selden Street because there is no curb cut. (Figure 5).
 - At night, visitors to the town center will use this lot for parking after business hours.
- It may be possible to move the curb on the south side of Bank Street back in order to make room for a sidewalk.
 - The Town would like to maintain the tree line on the south side of Bank Street.
- The width of Bank Street varies between 30 and 36 feet (Figure 6).
- The Town would like to install lighting along Bank Street to lead people back to their cars on Selden Street.

- There is essentially no access management to the Selden Plaza. There is no curb cut and no defined entrance or exit. Vehicles can drive straight into or out of a front row of parking spaces at the edge of the parking lot and street. Normally this design would not be allowed, but was grandfathered when the town ordinance was developed. It is not currently a priority to modify the access.

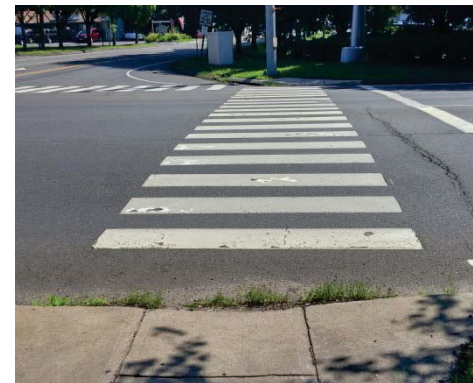
Figure 7. Ramp Missing Detectable Warning Strips/no Sidewalk Connection at Ramp Landing

- There is no crosswalk at the Bank Street approach.
- The three ramps provided are not ADA compliant and missing pedestrian detectable warning strips (Figure 7).

- This crosswalk has the only pedestrian signal heads at the intersection.
- This pedestrian signal does not have a countdown display during the walk phase. It only provides walk and don't walk displays.
- The walk phase does not appear to be long enough to meet the current crosswalk standards.
- Both sides of the crosswalk leave pedestrians on a ramp landing with no sidewalk connection (Figure 7).

- The pedestrian facilities at the intersection of Amity Road, Bank Street and Lucy Street are incomplete. The Bank Street approach does not have a crosswalk. Three crossings do not have a pedestrian signal; therefore, pedestrians cannot call for a pedestrian phase and may not know when they can cross. One corner is missing a pedestrian landing despite having a crosswalk leading to it. The signal equipment including the one pedestrian signal is out of date.

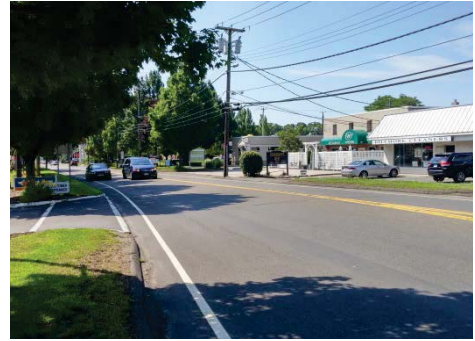
Figure 8. Potential for Sidewalk on West (left) Side of Amity Road

- Evaluate a left turn signal for the Bank Street approach.
- The west side of Amity Road would be preferred for a sidewalk south of Bank Street (Figure 8).

- There is no sidewalk on Bank Street; however, the Town would like to construct a sidewalk on one side of Bank Street with sidewalk lighting.
- The sidewalk on Amity Road ends at the intersection with Lucy Street and Bank Street. The sidewalk does not continue south towards the New Haven City Line. Pedestrians do not have a walking connection between Woodbridge and New Haven.

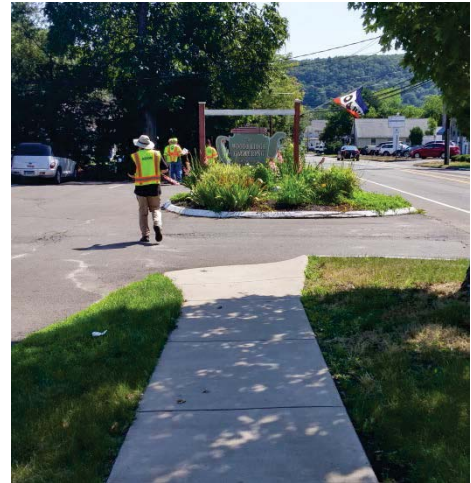
Figure 9. Sidewalk interrupted by Restaurant Sign

- The sidewalks are four feet wide and parts are experiencing heaving.
- Travel Lane widths: Five-foot westbound shoulder, nine-foot westbound lane, twelve-foot eastbound lane and two foot eastbound shoulder.
- The sidewalk is discontinuous at the driveway to Woodbridge Gathering Restaurant. The pedestrian path is interrupted by the restaurant's sign. The sign appears to be within the right-of-way (Figure 9).
- The driveway to Progressive is 55 feet wide with a steep slope and a non-conforming crosswalk most likely installed by the property owner.
- The hedges at 29 Lucy Street are overgrown and block some of the sidewalk (Figure 10).
- Sidewalk width increases to six feet at M&M Heating and Cooling.

- On Lucy Street, the sign for Woodbridge Gathering Restaurant is located on an island that appears to be within the right-of-way, and that interrupts the path of the sidewalk. Pedestrians must walk around the island in the middle of the restaurant driveway either in the shoulder or behind the landscaped island. This may be especially difficult for sight impaired users to navigate.

1. Inform the owner of the Woodbridge Gathering Restaurant that they must modify or remove their sign on the landscaped island within the right-of-way.
2. Inform the owner of 29 Lucy Street that there is a town ordinance requiring them to maintain their vegetation so that it does not encroach on the sidewalk.
3. The Local Traffic Authority (LTA) of Woodbridge should contact the Office of State Traffic Administration (OSTA) about receiving a pedestrian facility upgrade at the signalized intersection of Litchfield Turnpike and Bradley Road.
4. The LTA should contact CTTransit to request improvements at bus stops.
5. The LTA should contact CTTransit about relocating the bus stop on Amity Road to the Bradley Plaza in order to avoid having pedestrians crossing Amity Road.

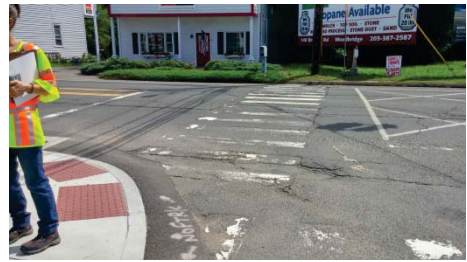
Figure 11. Worn Crosswalk Paint/ crosswalk Does Not Lead to Ramp Landing (northeast corner)

- There are two “push button for green” pedestals for pedestrians.
- There is no exclusive pedestrian phase.
- There is only one traffic signal for pedestrians, but no pedestrian signal.
- The paint on both crosswalks is worn out (Figure 11).
- Only the northwest corner has an ADA ramp and it is not compliant to the current standard.
- The ramps and crosswalks lead to destinations with no sidewalk, ramps or landing areas for pedestrians (Figure 13).

- The pedestrian facility is also incomplete at the signalized intersection of Litchfield Turnpike and Lucy Street. There is no exclusive pedestrian phase and no pedestrian signal which communicates to pedestrians that they can cross. There is only one sidewalk on the northwest corner. This intersection is planned to be improved as part of a project on Litchfield Turnpike by the CTDOT that will include a signal upgrade along with sidewalks on both sides of Litchfield Turnpike.

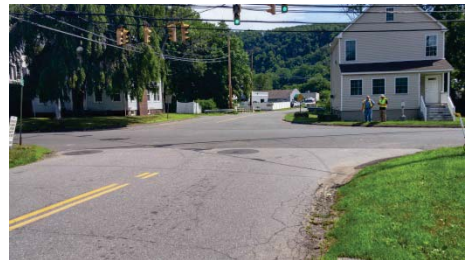
Figure 13. No Pedestrian Facilities

- There are no crosswalks, sidewalks or pedestrian signals at this intersection (Figure 13).
- There are two “push button for green” pedestals.

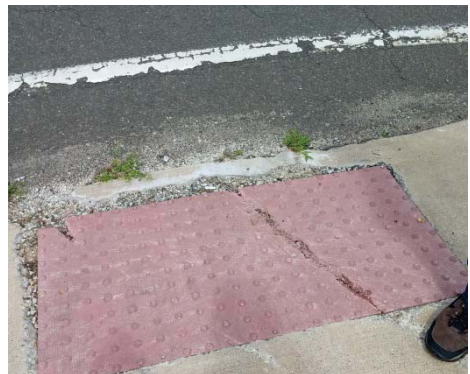
Figure 14. Handicap Ramp at South Corner of Bradley and Amity Road

- Ramp at the south corner of Bradley Road and Amity Road (Figure 14):
 - Detectable warning strip is not ADA compliant and is damaged.
 - The ramp directs people into the intersection.
 - The ramp does not lead to a crosswalk, sidewalk or ramp.

- There are multiple access driveways and intersections in the study area that do not have correctly aligned pedestrian ramps and are lacking crosswalks and detectable pedestrian warning strips.

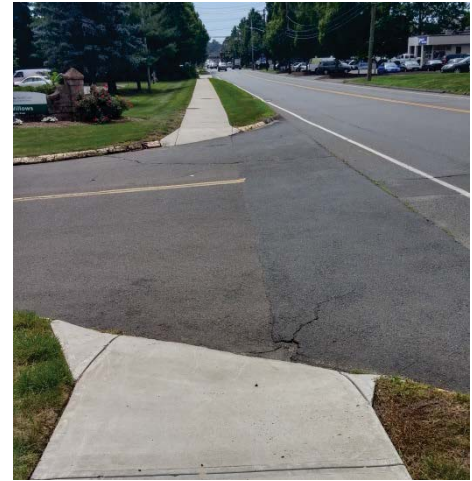
Figure 15. Handicap Ramp at The Willows

- The Willows driveway has a handicap ramp with no detectable warning strip or crosswalk (Figure 15).
- At Mettler Street the north ramp has a detectable warning strip but it does not direct pedestrians toward the ramp on the south side of the street. The south ramp does not have a detectable warning strip. (Figure 16)
- In front of Monro Muffler the sidewalk narrows to four feet.
- Landin Street has detectable warning strips, ADA ramps and a crosswalk. The ADA ramps do not direct pedestrians across the crosswalk.

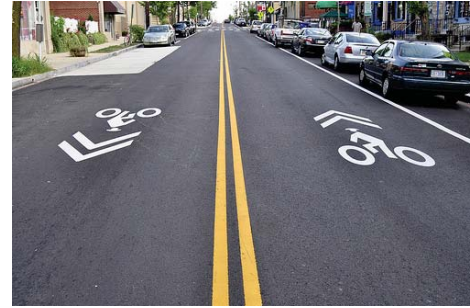
Figure 17. Sharrow Striping

6. The LTA can contact OSTA and request sharrow pavement markings on Lucy Street (Figure 17).
7. The Town of Woodbridge can update the standards of their public roads.

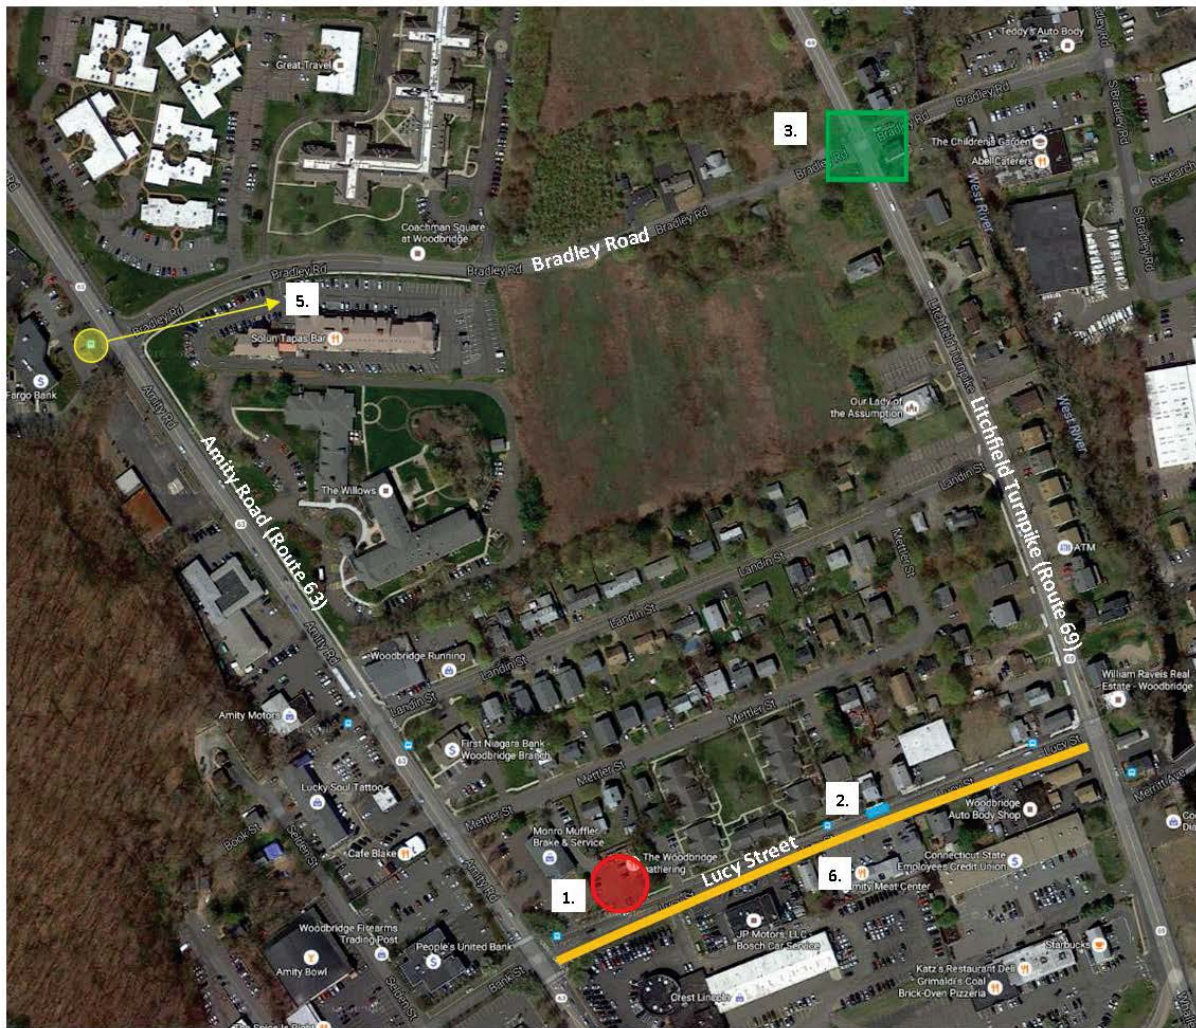
1. Intersection of Amity Road, Bank Street and Lucy Street;
Figure 18. Short Term Recommendations Map

1. Remove or modify Woodbridge Gathering Restaurant sign

2. Request that 29 Lucy Street maintain vegetation

3. LTA to contact OSTA about pedestrian facility upgrade

5. LTA to contact CT Transit about relocating Amity Road bus stop on Amity Road to Bradley Plaza

6. LTA to request sharrows on Lucy Street

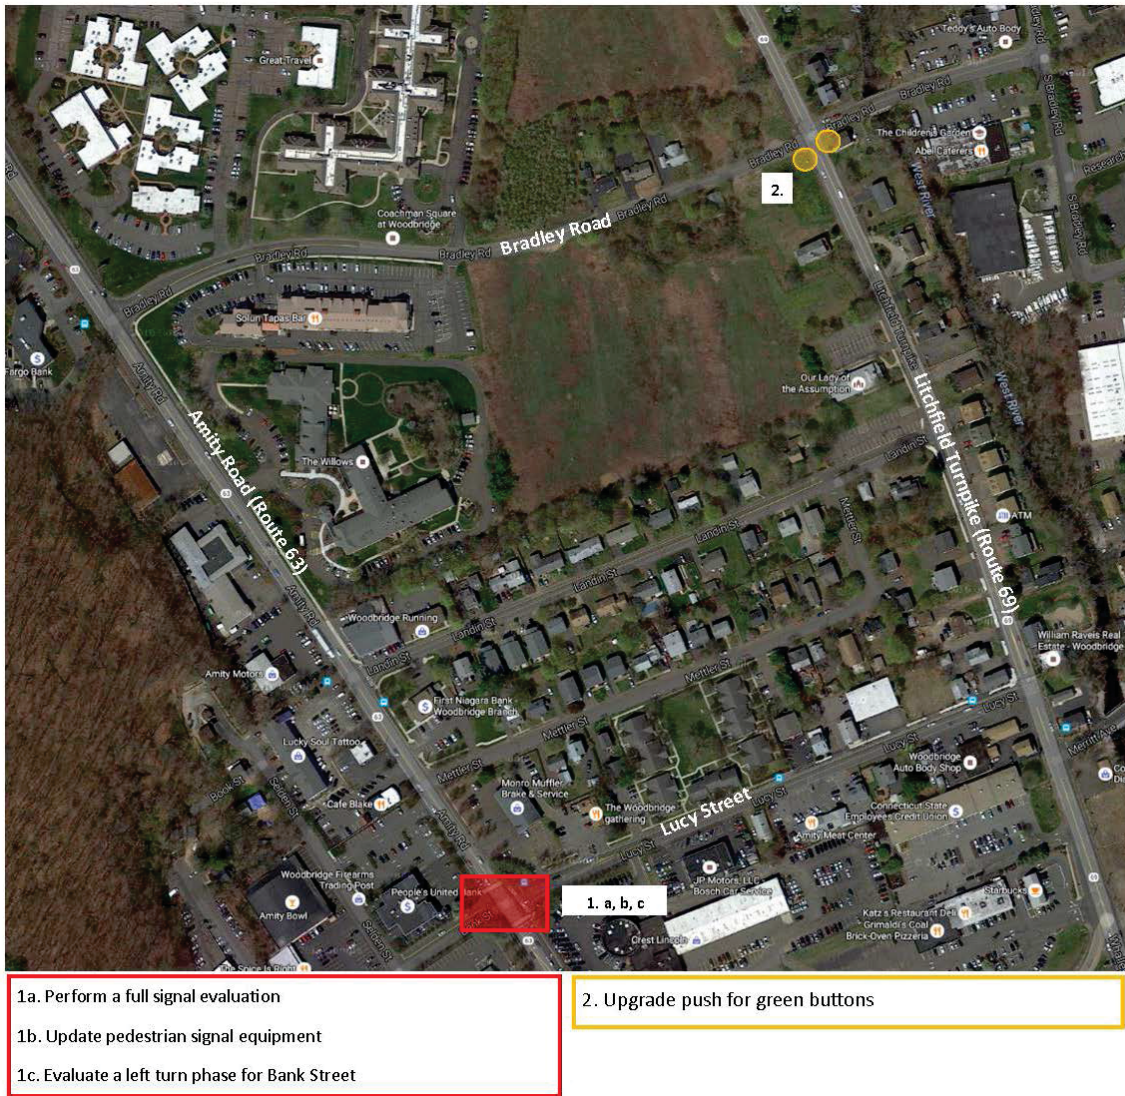
Figure 19. Medium Term Recommendations Map

- b. Update pedestrian signal equipment; and
 - c. Evaluate a left turn phase for Bank Street.
2. Upgrade the "push for green" buttons at the intersection of Litchfield Turnpike and Bradley Road.
