**Hot Mix Asphalt Research Investigation
For Connecticut:
Part E – Comparison of Field Performance
Of Superpave and Traditional Marshall Mixes**

Report Number CT-2250-3-12-9
July 24, 2014

SPR 2250 – Part E

Connecticut Advanced Pavement Laboratory
Connecticut Transportation Institute
University of Connecticut

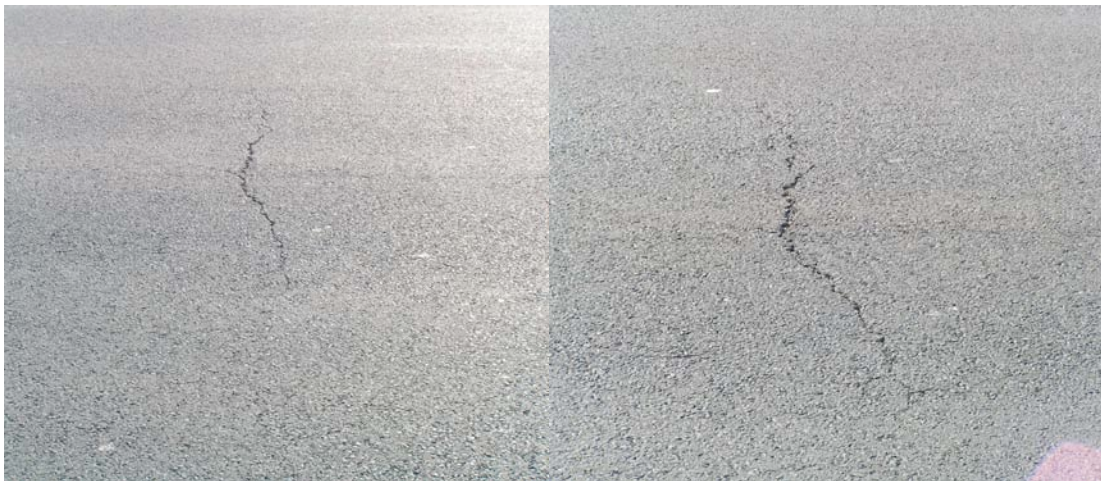
Figure 2. SuperPave 1 Year Transverse Crack Progression (Rt 140, Ellington)

Winter '08 & '09 Transverse Crack

Winter '09 & '10' Transverse Crack

During the second visit to each of the site sections, a general overview of the condition of the roadway was made, and several photographs of the pavements were again taken. Also during the second visit, the partially developed crack which was selected and photographed during the first visit was located and re-photographed for comparison purposes. A Year 1 and Year 2 comparison example is shown for both a Superpave section (Rt. 140 in Ellington) as well as a Marshall section (Rt. 66 in Columbia) in Figures 2 and 3 respectively.

The images were taken at slightly different angles, which may give the viewer a false impression that the cracks exhibited some change over the course of the year. In fact, none of the cracks in the 16 pavement sections examined for this research study exhibited any noticeable change over the course of one year.

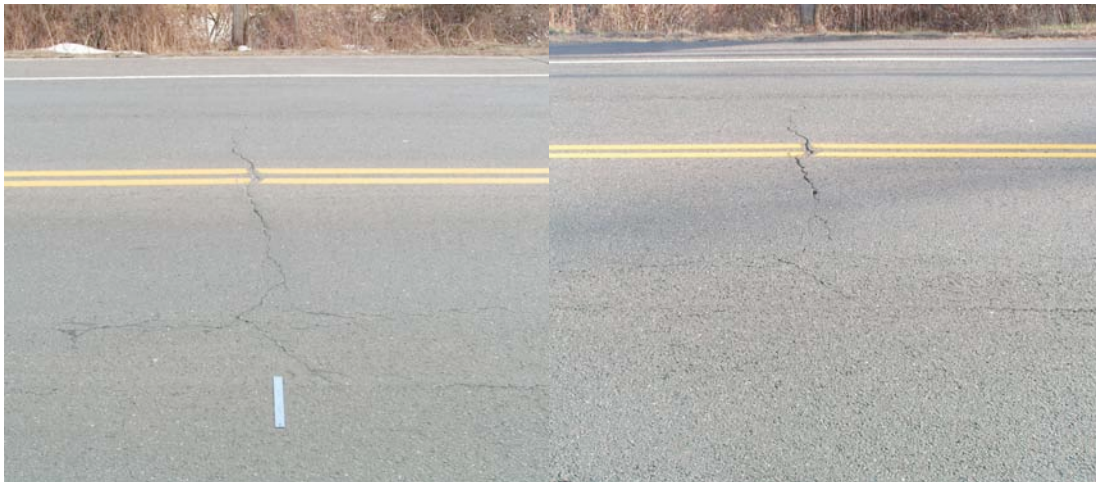
Figure 3. Marshall 1 Year Transverse Crack Progression (Rt 66, Columbia)

Winter '08 &'09 Transverse Crack

Winter '09 &'10 Transverse Crack

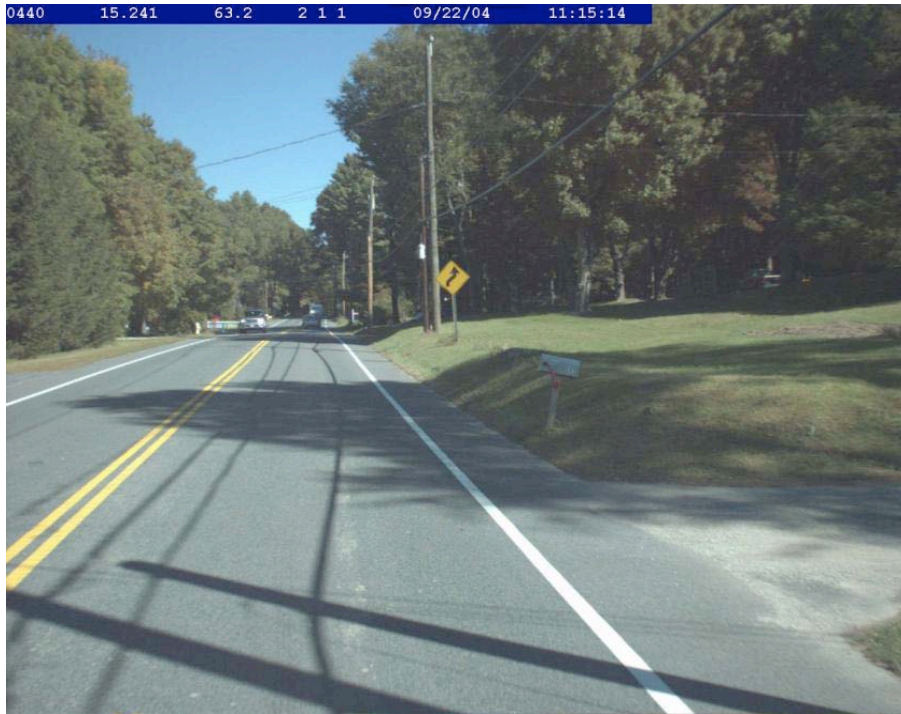
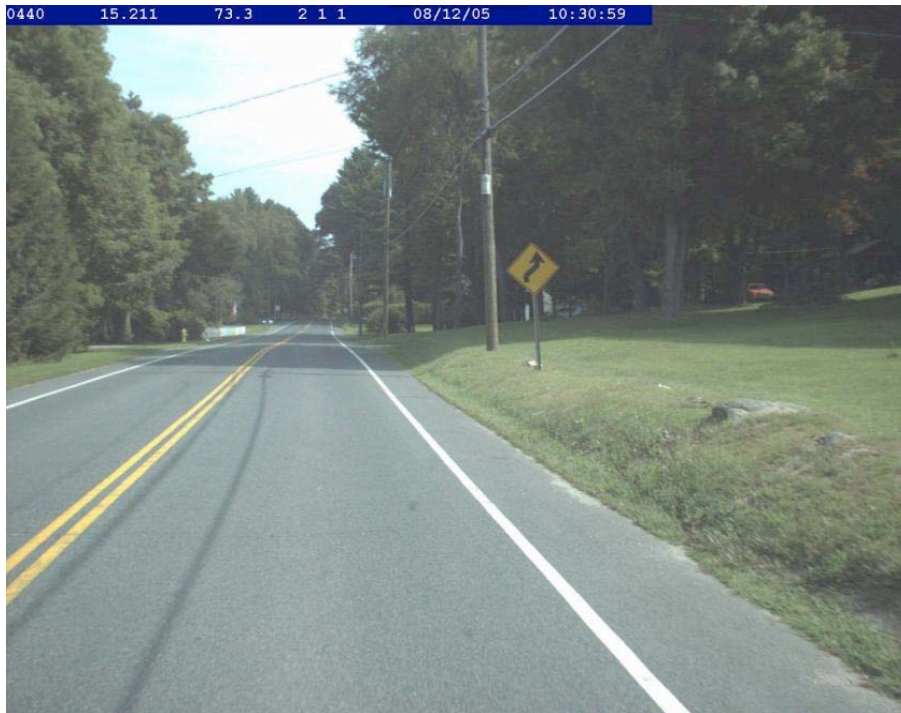
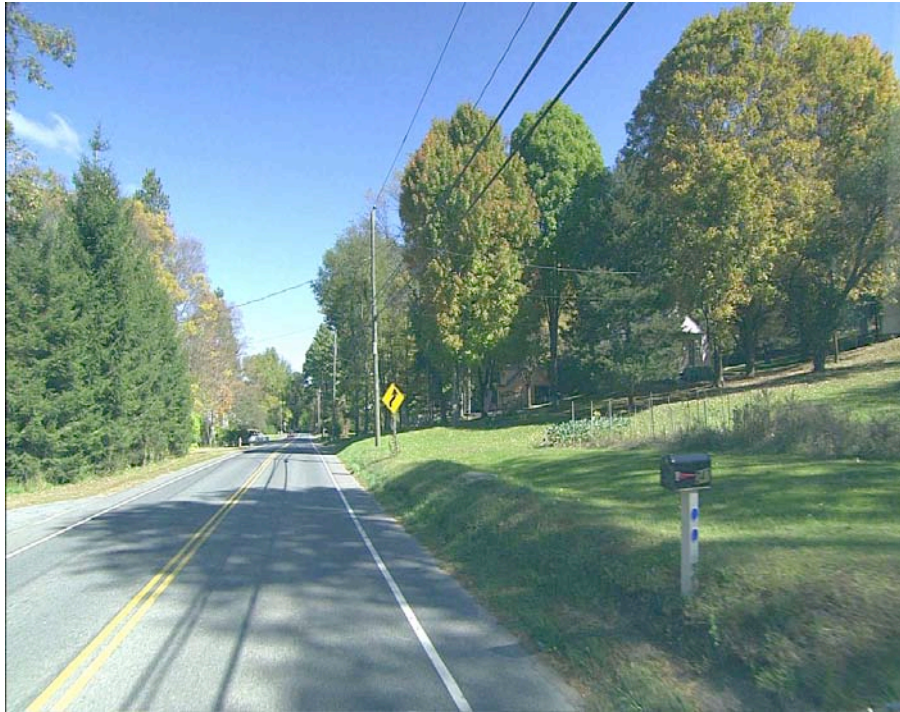
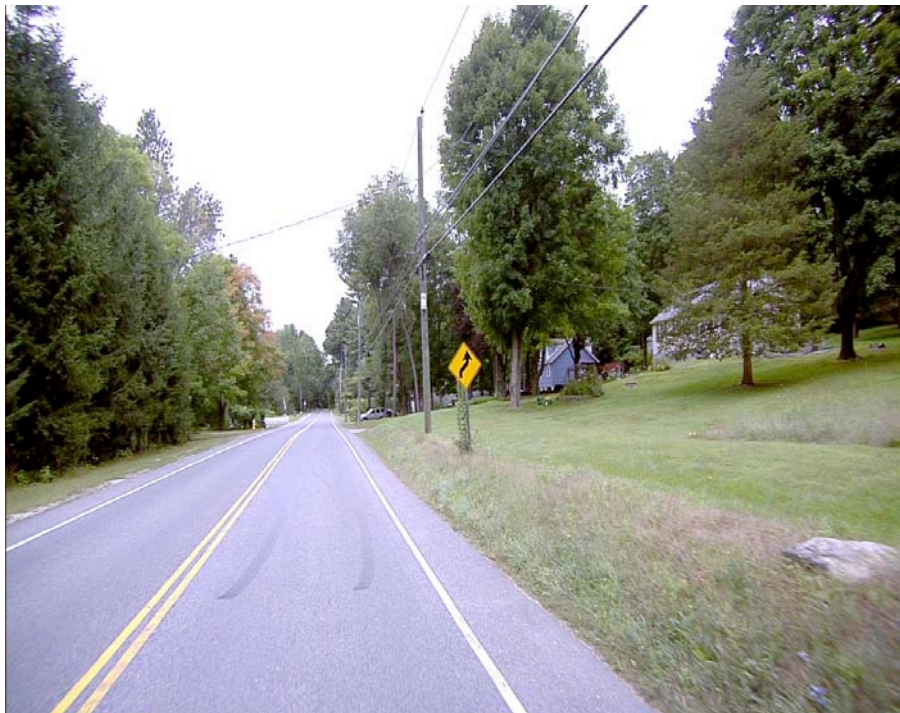
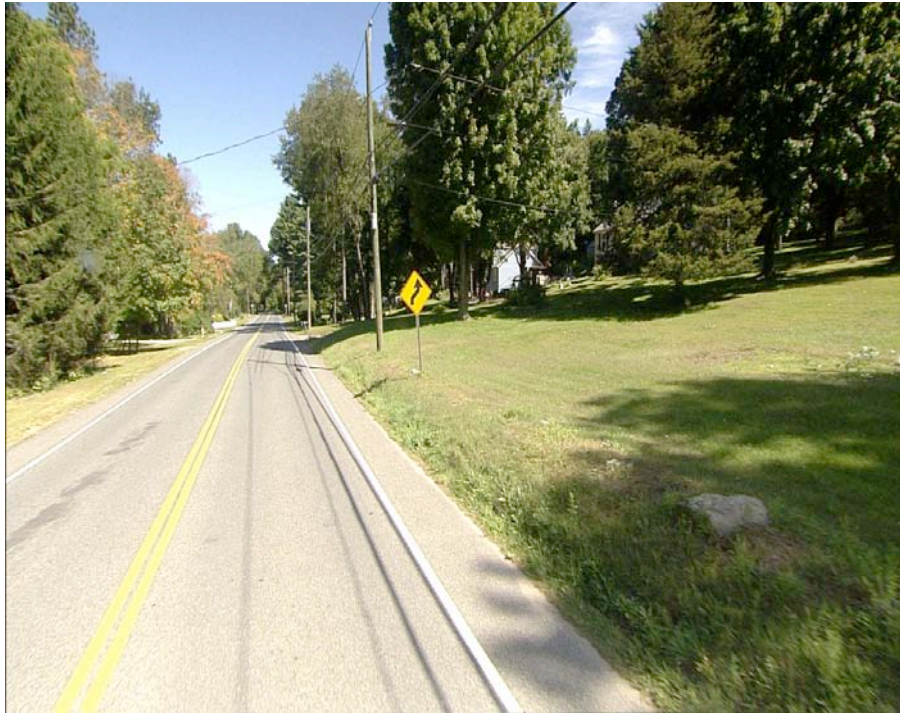
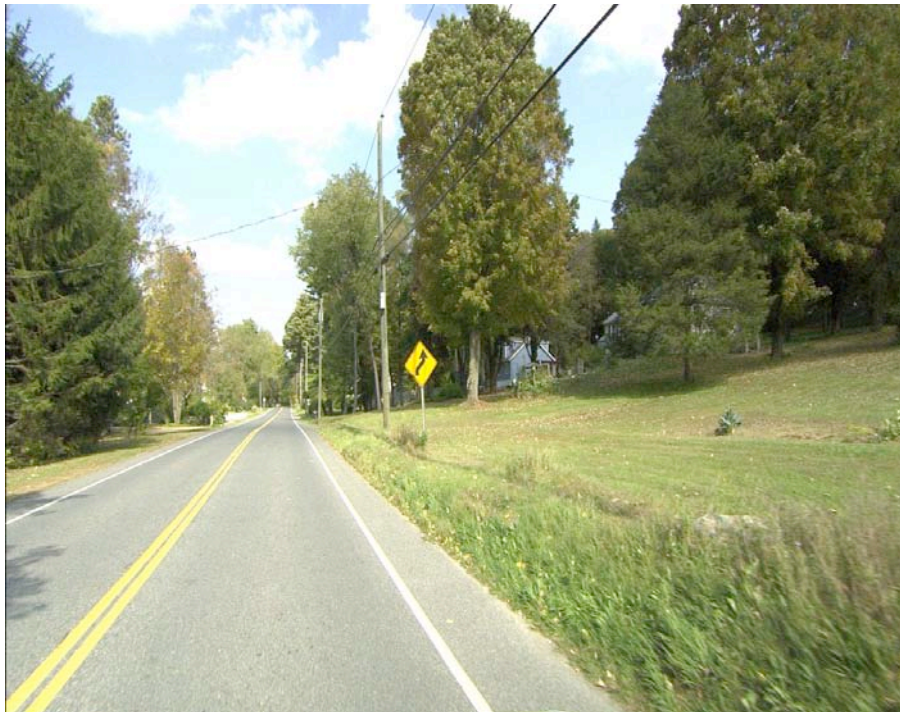
Figure 4. Rt. 44 N. Canaan 2004 (Marshall)

Figure 5. Rt. 44 N. Canaan 2005 (Marshall)

Figure 6. Rt. 44 N. Canaan 2006 (Marshall)

Figure 7. Rt. 44 N. Canaan 2007 (Marshall)

Figure 8. Rt 44 N. Canaan 2008 (Marshall)

Figure 9. Rt 44 N. Canaan 2009 (Marshall)

Figures 4 – 15 show the progress of two pavement sections, the first column Marshall and the second Column Superpave. Both sections were resurfaced in 2003. The sections are located spatially approximately 15 miles apart and in the northwest corner of the state, which experiences the harshest weather. Both were spot milled, making them interesting candidates for comparison, since there are many variables held constant.

In general there was very little difference in the length of time until either type of pavement displayed any sign of visual distress, the images above show that in this particular comparison that was not the case, as cracking was visible in the Superpave section four years prior to the Marshall section. The analysis used a small sample size relative to the number of photolog images available. There were 2 randomly selected locations on each of the 16 projects used in the analysis. This gave anywhere from 7 to 10 images per location and 284 images in total were analyzed.

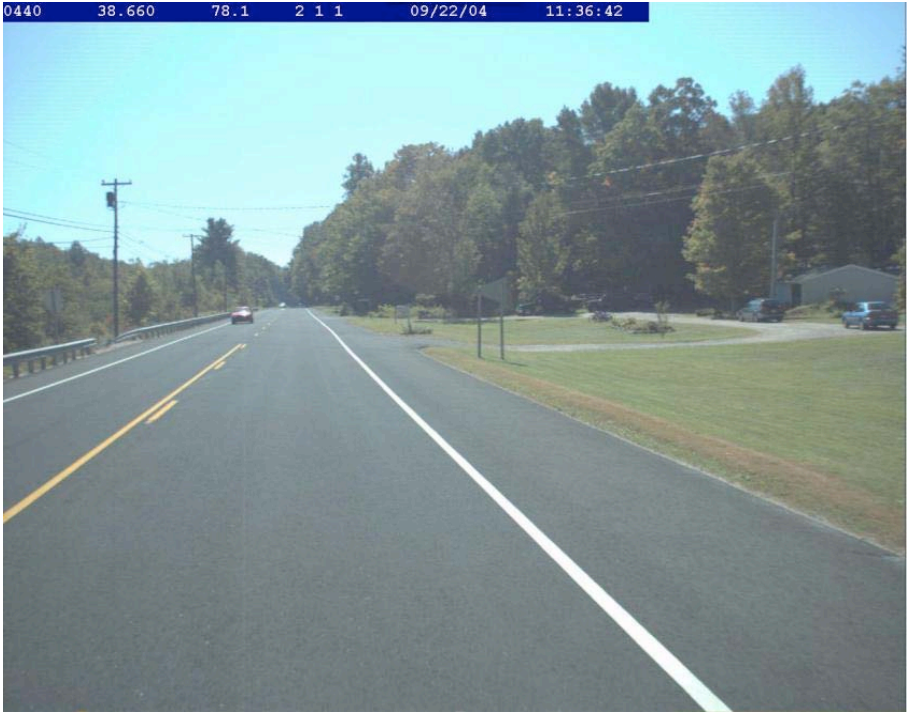
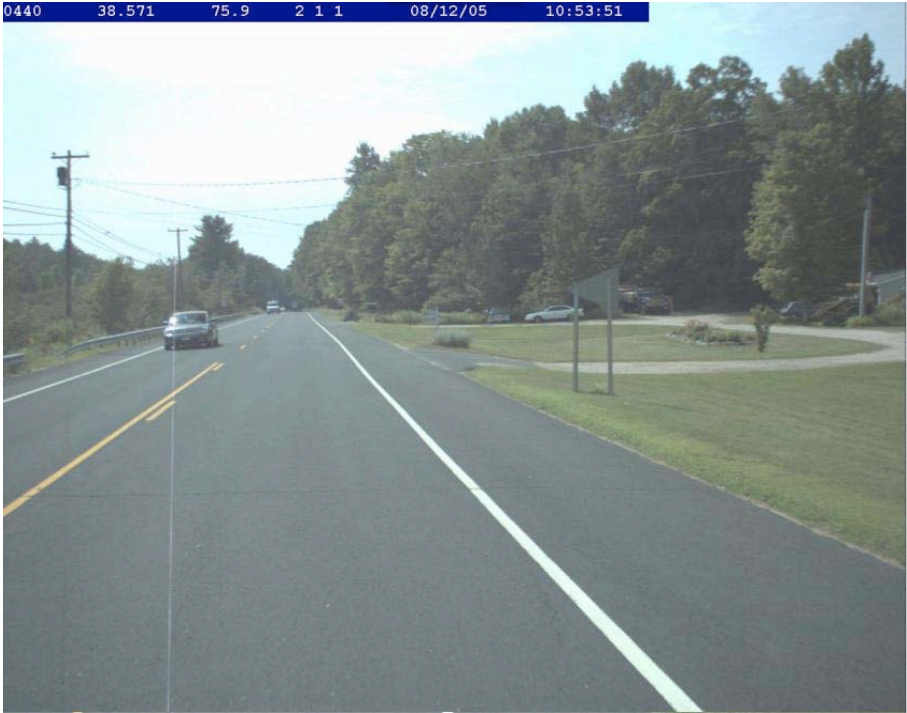
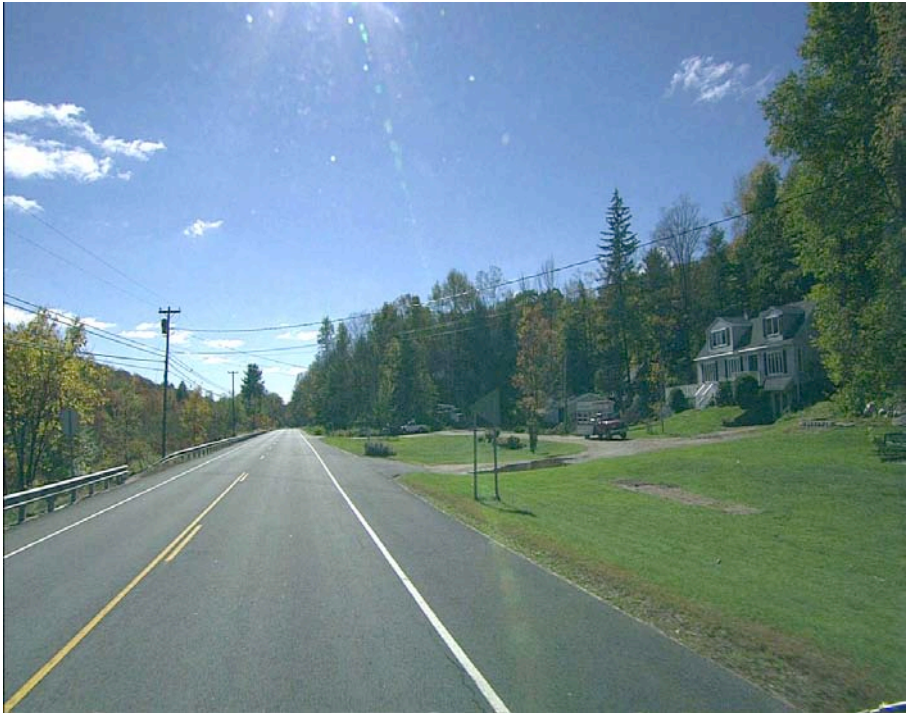
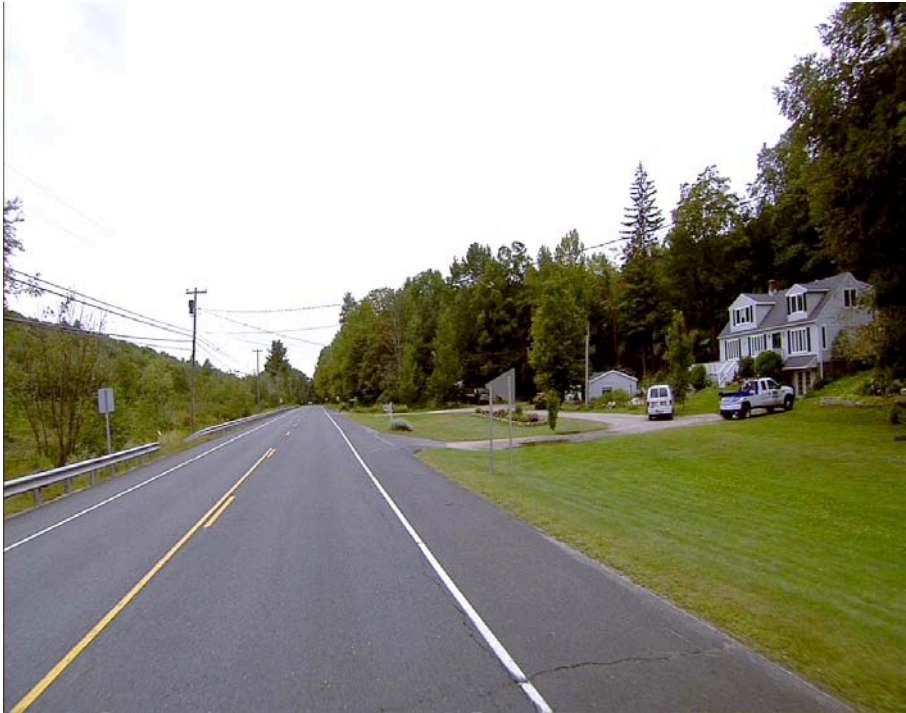
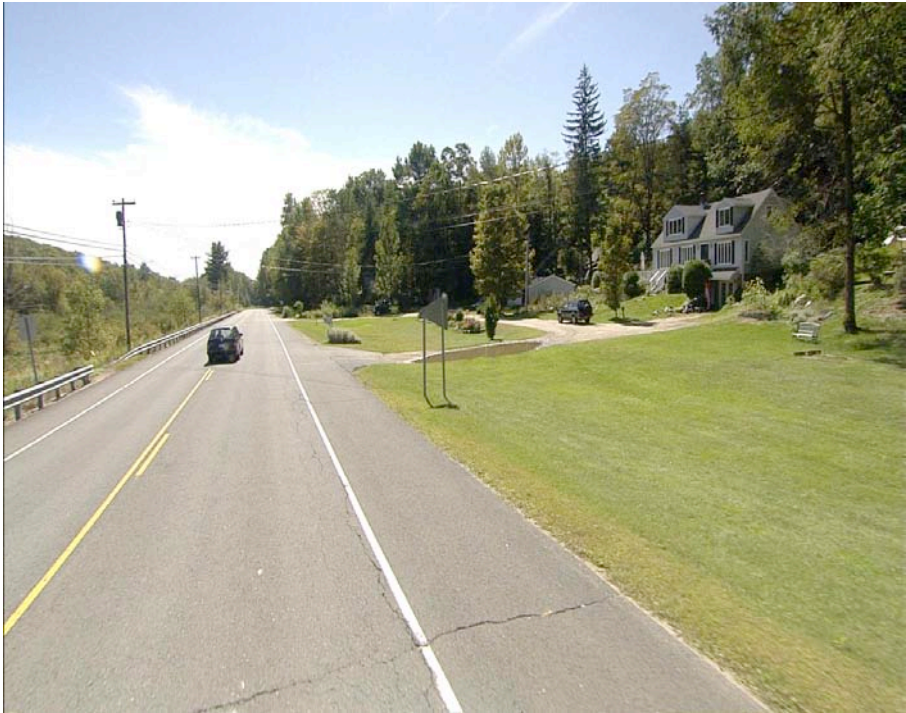
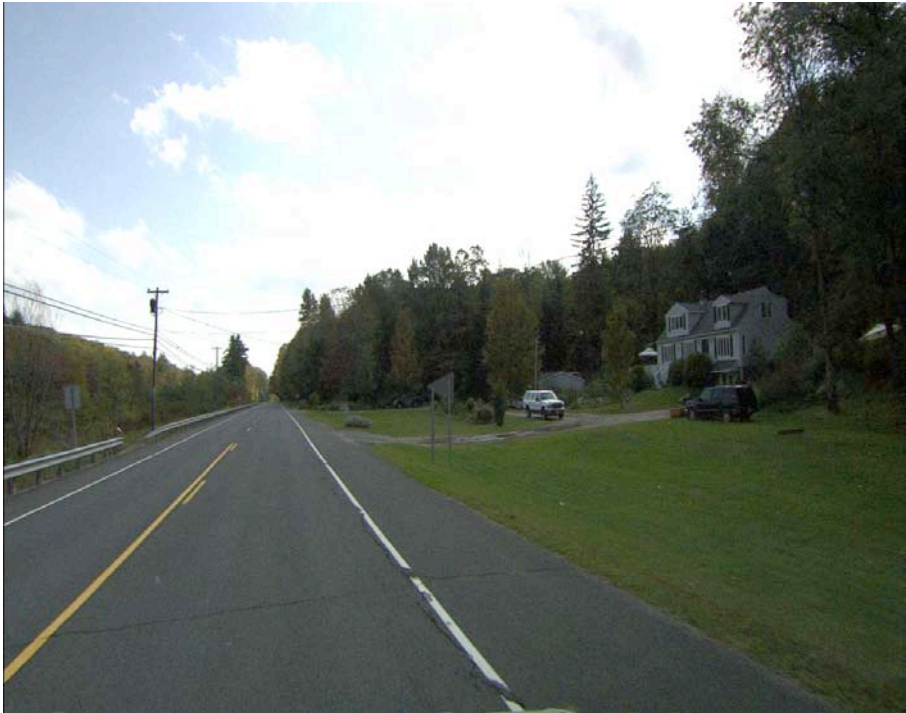
Figure 10. Rt. 44 Winchester/Colebrook 2004 (Superpave)

Figure 11. Rt. 44 Winchester/Colebrook 2005 (Superpave)

Figure 12. Rt. 44 Winchester/Colebrook 2006 (Superpave)

Figure 13. Rt. 44 Winchester/Colebrook 2007 (Superpave)

Figure 14. Rt. 44 Winchester/Colebrook 2008 (Superpave)

Figure 15. Rt. 44 Winchester/Colebrook 2009 (Superpave)

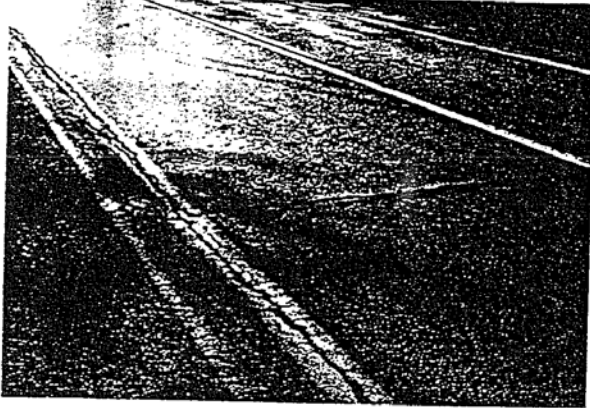
REFLECTIVE CRACKING

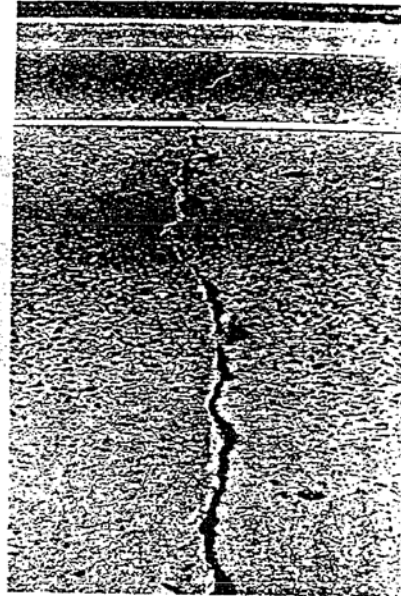
TRANSVERSE CRACKING

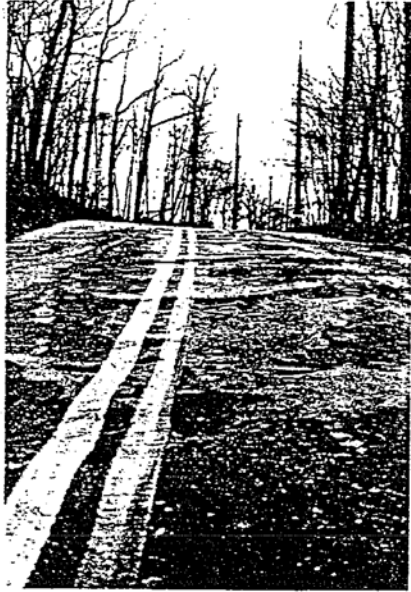
CORRUGATIONS

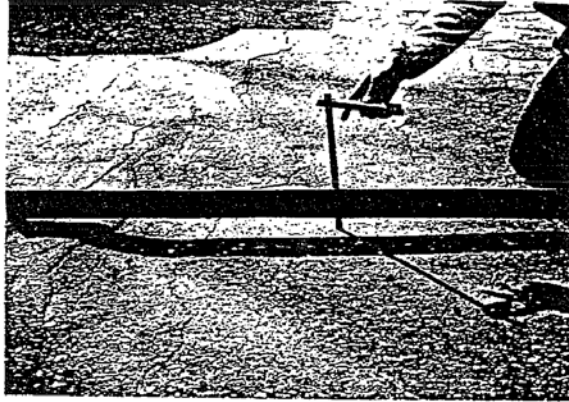
DEPRESSIONS

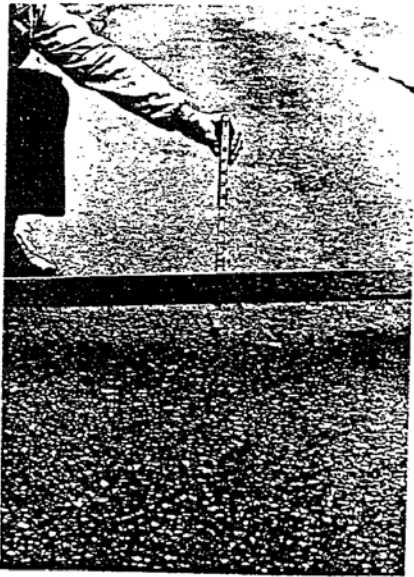
RUTTING

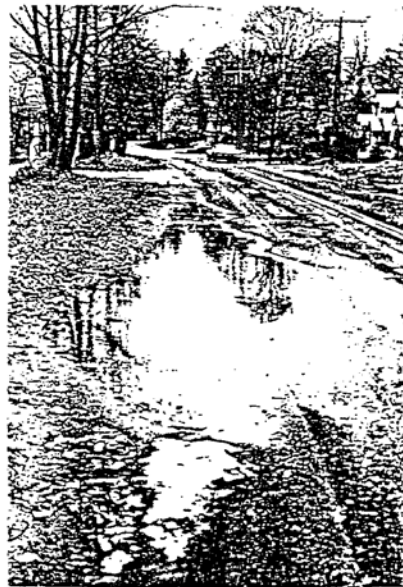
DEFICIENT DRAINAGE
