STATE OF CONNECTICUT

DEPARTMENT OF TRANSPORTATION

Project: State No.: 158-214
F.A.P. No.: TBD
Project Title: Rehabilitation of Saugatuck Swing Bridge #01349
Route 136 over Saugatuck River
Town: Westport

Subject: §106 Evaluation of State Project #158-214

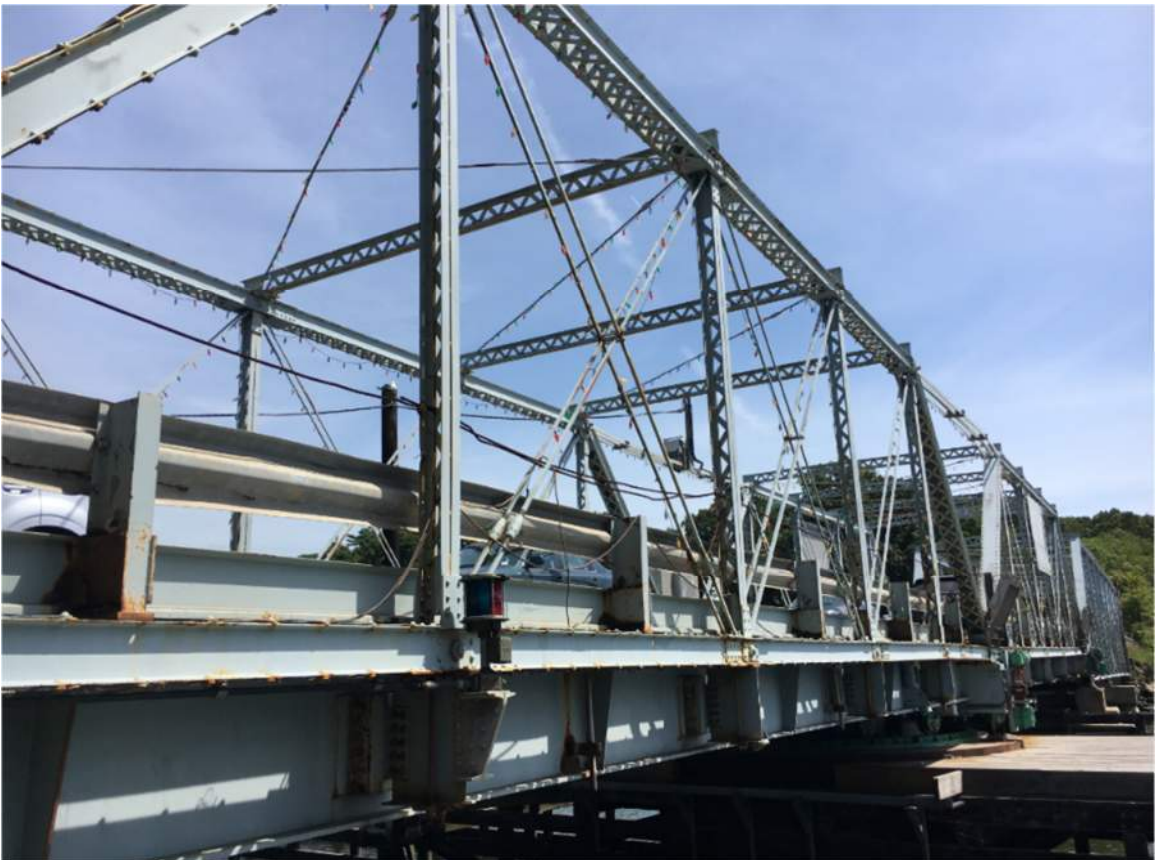
Image 2: Existing metal beam guiderail abutting the decorative trusses. When the guiderail is struck, the truss members restrict any deflection and the force of the impact is transferred to the truss.

Without space for deflection, the force of a vehicle strike is transferred directly to the trusses. This will address a safety deficiency of the bridge and protect the trusses from future damage by vehicle strikes. In addition to the horizontal widening, this alternative will increase the vertical clearance between the roadway and top of the truss to a minimum of 13'11" (Figures 2 and 3).

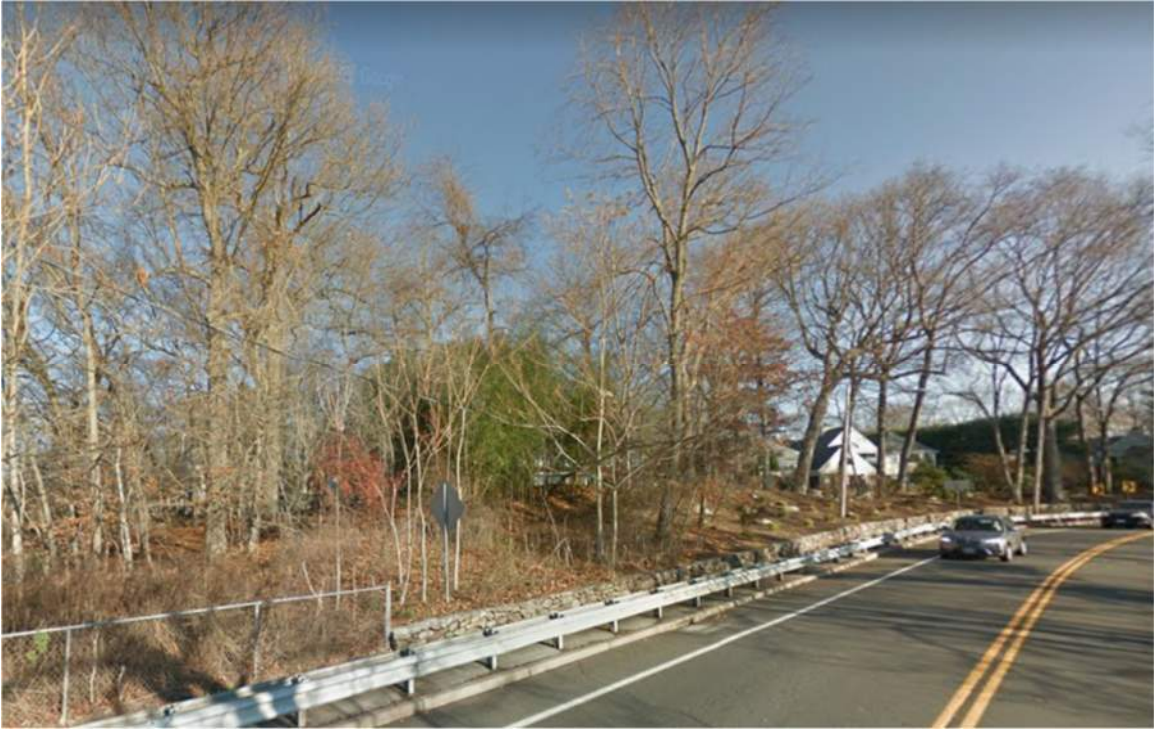
Image 6: Stone wall on southern side of Route 136. This wall abuts the property line of 12 Bridge Street. The wall terminates 375 feet east of Bridge #01349, which is located beyond the curve in Route 136.

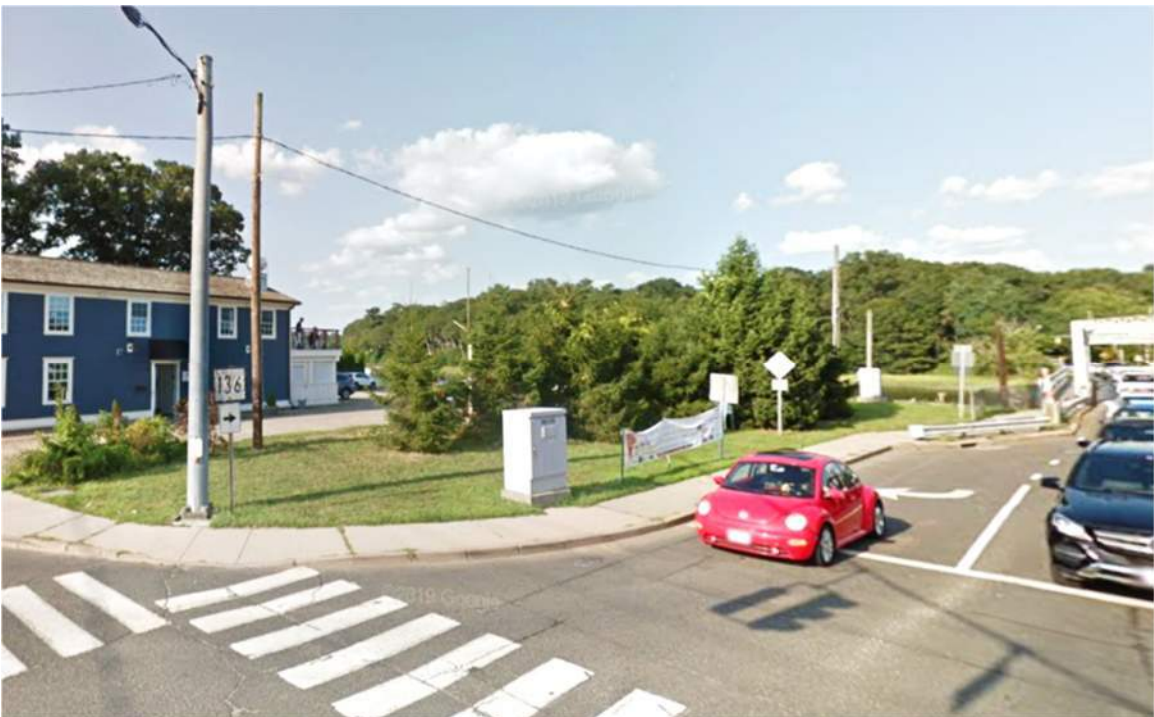
Image 7: Western terminus of stone wall that abuts the property at 5 Imperial Landing. The wall is within the existing road right of way.

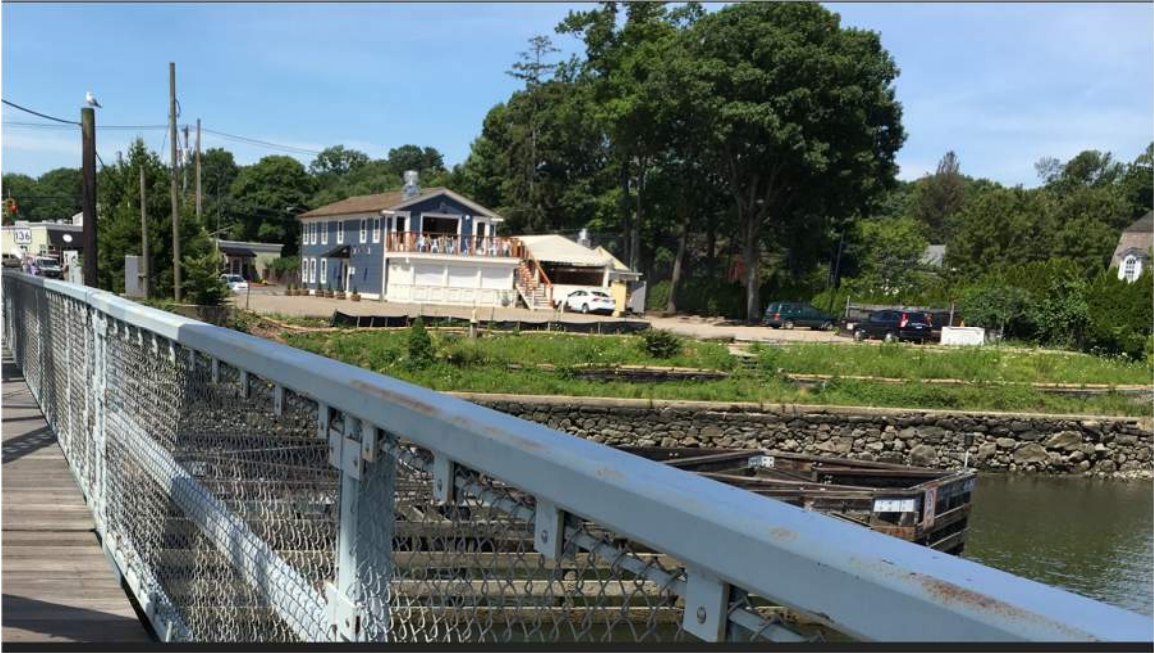
Image 8: Block 59 / Lot 000 (grass covered area) at the northwest corner of Bridge #01349. This property is owned by CTDOT and served as the approach for the detour bridge that was required for the previous rehabilitatoin in 1991.

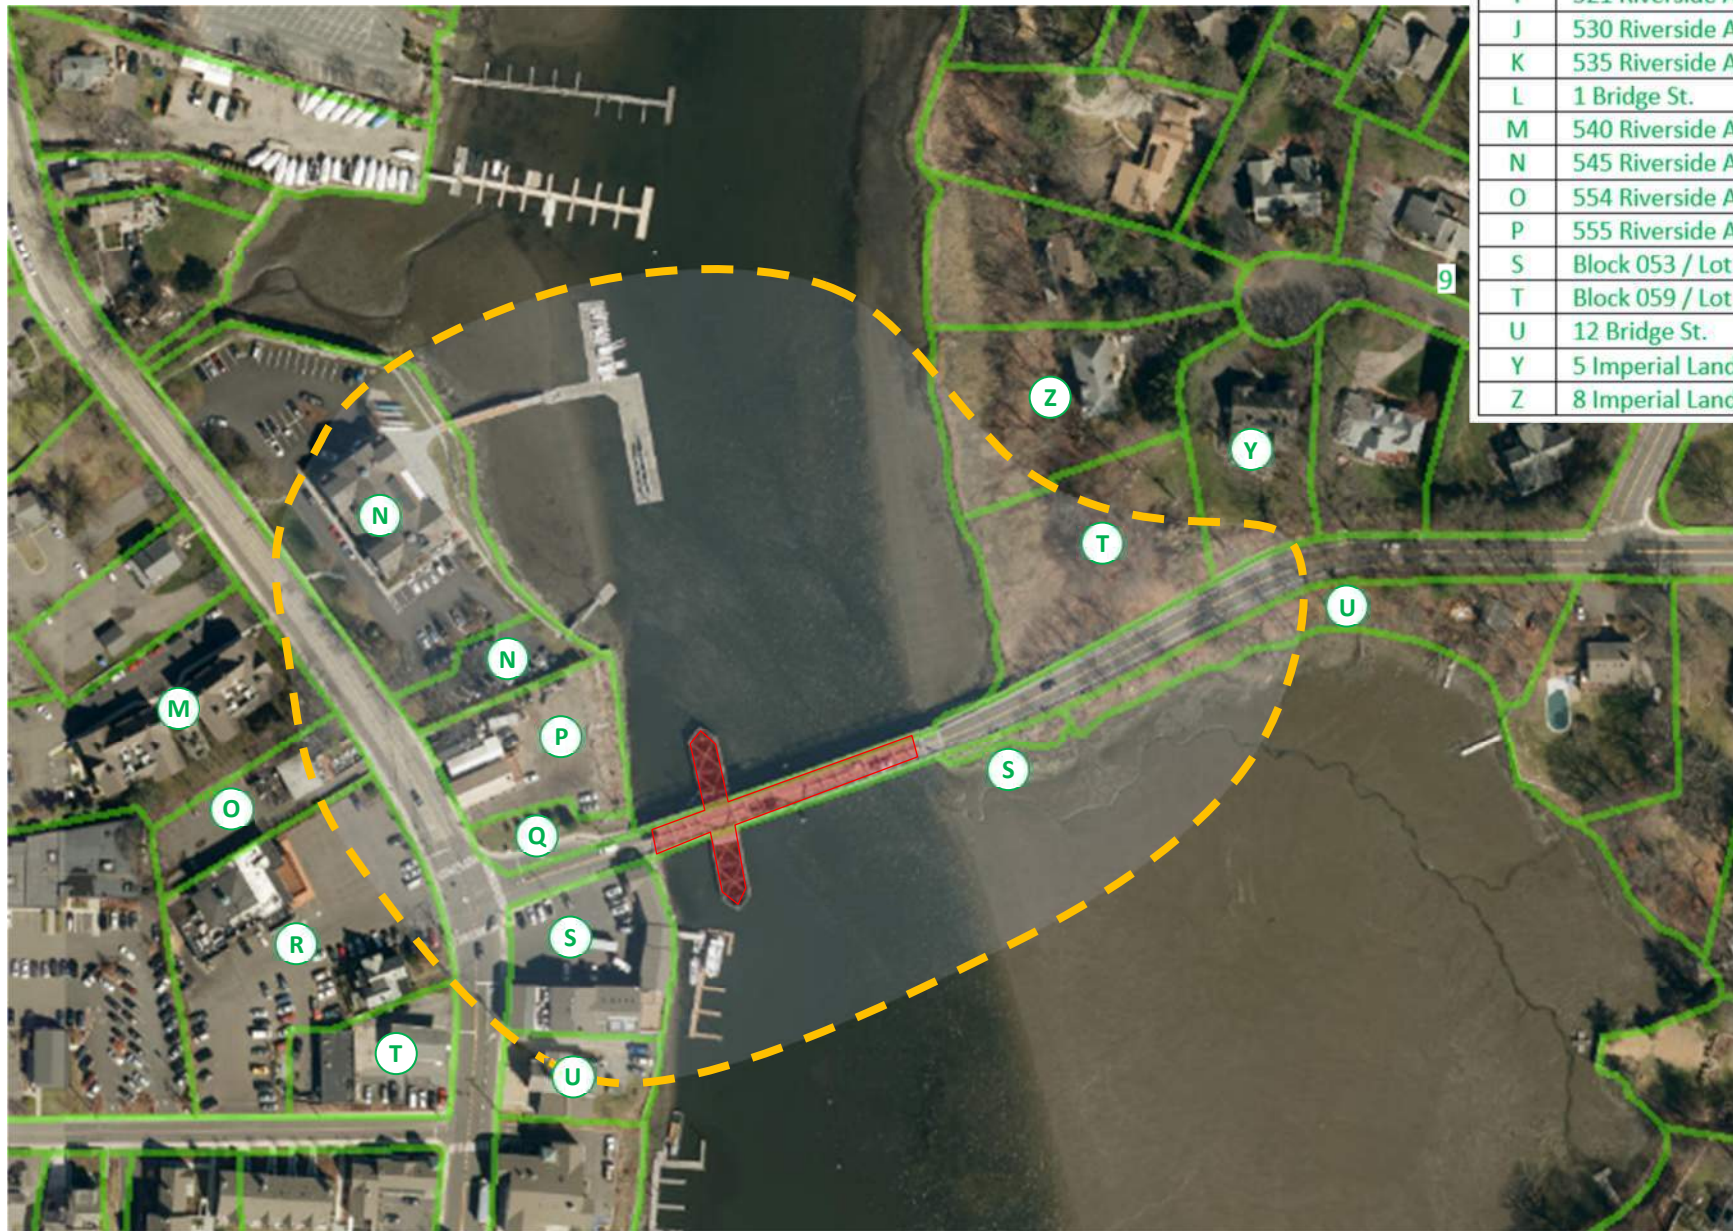
ID	Address
H	518 Riverside Ave
I	521 Riverside Ave
J	530 Riverside Ave
K	535 Riverside Ave
L	1 Bridge St.
M	540 Riverside Ave
N	545 Riverside Ave
O	554 Riverside Ave
P	555 Riverside Ave
S	Block 053 / Lot 000
T	Block 059 / Lot 000
U	12 Bridge St.
Y	5 Imperial Landing
Z	8 Imperial Landing

Figure 1: Area of Potential Effect (APE) of Project #158-214 outlined in orange. Bridge #01349 is highlighted in red. The legend in the upper right corner identify the addresses or Block/Lot of the parcels within the project APE.

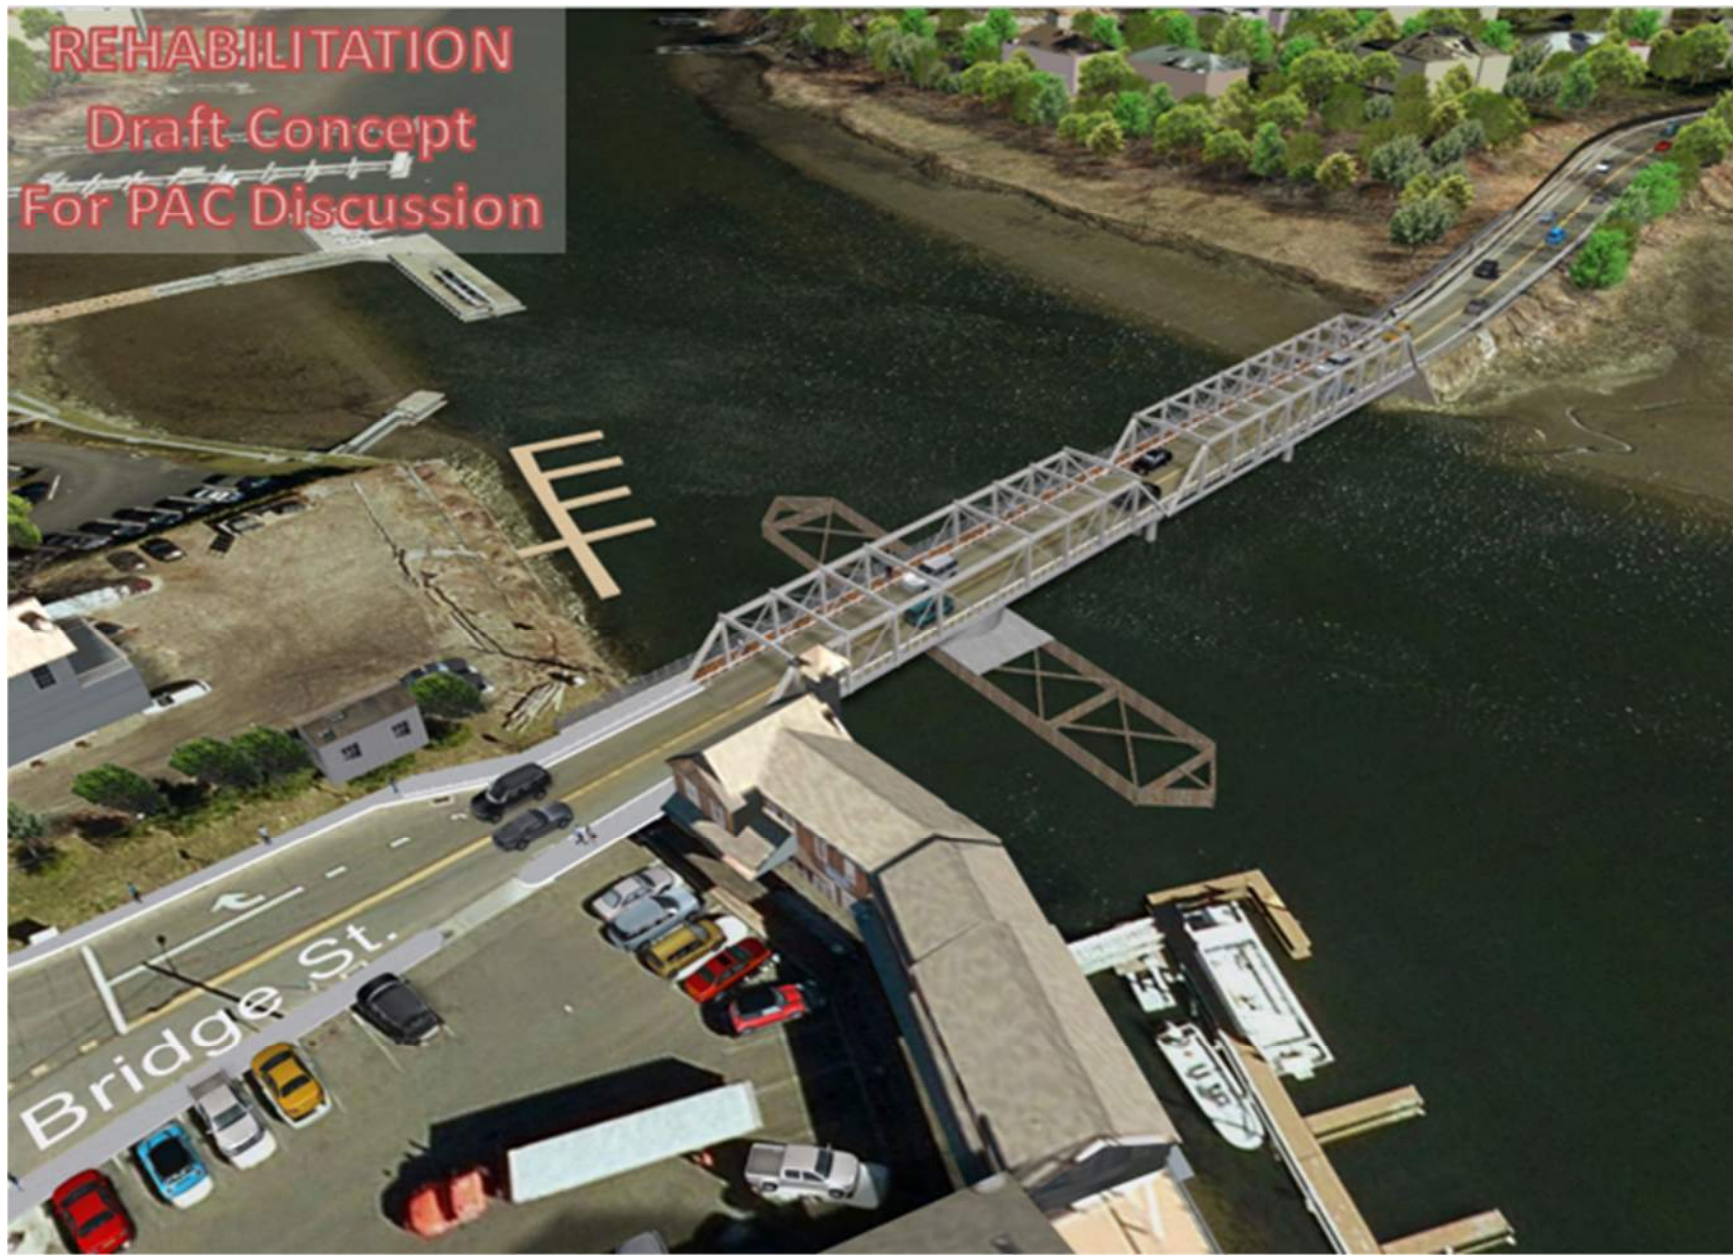
Figure 2: Conceptual rendering of Rehabilitation Alternative.

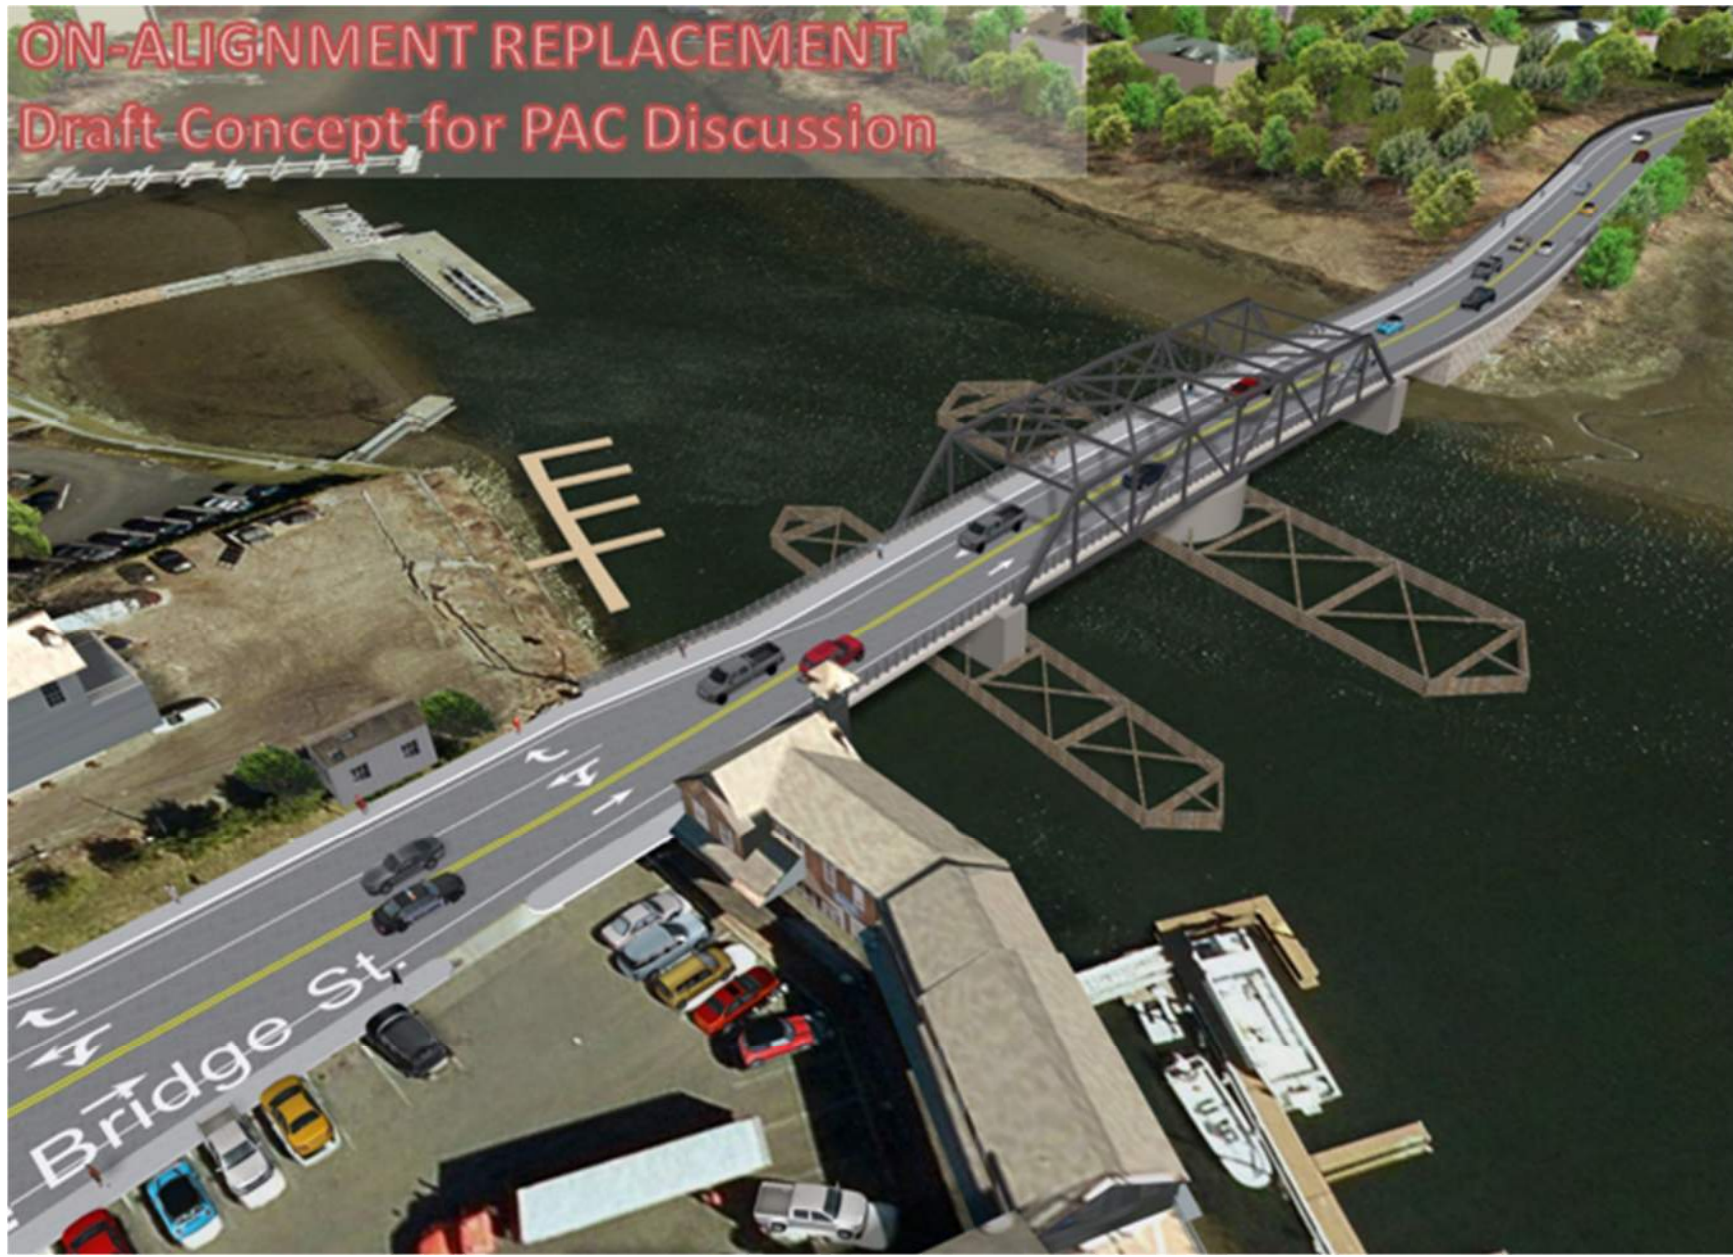
Figure 6: Conceptual rendering of the On-Alignment Replacement Alternative.

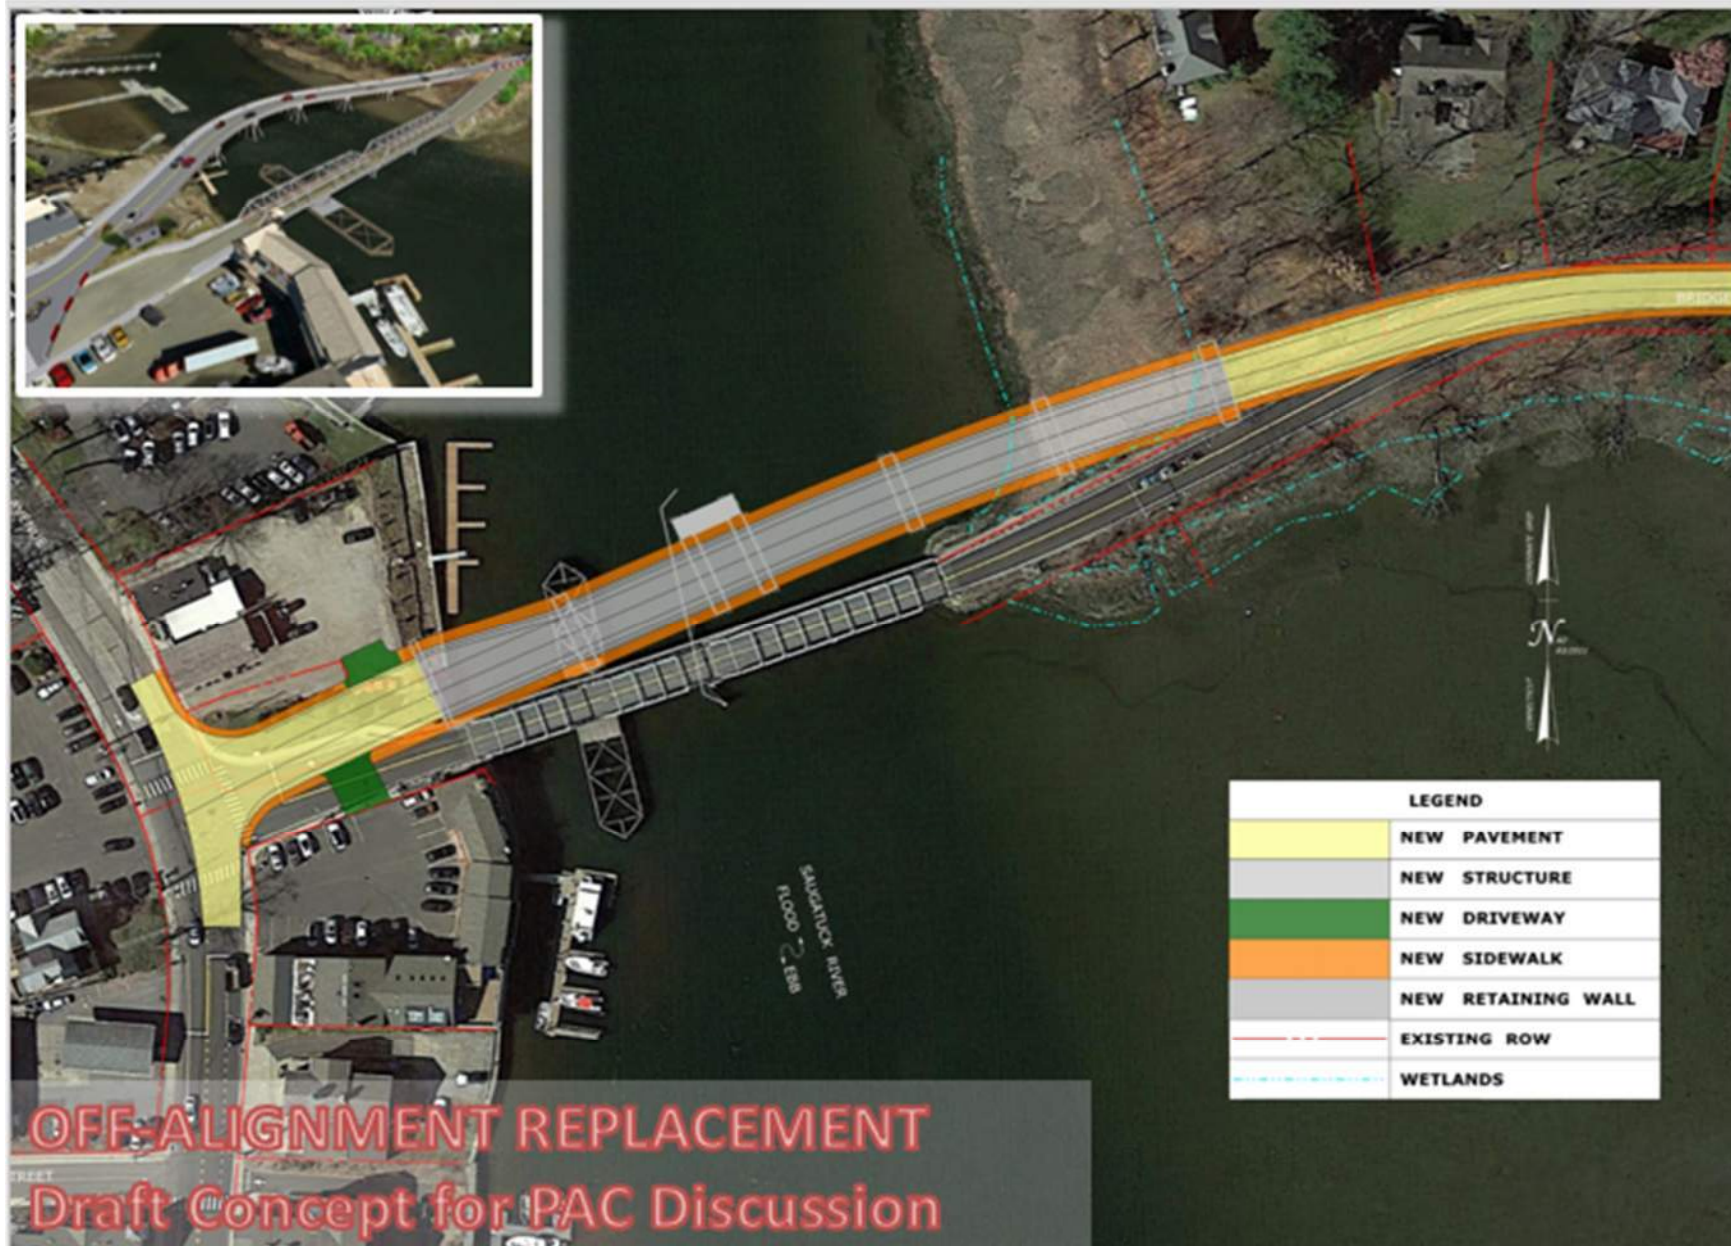
Figure 7: Conceptual plan of Off-Alignment Replacement Alternative. The inset image shows the detour bridge required by the other three alternatives.

The Off-Alignment Replacement Alternative will install a new bridge to the north of the existing structure (Figures 7 and 8). Like the On-Alignment option, the replacement bridge will include a moveable span and will be designed to meet current guidelines. It will carry two vehicle lanes and a sidewalk. As with the On-Alignment Replacement and Rehabilitation Alternatives, the Off-Alignment Replacement will install crash-tested guiderails and road barriers to stop traffic when the bridge is open and extend the dedicated right-turn lane from Bridge Street onto Riverside Avenue.

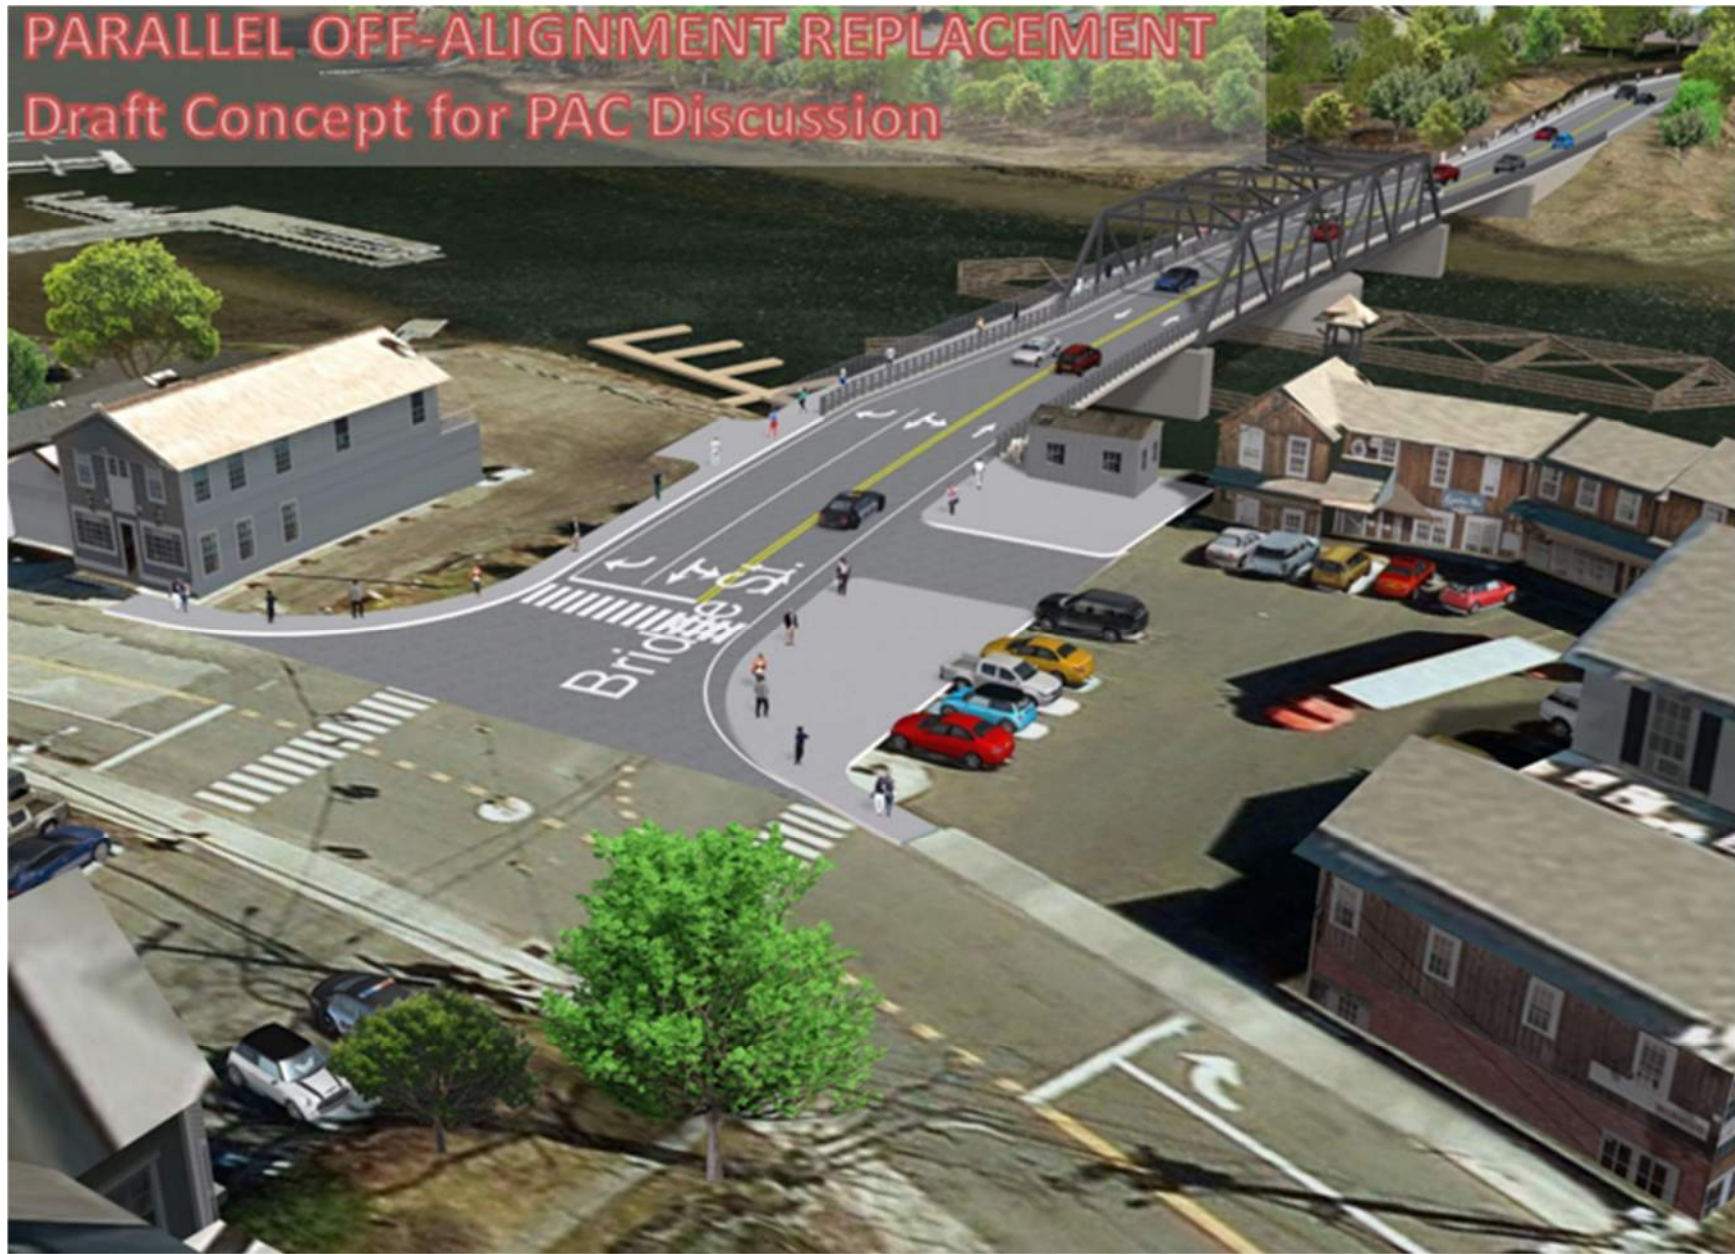
Figure 8: Conceptual rendering of the Off-Alignment Replacement Alternative.

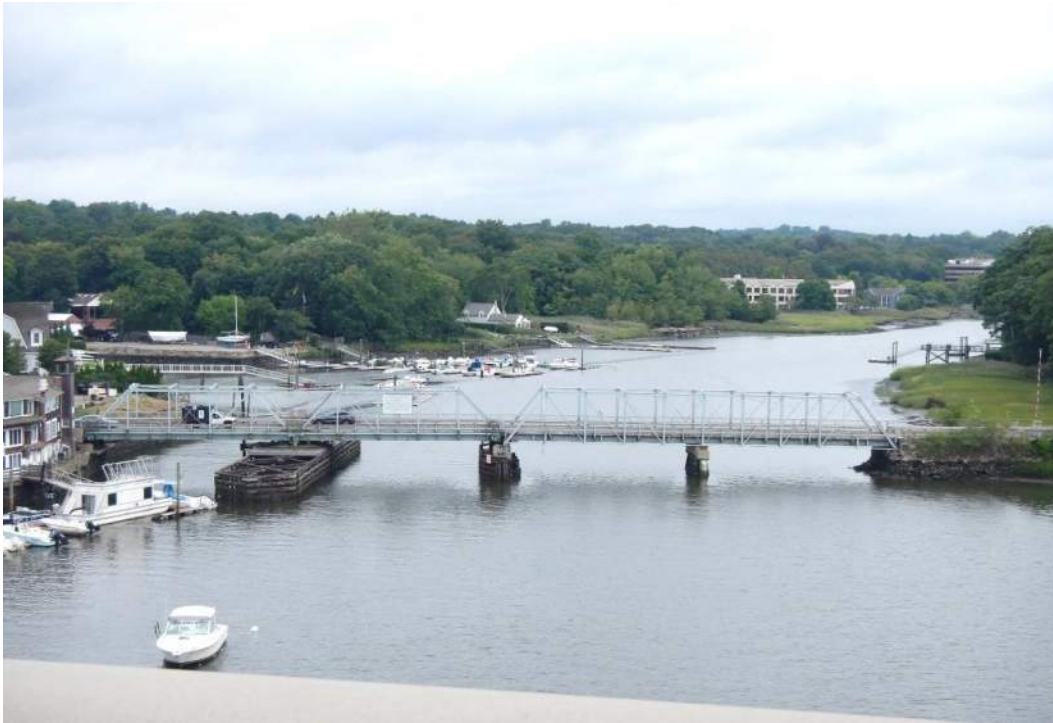
Image 1: Southern face of Bridge #01349, viewed from I-95.

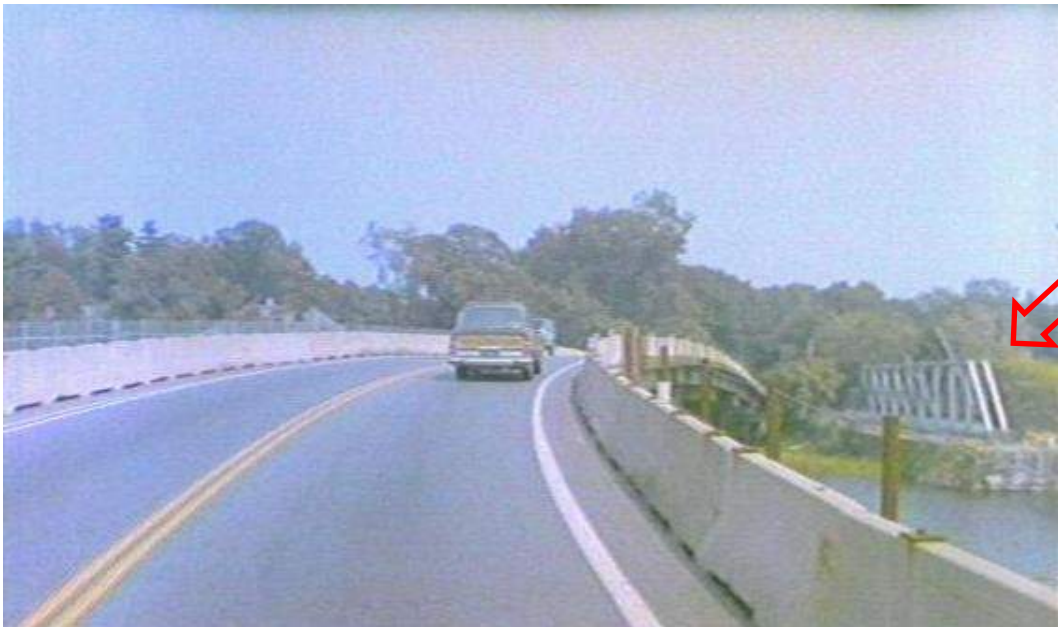
Image 5: View of Bridge #01349 from the temporary bridge installed to carry Route 136 during the 1991 rehabilitation. Note that the trusses have been moved from their original locations intact and are staged on the approach roadway (red arrow).

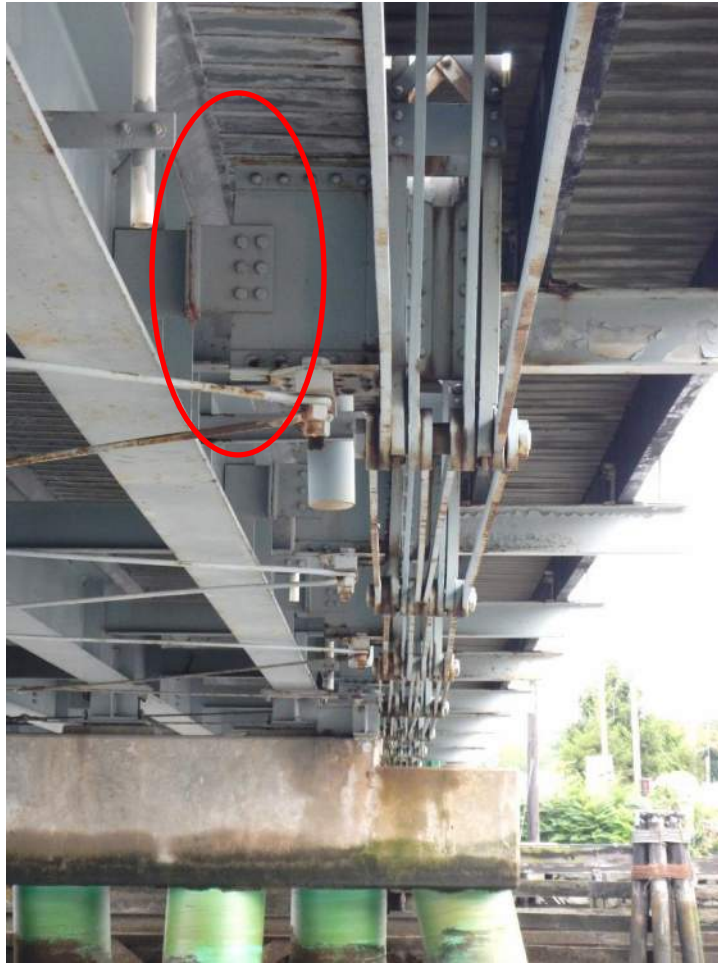
Image 6: The original beams of the truss were oriented perpendicular to the roadway. In 1991, they were cut and attached to the new superstructure beams (outlined in red), which are oriented parallel to the roadway.

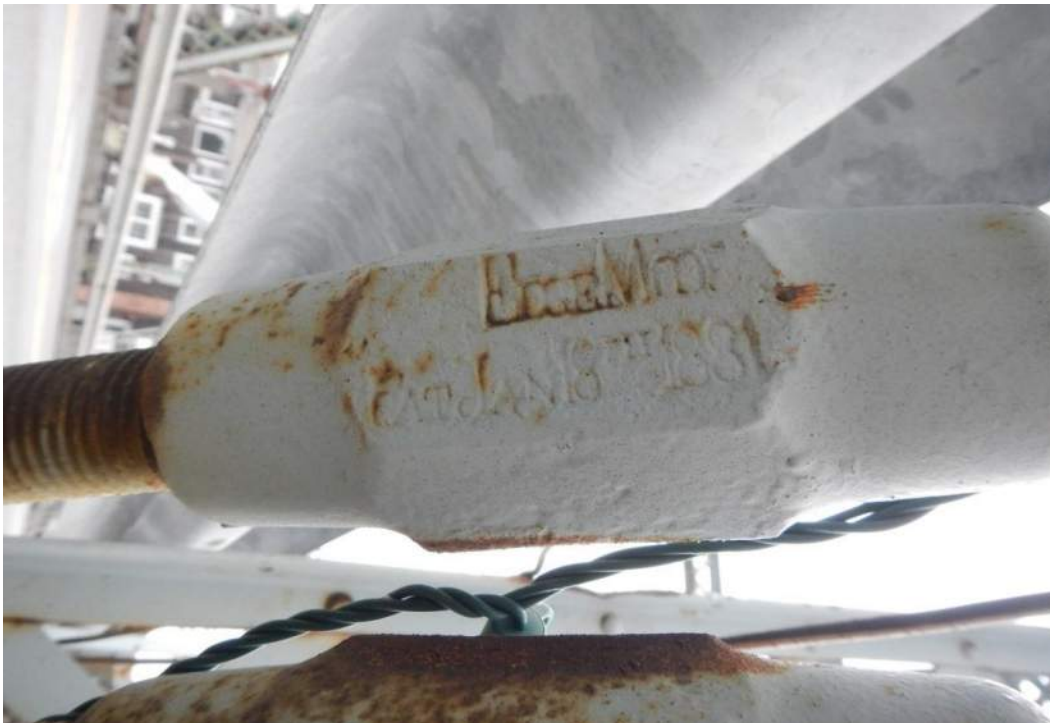
Image 7: Cast iron turnbuckle bearing the label “EdgeMoor – Pat [Patent] Jan 18th 1881”

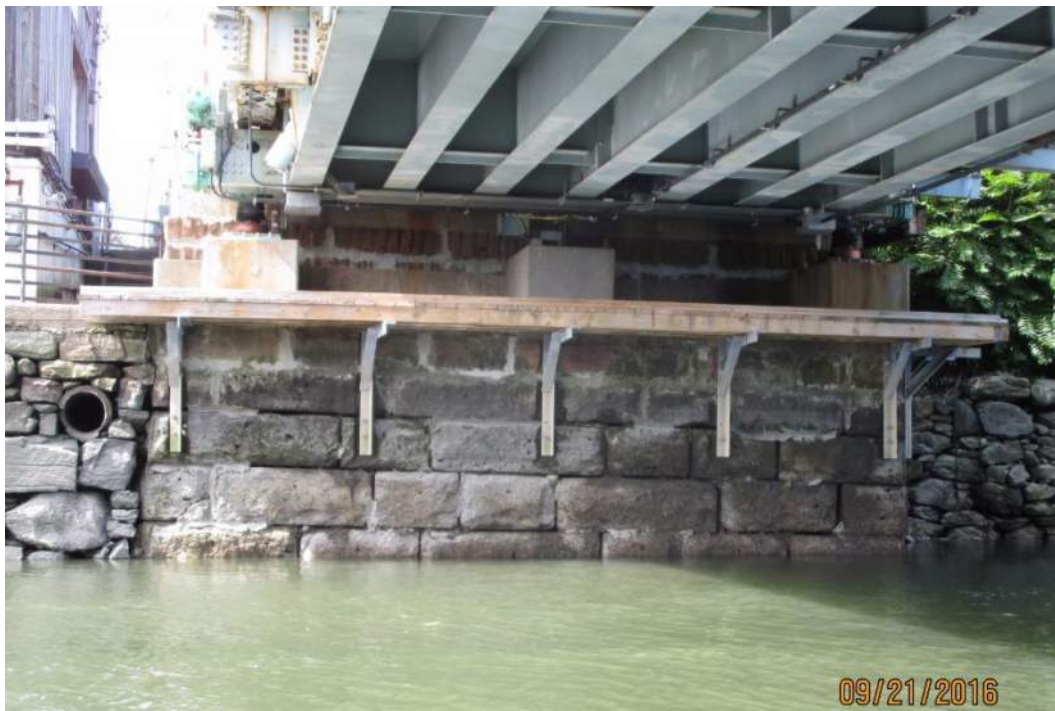
Image 9: Western abutment of Bridge #01349. The original ashlar masonry is visible. Reinforced concrete was introduced on top of the abutment in 1993 to raise the bridge clearance above the water and facilitate river traffic. The outriggers and catwalk allow access to the screw jacks that raise and lower the swing span when it is operated.

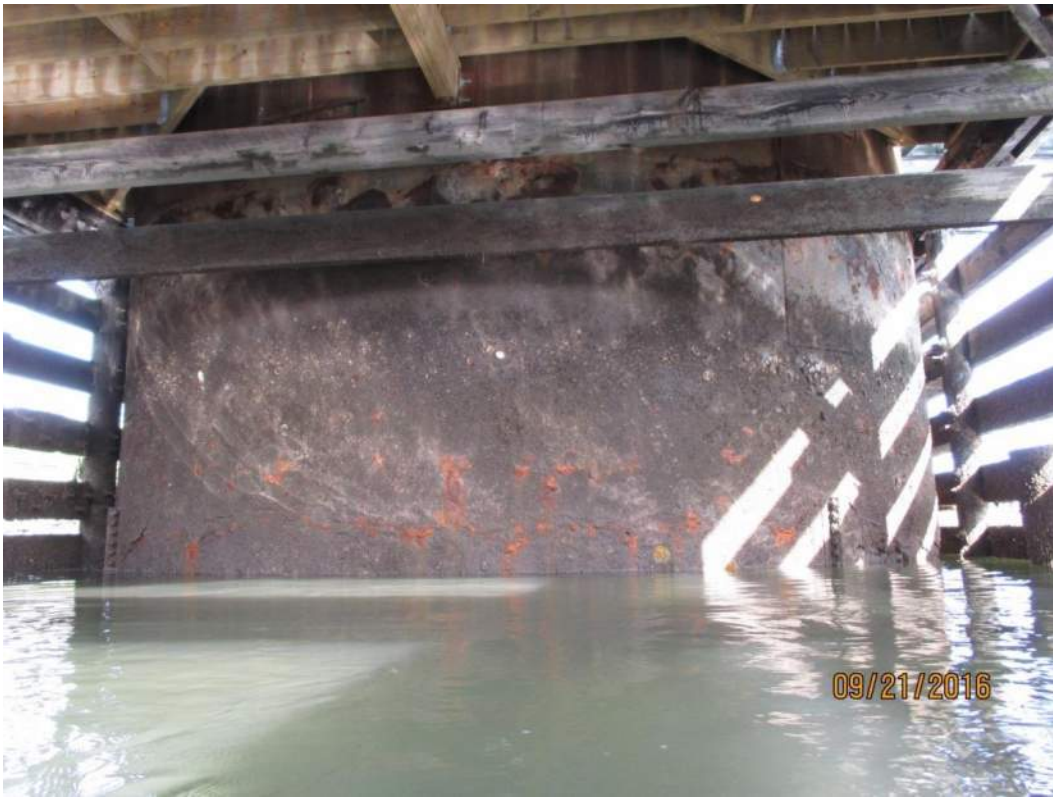
Image 10: Detail of pivot pier. In 1952, the original masonry pier was encased in a sheet metal form which was filled with concrete.

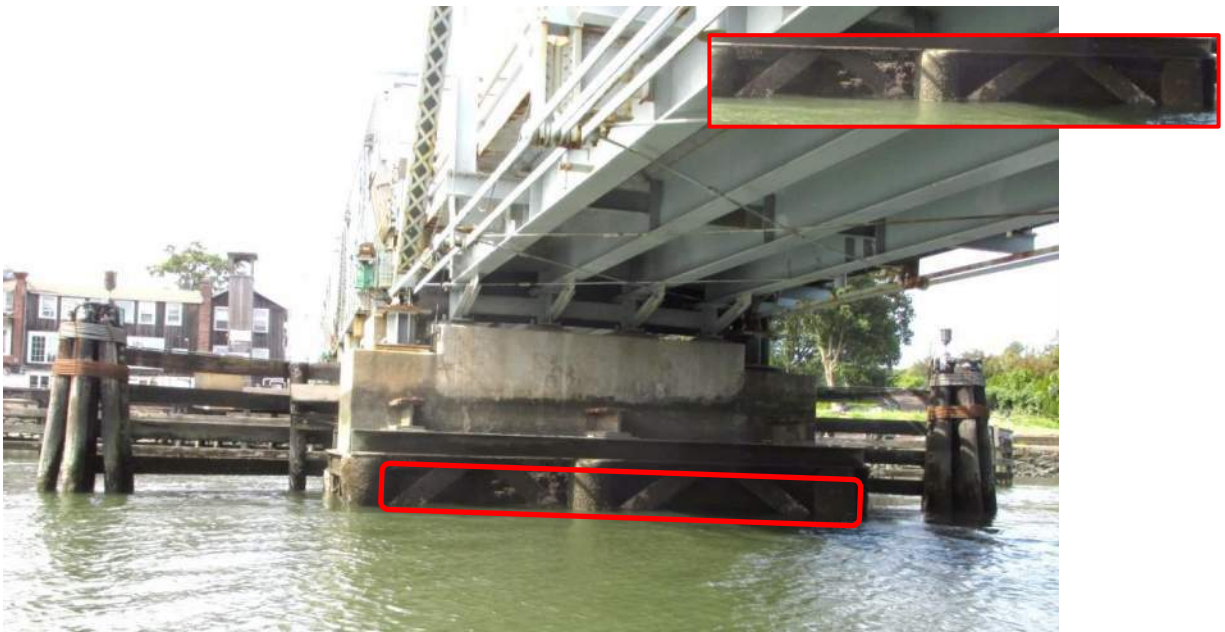
Image 11: Eastern face of Pier 2. The original masonry is outlined in red. It is obscured by modern pilings, a concrete cap and the timber cribbing that protects the western side of the pier. The detail in the upper right corner has been enhanced to highlight the masonry in the shadows.

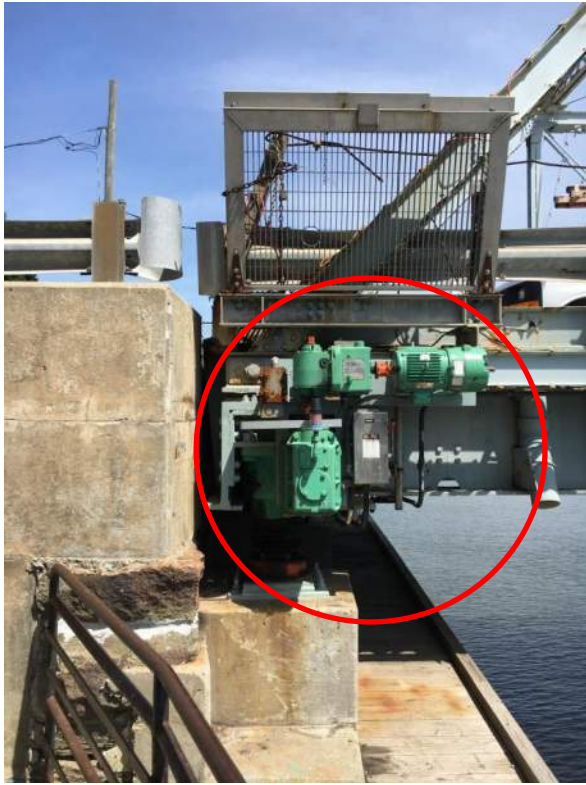
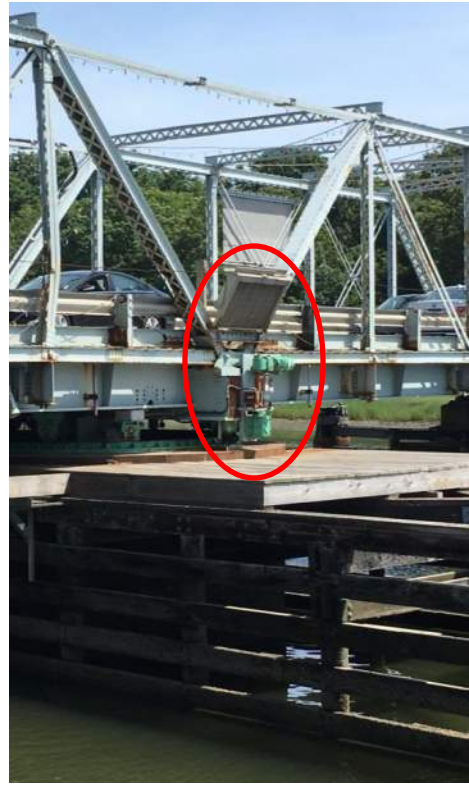
Image 12: The south side of the swing span now features an electric motor at the screw jacks (left photo) and at the center of the swing span (right photo, outlined) that are responsible for opening and closing the span. This is a minor change in the appearance of the bridge.

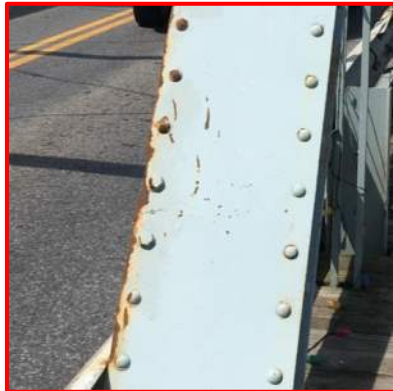
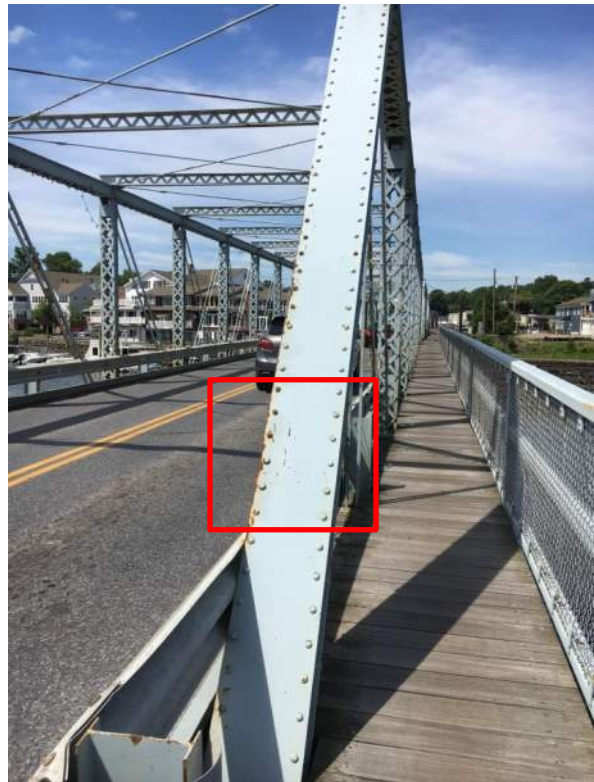
Image 13: There are a few locations where the original rivets have been replaced with bolts (see inset). However, almost all of the original rivets remain intact.
