# Individual Station Report

# **Springdale**

Connecticut Department of Transportation

# CONDITION INSPECTION FOR THE SPRINGDALE STATION

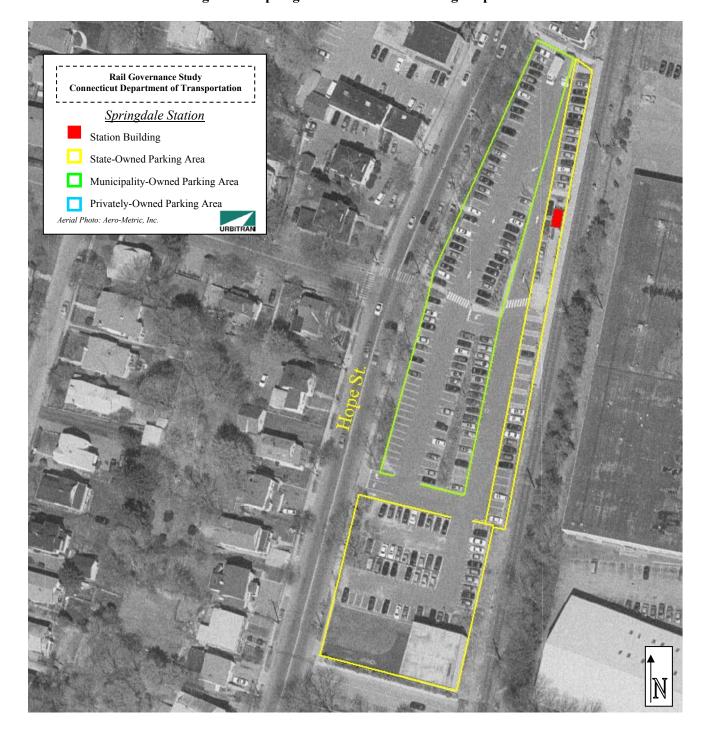
Figure 24: Springdale Rail Station Parking Map

The Springdale Rail Station has one surface parking lot. The lot has 208 total spaces. There are 146 permit parking spaces and 56 daily parking spaces available in the lot. Springdale also has an additional 6 handicap spaces. The total usage rate for the lot was 88% during the study. Table 24 presents specific information on parking at the Springdale rail station.

The State of Connecticut owns 37 parking spaces along the southbound side of the tracks at the Springdale Rail Station as well as 54 spaces in the southern portion of the lot. The City of Stamford owns the rest of the lot. The State owns 43.8% of the commuter parking at the Springdale Station. Figure 24 outlines the lot structure and ownership pattern at the Springdale Station.

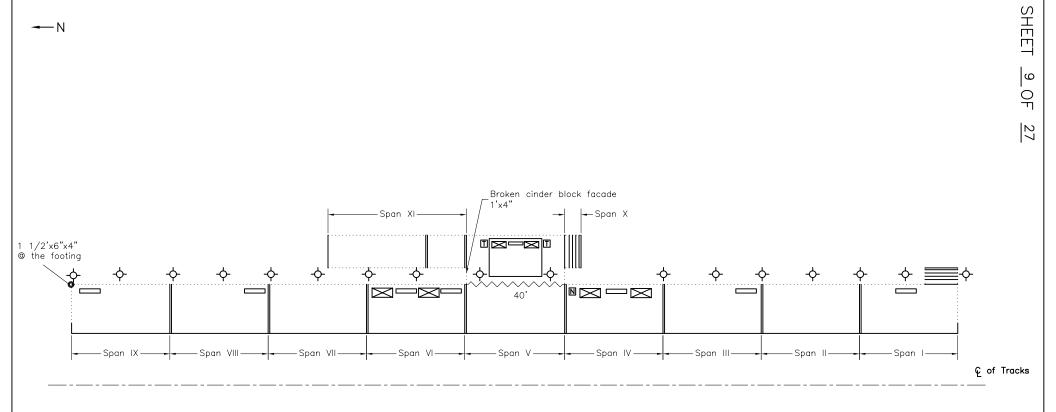
Urbitran Associates, Inc.
Connecticut Dept. of Transportation
Springdale Station Platform Plan
 ·

- The base plates below the double tee are rusted and deteriorated.
   Along the platform the railing is bent in multiple locations.
   The railing base plates are rusted and deteriorated.

<sup>\*</sup> The extent of deterioration noted during our inspection is minimal and does not require immediate repair. The type and extent of deterioration will not affect the station operations or commuters. Therefore, we recommend the that defects noted in this report be included in a future station maintenance rehabilitation contract.
