PROJECT NO. 154-127 BRIDGE NO. 00349 US ROUTE 1 OVER PATCHOGUE RIVER

PROJECT DESCRIPTION

Project Number: 154-127 Town: Westbrook, Connecticut Rehabilitation of Bridge No. 00349 U.S. Route 1 over Patchogue River

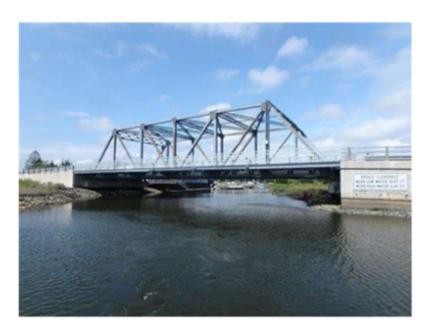
South Elevation- View from downstream

The bridge superstructure is comprised of an open steel grid deck supported by longitudinal wide-flange steel stringers. The stringers are supported by transverse wide-flange steel floorbeams, which are carried by two steel thru trusses. The trusses rest on two concrete abutments, which are founded on cast-in-place concrete piles encased in steel pipe. The bridge also supports a cantilevered sidewalk located outboard of the truss on the south side of the bridge.

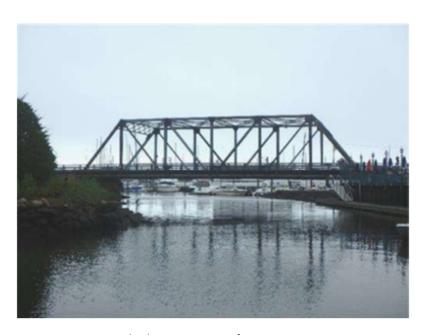
North Elevation- View from upstream

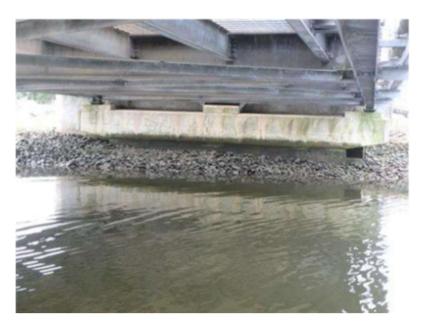
Abutment 1 Elevation

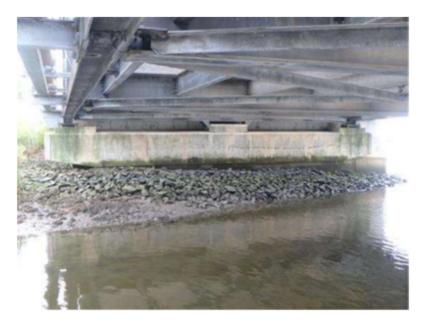
Abutment 2 Elevation

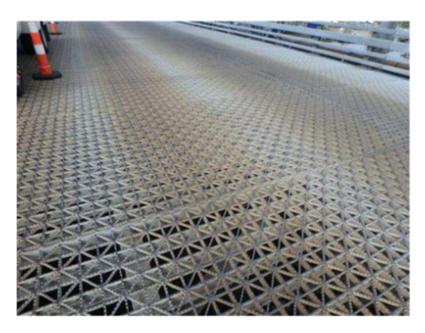
Steel Grid Deck with Areas of Peeling Galvanized Coating

The purpose of this project is to address the deficiencies in the bridge deck identified by recent inspections and to maintain the major components in a "State of Good Repair". The bridge deck has numerous weld cracks between the stringer top flange and bearing bar that require replacement. A poor connection detail between the steel grid deck and floor beam is resulting in diagonal cracks up to three inches long in the web of the bearing bars at 96 locations. The amount of cracking in the deck has gone beyond repair and needs replacement.

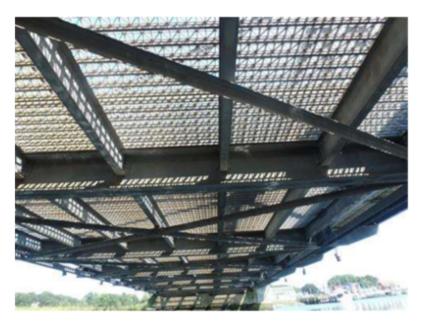
Underside of Steel Grid Deck and Framing Condition-Looking North

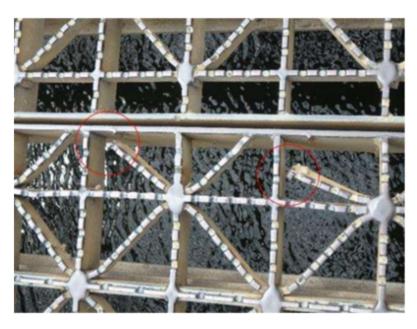
Steel Grid Deck has broken Diagonal Bars Between Floorbeams 2 & 3 and Stringers 3 & 4
