**Repair of Steel Beam/Girder Ends with Ultra
High-Strength Concrete – Phase II**

Report Number: CT-2295-1-17-2
Interim Report
January 31, 2017

University of Connecticut
School of Engineering
Department of Civil and Environmental Engineering

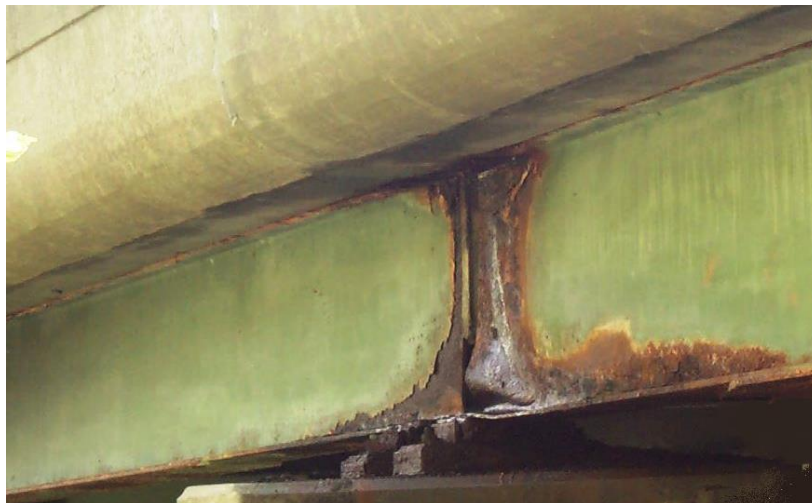
Figure 1.1: Typical corrosion damage of girder ends beneath the expansion joint

Extensive corrosion of bridge girders is most commonly found directly beneath deck expansion joints, which are usually located above girder supports at abutments and piers as shown in Figure 1.1 (Kayser and Nowak 1989; Usukura et al. 2013; Van de Lindt and Pei 2006). Purdue University completed an extensive investigation on the performance of expansion joints. Common problems cited with expansion joint systems were water leakage and deterioration at bridge bearings (Chang and Lee 2001). Figure 1.2 shows a girder end with corrosion damage beneath the expansion joint and a girder that has been repair because of corrosion damage.

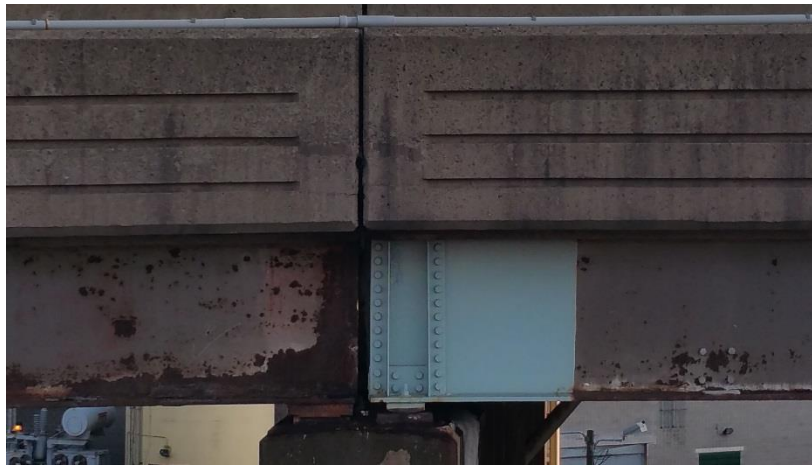
Figure 1.2: Corrosion damage and conventional repair method

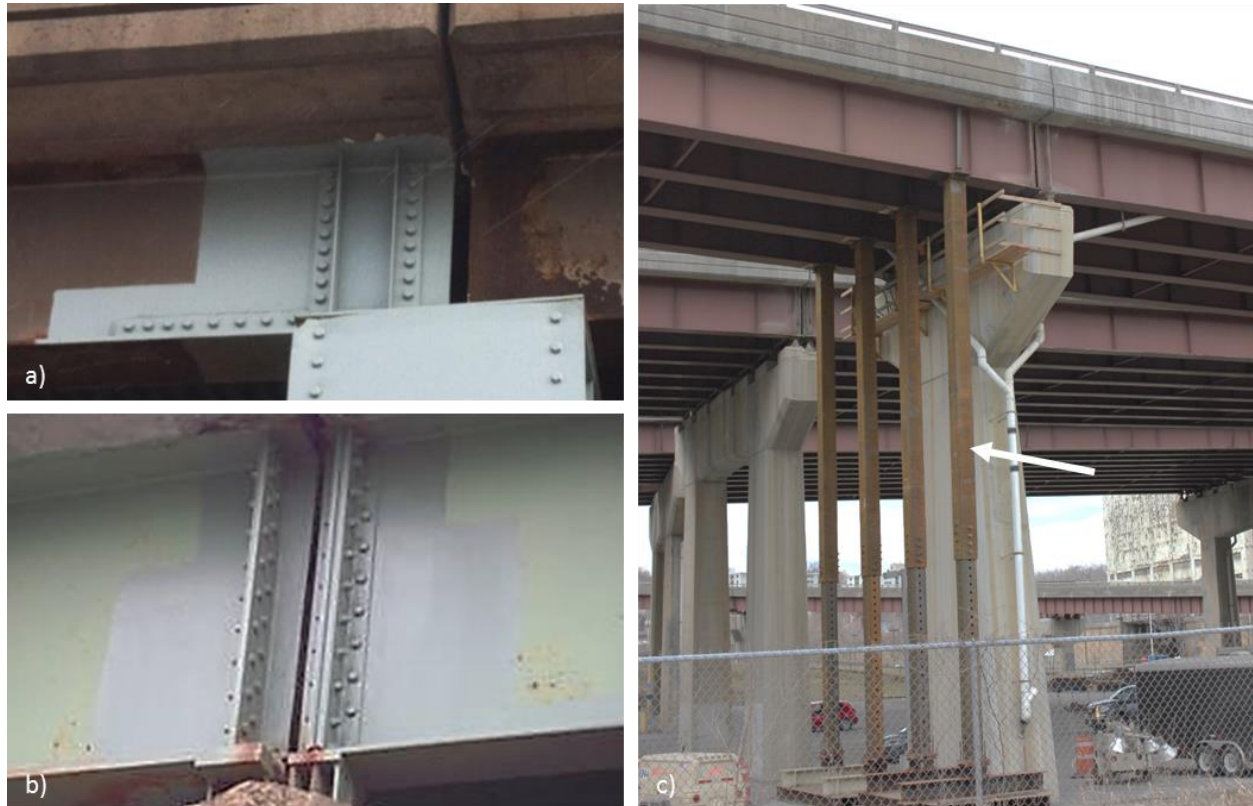
Figure 1.3: Conventional Repair Method for corroded girder ends including jacking of the superstructure during construction

manual labor. Jacking of the superstructure is required in order to provide a stress-free condition for implementation of the repair. Jacking often constitutes a large percentage of the project cost. For a bearing replacement project on the Putnam Bridge in Connecticut, 50% of the project cost was due to jacking (Close 2011). Figure 1.3(c) shows the extent of the rigorous jacking systems needed to raise and lower superstructures during repair. Jacking towers are indicated with an arrow. Surface preparation is also required before removing the corroded steel and welding new steel. Preparation requires lead abatement if the existing paint is lead-based.

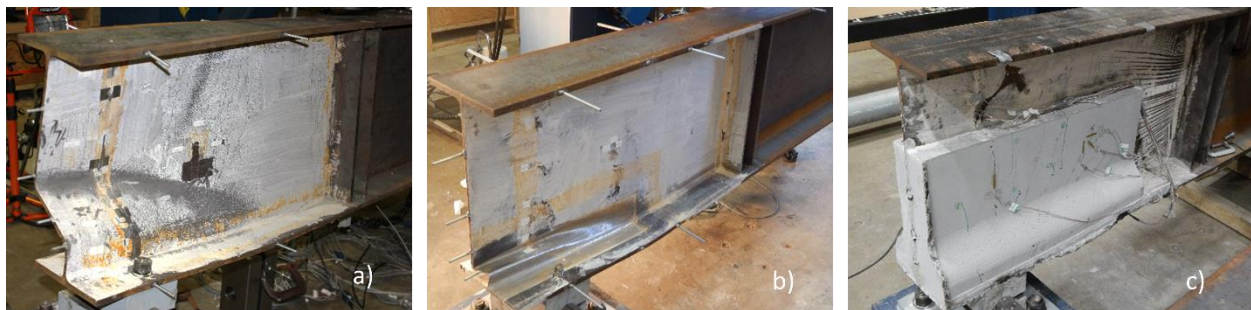
Figure 1.4: Phase 1 – a) Undamaged Girder, b) Damaged Girder, & c) Repaired Girder

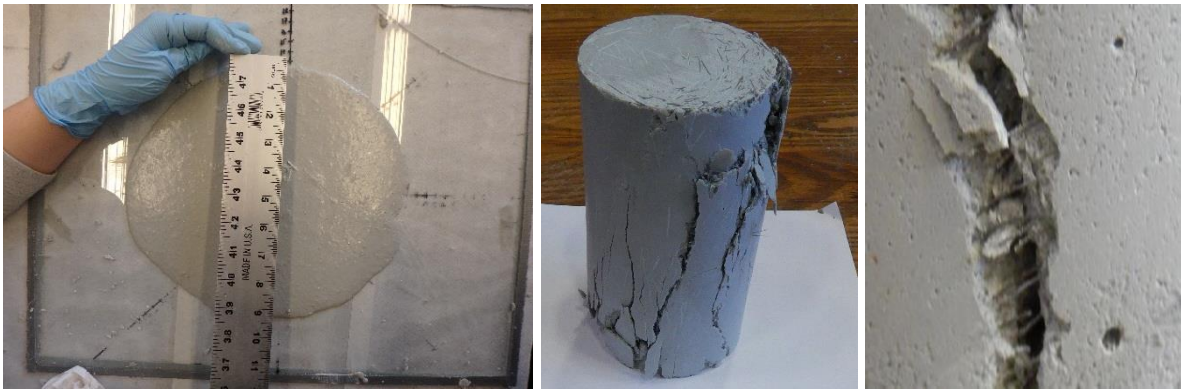
Figure 1.5: Material Testing of UHPC – a) good flowability, b) high compressive strength, & c) added tensile strength from steel fibers

UHPC material was chosen as the desired repair material over conventional concrete because of unique material benefits that it provided to the repair design. The UHPC mix used in this project has been accepted and tested by FHWA for several research projects (Graybeal 2014; Russell and Graybeal 2013; Yaun and Graybeal 2014). Russell and Graybeal (2013) document many of the advantages of UHPC compared to conventional concrete specific to the current application. The UHPC ready mix used in this research project (Ductal® JS-1212) significantly reduces onsite complications and inconsistencies with the constructability and performance of the repair. The flowability of UHPC may allow the repair to be poured or pumped to encase complex geometries with no concerns of clogging when used with tightly spaced shear studs. Figure 1.5(a) shows the results of a slump test with UHPC and the good flowability of the material. The high early strength of UHPC would allow for reduced lane closures and construction delays, as this particular mix is specified to achieve a compressive strength of 12-ksi (82.7-MPa) after 12 hours of curing at 120°F. UHPC has proven durability when exposed to moisture, freeze-thaw conditions, and abrasion. It has a very low permeability and water absorption capacity, which is approximately 10 and 60 times less than high-performance concrete and normal strength concrete, respectively (Abbas et al. 2016). Figure 1.5(b) shows a concrete cylinder used to determine compressive strength after 3 days of curing. The impervious nature of UHPC would prevent the repair panel or the base steel material of the girder from corroding further in the future. The crack resistance of UHPC due to its high tensile strength and ductility eliminate the need for the addition of reinforcing bars. Figure 1.5(c) shows how the steel fibers bridge micro cracks in the concrete to improve the compressive and tensile strength of fiber reinforced UHPC. Studies performed on the fatigue resistance of UHPC and UHPC shear connectors demonstrated the improved resistance compared to conventional concrete (Classen et al. 2016; Feldmann et al. 2011; Grünberg et al. 2008; Shaheen and Shrive 2008). The superior characteristics of UHPC may justify the added costs of the material.

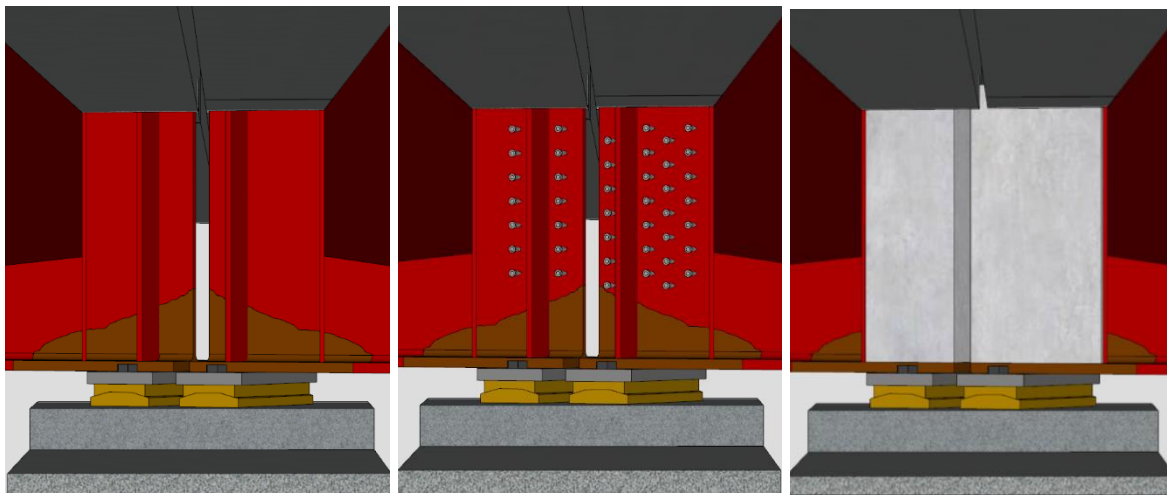
Figure 1.6: 3D rendering of the proposed UHPC repair method -1) Girder End Corrosion, 2) Welded Shear Studs, & 3) UHPC repair panel

experimental test will include several push-off tests to assess the interaction between shear studs cast into the UHPC repair panel. For the push-off tests, the shear studs will be welded to the thin web of the girder as opposed to the thick flange, which is most common. Experimental tests will be conducted on full-scale plate girders to investigate the performance of different repair geometries. The results for the experimental tests will be used to calibrate FE models which may then be used to test different configurations and various parameters. The results from both the experimental and analytical studies may be used to create a design guide to allow engineers to implement the design. The team will work with CTDOT to implement the repair in the field for an in-service bridge. This will include scope, design, construction, and monitoring the repair. Figure 1.6 shows a rendering of the proposed repair method sequence.

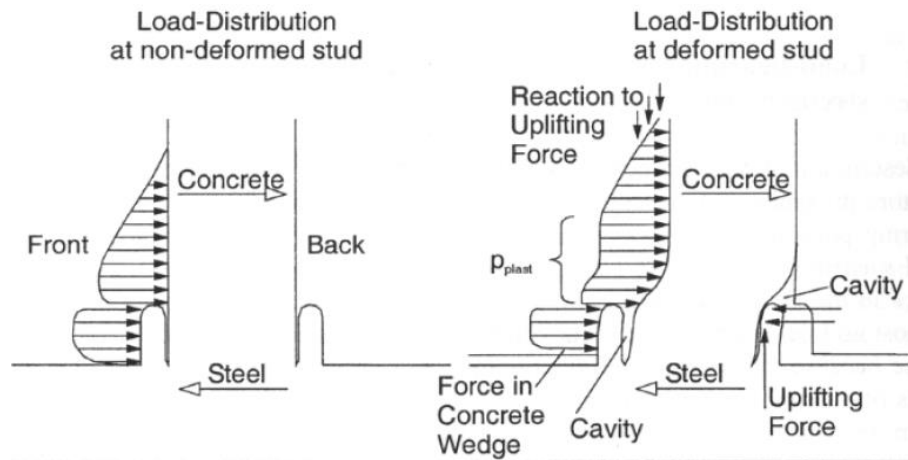
Figure 2.1: Force distribution of stud shank and weld collar under pure shear (Hegger et al. 2001)

Where A_{sc} is the area of the stud shank, f_{su} is the ultimate tensile capacity of the stud, f_{cu} is the compressive strength of the concrete, d_{wc} is the diameter of the weld collar, l_{wc} is the height of the weld collar, and η is an empirical factor typically taken as 2.5 for UHPC (Kim et al. 2015). A schematic of the mechanical behavior of the stud and weld collar under a pure shear load is provided in Figure 2.1.

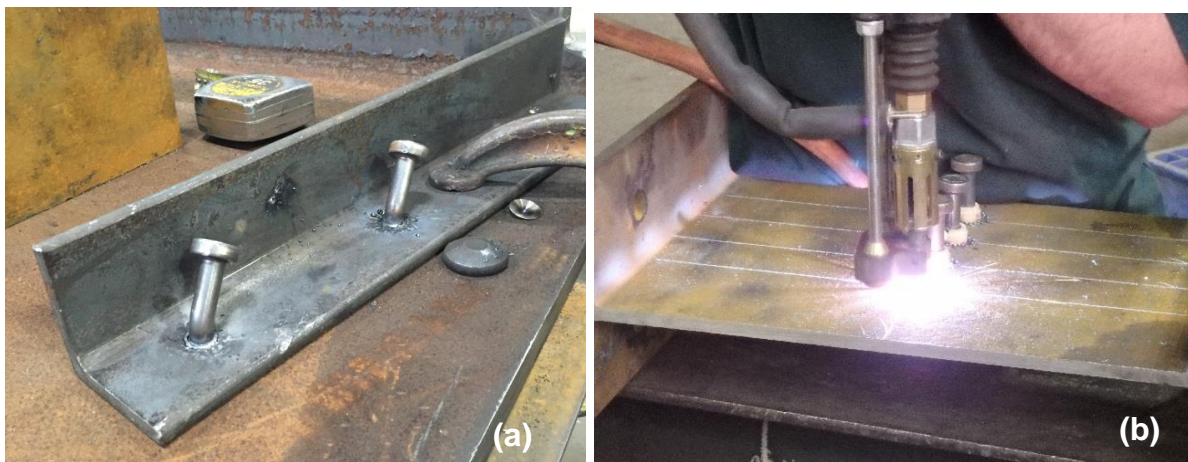
Figure 2.2: (a) bend test on studs; (b) welding using stud gun

To fabricate the specimens, the girders were cut into 12 inch sections so that several parameters could be studied from the same material. All specimens were designed according to AASHTO's design equations and fabricated by United Steel. In accordance with the American Welding Society, the shear studs were shot on a scrap piece of steel and bent to 30 degrees from their original axis to ensure the quality of the weld (Figure 2.2(a)). After the voltage was adjusted to produce the desired weld, the studs were shot onto the beam sample using a stud gun (Figure 2.2(b)). This is the typical method used in the field.

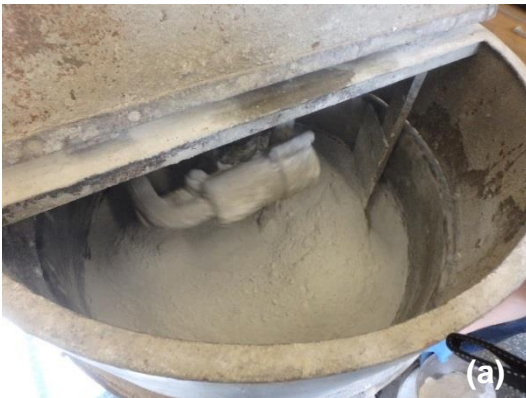
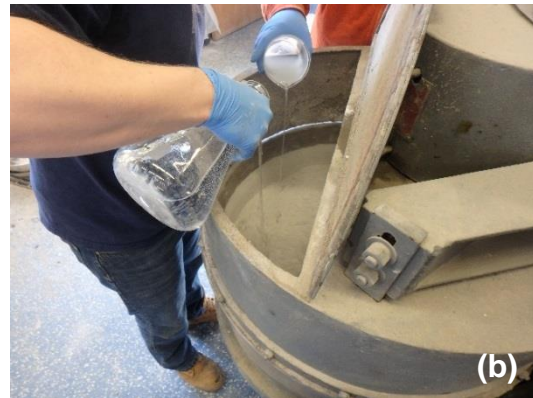
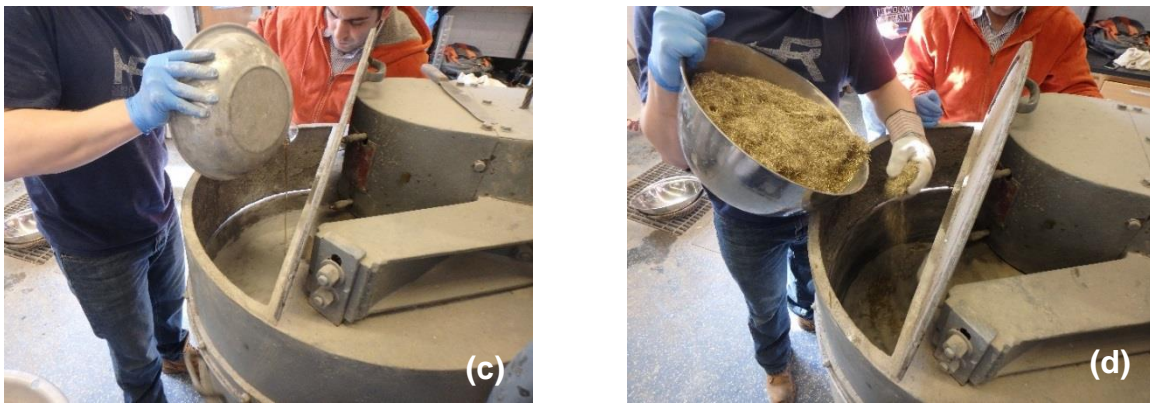
Figure 2.3: Mixing of (a) dry premix; (b) addition of water and superplasticizer,; (c) addition of chemicals; and, (d) addition of steel fibers

The mix design was cast and tested several times prior to casting the specimen in order to gain familiarity with the consistency and mechanical behavior of the material. All mixing and casting was conducted in the UConn Advanced Cementitious Materials and Composites Laboratory. The mixing procedure consisted of stirring the dry premix for approximately 5 minutes to eliminate any clumps (Figure 2.3(a)). Next, water and superplasticizer were slowly added and allowed to disperse (Figure 2.3(b)). Half of the water was substituted with ice in order to gain additional workability time. Next, all chemicals (Premia 150, Optima 100, and TurboCast) were slowly added (Figure 2.3(c)). Mixing continued until the concrete turned over and a uniform consistency was achieved. Finally, the steel fibers were slowly added and thoroughly mixed to ensure optimal dispersion (Figure 2.3(d)). This procedure was strictly adhered to for every specimen cast to establish consistency.

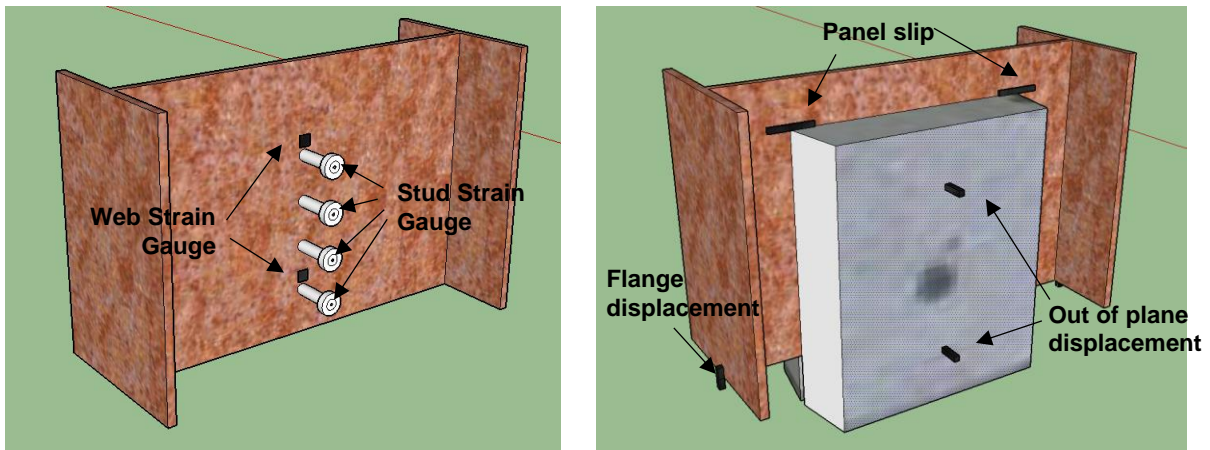
Figure 2.7: Typical instrumentation assembly for push-off test

Comprehensive instrumentation was installed on each specimen to extract all relevant data (Figure 2.7). The studs located on the front side were all instrumented with uniaxial strain gauges to capture axial deformation during loading. Biaxial strain gauges were installed just above the top and bottom stud to observe the demand on the web when the load is transferred to the adjacent studs. The panel was instrumented with displacement gauges which measured out of plane displacement, which occurs when the studs start to deform axially. Additionally, slip gauges were installed onto the web using high strength magnets to monitor the relative vertical displacement between the steel and the concrete. This movement showed the ductility of the system.

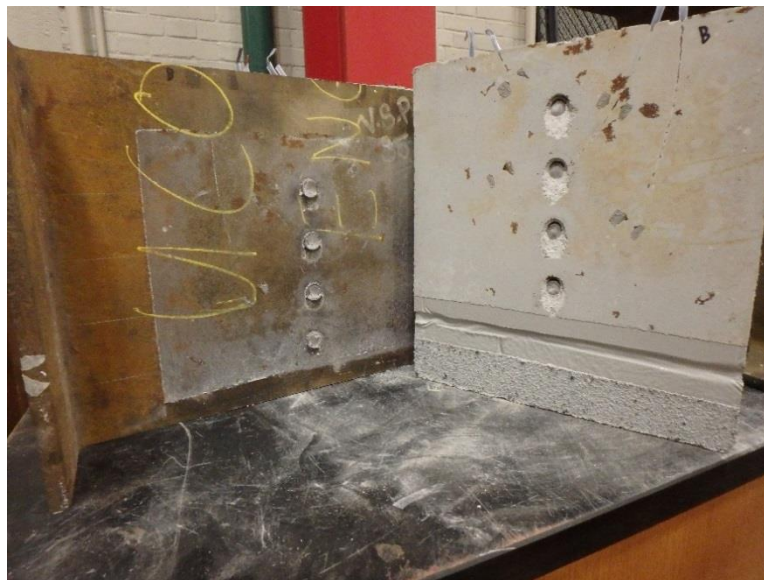
Figure 2.8: Typical failure of push-off specimen

The shear connection developed by the studs embedded in the UHPC generated a significant load bearing capacity even with the old steel as the base material. Excluding the regular strength concrete specimen, the capacity of the samples with $\phi 1/2$ " studs ranged between 118-134 kip. The specimen with $\phi 5/8$ " studs generated a load bearing capacity of 96 kip. The stud layout did not have any significant effect on the load bearing capacity as every specimen exceeded the theoretical capacity outlined in AASHTO. All of the specimens (except the regular strength concrete sample) failed via shear failure of the stud shank directly adjacent to the weld collar (Figure 2.8). There was little to no cracking observed in the concrete panel. However, a thin portion of the UHPC sheared off underneath each stud, indicating high shear forces concentrated in the region due to the weld collar.

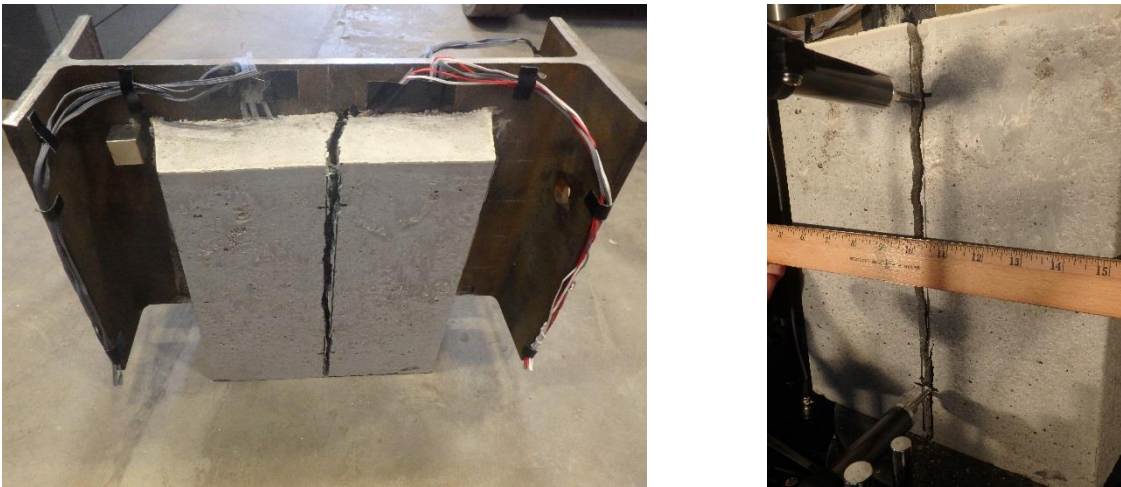
Figure 2.9: Failure of regular strength concrete sample via tensile panel splitting

The regular strength concrete sample showed that conventional concrete materials was not suitable for the envisioned repair method, as the panels split under tension when larger loads were applied (Figure 2.9). This demonstrates the need for reinforcement in the panel, which may be difficult to install. However, the specimens containing UHPC exhibited almost no cracking, due to the high-strength steels fibers that are dispersed throughout the matrix. These fibers activate to take on any tensile action in the panel that may arise when the studs bear on the concrete.

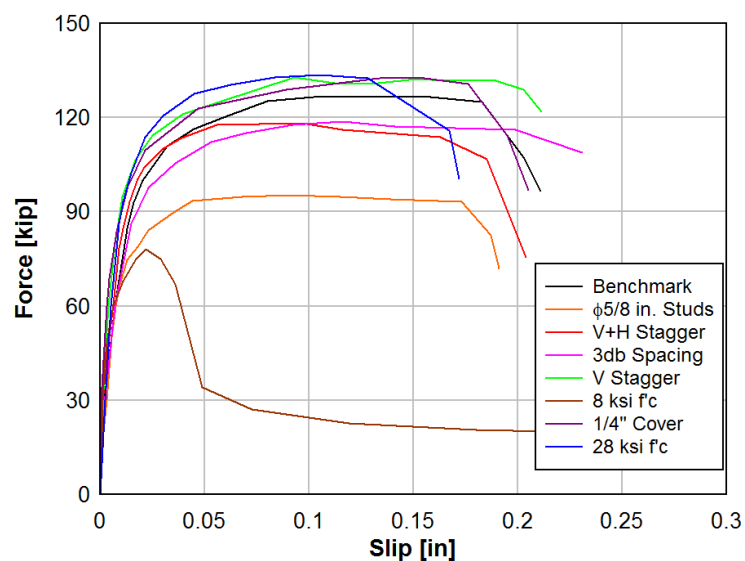
Figure 2.10: Force vs. slip summary for all specimens

Figure 2.10 shows the force vs. slip curves for all specimens tested. When compared to the specimens with UHPC embedded studs, the regular strength concrete sample with 8 ksi panels clearly generated a much lower ultimate capacity and achieved no plastic load bearing capacity. However, the specimens with UHPC sustained their ultimate load over a large slip range, characterized by the long plastic plateaus (Figure 2.10). This indicated that the shear connection demonstrates ductile behavior and is controlled by the stud material strength. The shear studs experienced much larger strains than the web itself. The lack of cracking observed in the UHPC panel above and below the studs indicated that the concrete's superior compressive strength was able to accommodate the stresses that developed between the studs.

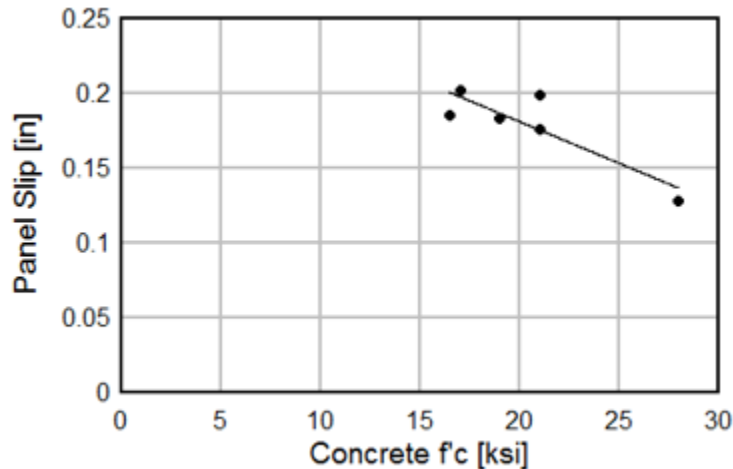
Figure 2.11: Panel slip vs. concrete f'_c for all UHPC push-off specimens

failure of approximately 0.128 inch (3.25 mm). This was most likely due to the confining effect of the UHPC as indicated by the increased elastic stiffness. At higher compressive strengths, confining action of the UHPC around the stud shank prevented the stud from deforming in a ductile manner. Less axial strain was generated throughout the length of the stud and a higher shear force was developed in the shank near the weld collar. Figure 2.11 shows the relationship between experimental panel slip and compressive strength of the UHPC panels, indicating a reduction in panel slip as concrete strength increases.

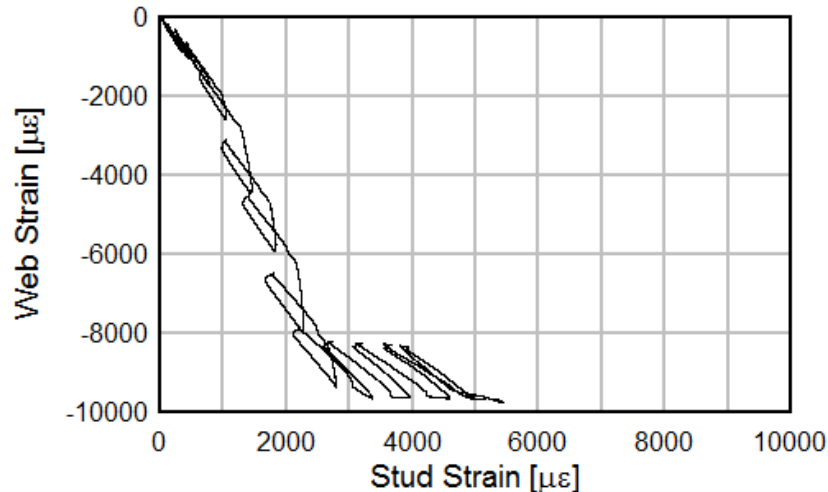
Figure 2.12: Typical strain transfer behavior between the web and shear stud

Figure 2.12 shows the transfer of strain between the stud and adjacent web on which it was welded. When initial loads were applied to the system, the web and studs act together to resist the demands in the elastic range. However, when larger displacements were induced, the web began to undergo larger plastic deformations (possibly because it is composed of a weaker grade steel), while the studs just began to activate. Upon further displacement, the web transferred the load into the studs, which eventually experienced yielding. At this point, the studs became the weak link in the system and continued to undergo plastic shear deformation until failure.

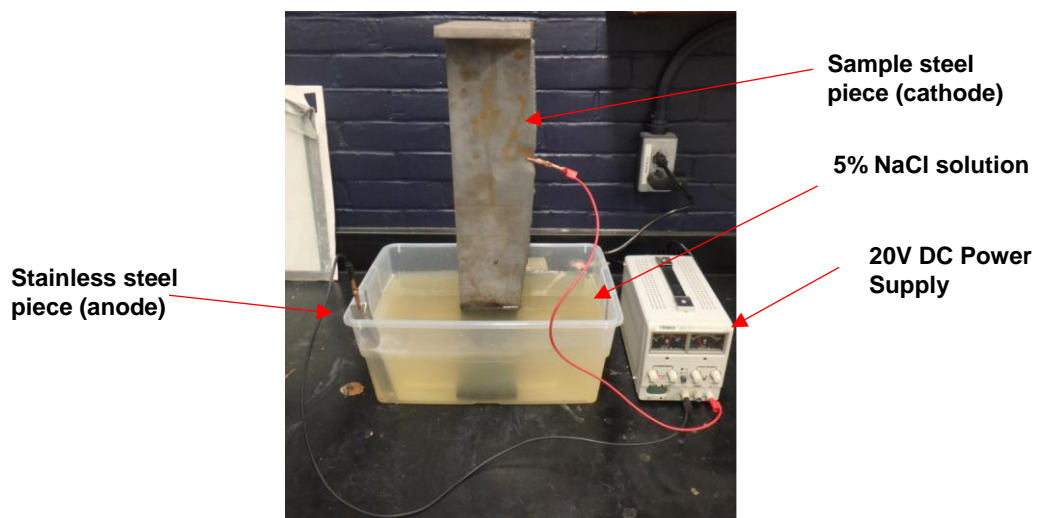
Figure 2.13: Experimental assembly of electrochemical corrosion test

In order to gain confidence with the deterioration process, a formal experiment was conducted on a sample piece of steel that was also used as the base material for the push-off experiments. The experimental setup is shown in Figure 2.13. The bottom flange and lower portion of the web were submerged in a 5% NaCl (sodium chloride) solution, which served as the electrolyte. A piece of stainless steel, which served as the cathode, was also submerged in the solution. A positive current of 2 amperes was impressed onto the sample piece of steel, and the negative wire was attached to the piece of stainless steel to complete the circuit and allow electrons to flow. The mass loss and change in web and flange thickness were monitored as a function of time.

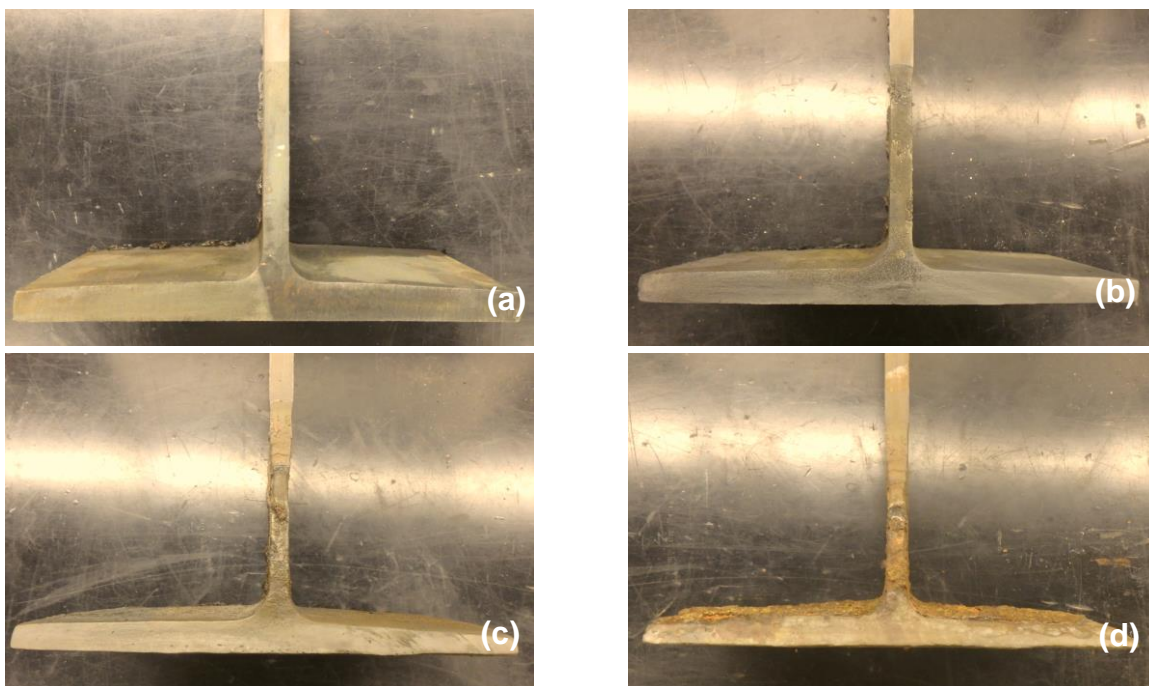
Figure 2.14: Corrosion at: (a) 0-hrs; (b) 42-Hrs; (c) 186-hrs; (d) 325-hrs

Figure 2.14 shows the progression of section loss of a rolled-steel girder section due to electrochemical corrosion. Figure 2.15 shows the extent of corrosion and degree of section loss as a function of time. Over time, the solution became darker and black sludge accumulated at the surface, and eventually dropped to the bottom of the container. This sludge is the oxidized byproduct of the steel, which accumulates at the surface when in contact with oxygen. Throughout the duration of testing, the web experienced approximately 30% section loss in about 14 days, while the flanges thicknesses reduced by about 12%. The difference in section loss between the web and the flange stems from varying initial thicknesses. The entire specimen, however, experienced a constant mass loss of about 2.07 grams per hour, which is consistent with Faraday's theoretical mass loss of 2.04 grams per hour.

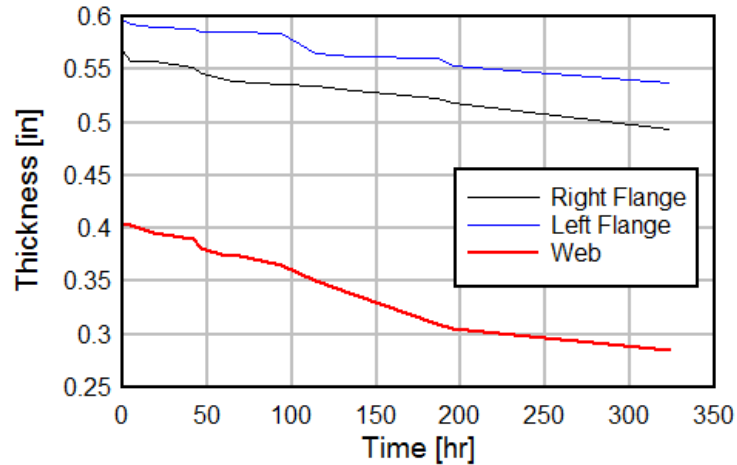
Figure 2.15: Steel Thickness vs. Time during Electrochemical corrosion

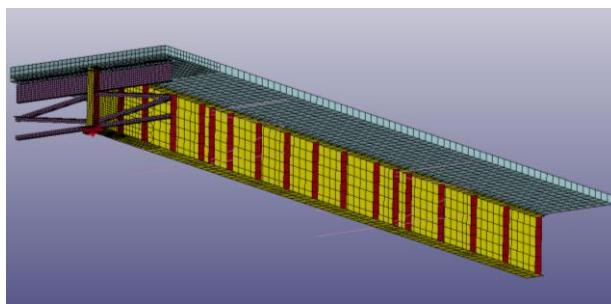
Figure 3.1: Full scale FE models of an interior girder from CT Bridge #818

An additional model was also created for CT Bridge #818 as it was the main bridge studied for the test specimen design. Models have also been created for this bridge with and without skew. Different designs and methodologies have been studied to ensure the models are accurate and efficient. Figure 3.1 shows a snap shot of the geometric model of full scale girders modeled after CT Bridge #818.

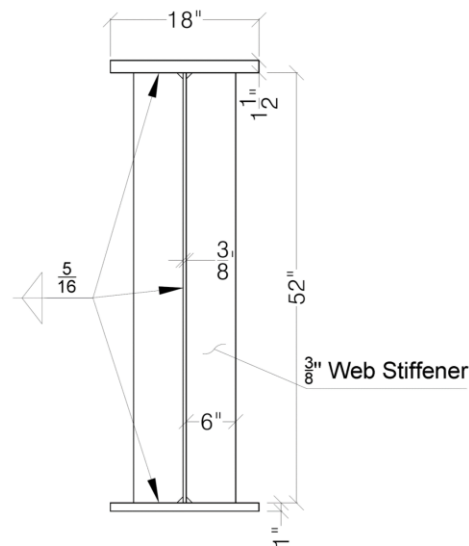
Figure 3.2: Cross Section of the Plate Girder Specimen

deep (D) plate girders with a $3/8$ inch web (t_w). The width of the flanges (b_f) is 18 inch. The bottom flange has a thickness (t_{bf}) of 1 inch and the top flange has a thickness (t_{tf}) of 1.5 inch. The top flange had a larger thickness than the bottom flange in order to provide additional resistance from lateral torsional buckling (LTB), similar to a composite deck. The flanges were connected to the web with a $5/16$ inch weld. The plate girder specimens have two different size stiffeners. The web stiffeners were 6 inch wide and $3/8$ inch thick. The bearing stiffeners were 6 inch wide and $1/2$ inch thick. The cross section of the plate girder specimens is shown in Figure 3.2. Complete shop drawings of the plate girder specimens may be found in Appendix C.

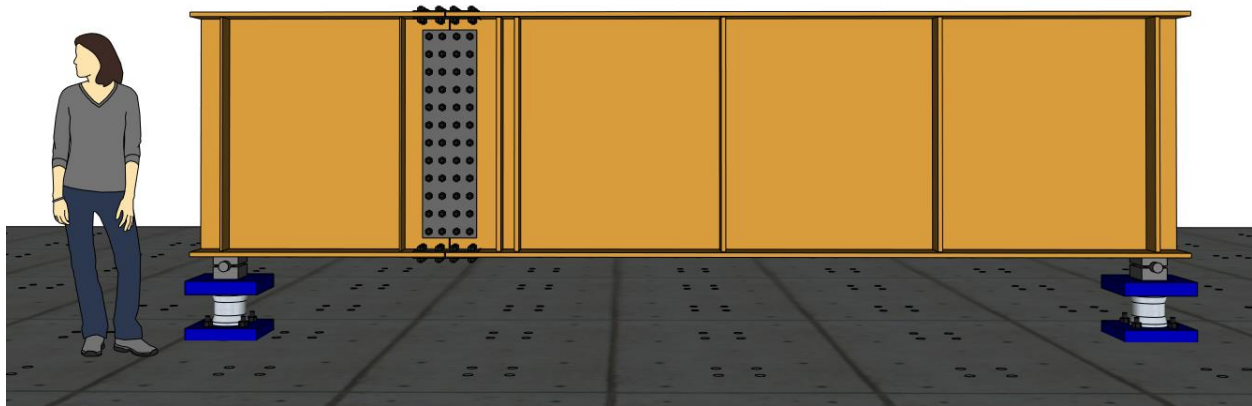
Figure 3.3: 3D rendering plate girder specimen for experimental testing with splice connection

girder. The splice connection was checked for shear and bearing of the bolts and yielding, rupture, and block shear of the web and flanges using the AISC Steel Construction Manual (AISC 2011). Preliminary finite element models were completed with and without the splice connection to ensure it did not have a detrimental effect on the performance of the plate girder. The results showed the load transfer through the end panel was not greatly affected by the splice connection. Figure 3.3 and Figure 3.4 show the design of the full-scale plate girder specimens with the splice connection. The final shop drawings for the plate girder specimens may be found in Appendix C.

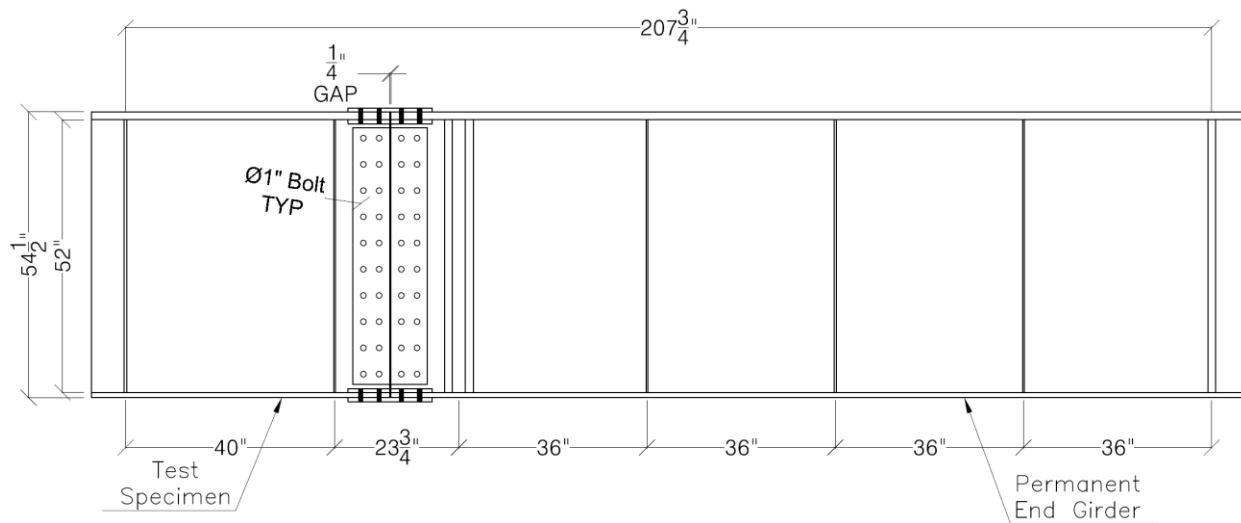
Figure 3.4: Plate girder specimen design for experimental testing

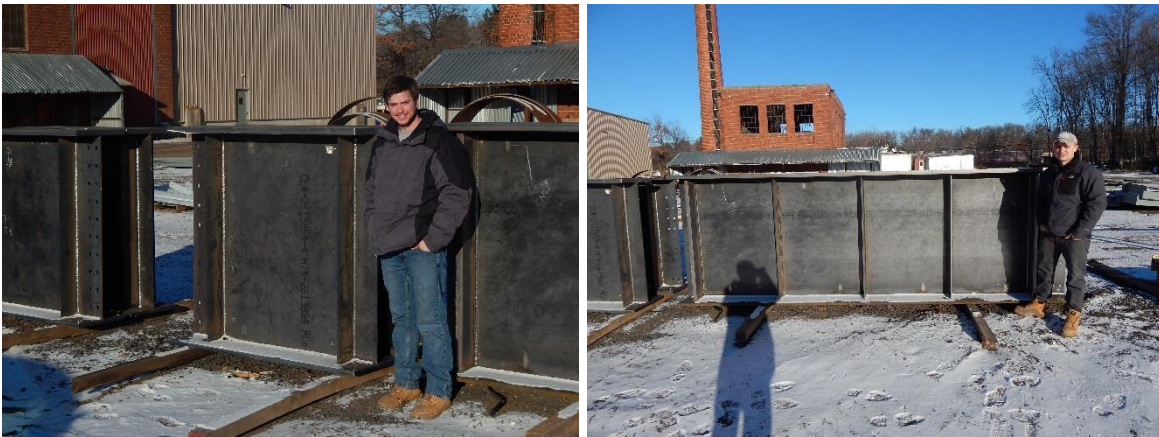
Figure 3.6: Complete Plate Girder Specimens at United Steel in East Hartford, CT

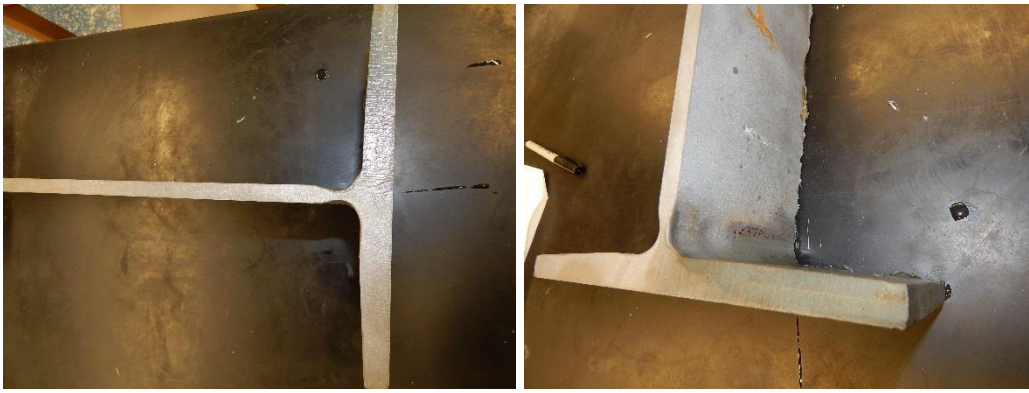
Figure 3.7: Simulation of corrosion damage by sandblasting steel beams

Modification of the test specimens will commence beginning with the simulation of corrosion damage of the girder end. In phase one of this study, the corrosion damage was simulated by removing a uniform section of steel material through CNC milling. However, this was a limitation for the study because inspection reports show that corrosion damage is non-uniform and varies in depth and size. Therefore, for this study, corrosion section loss will be simulated by sandblasting the material at locations where corrosion typically occurs in order to create a more relevant experimental test. Sandblasting has been found as a capable method to remove steel material. It may be easily performed and is simple to monitor and control. Figure 3.7 shows a test steel beam end with section loss from sandblasting. Other methods such as electrochemical corrosion (which is being used for the push-off tests) may be unpredictable to achieve a desired section loss at precise locations for large-scale samples. Section 4 provides additional information on experimental and analytical corrosion test.

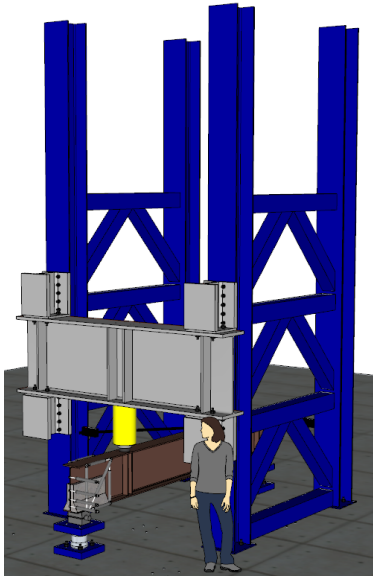
Figure 3.8: Rendering of Phase 1 Test Setup

The experimental testing for this research project will require more force demand than previous large-scale experimentation that has taken place at the University of Connecticut. Therefore, the large-scale test load frame in the UCONN Structures Laboratory has been modified and strengthened to achieve the desired capacity for this project. In phase one of this project, half-scale rolled girders were tested until failure. The existing load frame consisted of four 20-foot tall HP14x89 columns and a single W36x160 spreader beam; two sets of two columns were connected by welding HSS8x8x $\frac{1}{2}$ tubes in K-braces with the spreader beam connecting the two units as shown in Figure 3.8. Each column was tied into the UCONN Structures Lab with four $1\frac{1}{8}$ inch anchor rods secured to the 4-foot thick strong floor. This load frame setup was designed for a 500 kip Enerpac double-acting hydraulic load ram attached to the spreader beam which spanned 8 foot between two columns. The complete test setup for phase one is shown in Figure 3.9.

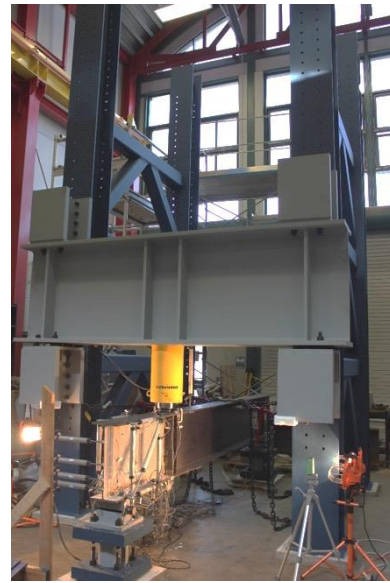
Figure 3.9: Phase 1 completed test setup

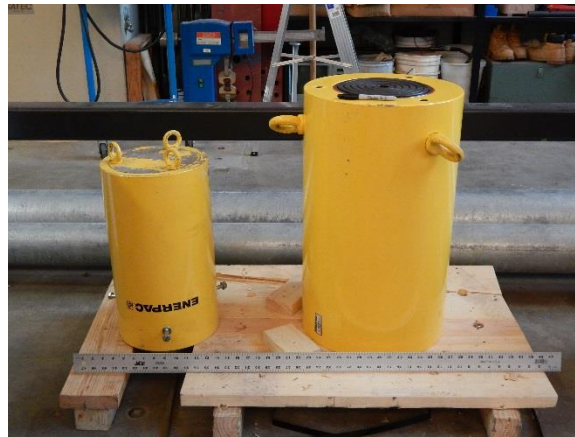
Figure 3.10: Enerpac CLRG-25012 (500-kip) and 50012 (1,000-kip) Hydraulic Cylinder

The second phase of this research project required a much larger force range for testing. An Enerpac CLRG-50012 1,000 kip hydraulic load ram will be used for experimental testing of the plate girder specimens. Figure 3.10 shows the 1,000 kip and 500 kip Enerpac load rams. The controlling element from the existing setup was the tensile strength of the anchor rods. Since the existing spreader beam spanned between two columns, they placed a much higher demand on the anchor rods. For the new test setup three additional spreader beams will be added to the system to equally engage all four columns and clusters of anchor rods. Two spreader beams will span between the columns of the two units and a third beam will connect the two spreader beams. Depending on the desired capacity of the system, the load ram may be placed at several locations along the middle spreader beam. The static load capacity of the load frame will be 1,000 kip with a maximum bearing reaction force of 750-800 kips depending on the length of the test specimen. The load frame will also be modified to allow an MTS ASSY-244.41S Actuator to be mounted directly over the bearing of the plate girder to provide a dynamic load to simulate traffic. This actuator may apply a maximum force of 110 kip. A photo of the MTS Hydraulic Actuator is shown in Figure 3.11. Figure 3.12 shows a rendering of the new load frame design. Figure 3.13 shows the erected load frame in the UCONN Structures lab. AutoCAD drawings of the complete experimental test setup are shown in Appendix D.

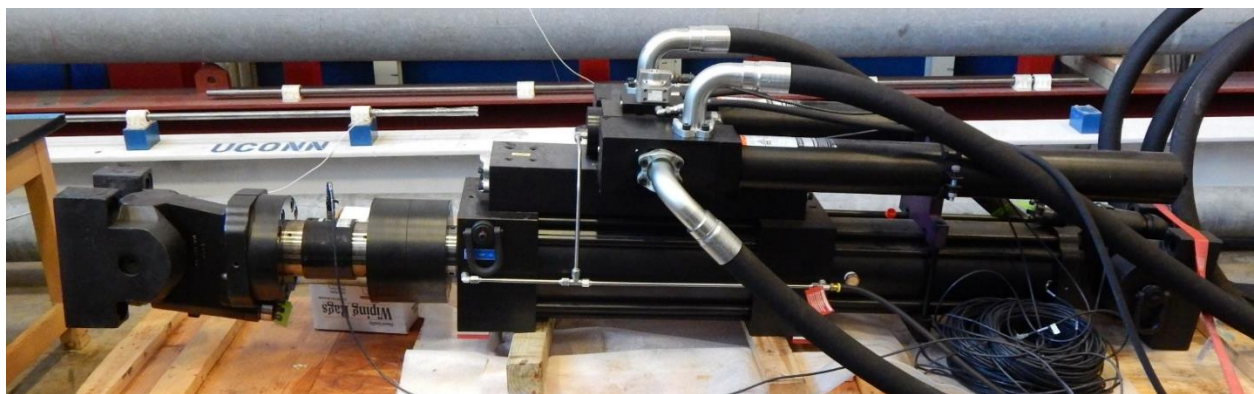
Figure 3.11: MTS ASSY-244.41S Hydraulic Actuator for dynamic loading to simulate live load traffic

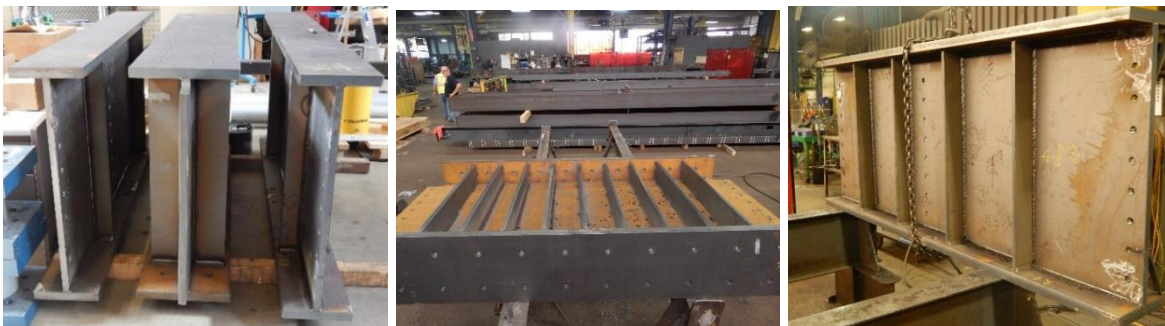
Figure 3.14: New plate girder spreader beams for the experimental test setup

Due to dimensional constraints the spreader beams were designed as plate girders. In order to improve the overall stiffness of the test setup, the spreader beams needed to

be deep while still fitting between the flanges of the columns. The spreader beams between the columns are 7'10" long and have a depth of 36 inch, a web thickness of 1 inch, a flange width of 11 inch, and a flange thickness of 1.5 inch. The cross spreader beam connecting the two spreader beams is 7'10" long and has a depth of 36 inch, a web thickness of 1.25 inch, a flange width of 16 inch, and a flange thickness of 1.5 inch. During phase I, reduced stiffness of the overall test setup affected the results of the tests because of slip in the load frame connections. Therefore, for this test, a Sherwin Williams Protective and Marine Coating was used on the load frame to provide a Class B slip coefficient with an acceptable coefficient of friction for slip critical condition. Calculations were completed to ensure that the entire testing system could withstand the demands of the experimental tests. The capacity of the floor bolts, beam connections, and spreader beams were designed and checked to provide adequate stiffness and strength during testing. The new spreader beams are shown in Figure 3.14. Shop drawings for the new load frame members are shown in Appendix E. The load frame assembly with the slip resistant paint applied is shown in Figure 3.15.

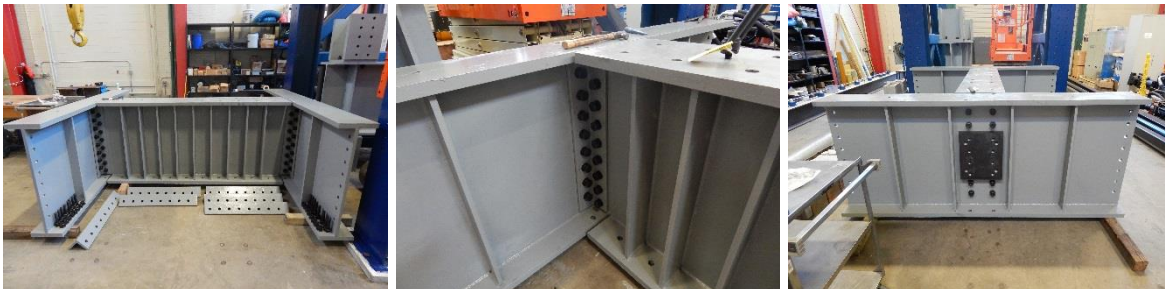
Figure 3.15: Load frame plate girder assembly with slip resistant paint

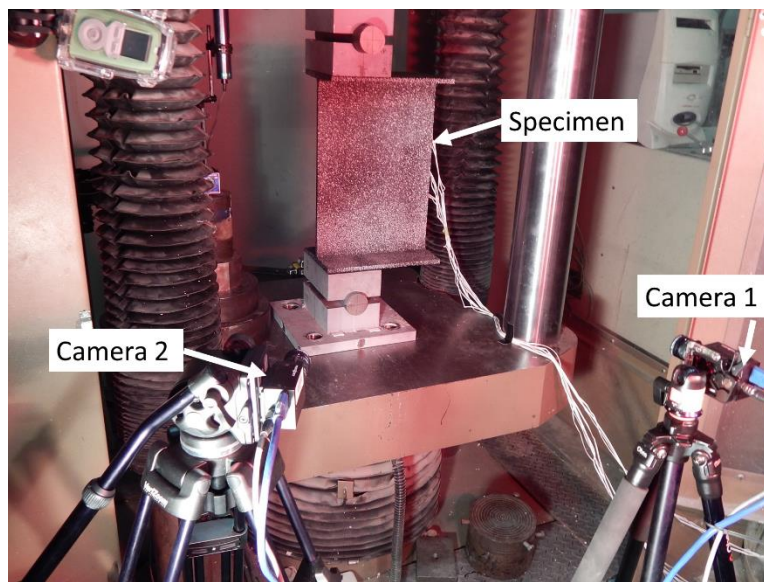
Figure 3.16: Setup of DIC cameras for experimental testing of corroded girders

before and after the repair is applied. It will provide invaluable understanding regarding the transfer of load from the plate girder to the repair. 3D DIC systems are capable of capturing out of plane displacements and protrusions including buckling. The DIC system consists of two charge-coupled device (CCD) progressive scanner cameras along with full-spectrum LED lighting, ultra-low distortion lenses, and a mounting system. The surface of the specimen being tested should be painted with a speckle pattern in order to improve the software's ability to track points along the surface. Figure 3.16 shows the test setup of the 3D DIC system for a corroded beam test which will be explained in the next section.

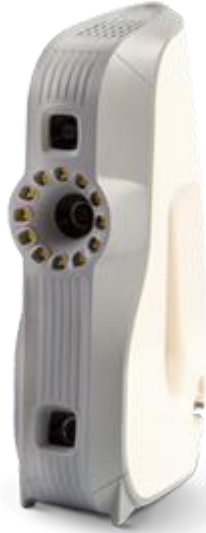
Figure 4.1: Artec Eva 3D Scanner

An Artec Eva 3D scanner was purchased (Figure 4.1). This scanner is capable of producing a complete 3D rendering of a scanned section with an accuracy of ≤ 0.5 -mm. The scanner is portable and may be used to measure corrosion damage of deficient, in-service bridges (Figure 4.2). This will allow engineers to determine the extent and pattern of corrosion damage in the field. For the experimental testing, this will allow for the replication of corrosion damage by removing similar volume and patterns of extreme damage from each of the experimental specimens (Figure 4.3). The damage may then be imported into finite element models to more accurately represent the specimens and capture their performance. The loss in section computed by the scanner could be used to more accurately predict girder capacity loss due to corrosion damage rather than current methods of field measurements and the assumption of a uniform reduction of cross sectional area. 3D scanning has the potential to be powerful tool for inspectors in measuring corrosion damage of structures in the field. The technology is accurate and provides a thorough understanding of the corrosion damage pattern and depth.

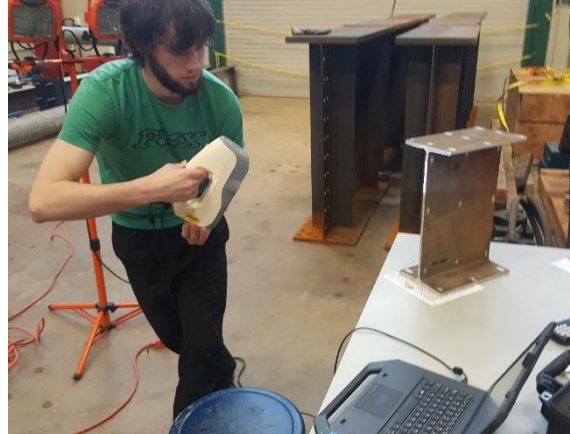
Figure 4.2: 3D Scanning using the Artec Eva

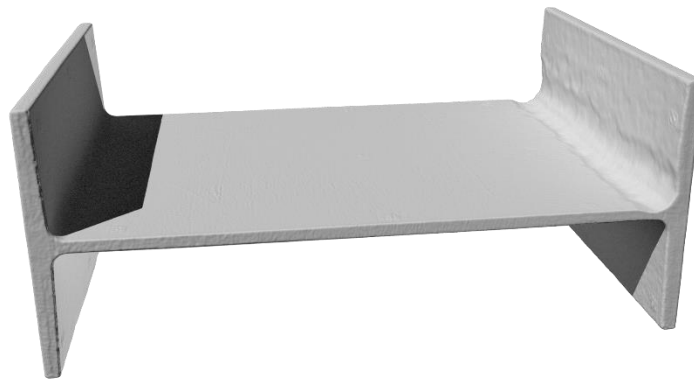
Figure 4.3: 3D point cloud of corroded girder

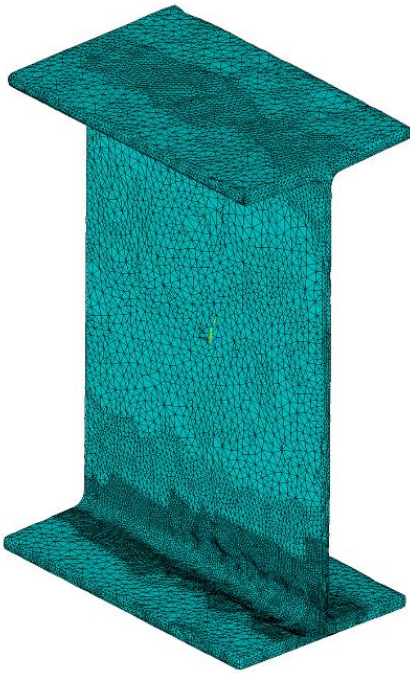
Figure 4.4: Finite Element 3D scanned mesh

To be able to accurately represent corrosion damage, methods are needed to accurately model non-uniform corrosion in Finite Element Models. Importing 3D scan data into finite element programs would provide an accurate geometry of the damaged section. Scans were taken of sections of corroded steel rolled girders from the old Q-Bridge in New Haven, CT. Several programs were used to convert the point cloud collected from the 3D scanner to a finite element mesh. Gmsh is open source software that was used to obtain finite element geometry from 3D scan data. An example of the finite element mesh is shown in Figure 4.4. A finite element simulation of the corroded section was run in Abaqus with the proper boundary conditions to determine the failure mode of the section. The deformed shape of the beam is shown in Figure 4.5 and Figure 4.6. The results of the model were found to be accurate as precise stress contours and buckling patterns were captured.

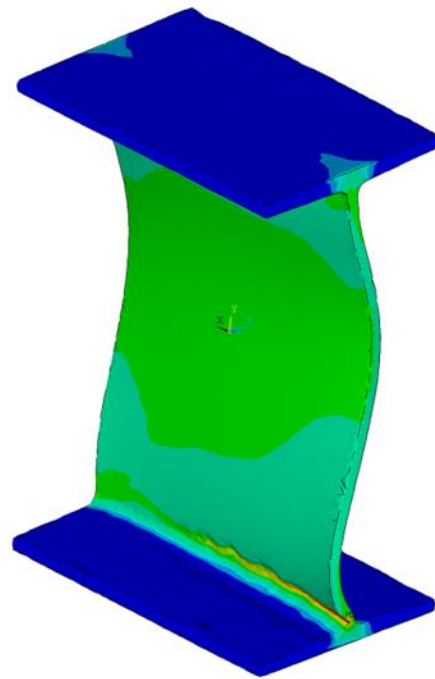
Figure 4.5: Overall deformed shape of the corroded steel girder
