**Repair of Steel Beam/Girder Ends with Ultra
High-Strength Concrete – Phase II**

Report Number: CT-2295-1-17-2
Interim Report
January 31, 2017

University of Connecticut
School of Engineering
Department of Civil and Environmental Engineering

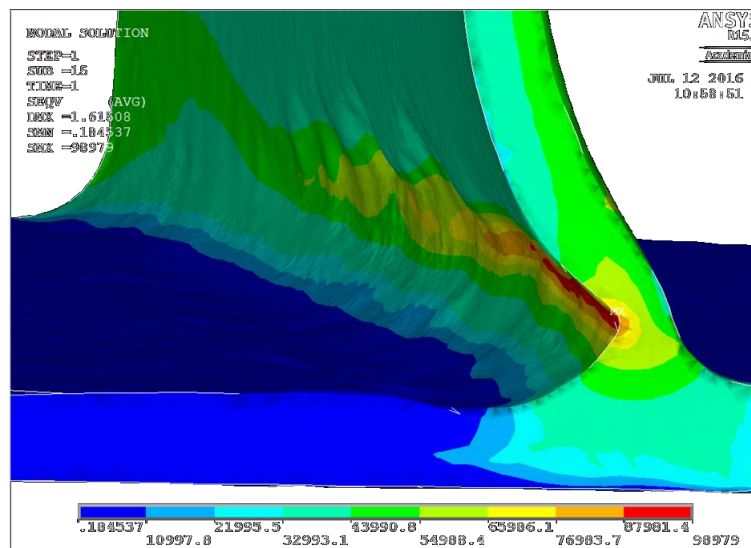
Figure 4.6: Stress contour of the corrosion damaged section of the steel girder

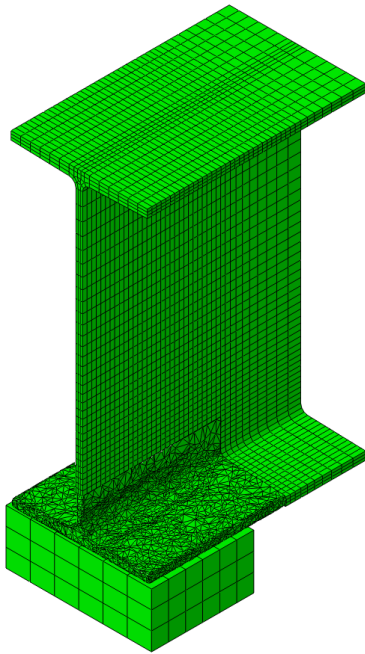
Figure 4.7: FE geometry with the scanned corroded area and the idealized geometry for the intact rolled-steel shape

girder with corrosion damage. The intact portion was replaced with an idealized model based on the geometry of the rolled-steel shape in order to improve computational efficiency. Figure 4.7 shows the finite element geometry with the scanned corroded area and the idealized geometry for the intact rolled-steel shape. Figure 4.8 shows the deformed shape of the girder section. Table 4.1 shows the progression of each of the four rolled-steel girder sections from the 3D scan to FEM geometry to analysis, and the results.

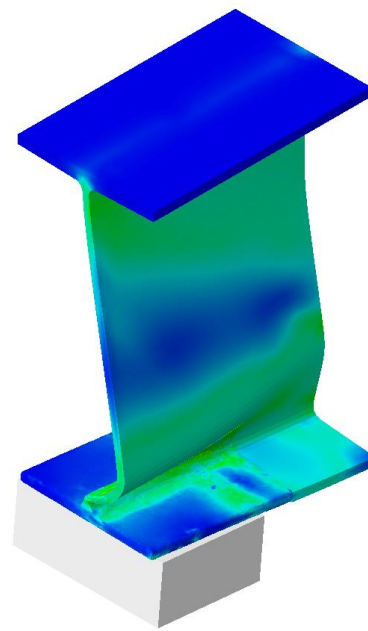
Figure 4.8: Deformed shape for corroded rolled-steel girder

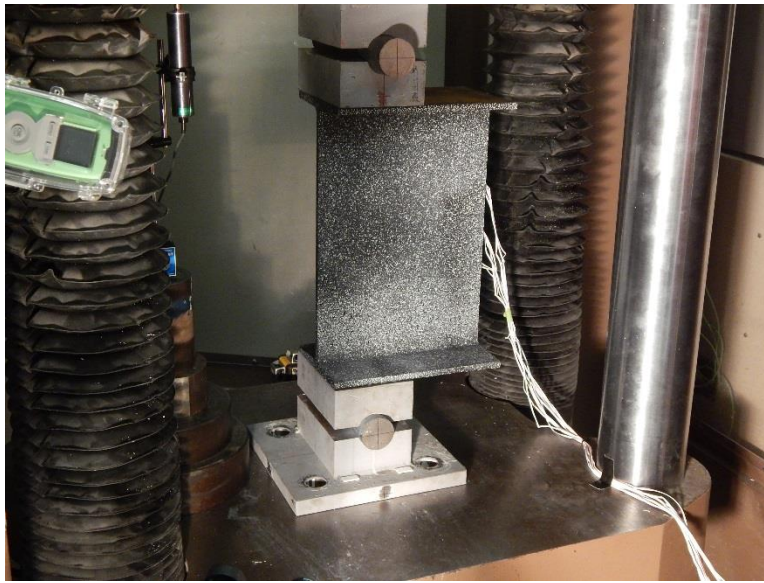
Figure 4.9: Experimental test setup for corroded beam ends

Experimental Tests will be conducted on the four corroded rolled-steel girder sections that were salvaged from the old Q-Bridge in New Haven, CT. The results of these tests will be used to validate the finite element models of the corroded girder sections. Similar results will show that the 3D scanned geometry of the corroded area could be used to accurately model to the structural section. The 3D DIC system explained in Section 3.5 will also be used to capture the strain field on the surface of the girder under loading. The results from the DIC will be used to compare with the results of the finite element models. Figure 4.9 shows the layout for the experimental testing of the corroded girder specimens. A bearing load was applied directly at the location of maximum corrosion of the beam. Two roller bearings were used to apply the load to the rolled girder.

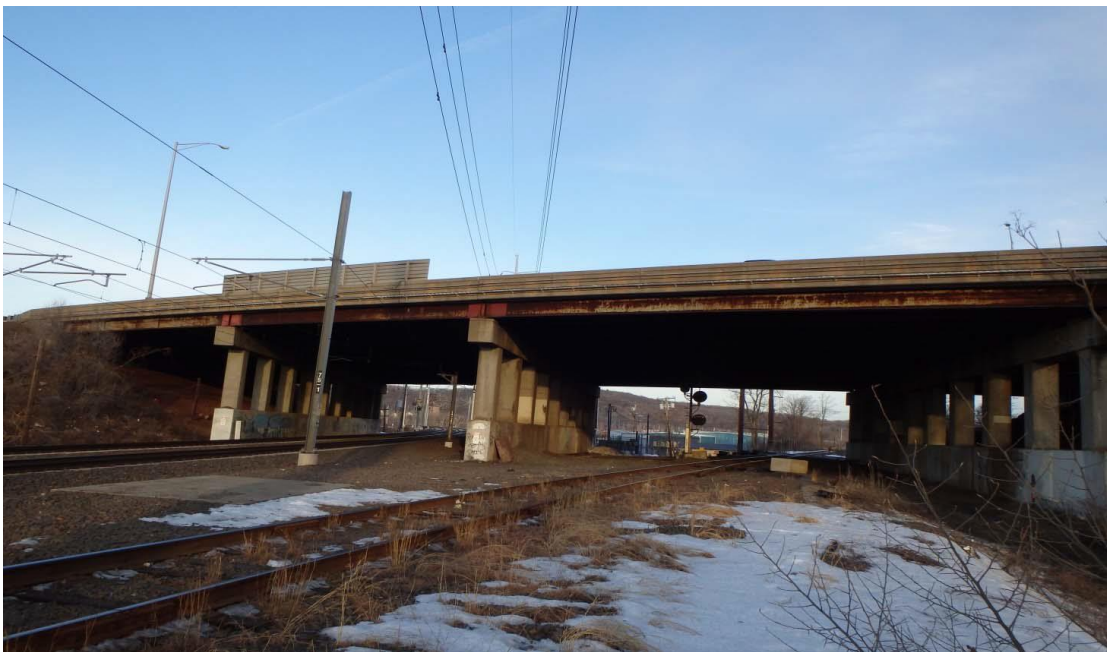
Figure 5.1: Bridge No. 03094 in New Haven, CT, servicing I-91 over Amtrak Railroad

Bridge No. 3094, constructed in 1965, is located in New Haven, CT. The bridge carries I-91 Northbound and Southbound over an Amtrak Railroad (AI-Engineers 2016; CME 2015). The bridge is located between exits 7 and 8. The bridge has a rolled-steel girder superstructure with a reinforced concrete deck with four simply supported spans. The span lengths vary due to a variety of different skew angles. The substructure consists of two reinforced concrete abutments and three reinforced concrete piers. The bearings are elastomeric expansion bearings and steel fixed bearings. Figure 5.1 shows Bridge No. 03094.

Field inspection of the bridge superstructure showed that the girders are in poor condition as the girder ends exhibit extensive rust. The webs have a maximum section loss of 5/16 inch and the bottom flange has a maximum section loss of 1/4 inch. This resulted in a maximum bearing capacity loss of 58.3% and a maximum shear capacity loss of 21%. Figure 5.2 shows portions of the corrosion damage to girder ends. The superstructure was deemed structurally deficient and requires extensive repairs for corrosion damage.

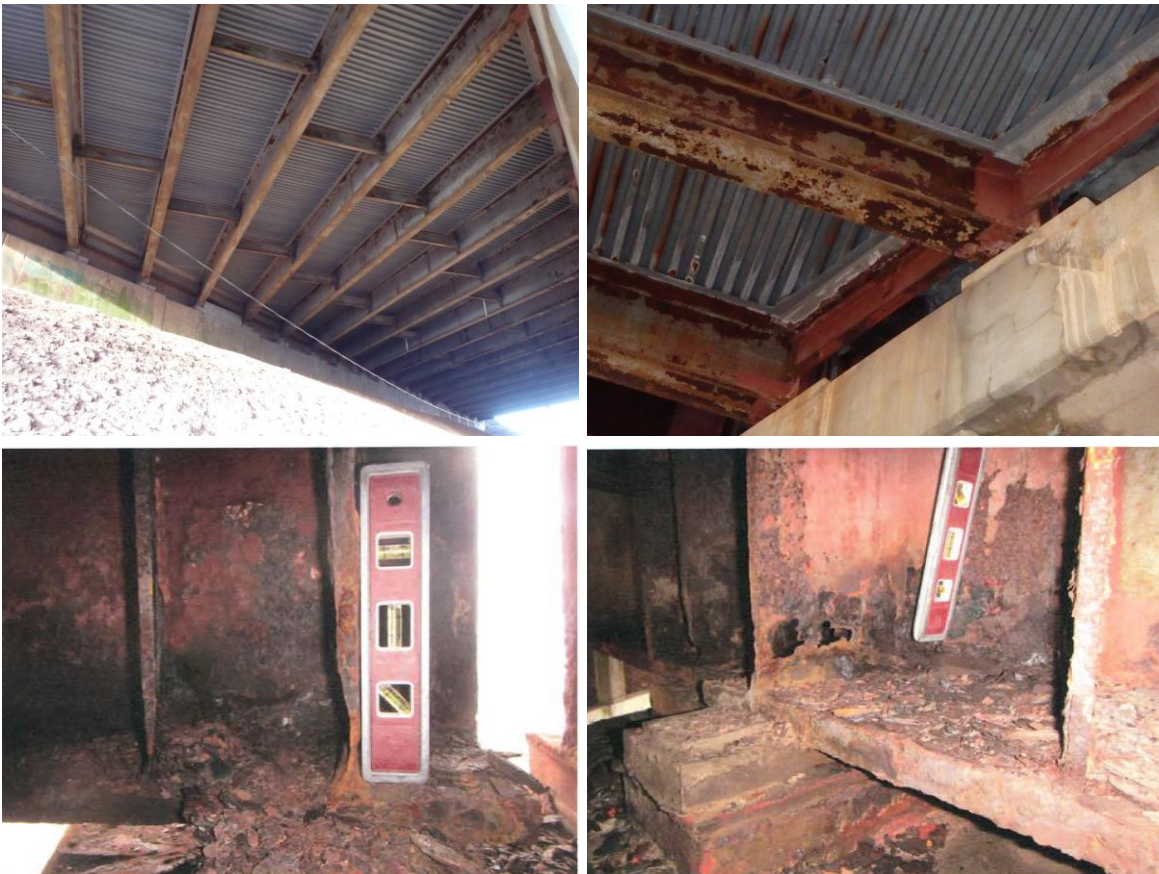
Figure 5.2: Severe corrosion damage of girder ends

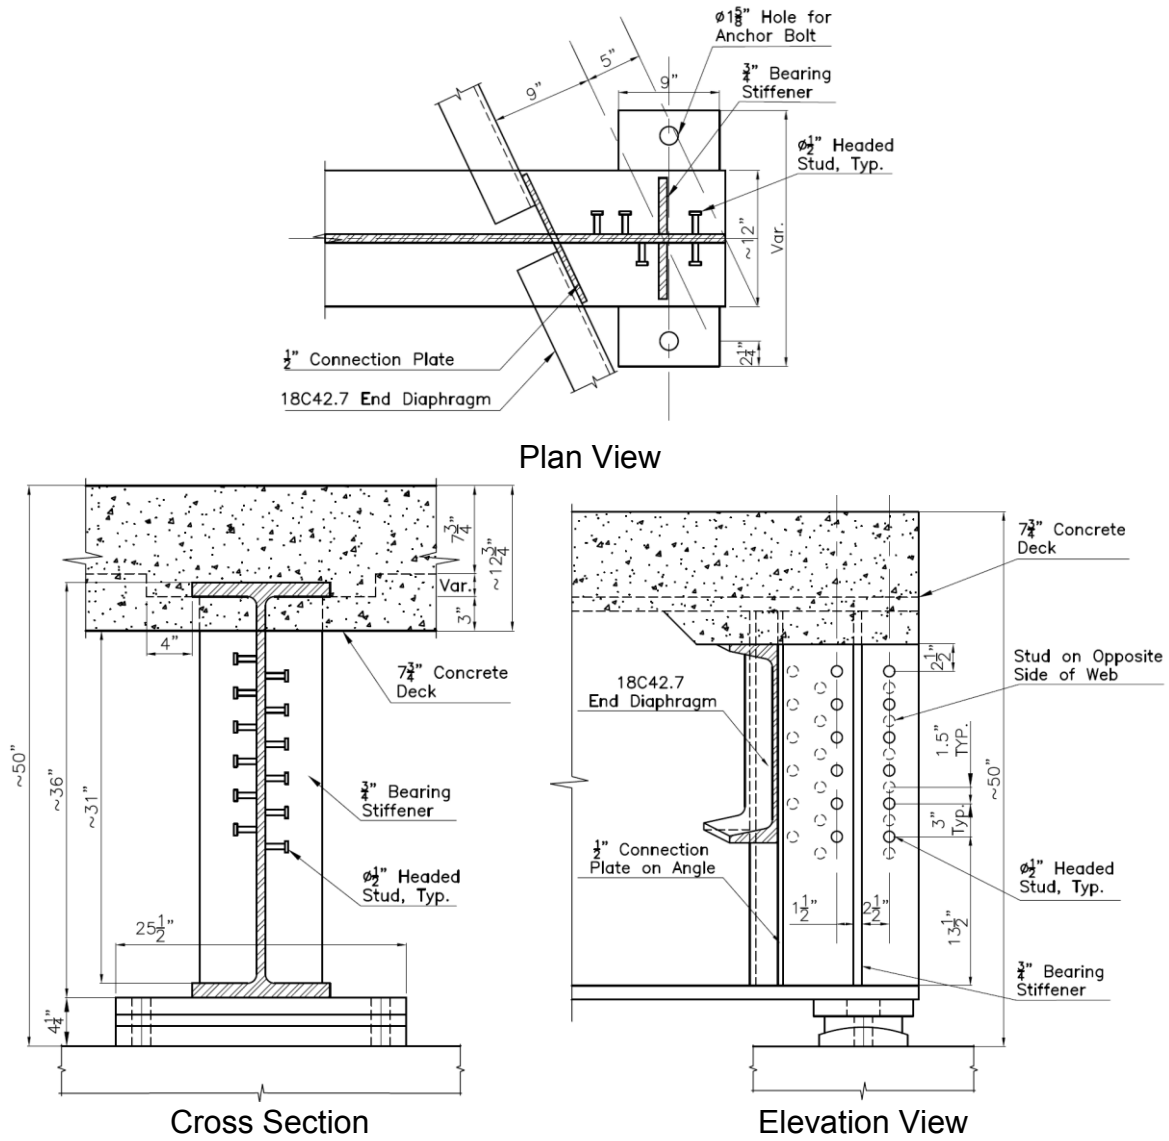
Figure 5.3: Design of potential shear stud layout for a corroded girder end

The design for each girder is based on the number of shear studs needed to provide sufficient capacity. There is no requirement for the pattern or placement of shear studs on the web of the girders. The only requirement is that the studs be welded to the uncorroded portions of the web. The studs should not be spaced closer than $3d_b$, where d_b is the diameter of the stud shank. This drastically simplifies field application of the repair because welding contractors do not need to individually measure and mark out the location of each stud. They only need to verify that the correct numbers of studs are welded to the web with sufficient spacing. Recommendations may be provided on placement to avoid back-to-back studs on the web. This would improve the load transfer path from the web, through the studs, and to the UHPC repair panel. The results of the push-off tests validate the flexibility of stud spacing and location to generate the desired stud capacity. Further tests are required to verify this design parameter, but current results satisfy this design. Figure 5.3 shows the design for the potential shear stud layout on the web of a corroded girder end. The location and spacing of the studs could vary for different repairs. Figure 5.4 shows the full height UHPC repair which encases the bearing stiffeners and the corroded web and flange. Sample Design drawings for the UHPC repair of Bridge No. 3094 may be found in Appendix G.

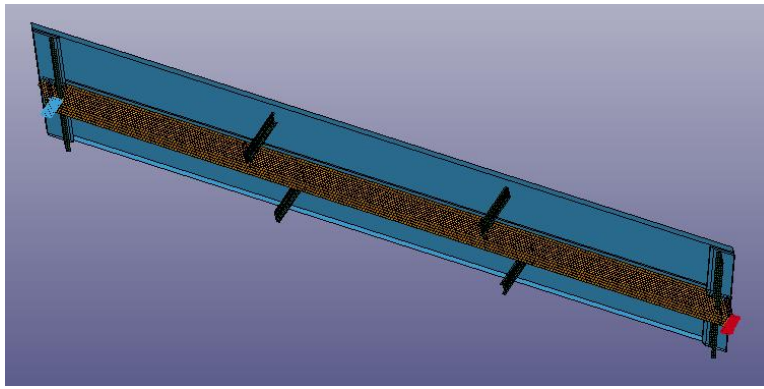
Figure 5.5: Finite Element model of Bridge No. 3094

Finite Element models of the complete bridge will be created to determine how the UHPC repair affects the performance of the bridge under live load. The model will include the girder with all stiffeners, cross bracing, composite deck, and bearings. The model will be simplified to improve the efficiency by providing geometric symmetry and realistic boundary conditions. Figure 5.5 shows the finite element model-create for Bridge No. 3094.

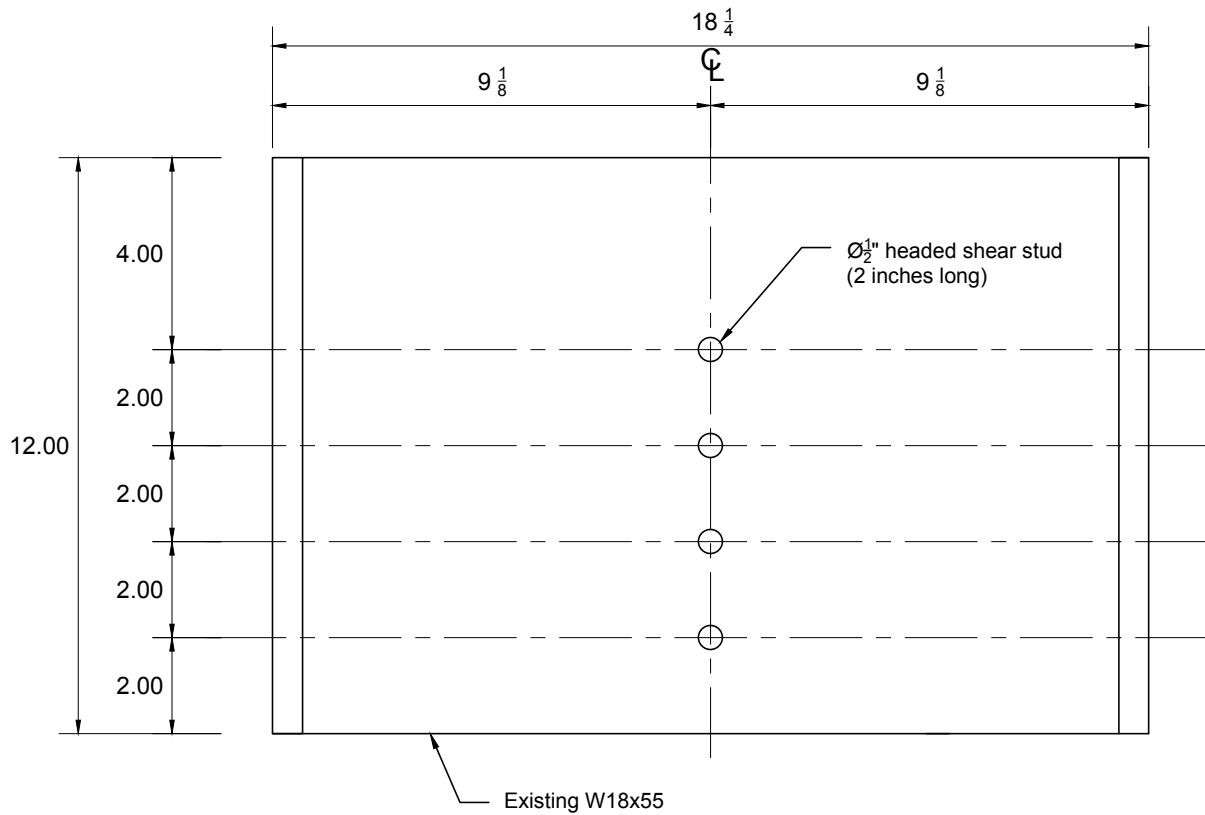
S1-1: Benchmark - 4db
Scale - 1:4

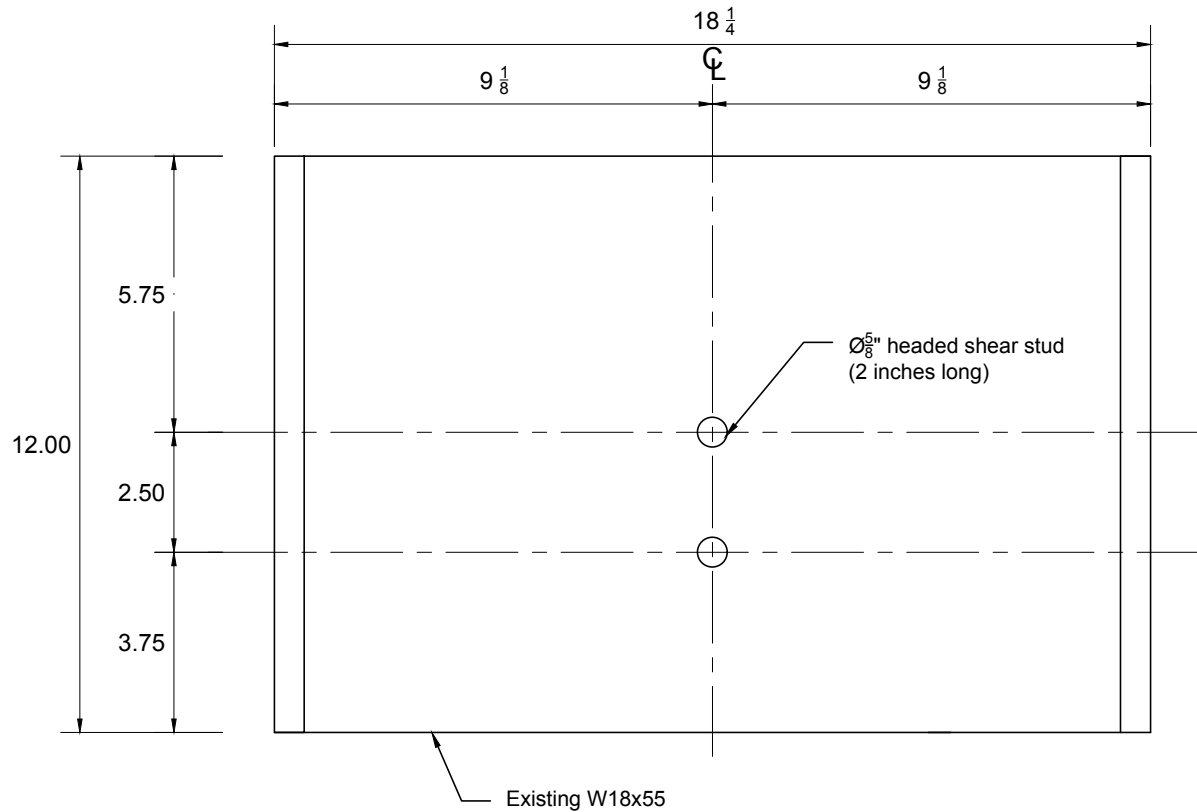
S3-1: No Stagger Pattern - 5/8" studs
Scale - 1:4

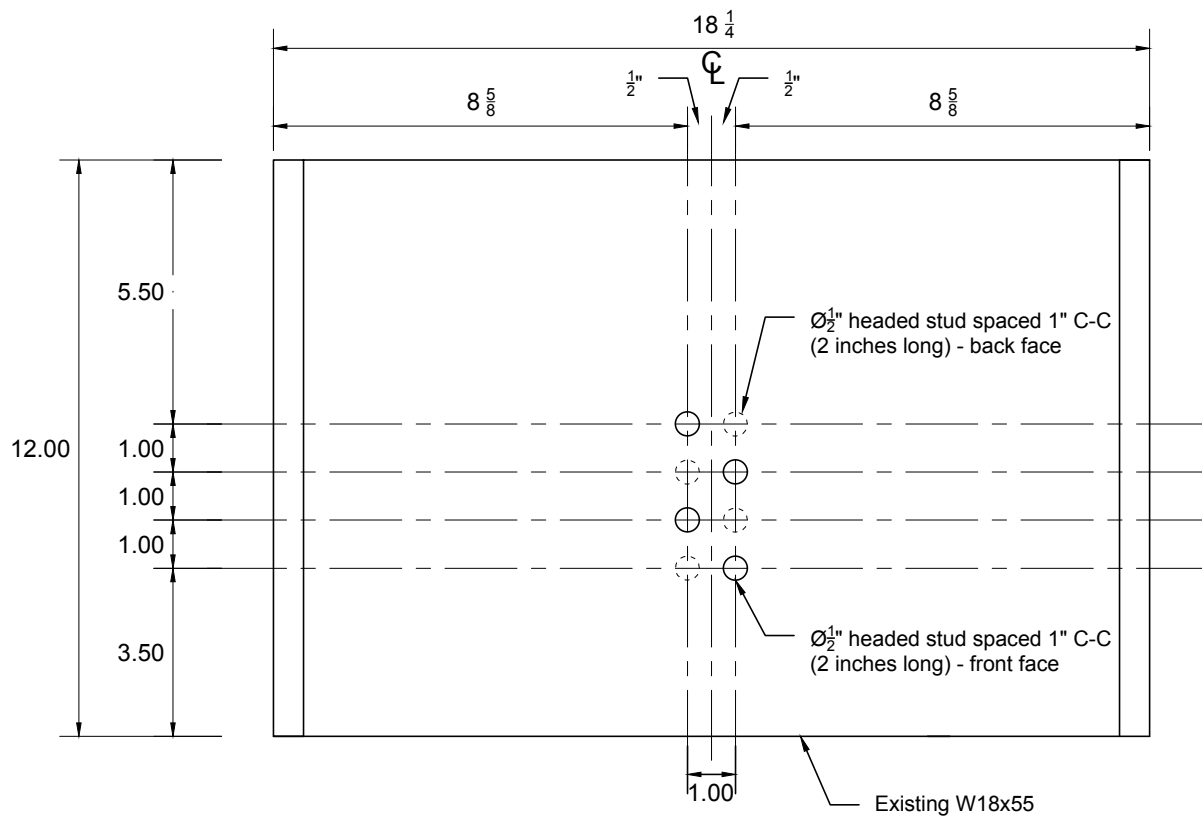
S4-1: Horizontal and Vertical Stagger Pattern
Scale - 1:4

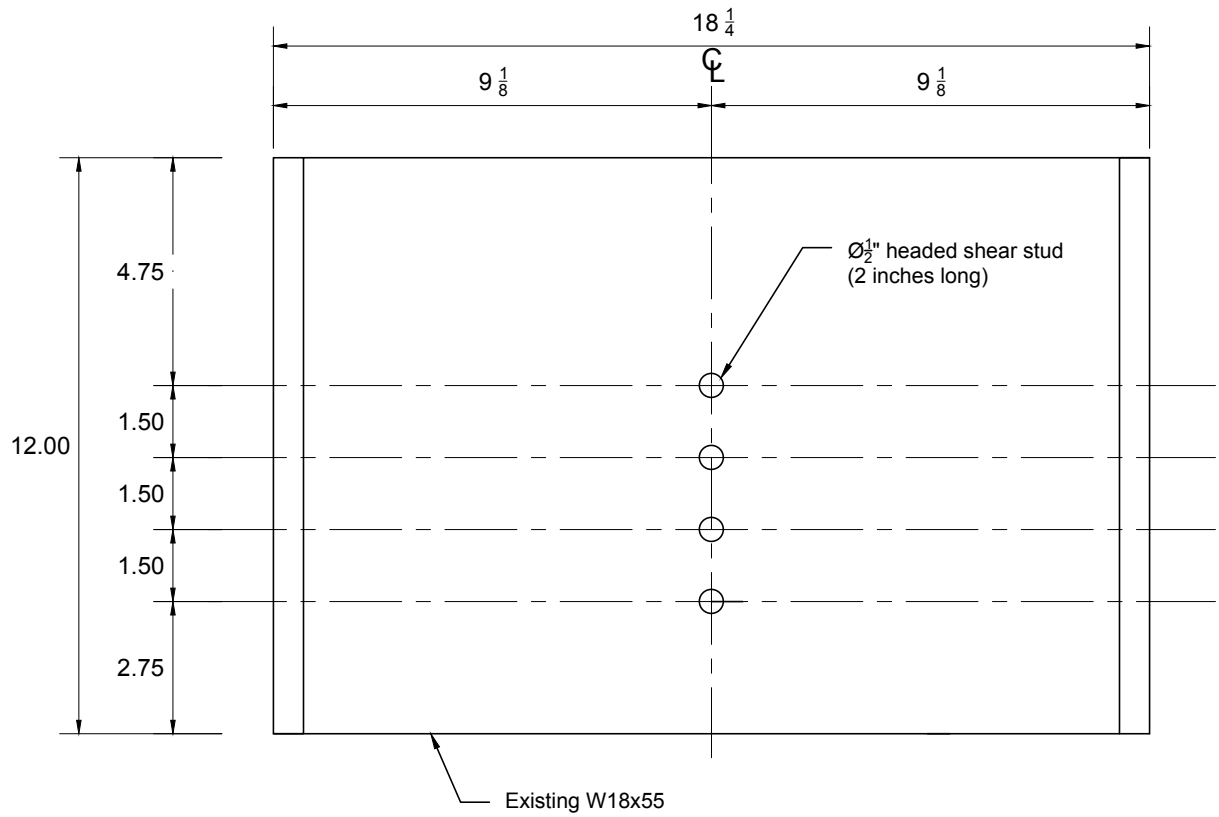
S2-1: 3db Stud Spacing
Scale - 1:4

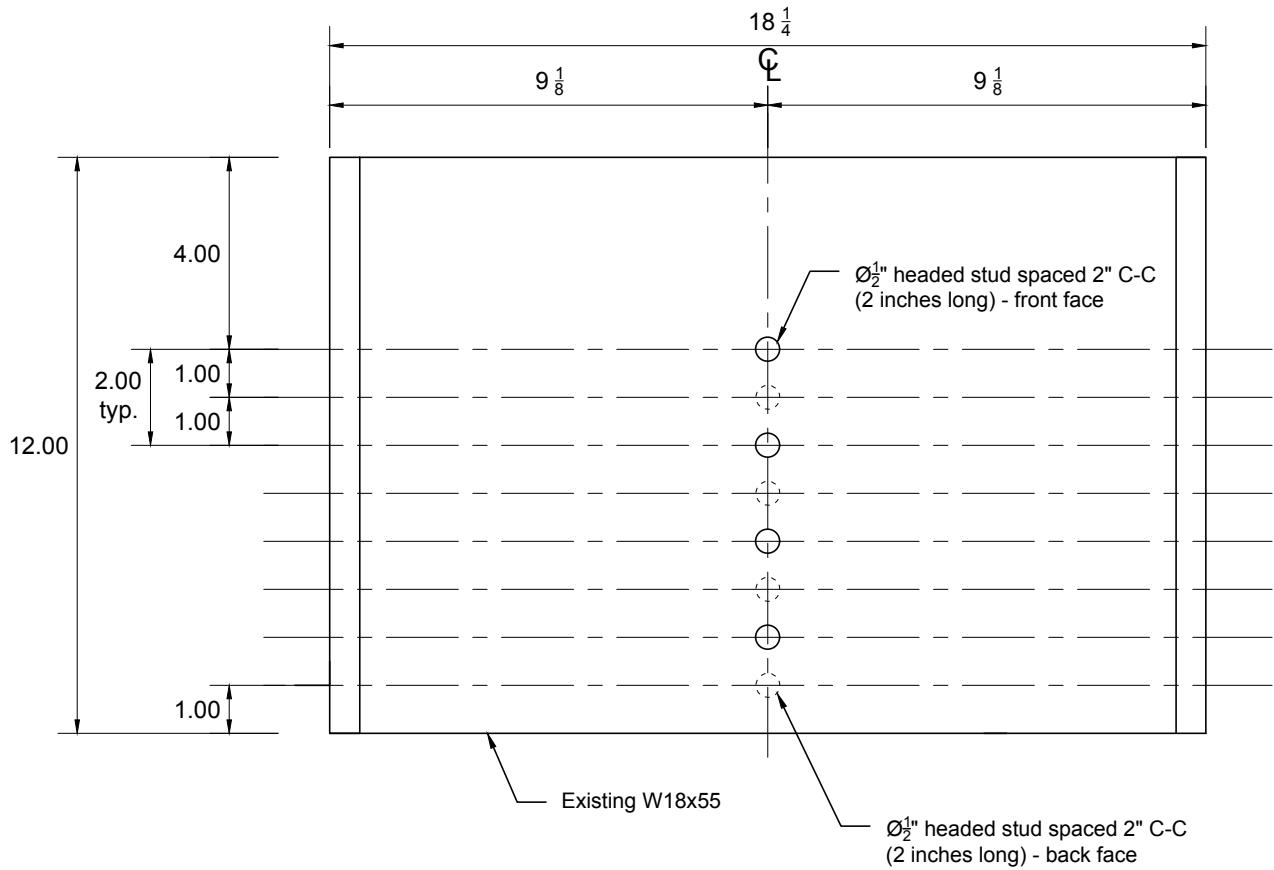
S5-1: Vertical Stagger Pattern
Scale - 1:4

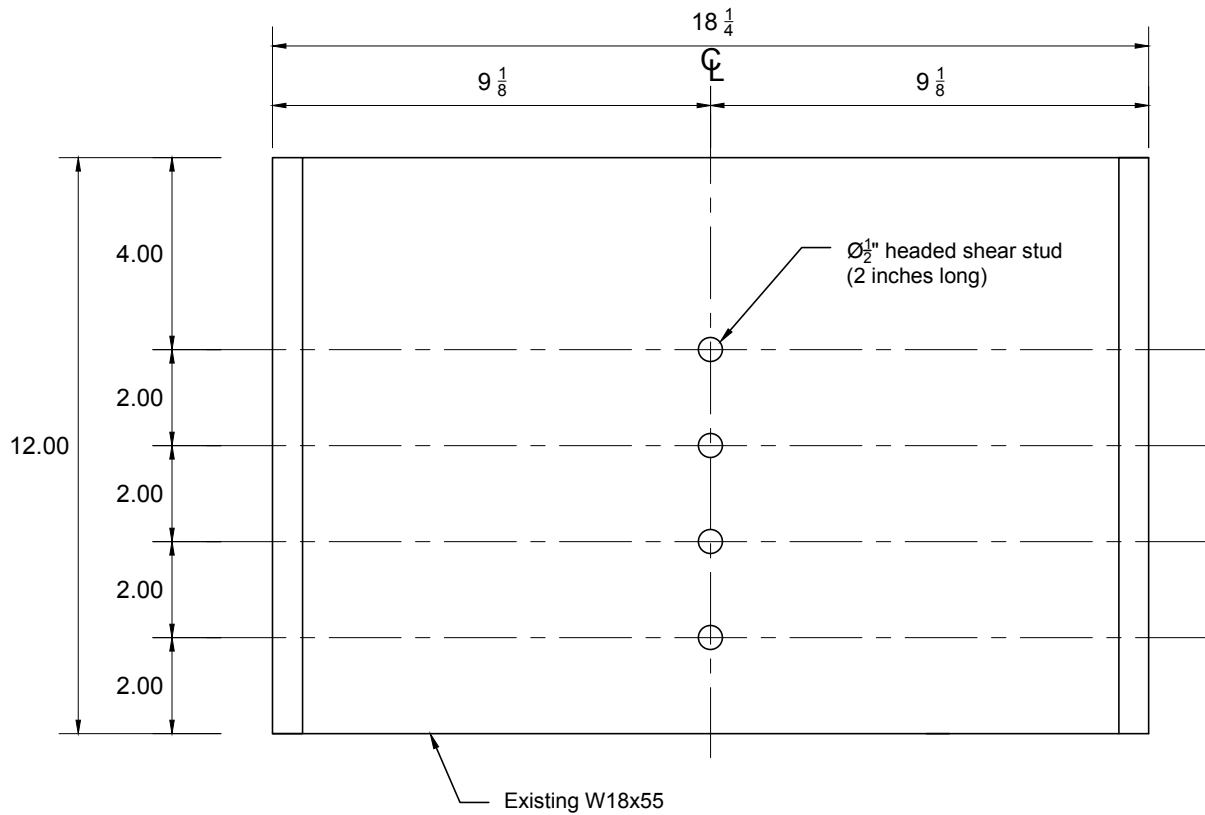
S6-1: Benchmark - RSC Sample
 Scale - 1:4

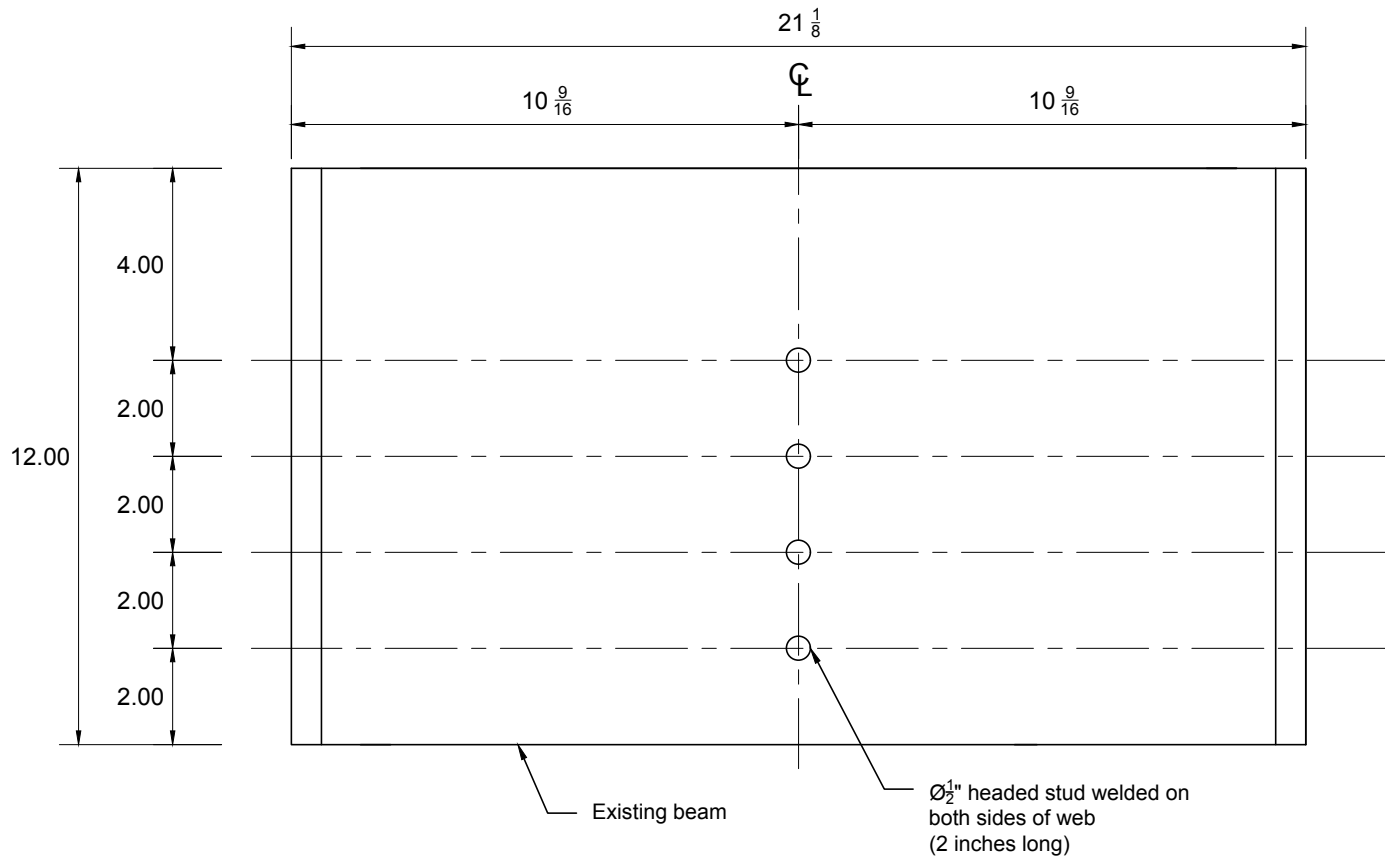
S7-1: Reduced Cover Specimen
 Scale - 1:4

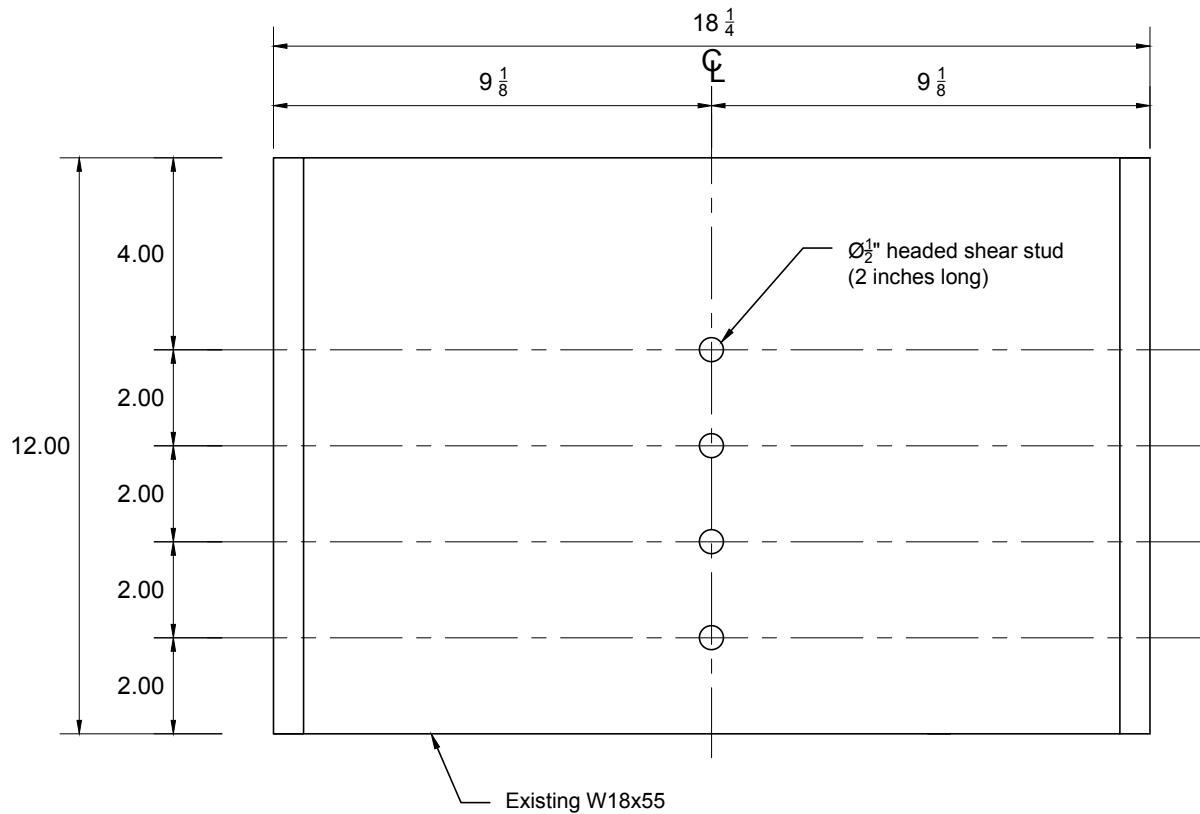
S8-1: Ultimate Strength Specimen
Scale - 1:4

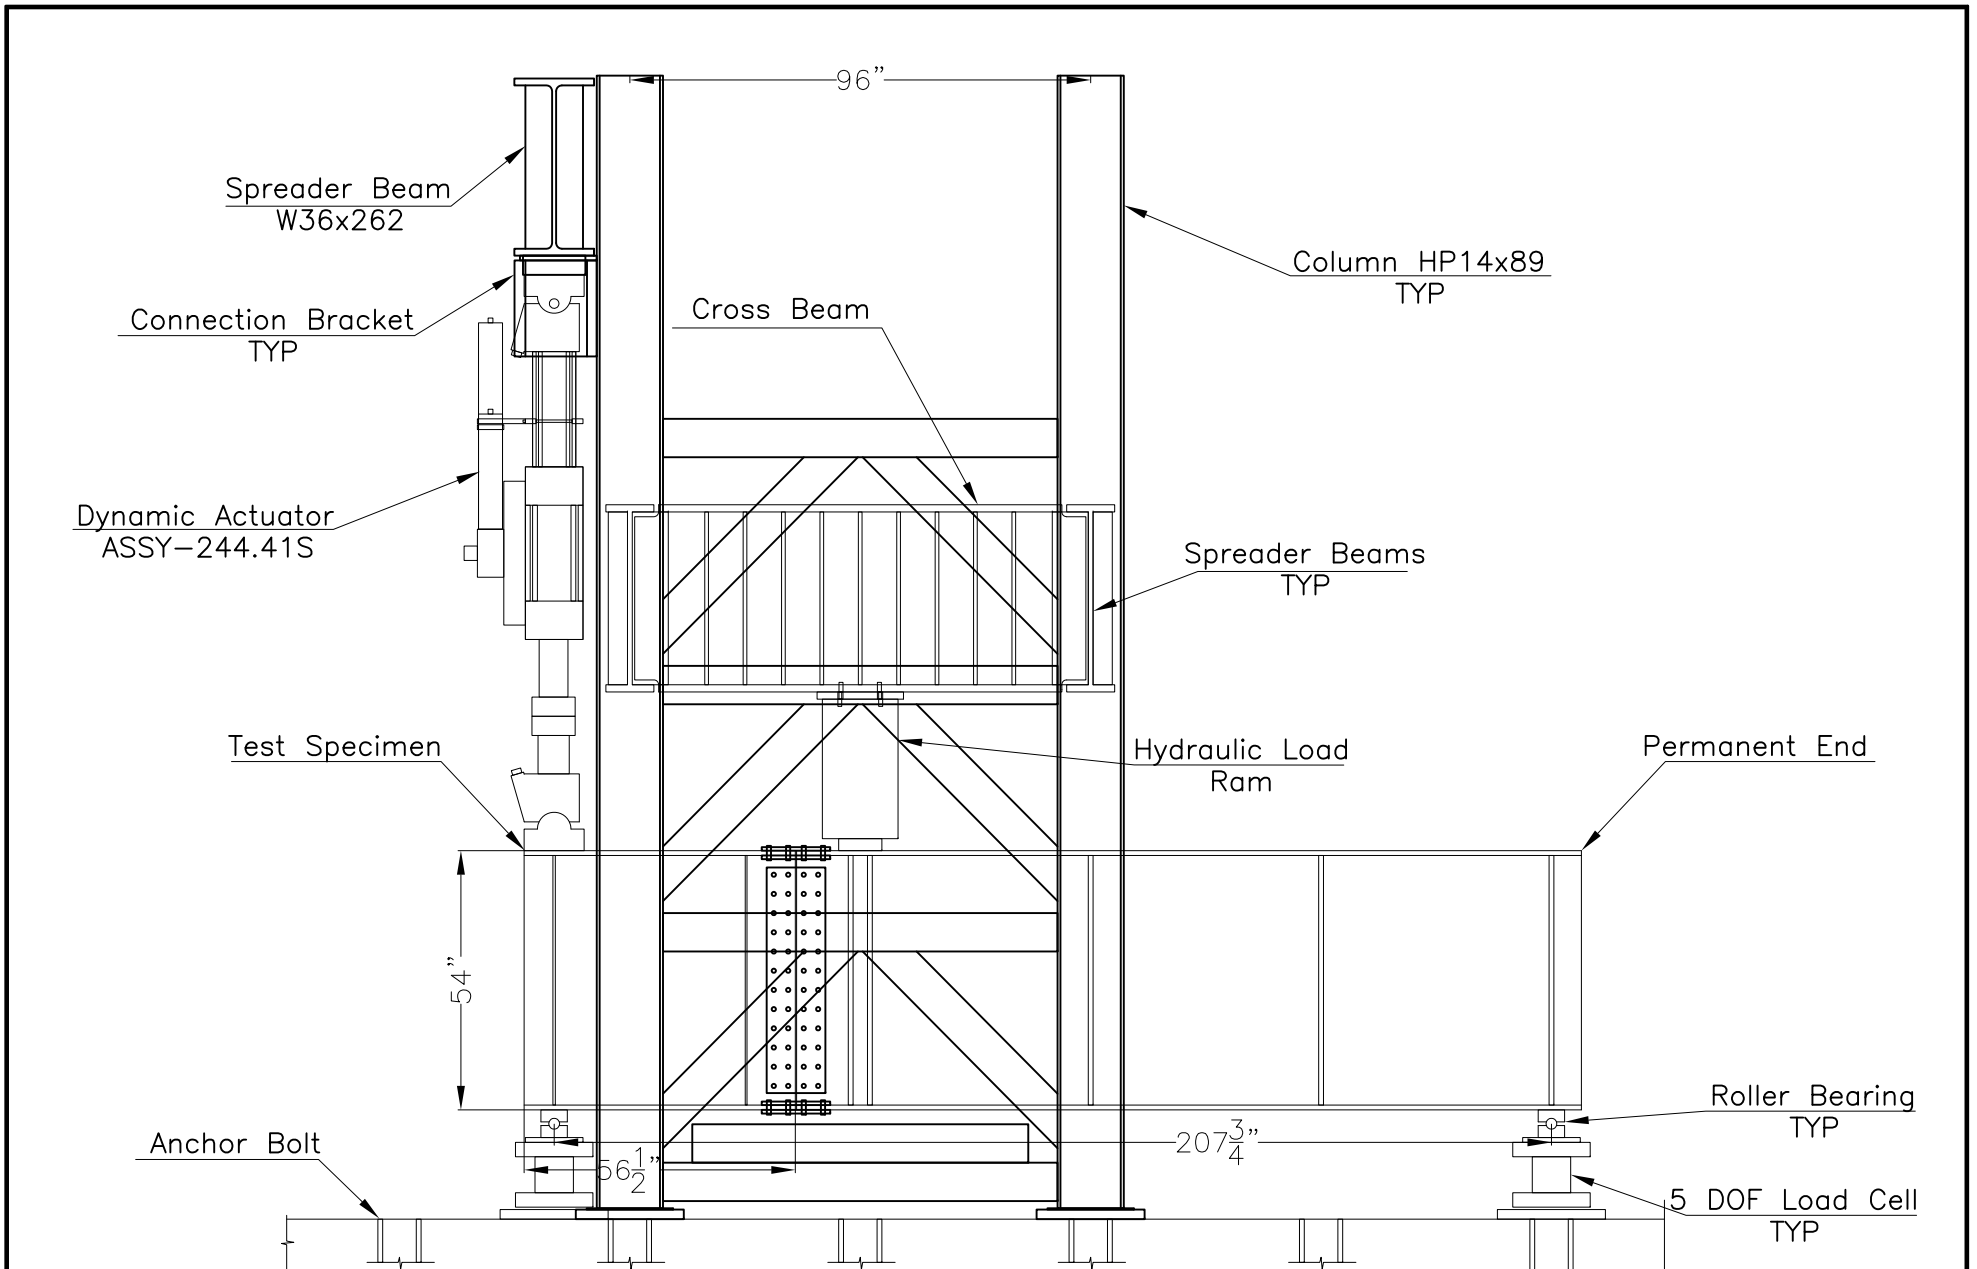
<p>University of Connecticut</p>	<p>Connecticut Department of Transportation</p>	Project: ConnDOT Phase II	
		Title: Large Scale Set Up - Elevation View	
Drawn by: Kevin McMullen		App. by:	
Scale: 1:40	Sheet No: S-01	Date: October 27, 2016

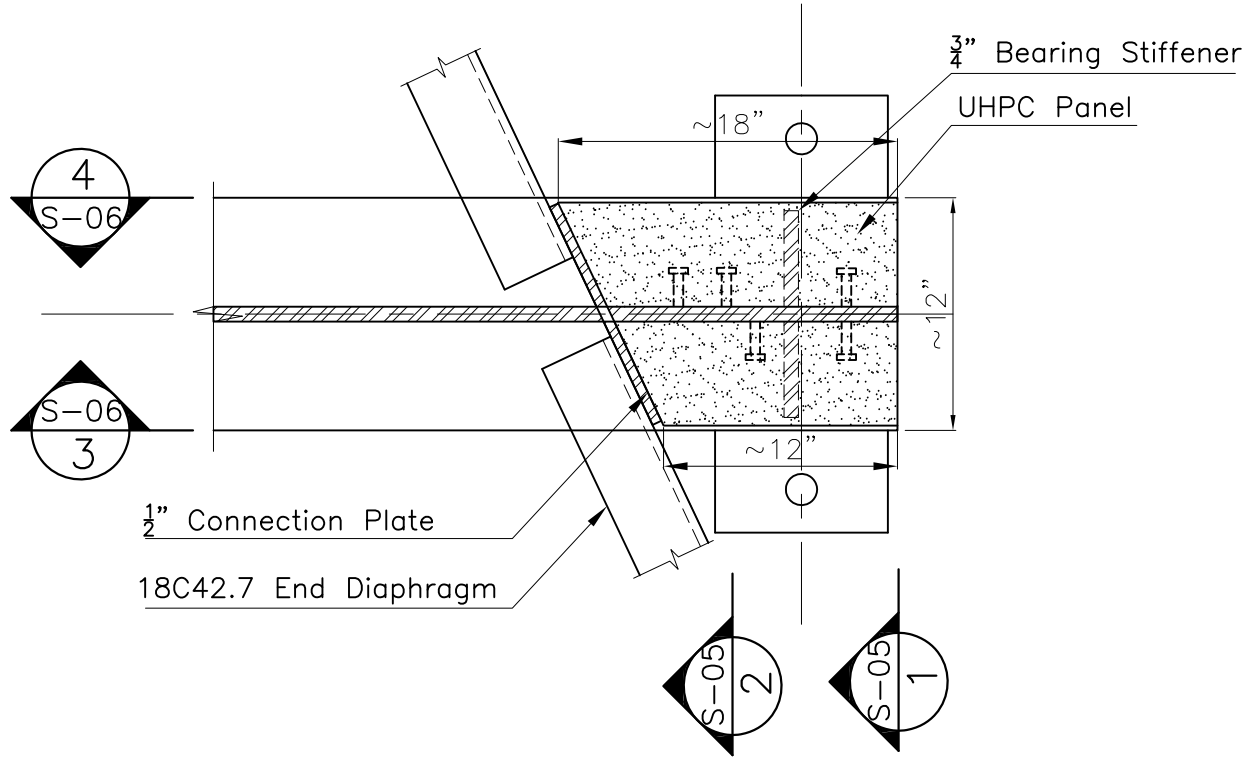
1:10 2 Girder Type 1 Repair
With Bearing Stiffener
