**EFFECTIVE SEALING AND MONITORING OF
SMALL MOVEMENT EXPANSION JOINTS
IN CONNECTICUT BRIDGES**

March 2017

JHR 17-329

Project 15-02

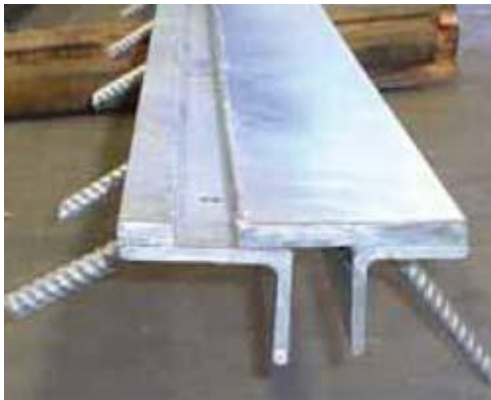
Figure 2: Typical sliding plate joint (Lesa Systems 2016)

Sliding plate joints (Figure 2) are typically used for movements between one and three inches and bridge deck spans up to 350 feet (Lesa Systems 2016). They are simple in construction and reasonably cost-effective. The main idea behind sliding plate joints involves two overlapping steel plates being attached to the deck so that one of the plates is flush with the roadway. The plates slide against each other to accommodate various types of movements. These joints prevent debris from entering through to the substructure. Due to their reliable construction, they provide a good barrier for a long period of time. The down-side of the sliding plate joint, however, is that they do not provide an effective seal against water intrusion or deicing chemicals. Additionally, small particles of debris such as sand or glass can get stuck in between the plates and cause unwanted friction which may lead to wearing of the plates over time.

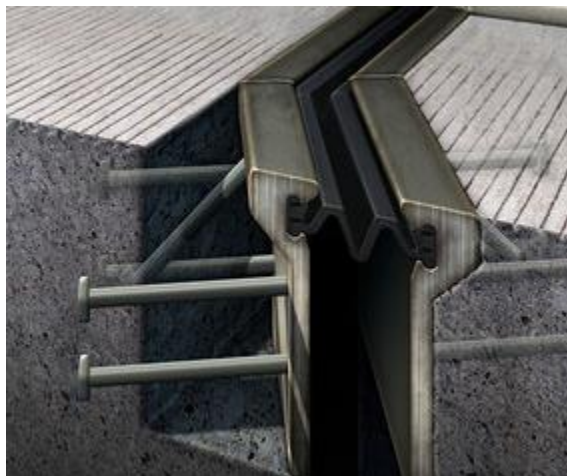
Figure 6: Typical strip seal joint (DSB 2015)

A strip seal (Figure 6) typically consists of a “V”-shape neoprene gland which is mechanically locked into a metal facing located on the header of the joint (DSB 2015). Movement is accommodated by unfolding of the elastomeric gland. This gland provides a waterproof seal which protects the substructure of the bridge from water and road salts. However, if debris gets caught inside the gland, the joint becomes vulnerable to puncture once the gland closes during the summer season when the bridge joint is narrowest. Additionally, faulty installation or dirty locking devices can cause pulling out of the gland from the metal rail edges.

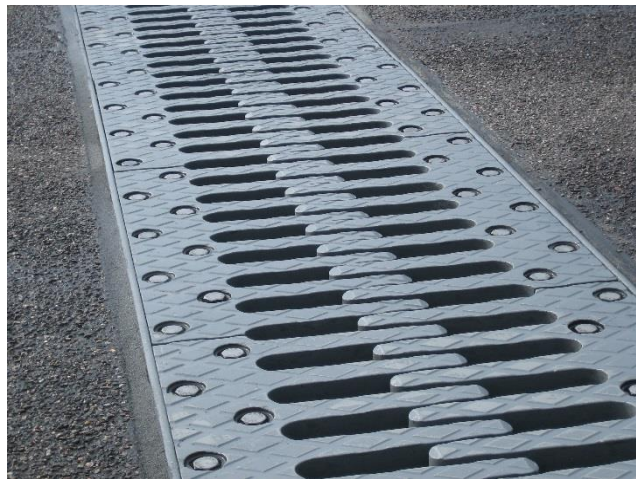
Figure 7: Typical finger joint (Tensa 2015)

Finger joints (Figure 7), which are applicable for bridge movements of 3 inches or greater, are one of the most dependable expansion joints for larger movement bridges (Tensa 2015). They allow debris and water to enter, but a diaphragm that hangs between the two bridge decks catches any unwanted material and allows it to flow out to the sides of the bridge deck. Finger joints can accommodate for rotational and vertical movement, which can be crucial for medium movement bridges (especially in seismic regions). Some problems of the finger joint, however, include damage to the “fingers,” which may lead to them bending upwards. This can result in a rough bump for vehicles or puncturing of the tires. Additionally, the diaphragm that hangs below the roadway must be constantly cleaned to prevent buildup of debris. This operation may prove to be costly and time consuming.

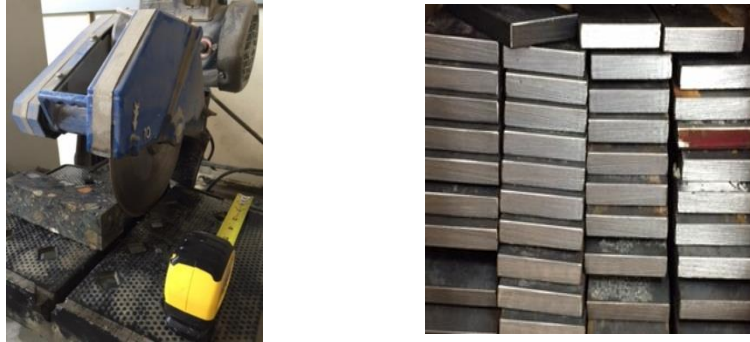
Figure 12: Fabrication of coupons for experimental testing

materials were obtained to adequately replicate those present in the field. With the assistance of CT DOT, a large piece of concrete was salvaged from a local bridge undergoing replacement. This was done to reflect the type of concrete in joint headers, typically found throughout the state. Steel was also obtained with the assistance from UConn's Civil Engineering machine shop. Blocks were fabricated using typical A36 steel, the material commonly found at the joints of bridge decks with angle headers. Each specimen contained a 12.7 x 50.8 x 12.7 mm (0.5 x 2 x 0.5 in.) volume of sealant applied in between two substrate blocks measuring 76 x 50.8 x 12.7 mm (3 x 2 x 0.5 in.) (LxWxH).

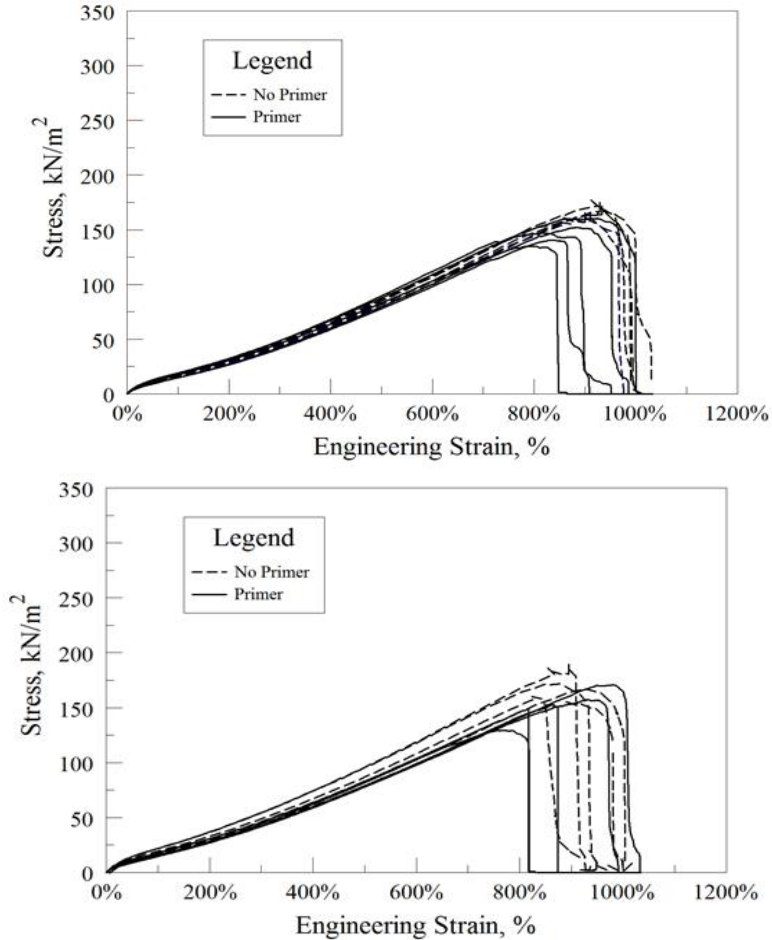
Figure 18: Results for specimens containing foam sealant, steel substrate (top) and foam sealant, concrete substrate (bottom)

After testing five specimens per variable for each substrate (concrete and steel), both results revealed the foam sealant has a lower tensile modulus (compare Figures 18 and 19). In addition, Figures 18 and 19 show that ultimate stresses and strains for specimens containing foam sealant were lower than those containing solid sealant. Specifically, specimens containing foam sealant exhibited an average ultimate stress of 155 kPa while maintaining an average ultimate strain of 922.5%. Meanwhile, the solid sealant exhibited an average ultimate stress of 312 kPa with a corresponding average ultimate strain of 1027%. While the foam sealant showed a smaller average strain, the corresponding ultimate stress is about 49% of the solid sealant's ultimate stress capacity. Although typical civil engineering materials are characterized by their ultimate capacity, this reduction in ultimate stress is actually favorable for reducing the stresses at the interface of the silicone sealant and the bridge header. There was no significant difference observed in maximum stress or strain properties of the specimens between steel and concrete substrates.

The key characteristic that can be taken from this experiment is the failure mode of each specimen. Figures 18 and 19 show the stress vs. strain curves of each specimen; although the strain ranges are comparable, and an obvious reduction in modulus is observed in the specimens containing foam sealant, all solid sealant specimens exhibited an adhesive failure, while the foam sealant specimens failed via cohesive failure. Adhesive failure is characterized by detachment of the sealant from the substrate prior to material failure. Cohesive failure, on the other hand, pertains to ripping or shearing of the silicone material itself while maintaining its attachment to the substrate. Both failure modes can be observed in Figures 18 and 19, as a cohesive failure is characterized by a smooth, rolling peak as the stress approaches its ultimate limit state. Adhesive detachment, however, can be seen when the stress peak sharply drops, indicating a sudden failure under tension. Cohesive failure was observed in 100% of the specimens containing foam sealant for both substrates (concrete and steel). For specimens containing solid sealant, however, 90% of the specimens failed via adhesive failure. Figures 20-23 show the specimens post failure.

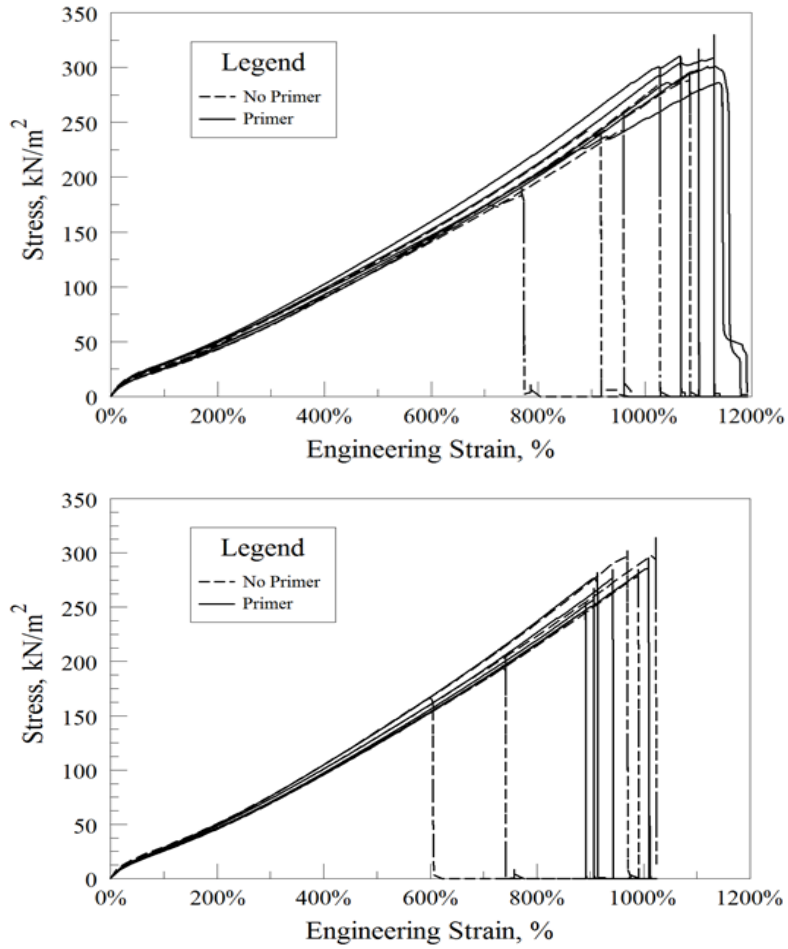
Figure 19: Results for specimens containing solid sealant, steel substrate (top) and solid sealant, concrete substrate (bottom)

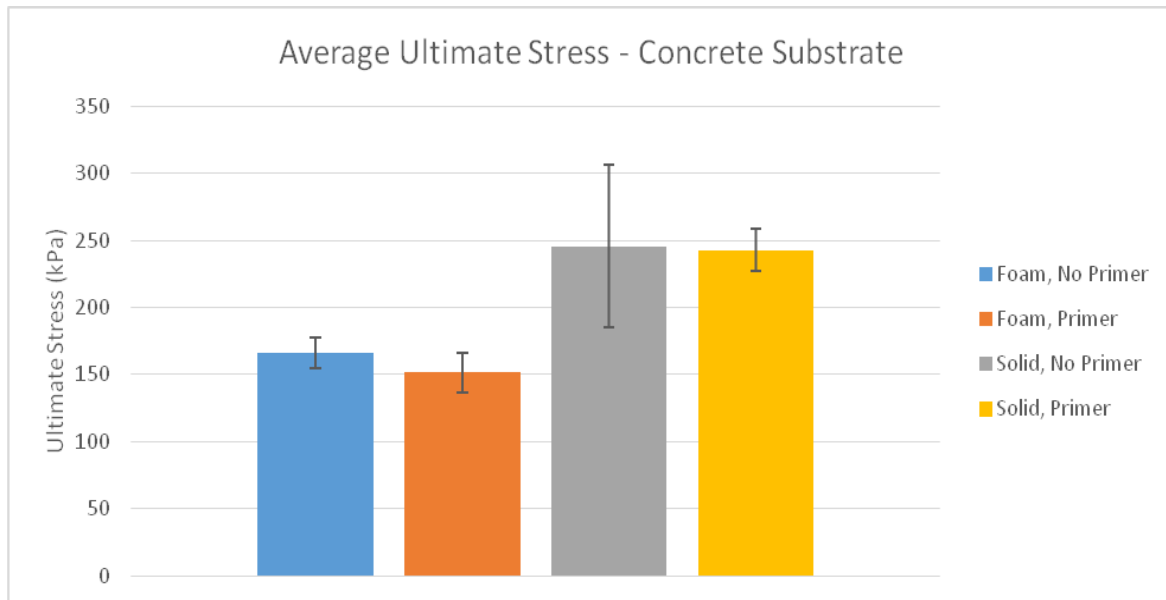
Figure 24: Average ultimate stress for specimens with a concrete substrate

and primer still exhibited excellent bond as all specimens failed cohesively, as expected. The breakdown of average ultimate stress, average ultimate strain, average modulus at 100% strain, and failure mode fraction is shown in Table 3. Figures 24-25 show a graphical comparison of average ultimate stress for each substrate.

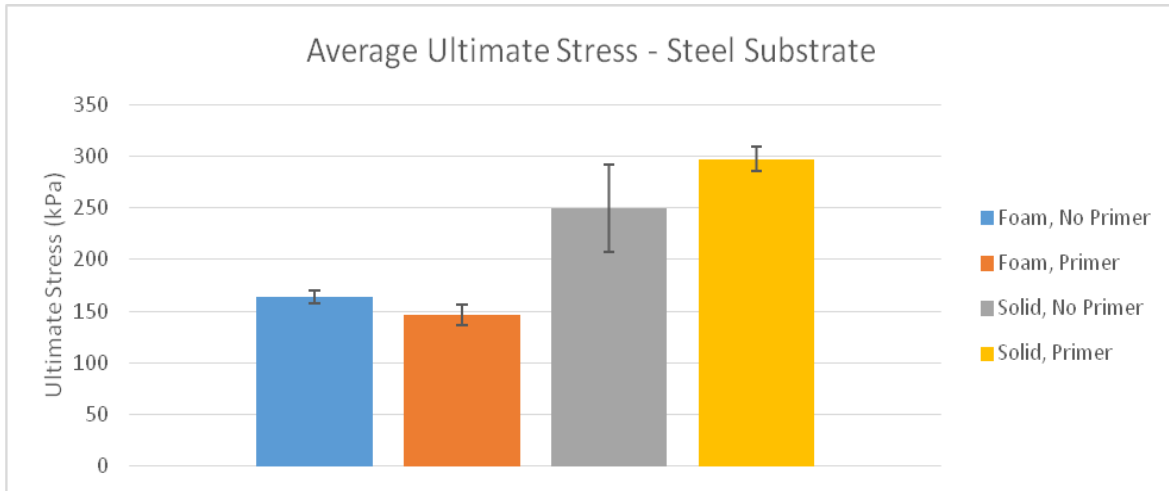
Figure 25: Average ultimate stress for specimens with a steel substrate

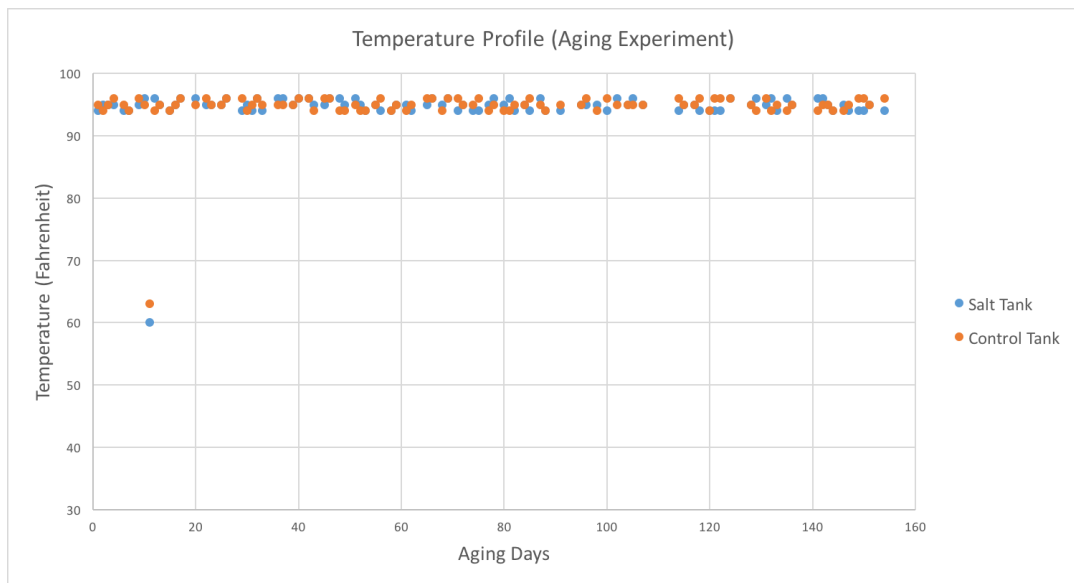
Figure 27: Temperature profile of water tanks

Each tank was heated to 95 °F (35 °C) using a 400-W submersible water heater with a sensor and activator. The temperature for both tanks was kept to a strict deviation tolerance of ± 1 °F (± 0.55 °C). Temperature profiles of each tank were recorded regularly (Figure 27). The low temperature in each tank observed on day 10 was due to a power outage of the building in which the tanks were located; however, power was restored within 6 hours and the target temperature was regained shortly afterwards.

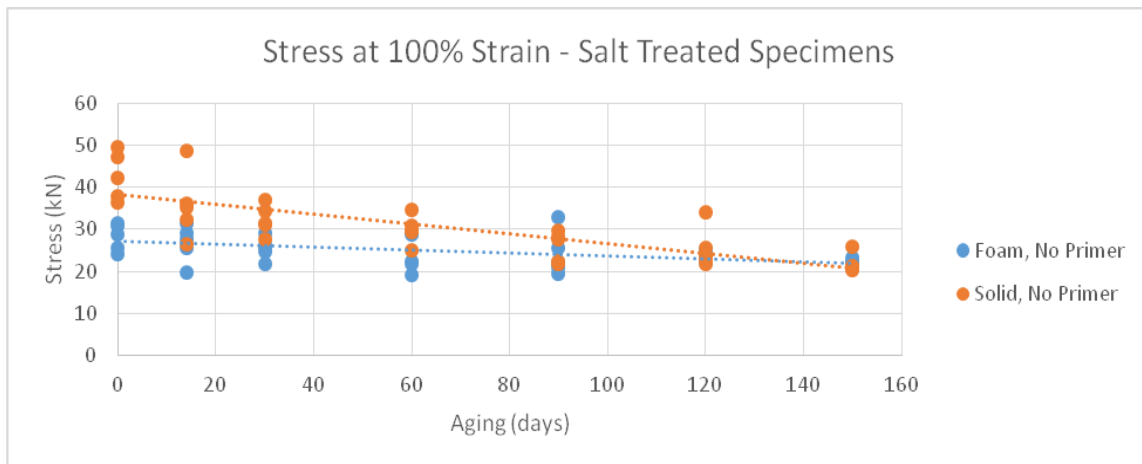
Figure 36: Stress at 100% strain for specimens exposed to salt without primer treatment

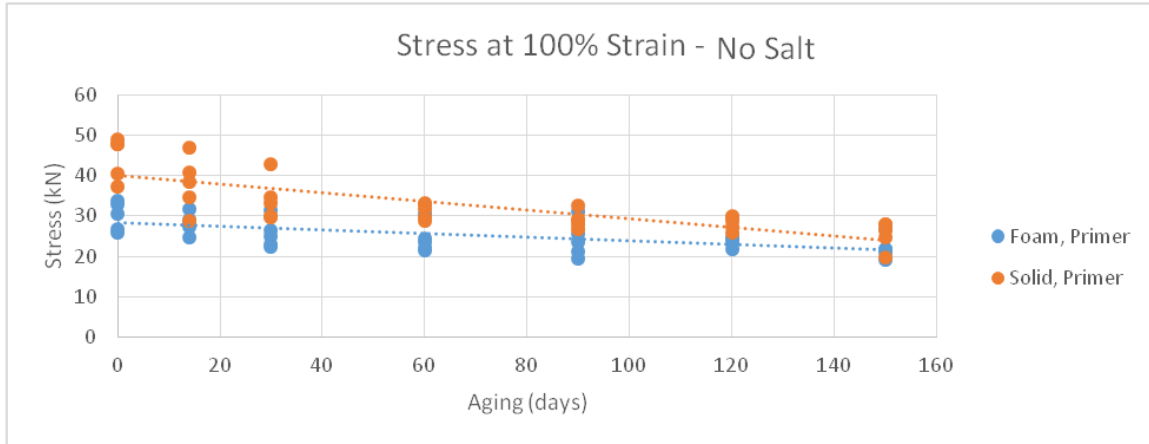
Figure 37: Stress at 100% strain for specimens not exposed to salt and with primer treatment

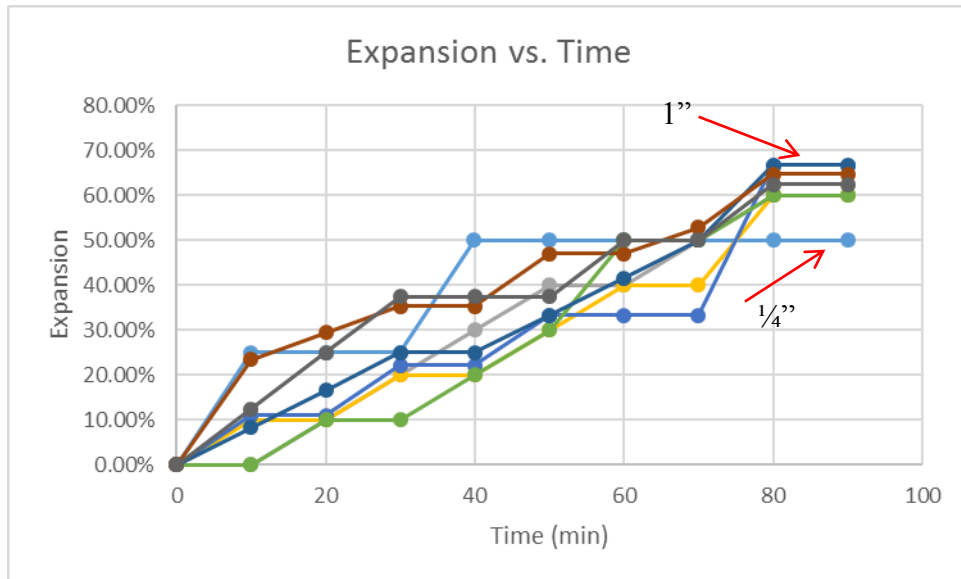
Figure 44: Expansion vs. time for foam sealant

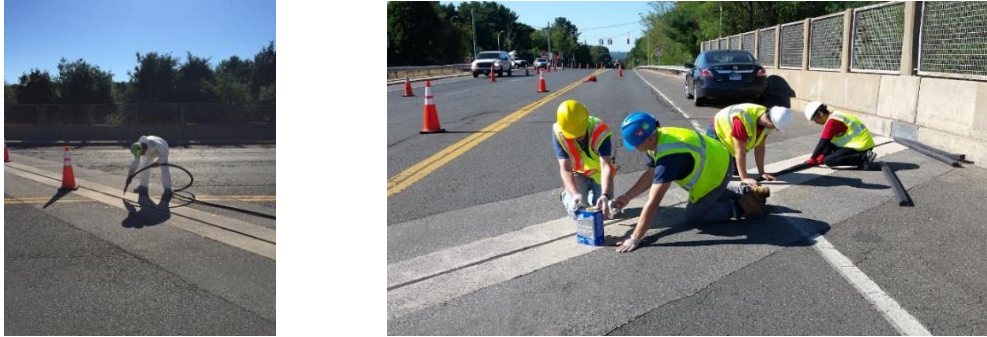
Figure 48: Sand blasting and primer application onto the Route 6 Bridge joint

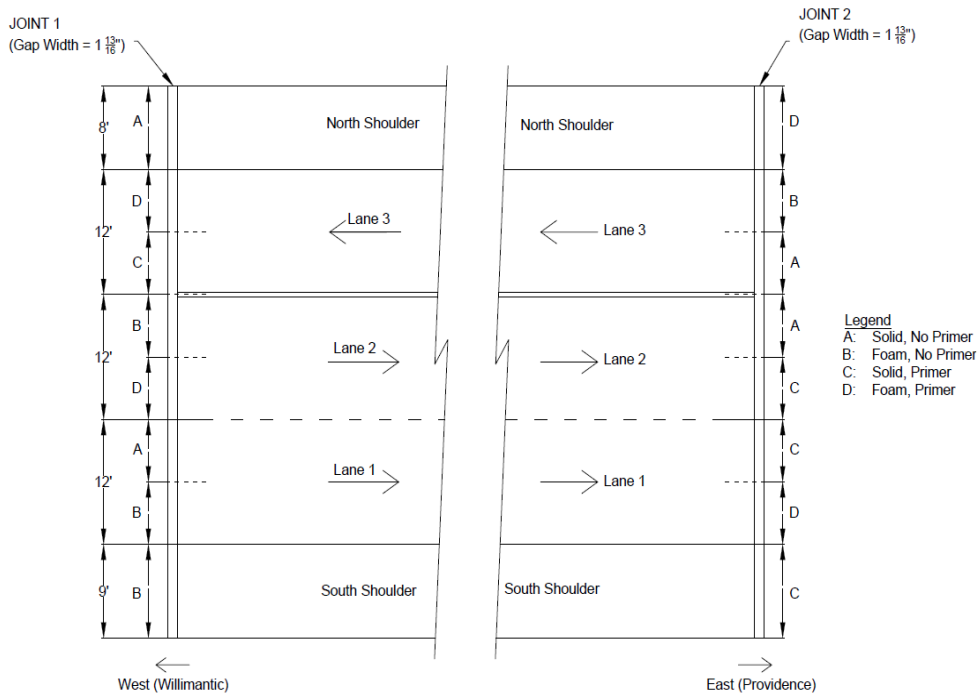
Figure 50: Sealant and primer placement plan, Route 6 Bridge

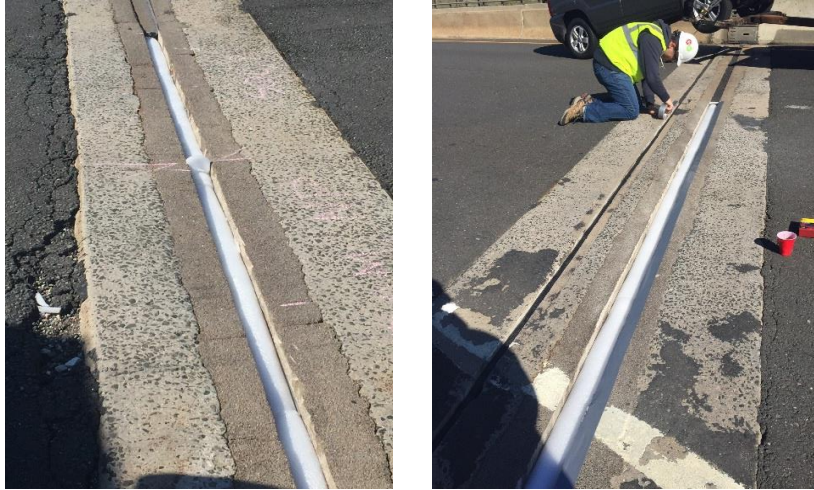
Figure 55: Installation of backer rod and duct tape lining, Route 291 Bridge

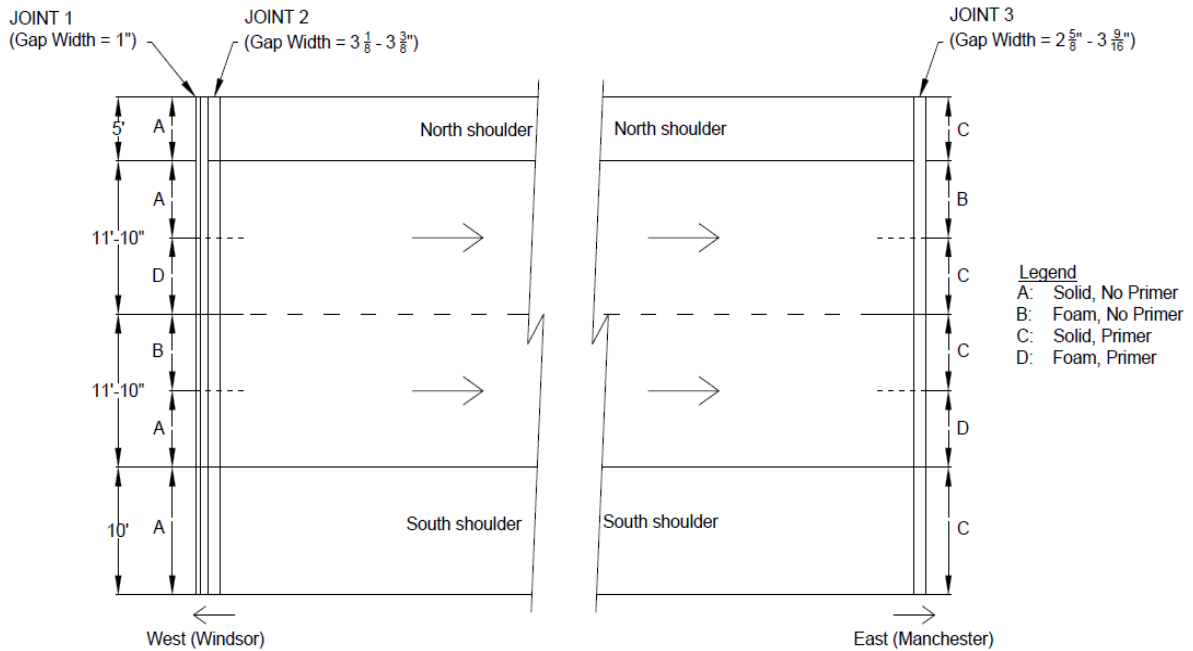
Figure 56: Sealant and primer placement plan, Route 291 Bridge

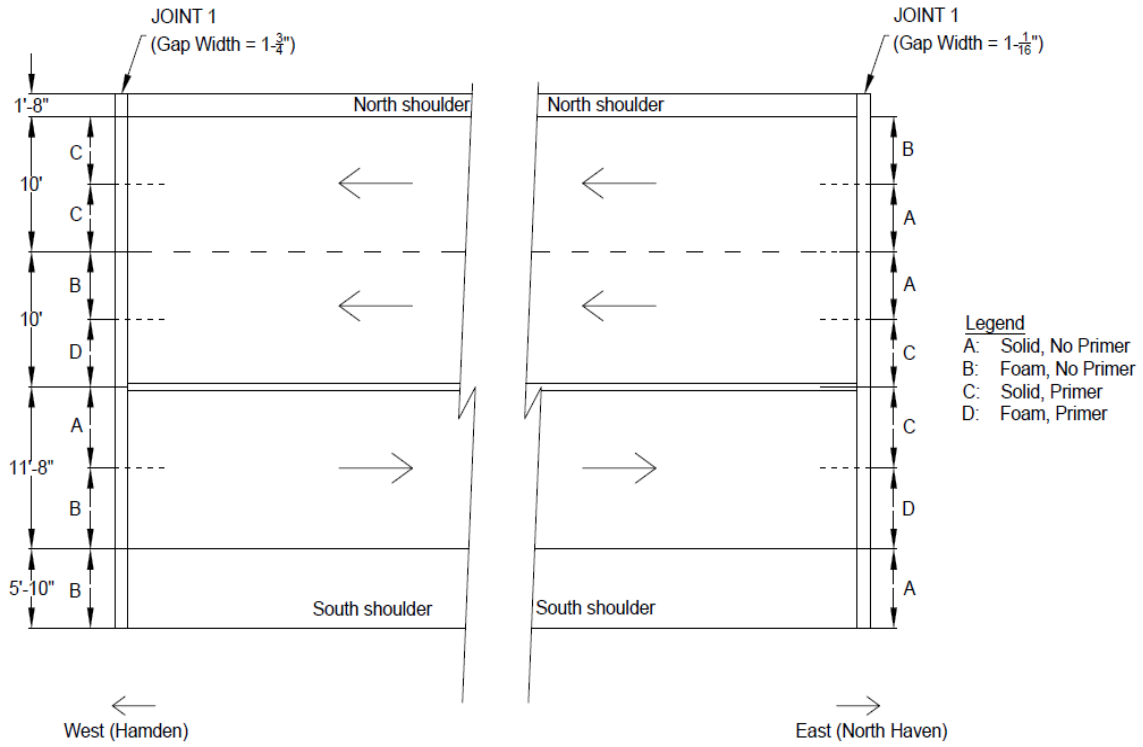
Figure 59: Sealant and primer placement plan, Route 22 Bridge

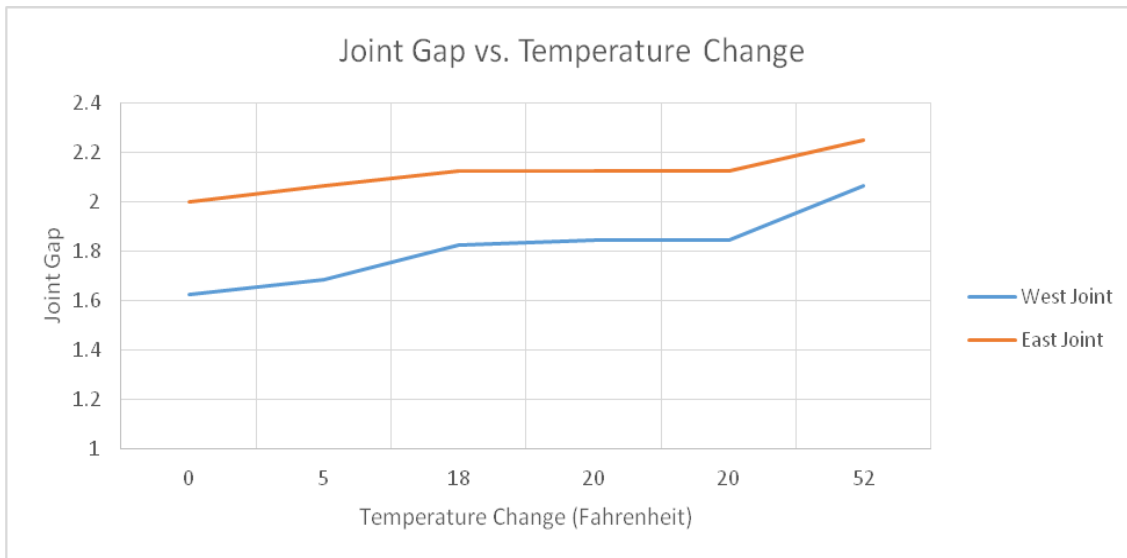
Figure 61: Joint gap as a function of temperature change for Route 6 Bridge

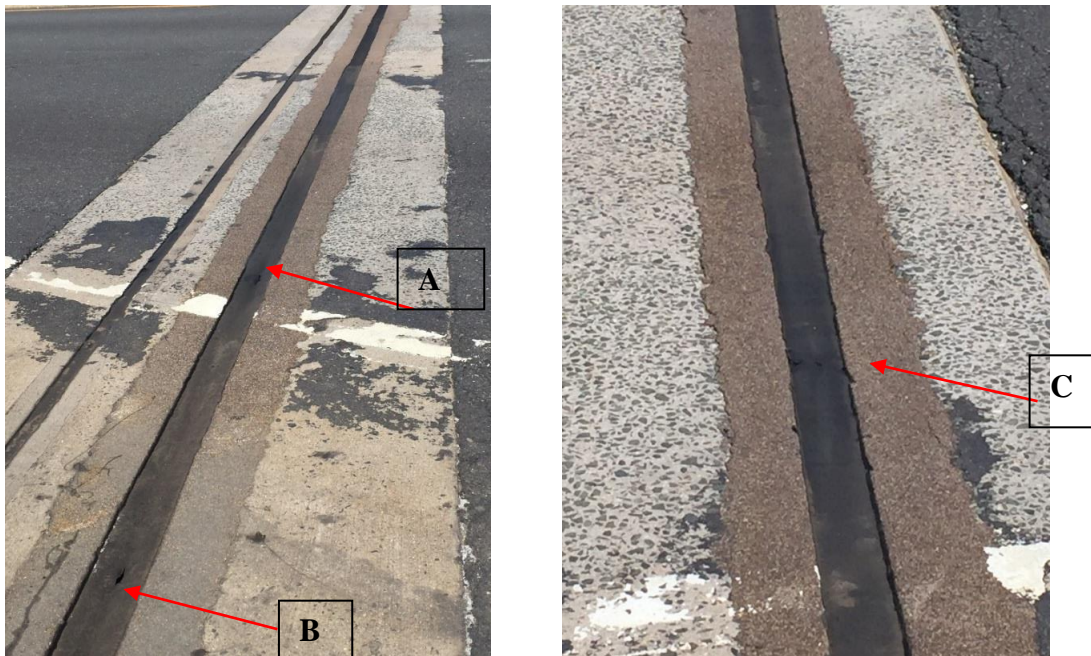
Figure 71: Visual observation of damage on Route 291 Bridge
