Asphalt Pavement Analyzer
Equipment Acquisition
Final Report

SPR 2248
Report Number CT-2248-F-07-8

Submitted to:
Connecticut Department of Transportation

Connecticut Advanced Pavement Lab
Connecticut Transportation Institute
School of Engineering
University of Connecticut

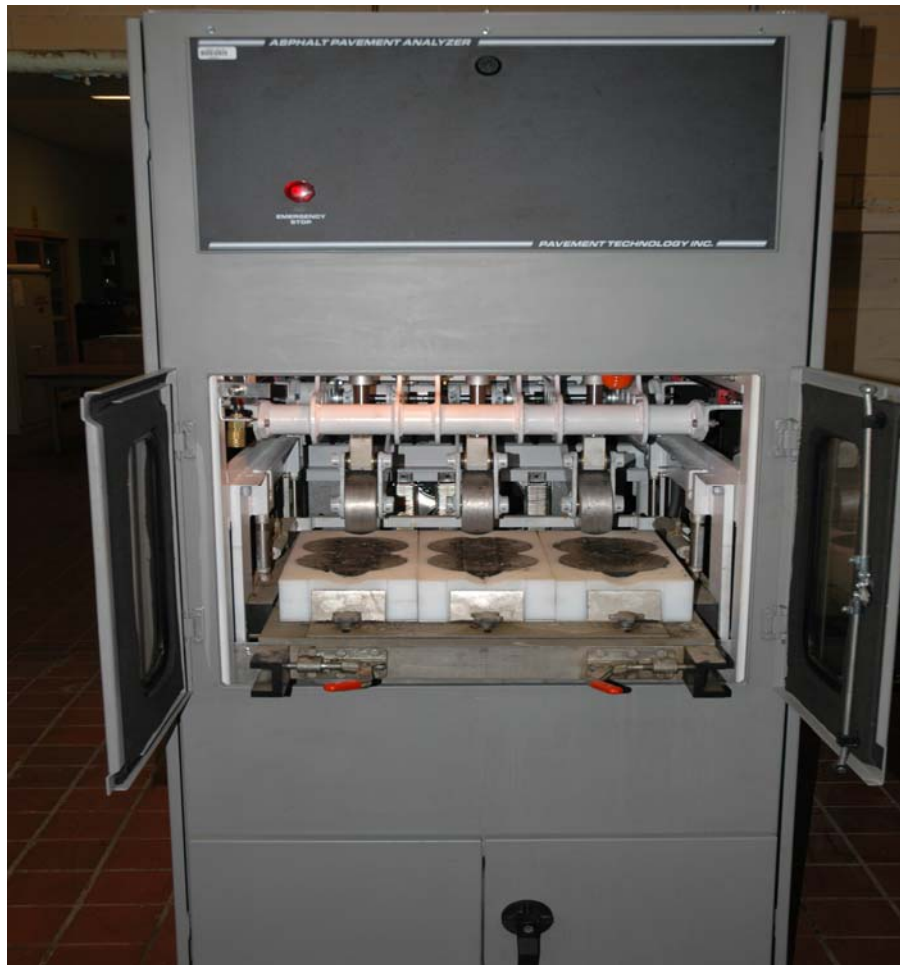
Figure 1. Asphalt Pavement Analyzer

The Asphalt Pavement Analyzer (APA), along with the asphalt vibratory compactor (See Figures #1 and #2) and the asphalt vibratory compactor sound-proof shield were selected for purchase because they provide the capability to test specimens in both wet and dry conditions.

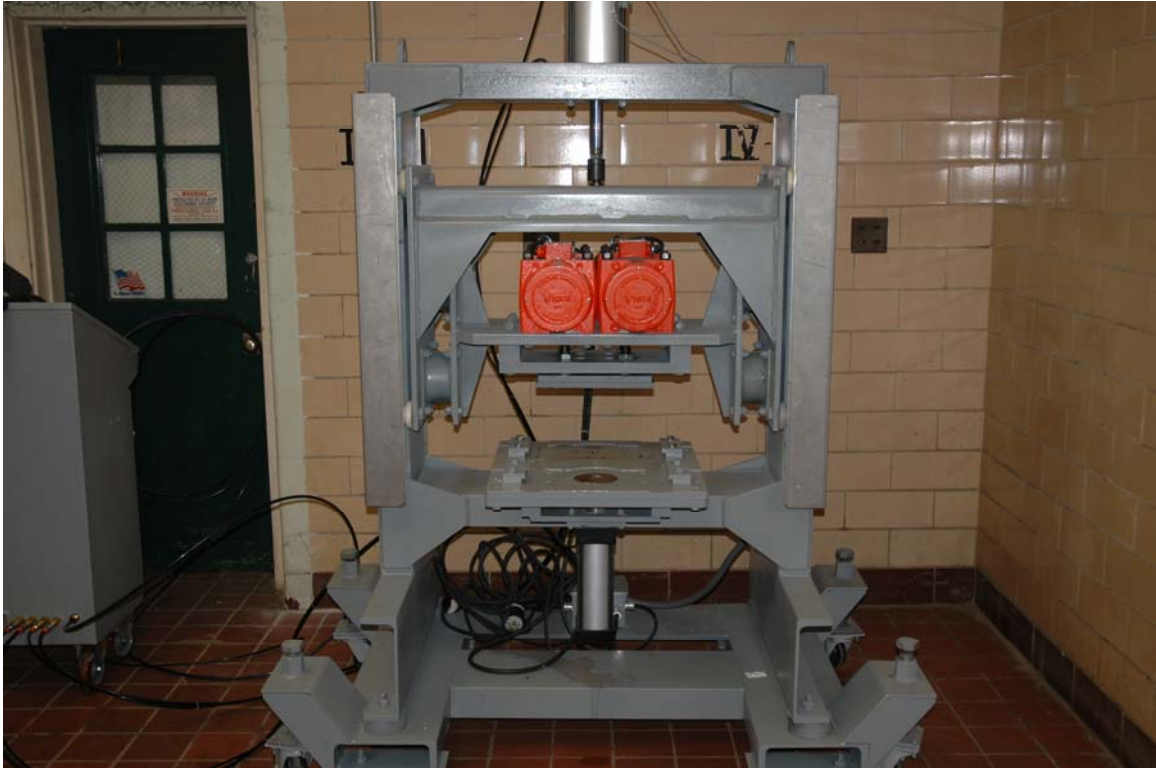
Figure #2. Asphalt Pavement Analyzer Vibratory Compactor

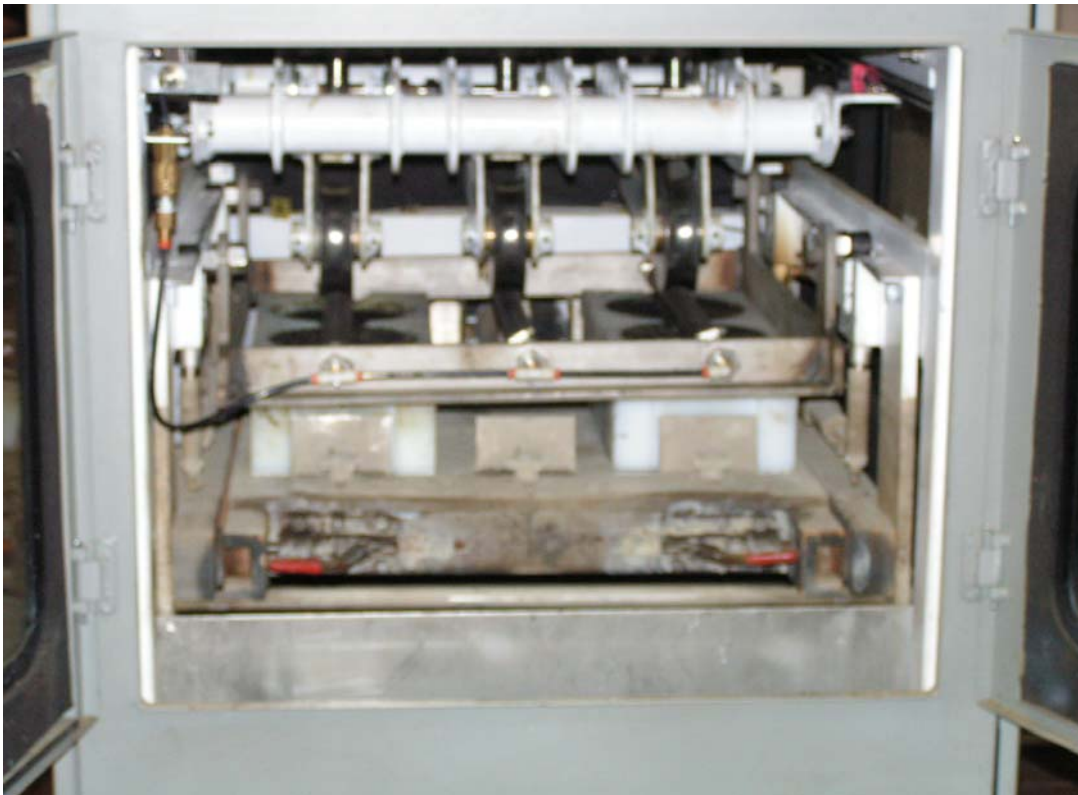
AASHTO TP 63 utilizes pressurized rubber hoses laid across three dual-series sets of test specimens as shown in Figures 3 and 4.

Figure 3. AASHTO TP 63 Set Up

Once the test specimens have been fabricated they are placed in the testing chamber and conditioned as desired under the pressurized rubber tube rack. The tubes are pressurized to 100 ± 5 psi. When conditioning of the specimens has completed, the test begins. The test consists of the wheels passing back and forth over the three sets of specimens up to 8,000 times. A raw data chart is generated during the course of the test indicating the number of completed cycles, rut depths and cabin temperature for each of the three sets of specimens. Also generated within the same program is a final data sheet (Figure 5.) indicating temperature, rut depth per specimen and average rut depth for 0, 25, 4000 and 8000 cycles respectively. In the last column is the percent change in average rut depth between 25 and 4000 cycles and then from 4000 to 8000 cycles respectively.

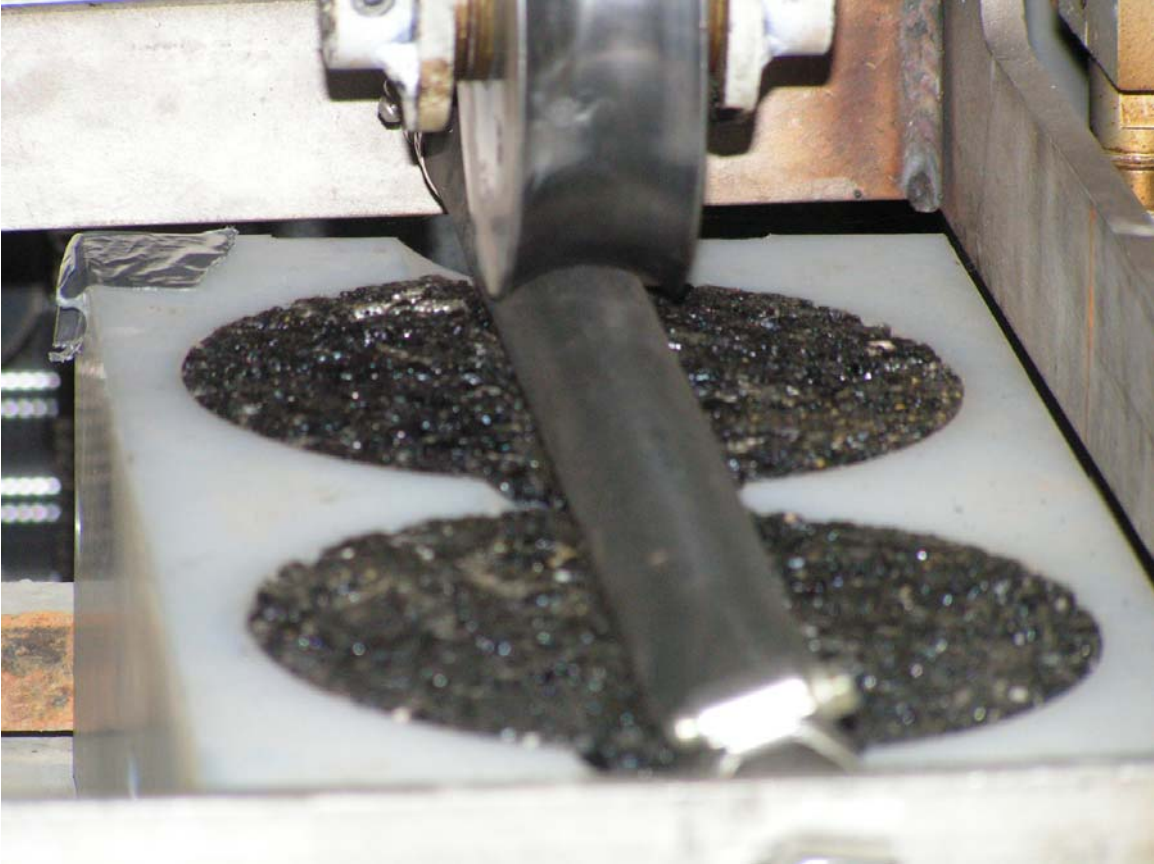
Figure 4. AASHTO TP 63 Close-up Pressurized Tube Over Test Specimen

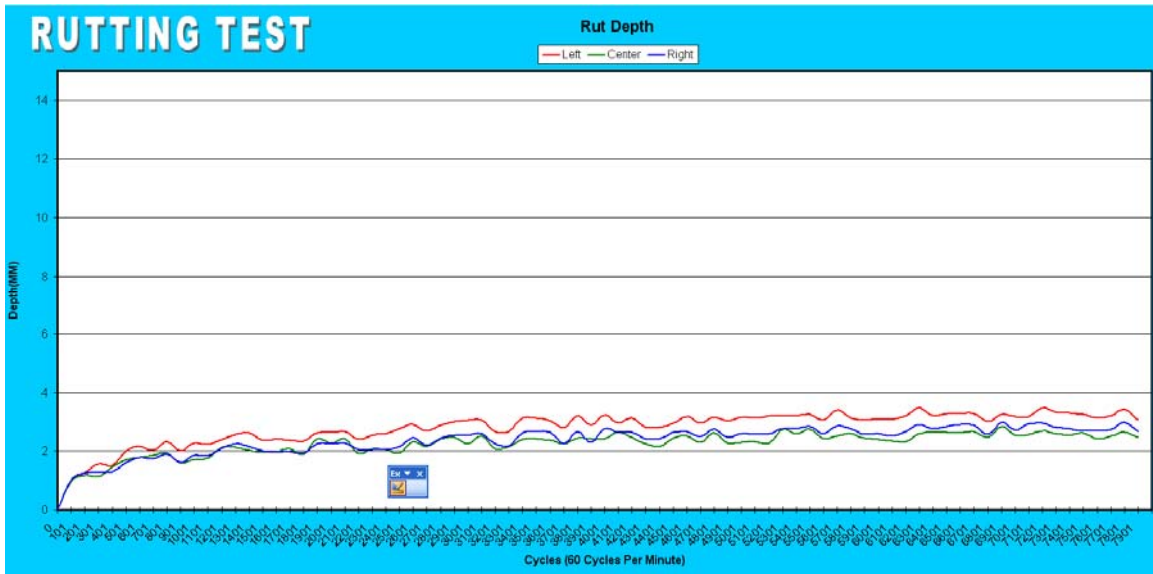
Finally the last screen generated over the duration of the test is a graphical depiction of the rut depth accumulation versus the number of cycles as shown in Figure 6.

Figure 6. Rut Depth Accumulation Chart

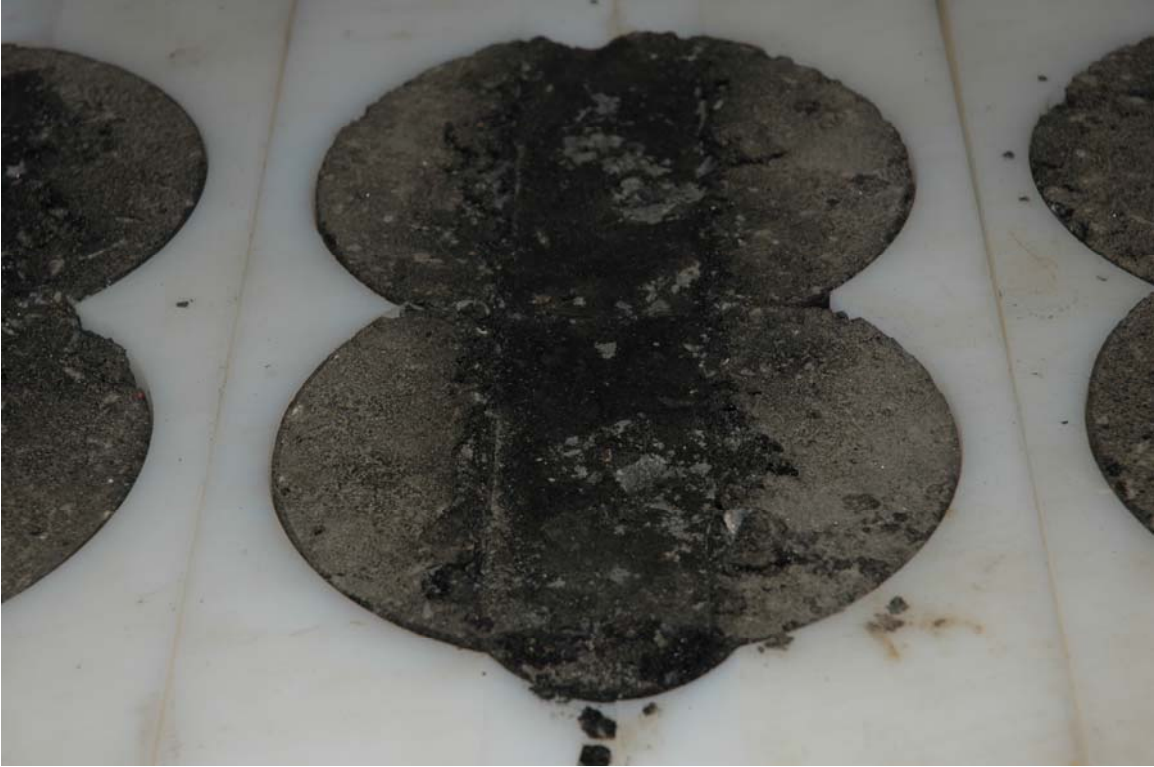
The destructive nature of this test is a result of the presence of water, increased loading and direct contact between the wheel loads and the test specimens. Figure 8 shows an image of the result of a Hamburg Wheel Track Test specimen once the test has been completed.

Figure 8. Hamburg Wheel Track Specimen after Testing

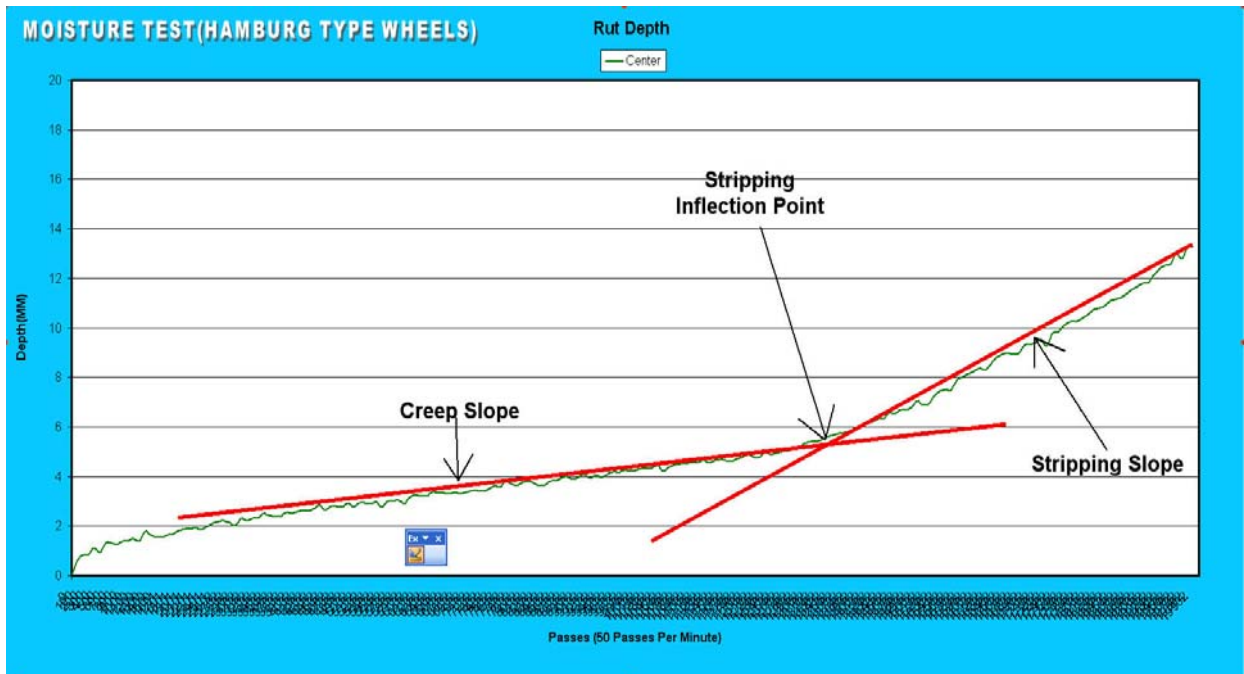
Data is collected and compiled by the APA computer similarly to the TP 63 test. In addition to the raw data and end results sheet, there is another significant determination that can be made which is known as the stripping inflection point. Graphically, this inflection point is the intersection of the tangents of the creep slope and the stripping slope. The creep slope represents the permanent deformation in the HMA being caused by the repeated loading prior to the onset of permanent damage caused by stripping due to water damage. The stripping slope represents the total damage being caused by the repeated loading and the water as soon as water damage begins to accumulate. The intersection of these two slopes is the inflection point and is determined as shown in Figure 9.

Figure 9. Stripping Inflection Point Determination

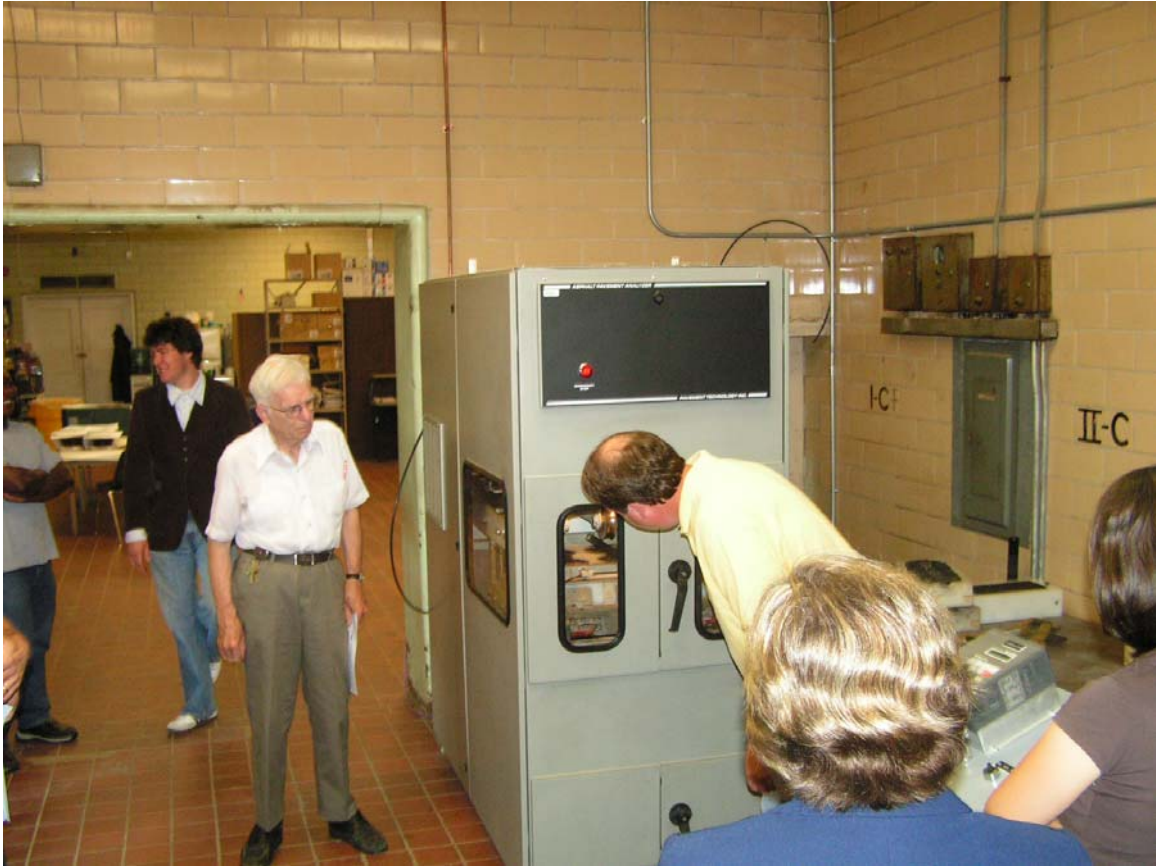
Figure 10. James Mahoney Demonstrates Use of the New Equipment

AASHTO TP 63, The Asphalt Pavement Analyzer (APA) test was demonstrated as well the compaction of asphalt beam specimens using the vibratory compactor acquired as part of this project. Specimens that had been run through the complete testing process for the APA and the Hamburg Loaded Wheel Test were displayed.

An equipment demonstration was held on July 13, 2007 at the CAP Lab. The CAP Lab invited personnel from ConnDOT's Research and Materials Lab as well as the CAP Lab Advisory Board. The general concept of operation of the equipment was discussed as well as its testing capabilities.
