**Summary of the 2006 Use of a Notched Wedge  
Joint in Connecticut Pilot Projects  
Phase 1 Interim Report**

Research Project  
SPR-2249

Report No.  
CT-2249-1-07-3

Connecticut Advanced Pavement Laboratory  
Connecticut Transportation Institute  
University of Connecticut  
Storrs, Connecticut

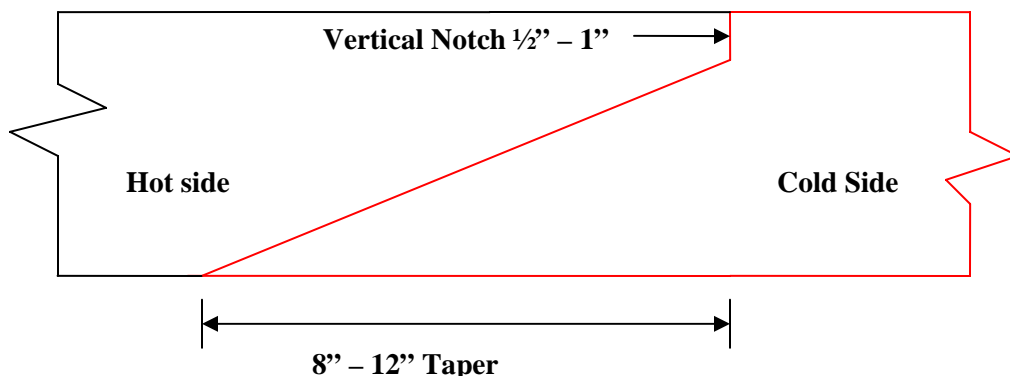
**Figure #1 – Notched Wedge Forming Device**

The notched wedge joint was formed by using a Contractor supplied device attached within the wing of the paver to form its shape (Figure #2). The device was designed to create a notched wedge joint to meet the State's trial specifications. The device allowed for adjustment in the formation of the wedge in its length and slope. The depth of the notch is also adjustable. To compact the wedge, a vibrating plate compactor was used. The plate is connected to the paver and is set just behind the wing directly over the wedge (Figure #3).

There is a considerable amount of research available that indicates the notched-wedge joint (Figure #1) can be used to achieve a higher level of density than the traditionally used butt joint. One such instance is Buchanan, (3); he reports that in four out of five construction projects (one project each in the States of Colorado, Indiana, Alabama, Wisconsin and Maryland) investigated over the course of that research, the notched wedge joint resulted in an increased centerline density when compared with the traditional butt joint.

The purpose of this study was to evaluate the constructability and durability of an alternate Hot Mix Asphalt (HMA) longitudinal joint method, the notched wedge joint (Figure #1). The notched wedge joint is a longitudinal joint method being investigated to improve upon the State's standard longitudinal joint method known as a butt joint. Constructability includes the time, effort, equipment to form and compact the material at the joint and the resulting in-place density upon completion. Durability includes the long term performance of the joints which will be evaluated according to their ability to delay the formation of cracks at the joint as well as minimizing the width of the crack that forms.

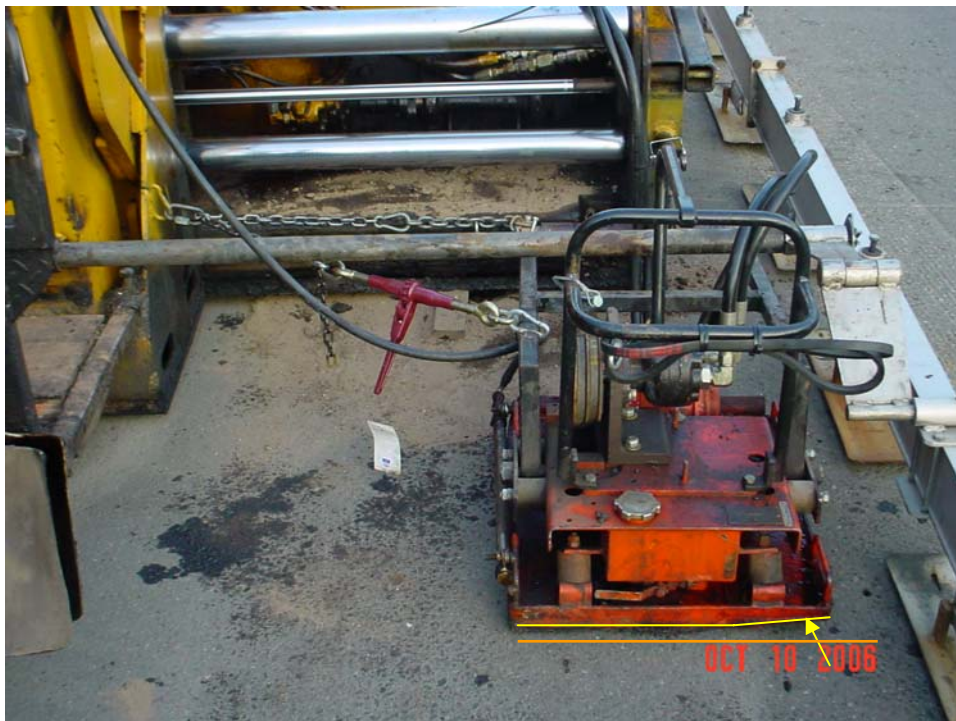
**Figure #3 – Wedge Compaction Device and Setup**

***Project Equipment:*** Tilcon had modified some equipment to help in the compaction of the notched wedge joint. In order to attach the vibrating plate to the paver, mounting points were welded or cut into the wing of the paver. A welded steel pipe, chain binder and chains were used to attach the plate at various points. The chain mounts were adjustable to keep the plate parallel to paving. The vibrating plate was connected to run off the hydraulic system of the paver's vibrating screed so they started and stopped in unison. To ensure that the vibrating plate's width matched that of the wedge, it was further modified by cutting off a portion of the base and welding it back at an angle to prevent it from dragging on the base which is pointed out by the arrow in Figure #3.

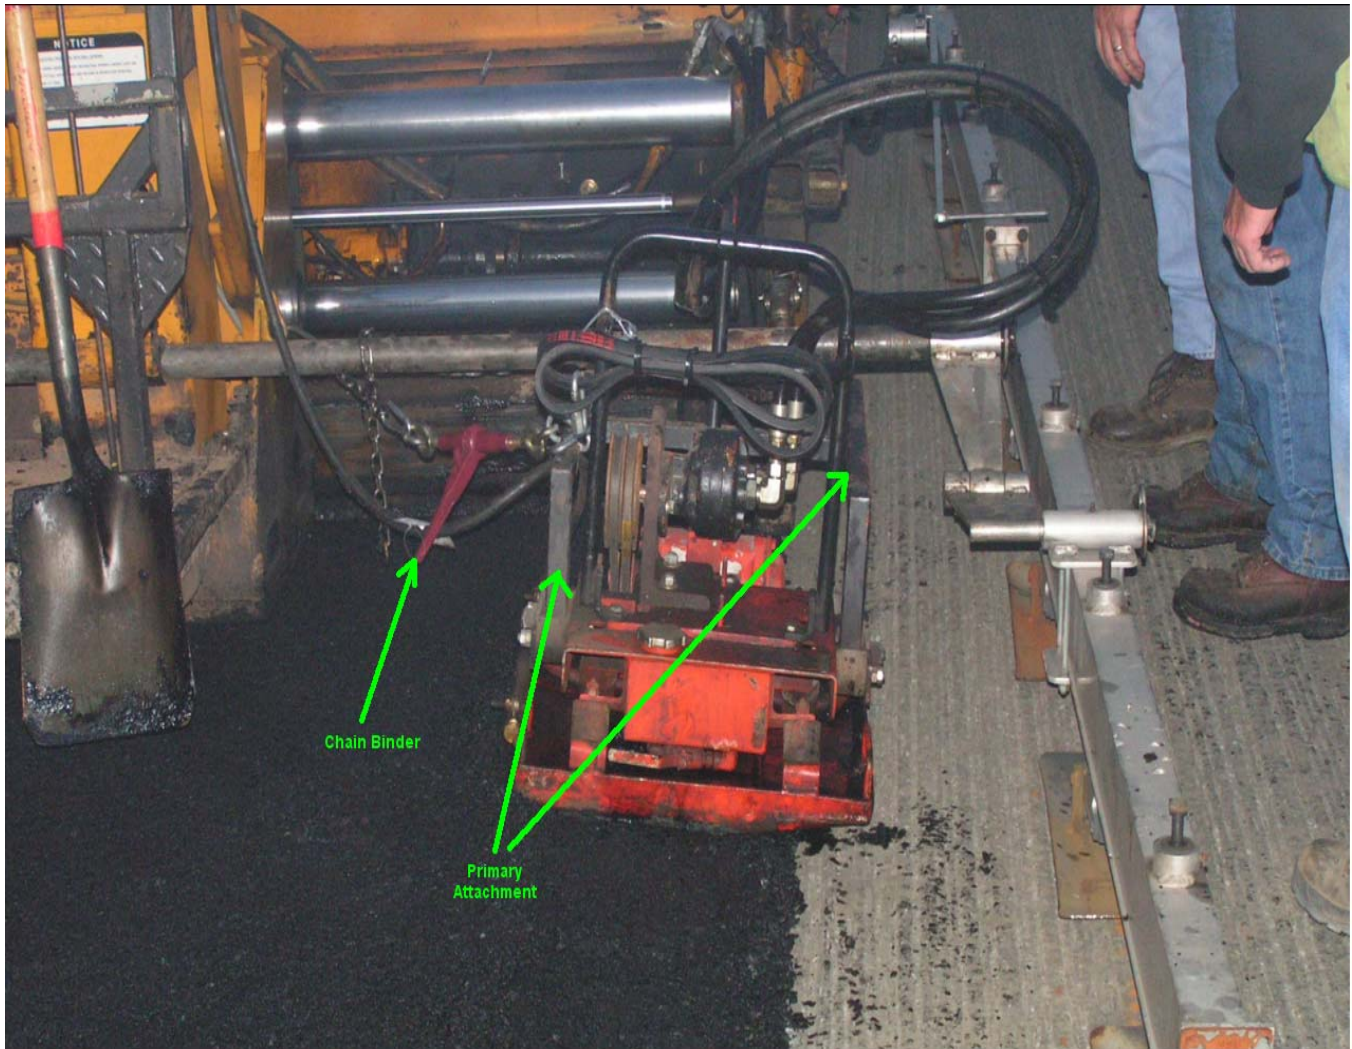
**Figure #4 – Project #98-98 Compaction Device Setup and Attachments**

**Project Equipment:** The contractor utilized the same notched wedge joint device and vibrating plate as the contractor in the previous pilot project. They modified their paver to adapt to the new equipment. However, there were some mechanical improvements to the device and vibrating plate setup. The vibrating plate had new mounting locations. While the primary attachment was still mounted to the wing, the chain attachments were mounted to the body of the paver. This eliminated the danger of cutting the chain when closing the wing. A ratcheting device (chain binder) was added to the chain mount to make it easier to adjust the angle of the vibrating plate. Figure #4 shows the setup used on this pilot project.

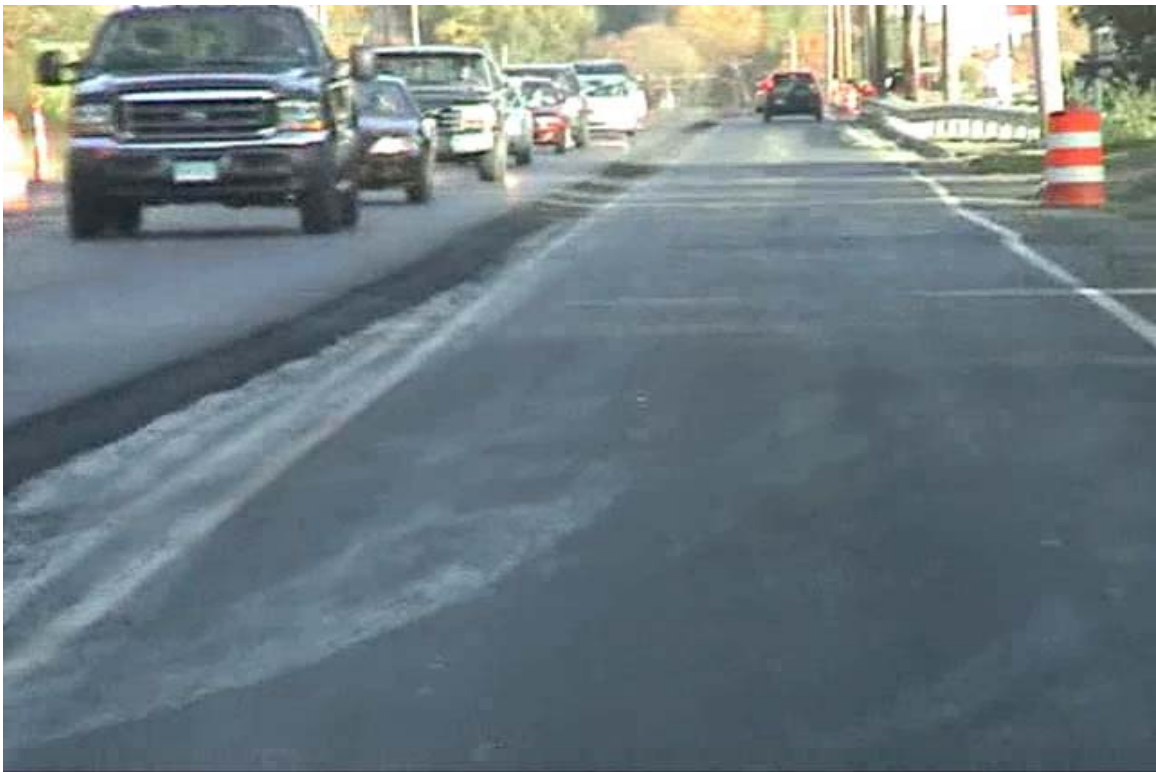
**Figure #5 – Project #98-98 Notched Wedge Joint at Centerline of Roadway**

and shoulder, the exposed notched wedge joint was at the centerline of the roadway (Figure #5). This also meant that a completed joint was formed between the shoulder and westbound travel lane that same night. Tack coat on the joint was again an issue. The majority of the joint had only the bottom half coated as shown in Figure #6. This problem will need to be addressed on future trial or study projects incorporating the notched wedge joint method.

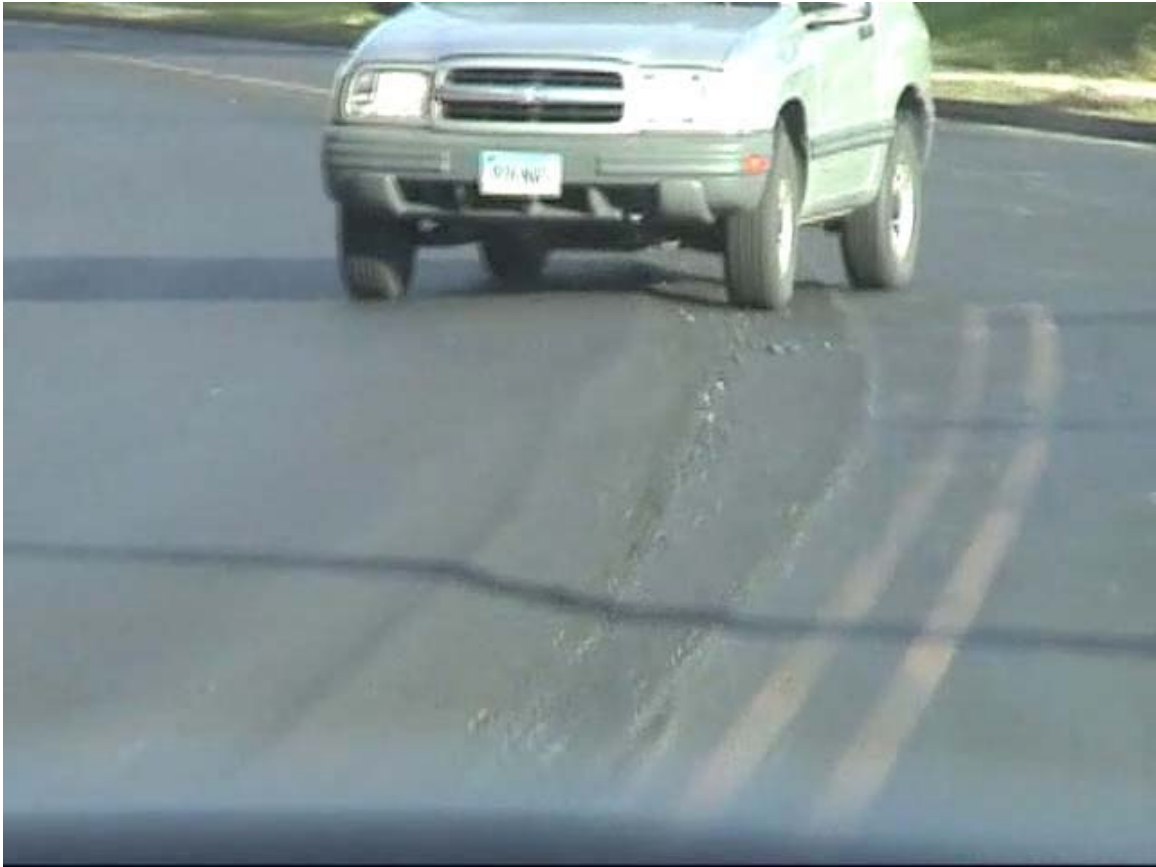
**Figure #7 – Traffic Traversing the Open Joint**

**Field Observations – Traffic on Open Joints:** The construction and use of the exposed joint as it was opened to traffic was filmed once again. Because the joint was located at the centerline of opposing traffic it was not traversed as regularly as it was on the previous project. It was only traversed when cars were entering/exiting businesses and side streets. This resulted in very little loose aggregated visible in the travel lanes. No additional sweeping was performed as it was deemed not to be necessary. Once again cars and trucks had no problem traversing the notched wedge joint (Figure #7).

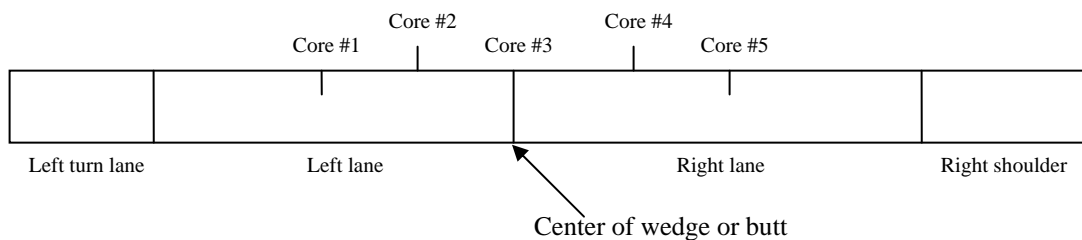
**Figure #8 – Sampling Plan – Cross-Sectional View**

○ = Core Locations  
 + = Nuclear Measurement Locations

\* Nuclear Density measurements will be made 12" and 6" to the left of the joint as well as on the joint and 12" and 6" to the right of the joint at each of the five core locations in each of the day's sections. This is a total of 25 nuclear density measurements per section.

\*\* Five longitudinal feet as well as 6 transverse inches will separate each of the core locations in each section.

It was desired at the outset of this research that profiles be obtained that demonstrated the behavior of density from the cold side of the joint across to the hot side of the joint. If such profiles could be obtained, this may explain a great deal about the problem with the premature failure of the longitudinal joints. More specifically, it was desired to determine what the density of the material was on both sides of the joint as well as directly on the joint for comparison purposes.

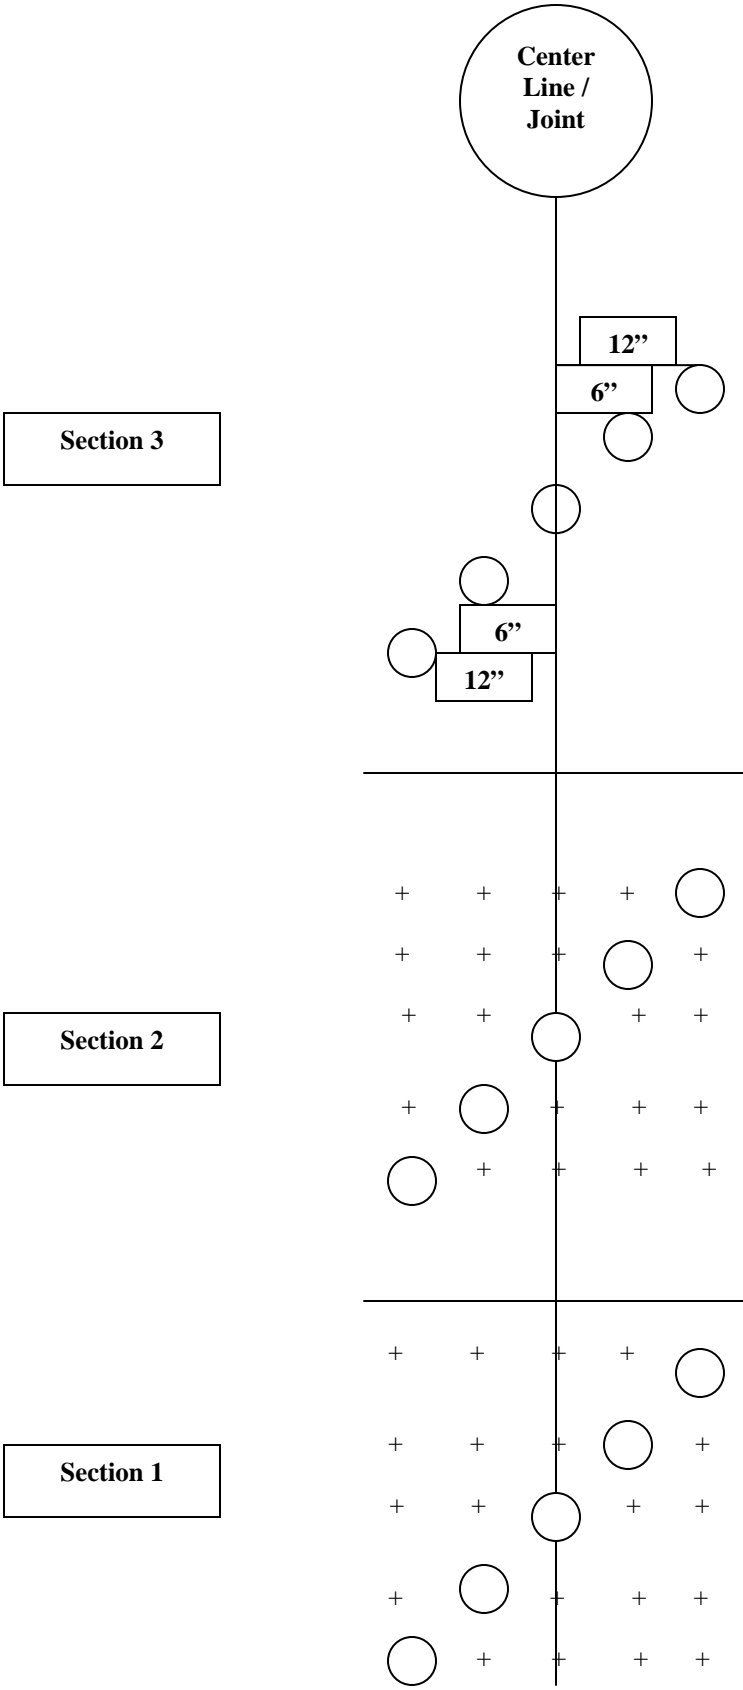
Figure #9 – Sampling Plan – Plan View

immediately adjacent to one another in the form of a profile for a number of reasons. These reasons include: each core that would be cut would have been disturbed by the extraction of the previous core and the damage to the mat would have been problematic. It was determined then that nuclear density profiles would be measured across the joint starting 1 foot from the joint on the cold side and continuing in 6 inch increments to 1 foot from the joint on the hot side (Figures #8, #9). It was decided that this would take place every 5 feet in the direction of paving. A core would be extracted from the first profile in the location where the nuclear density testing took place 1 foot from the joint on the cold side. Moving to the next profile which would be 5 feet in the longitudinal direction, a core would be extracted in the location where the nuclear tests were performed 6 inches from the joint on the cold side. 5 feet from that location in the direction of paving another core would be extracted directly on the joint where nuclear measurements took place. This would be repeated for core extraction 6 inches from the joint on the hot side and finally 1 foot from the joint on the hot side. Thus five nuclear density profiles and five cores would be obtained over each 20 foot section (Figure #9).

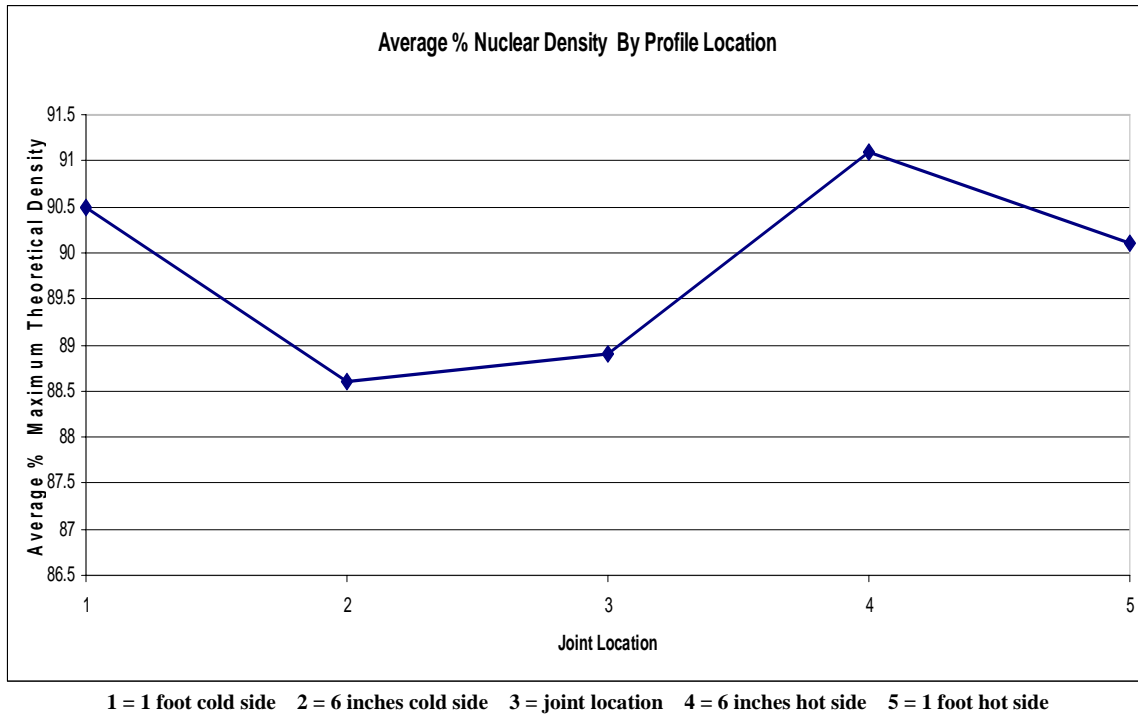
**Figure #10 – Average % Nuclear Density by Profile Location**

Figure #10 shows a plot of the average nuclear density behavior. The cold side of the joint overall appears to maintain lower density and more specifically the area of lowest density occurs from 6 inches on the cold side of the joint to the joint location itself. This may be due in part to less lateral confinement present during the compaction of the first paver pass. During the compaction of the second paver pass, the first paver pass provides

Considering both Figure #10 and Appendix A, the graphical differences between density profile A and B can be explained by the magnitude of the statistic  $F$ . The drop in density from 1 foot on the cold side to 6 inches on the cold side is shown both in the plot as well as the amount that the statistic  $F$  exceeds the critical value of  $F$ . This may again be due to the lack of lateral confinement as the edge of the cold pass is compacted.

This is not the case for the comparison between location B and location C. It can be seen in the plot that the density average increases slightly at the joint location but that the magnitude of the difference is not nearly as drastic as the first comparison. This is evident not only by viewing the slope of the line between them but also by comparing the  $F$  statistic with the critical value of  $F$ .  $F$  did not exceed  $F_{crit}$  in this comparison and thus there is no statistically significant difference between the average density at the joint and the average density 6 inches from the joint on the cold side. This reinforces that the lowest area of density across the joint profile is from 6 inches on the cold side to the joint itself.

The comparison between the joint and 6 inches from the joint on the hot side indicates a drastic increase in density on the hot side of the joint.  $F_{crit}$  was indeed far exceeded by the statistic  $F$  in this comparison as can be seen in Appendix A. This is also evident in the slope increase between these two points on the plot. This is most likely due to the presence of the already placed cold side to act as lateral confinement for the hot side of the joint.

There is also a statistically significant difference between locations D and E. The average density value decreases from 6 inches on the hot side to 1 foot on the hot side. Although the difference is significant, the difference between  $F$  and  $F_{crit}$  is not nearly as large as the differences seen between A and B and between C and D. It can also be seen that the average density value 1 foot from the joint on the hot side is very near the average density value 1 foot on the cold side. This indicates the non-homogeneous nature of the density around the joint and that those conditions become more homogeneous toward the center of the mat.

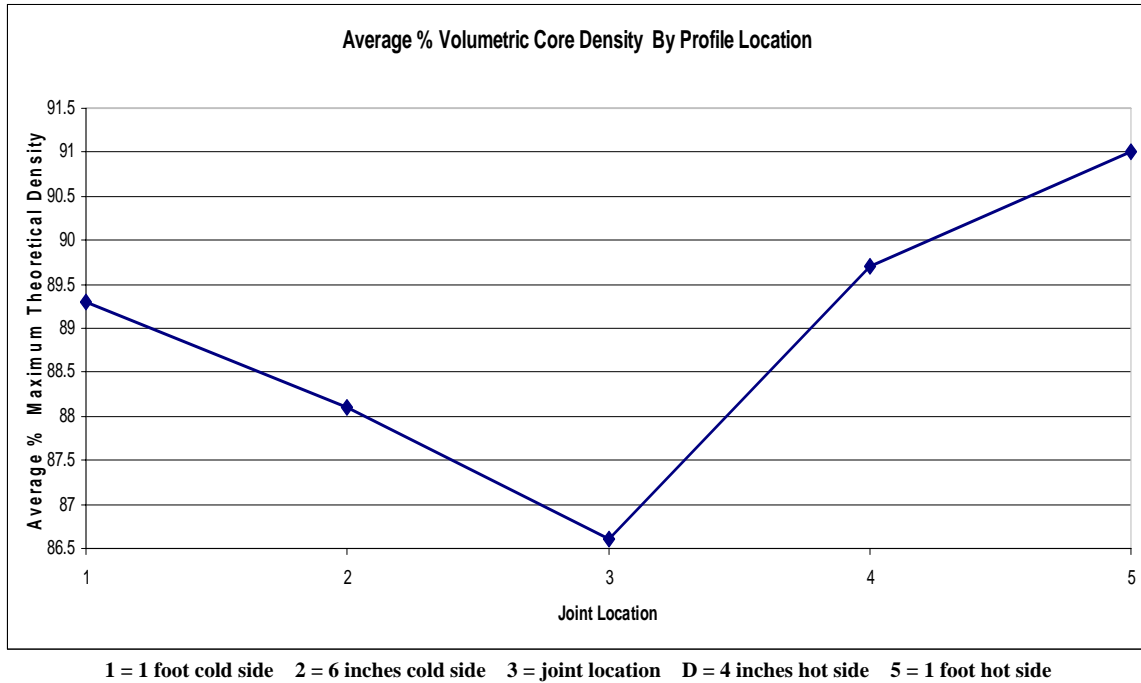
**Figure #11 – Average % Volumetric Core Density by Profile Location**

the lateral confinement that the second pass can be compacted against. This holds true for traditional butt joints as well. Figure #11 shows the data plotted in the same manner for the volumetric core data as a quick check. It is important to note that although the volumetric core data was averaged and plotted, there were no statistical analyses conducted on the core data due to the inadequate sample size. All of the following statistical analyses were conducted using the nuclear density values.
