**Connecticut Permanent Long-Term Bridge Monitoring
Network Volume 2: Monitoring of Curved
Post-Tensioned Concrete Box-Girder Bridge – I-384 WB
Over I-84 in East Hartford (Bridge #5686)**

Prepared by: Adam Scianna, Stephen Prusaczyk
Zhaoshuo Jiang, Richard E. Christenson, John T. DeWolf
Jeong-Ho Kim
August 18, 2014
Report Number CT-2256-3-13-4

Connecticut Transportation Institute
University of Connecticut

Prepared for:
Connecticut Department of Transportation

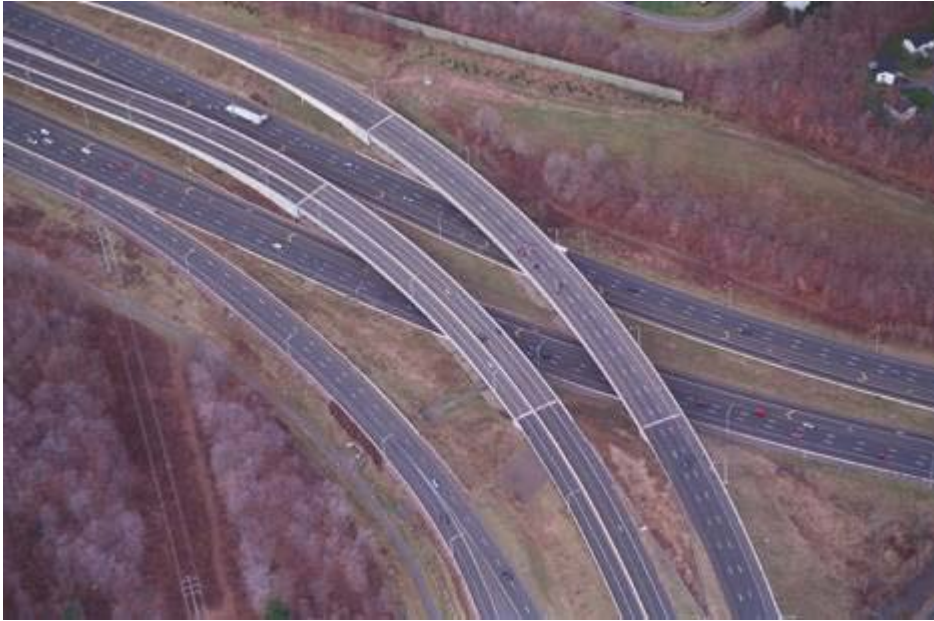
This report is for the I-384 Overpass in East Hartford (Inventory Number 5686), located at the intersection of this highway with I-84. The bridge was constructed in 1985. It is a curved, post-tensioned, five-celled, box-girder bridge with three unequal spans. An aerial view is shown in Figure 1. There are two curved box-girder bridges in the interchange, located between the two transverse expansion joints that appear as white lines in the photo. The monitored bridge is the one on the right, i.e. the longer of the two bridges. Figure 2 shows a view taken below the bridge from one of the two abutments.

Figure 1. Aerial View of Post-Tensioned Box-Girder Bridge

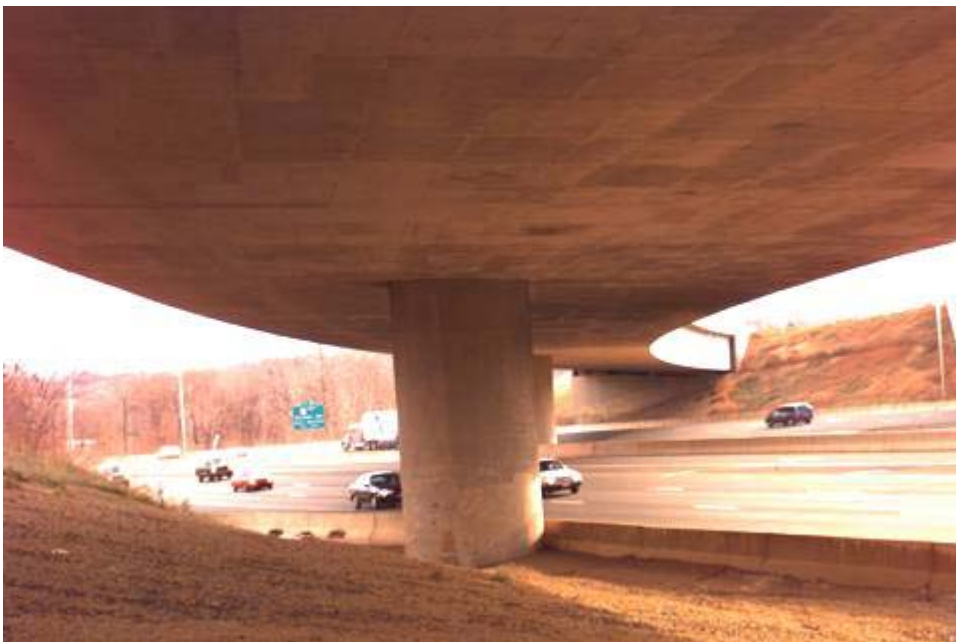
Figure 2. Underside of Post-Tensioned Box-Girder Bridge

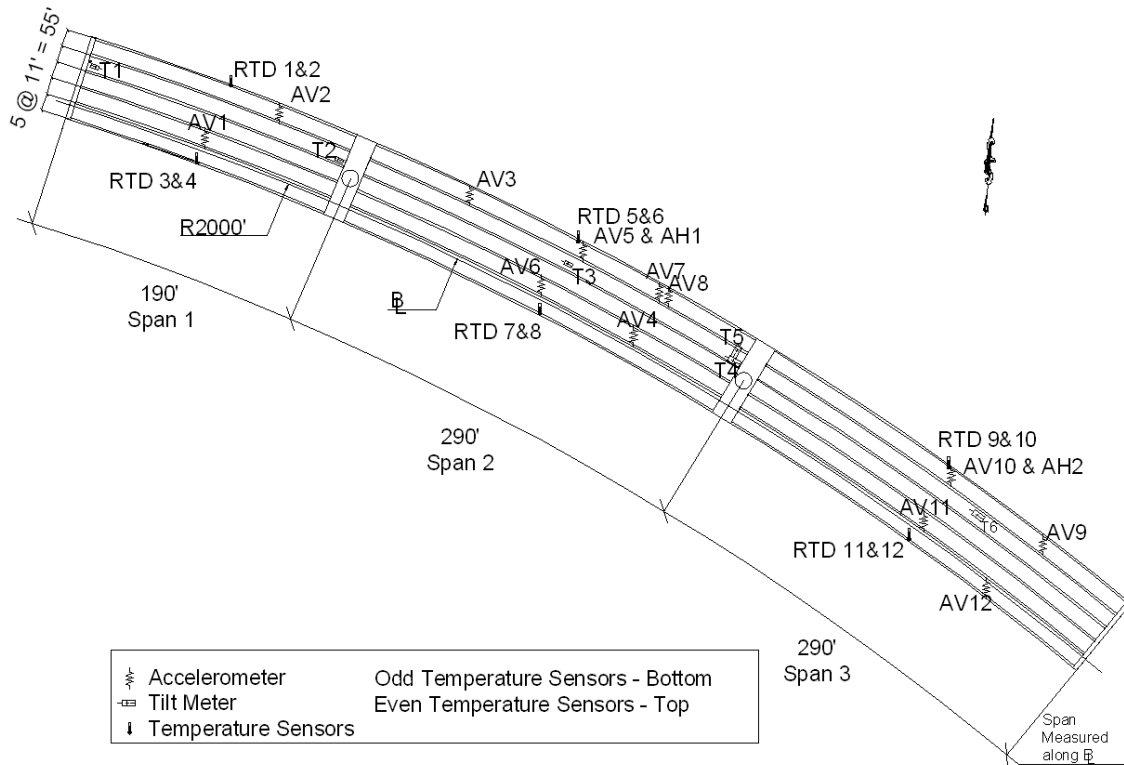
noted, the changes essentially followed similar patterns. The main problem was that strain gages lacked the resolution to measure dynamic strains, i.e. those associated with live loads. Thus, all data collection prior to the recent upgrade of the monitoring system has been based on data from the thermocouples, accelerometers and tilt meters placed inside the box girders. They are distributed over the three spans and across the cross-section. The plan layout is shown in Figure 5.

Figure 5. Locations of Sensors for Post-Tensioned Box-Girder Bridge

After development of a detailed specification, the monitoring system was put out to bid. The system chosen has twelve thermocouples, sixteen accelerometers, six tilt meters, and sixteen strain gages. Three additional thermocouples were added in the summer of 1999. The sensors are connected to an HP Computer, with two scanning A/D Converters, one capable of handling 32 channels and one 64 channels. The strain gages are connected to the 32 channel converter, and the accelerometers, tilt meters, and thermocouples are connected to the 64 channel converter. An external power source provides excitation, and an onsite laptop computer is connected to the monitoring instrument. The computer controls the instrument using a monitoring program written in HP VEE. The system has been designed to be remotely accessed for data retrieval and system control.

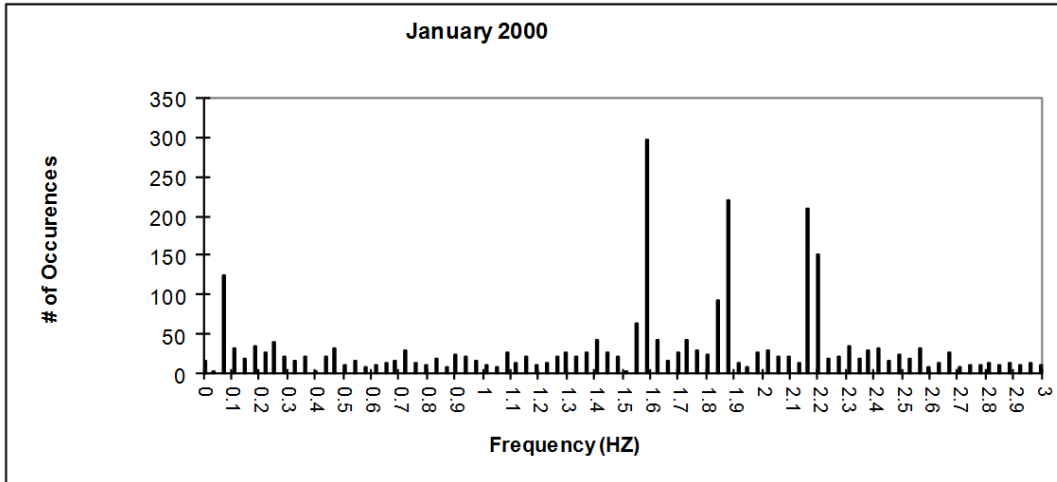
each accelerometer, and they analyzed the occurrences with histograms. This approach was based on the fact that true natural frequencies should occur significantly more often than other supposed frequencies. Figures 6 and 7 show histograms for data collected in the months of January and May, respectively.

Figure 6. Histogram for January 2000

These figures show slight shifts in the natural frequencies. Ultimately the natural frequencies were confirmed with an extensive finite element analysis by Fu (1999), reported in the next section of this report.

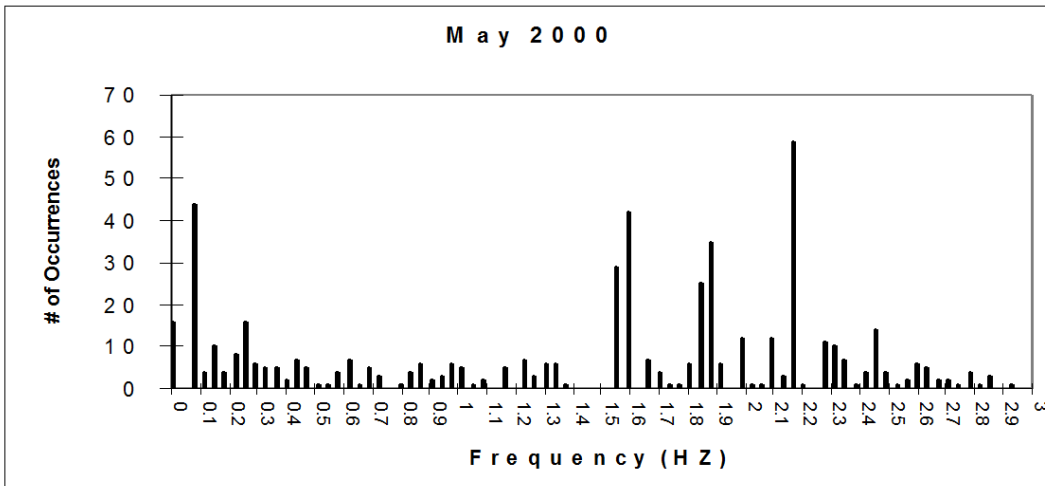
Figure 7. Histogram for May 2000

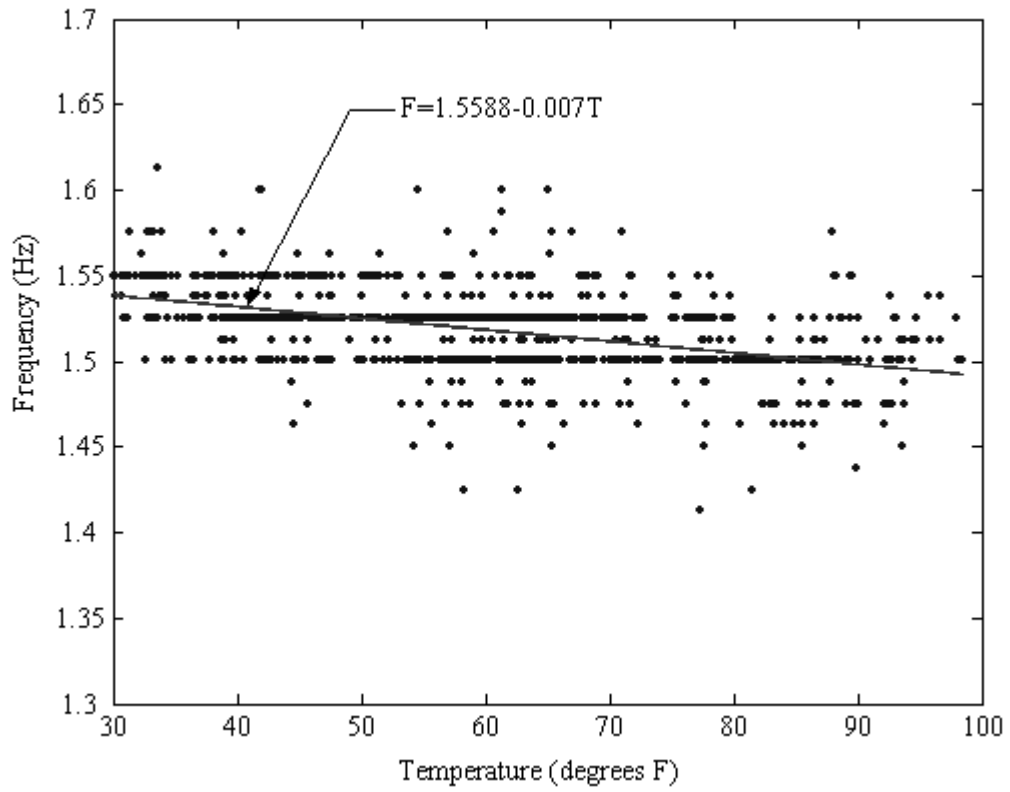
Figures 9, 10 and 11 show the first three measured natural frequencies versus the in-situ concrete temperatures. The scatter in these plots is mainly due to the noise resulting from the data acquisition system. This is a normal problem with field data. It is necessary to look at large sets of data to determine the general trend. Thus, the field data shows, from a statistical view, that the temperature-natural frequency relationship is basically linear. As shown, in all modes the natural frequencies decrease as the temperature rises. This needs to be incorporated into the baseline for long-term monitoring.

Figure 9. Natural Frequency Variation with Temperature Change for Mode 1 (1.52 Hz)

$$F_1=1.5588-0.007T \quad (\text{First Natural Frequency: } 1.52 \text{ Hz}),$$

The resulting equations are shown on the figures. These three linear regression equations, developed with a full-year cycle data from 2002, were also used for comparison with data collected in 2005. There were gaps in the data collection during 2005, but there is sufficient
