Enhancing Connecticut's Crash Data Collection for Serious Injury and Fatal Motor Vehicle Collisions

Report Number: CT-2302-F-18-1

Final Report

Connecticut Transportation Safety Research Center
Connecticut Transportation Institute
School of Engineering
University of Connecticut

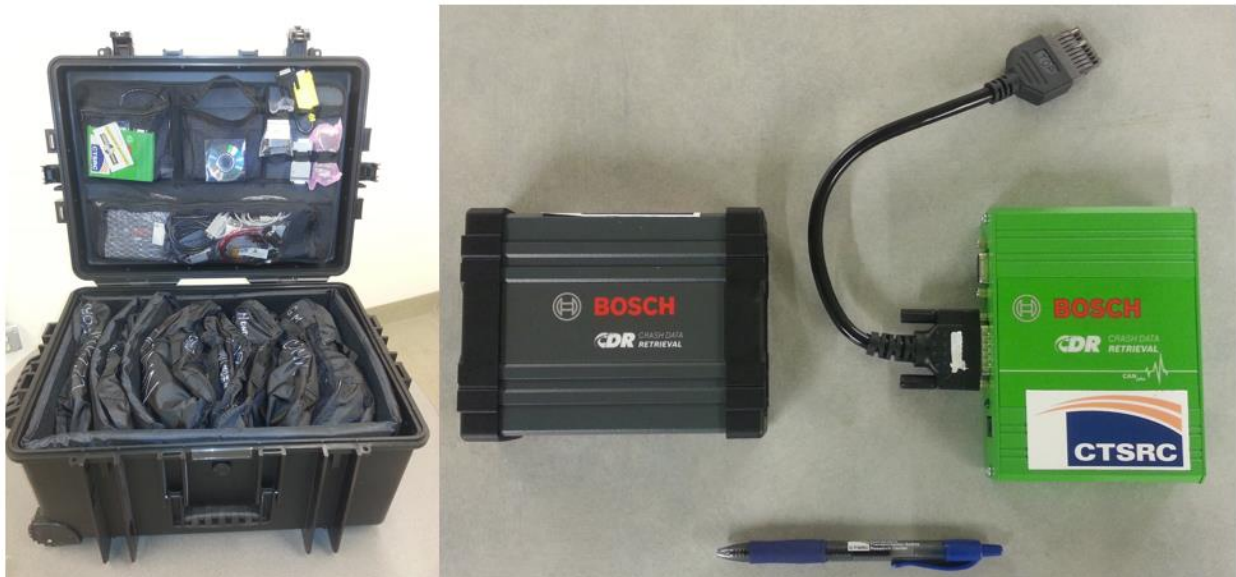
Figure 1: BOSCH EDR Download Kit

To enhance the collection of crash data CTSRC purchased two complete BOSCH Crash Data Retrieval units for downloading vehicle EDR data (Figure 1). These units were purchased from Crash Data Group, Inc. who is the sole source distributor for the Bosch Crash Data Retrieval product line in the United States and Canada. These units are now used as part of an equipment loan program to allow authorized and trained law enforcement technicians to download data from vehicles involved in serious or fatal crashes as part of their crash investigations. This provides rapid, consistent, and uniform data collection while ensuring that Fatality Analysis Reporting System (F.A.R.S) reporting standards are met.

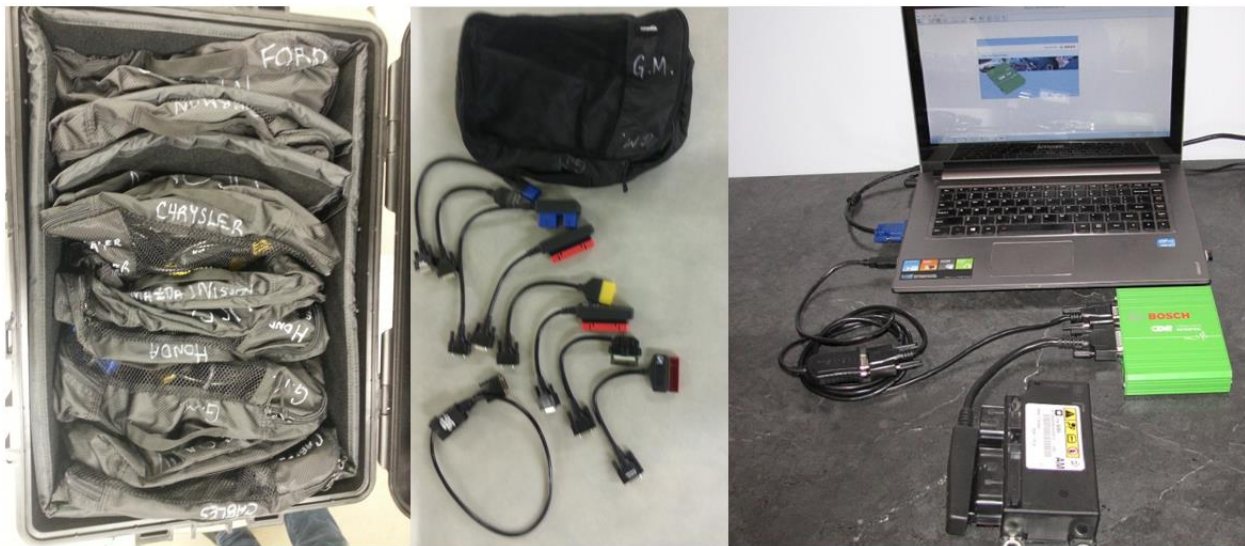
Figure 2: EDR Cables by Make and Model

Before the CTSRC team was able to assist in any download, the police department requesting service was required to obtain a search and seizure warrant signed by a Connecticut Superior Court judge. Once obtained, CTSRC sent out our certified EDR technician with one of the BOSCH kits to perform the download. Due to the condition of many of the cars the team quickly realized that data downloads of in place EDR modules was challenging. Therefore, the CTSRC team requested that the EDR be removed from the vehicle prior to the technician's arrival. Performing these downloads in a garage or controlled lab setting made downloads much easier and lessened the likelihood of damaging the connector pins of the EDR. Upon arrival at the police department, the technician would identify the make, model and year of the vehicle to be downloaded and then select the appropriate cable(s) or adaptor(s) (Figure 2). After connecting the EDR to the reader and the reader to the laptop, the data download would begin and typically take less than 60 seconds to complete of the EDR download. The resulting data was then exported as a report from the EDR software and converted to a PDF. The resulting document was downloaded to a thumb drive and provided to the police department for analysis. The EDR technician would then assist the department in navigating the contents of the report but would leave the interpretation of the data to the investigating officer.

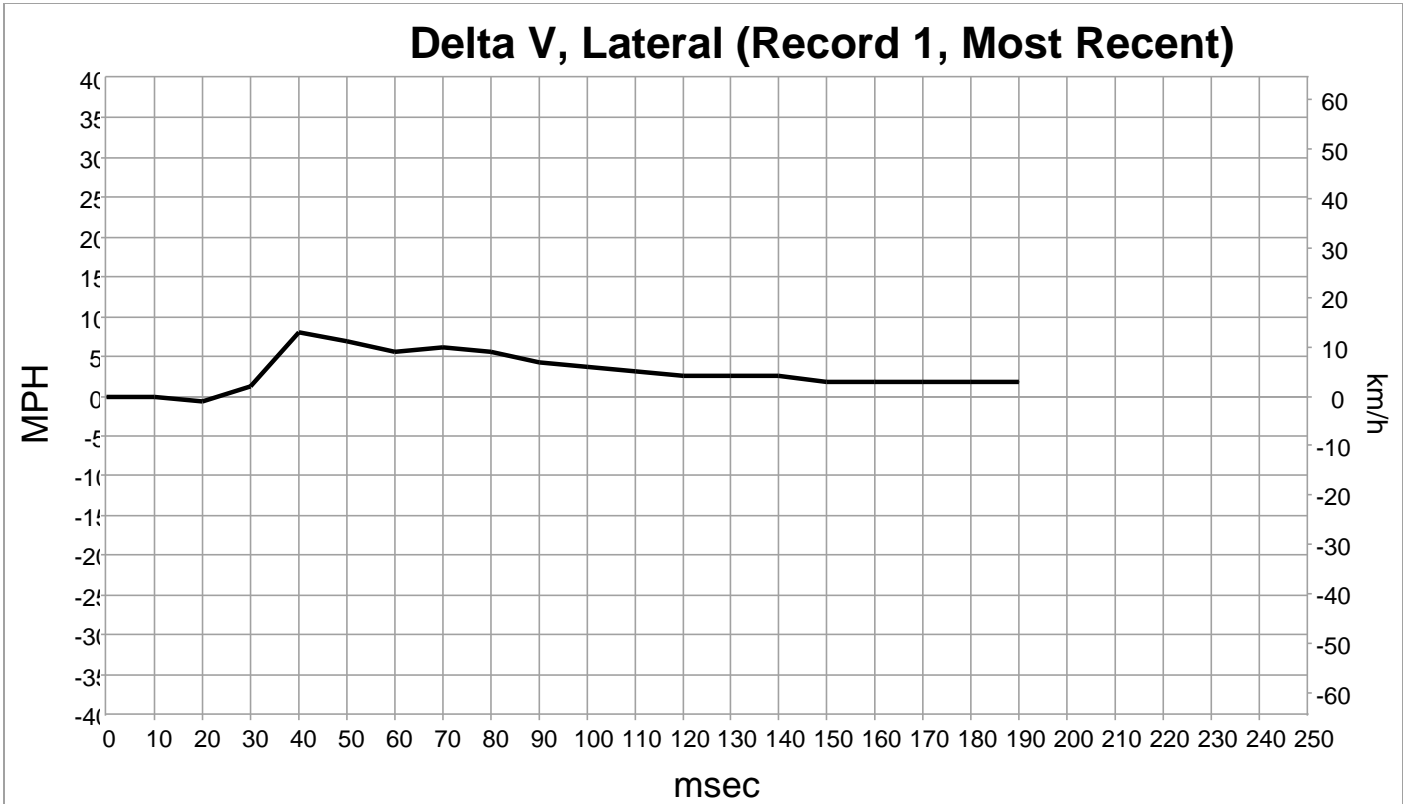
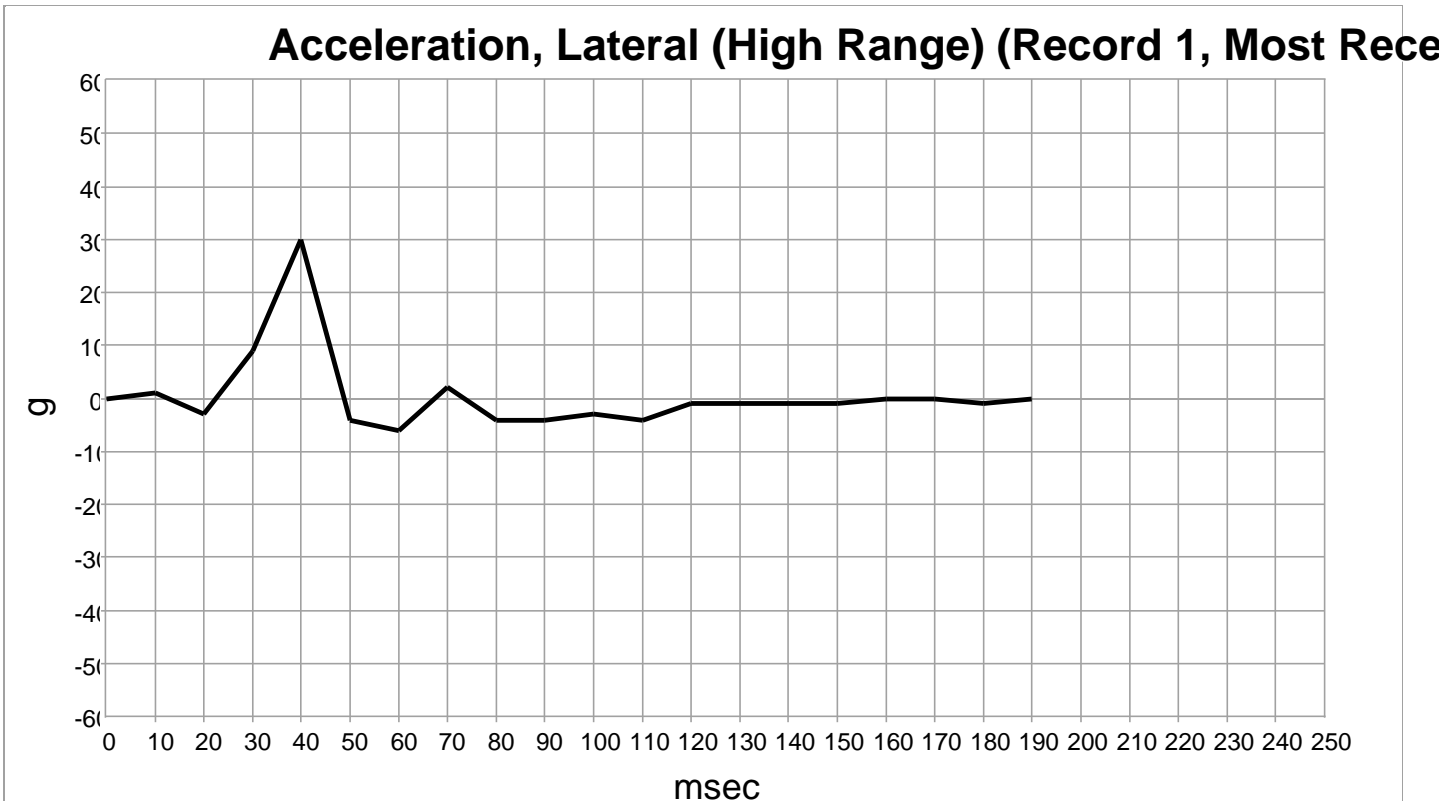
Lateral Crash Pulse (Record 1, Most Recent)

Time (msec)	Delta-V, Lateral (MPH [km/h])	Lateral Acceleration (Lateral G High Range) (g)
0	0.0 [0]	0.25
10	0.0 [0]	0.58
20	-0.6 [-1]	-2.98
30	1.2 [2]	9.28
40	8.1 [13]	29.58
50	6.8 [11]	-4.26
60	5.6 [9]	-6.00
70	6.2 [10]	1.95
80	5.6 [9]	-3.53
90	4.3 [7]	-4.12
100	3.7 [6]	-3.28
110	3.1 [5]	-4.00
120	2.5 [4]	-0.73
130	2.5 [4]	-1.40
140	2.5 [4]	-1.14
150	1.9 [3]	-0.57
160	1.9 [3]	0.03
170	1.9 [3]	0.13
180	1.9 [3]	-0.72
190	1.9 [3]	-0.36
200	Data Not Available	Data Not Available
210	Data Not Available	Data Not Available
220	Data Not Available	Data Not Available
230	Data Not Available	Data Not Available
240	Data Not Available	Data Not Available
250	Data Not Available	Data Not Available

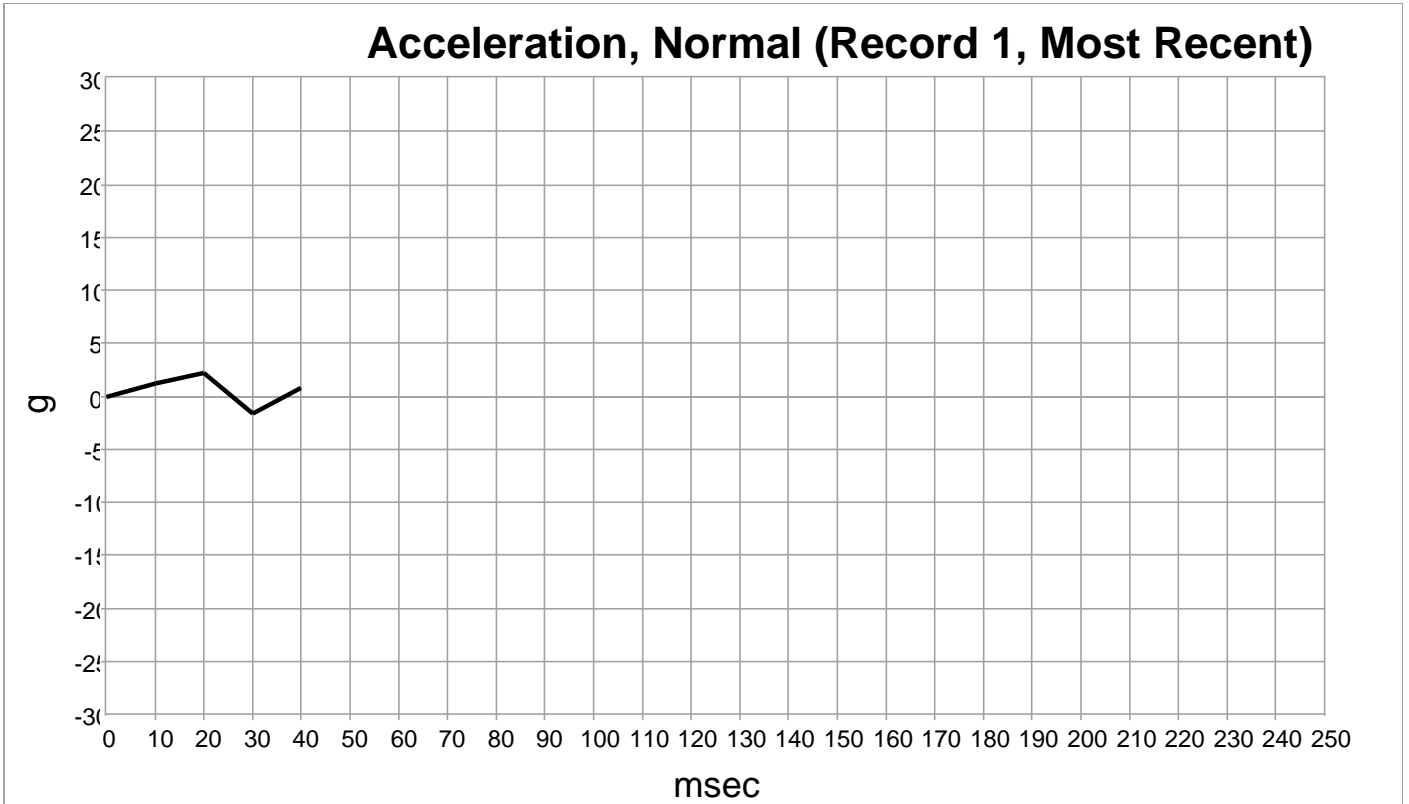
Normal Acceleration (Record 1, Most Recent)

Time (msec)	Normal Acceleration (Vertical G Low Range) (g)
0	0.0
10	1.2
20	2.2
30	-1.6
40	0.8
50	Invalid Data
60	Invalid Data
70	Invalid Data
80	Invalid Data
90	Invalid Data
100	Invalid Data
110	Invalid Data
120	Invalid Data
130	Invalid Data
140	Invalid Data
150	Invalid Data
160	Invalid Data
170	Invalid Data
180	Invalid Data
190	Invalid Data
200	Data Not Available
210	Data Not Available
220	Data Not Available
230	Data Not Available
240	Data Not Available
250	Data Not Available

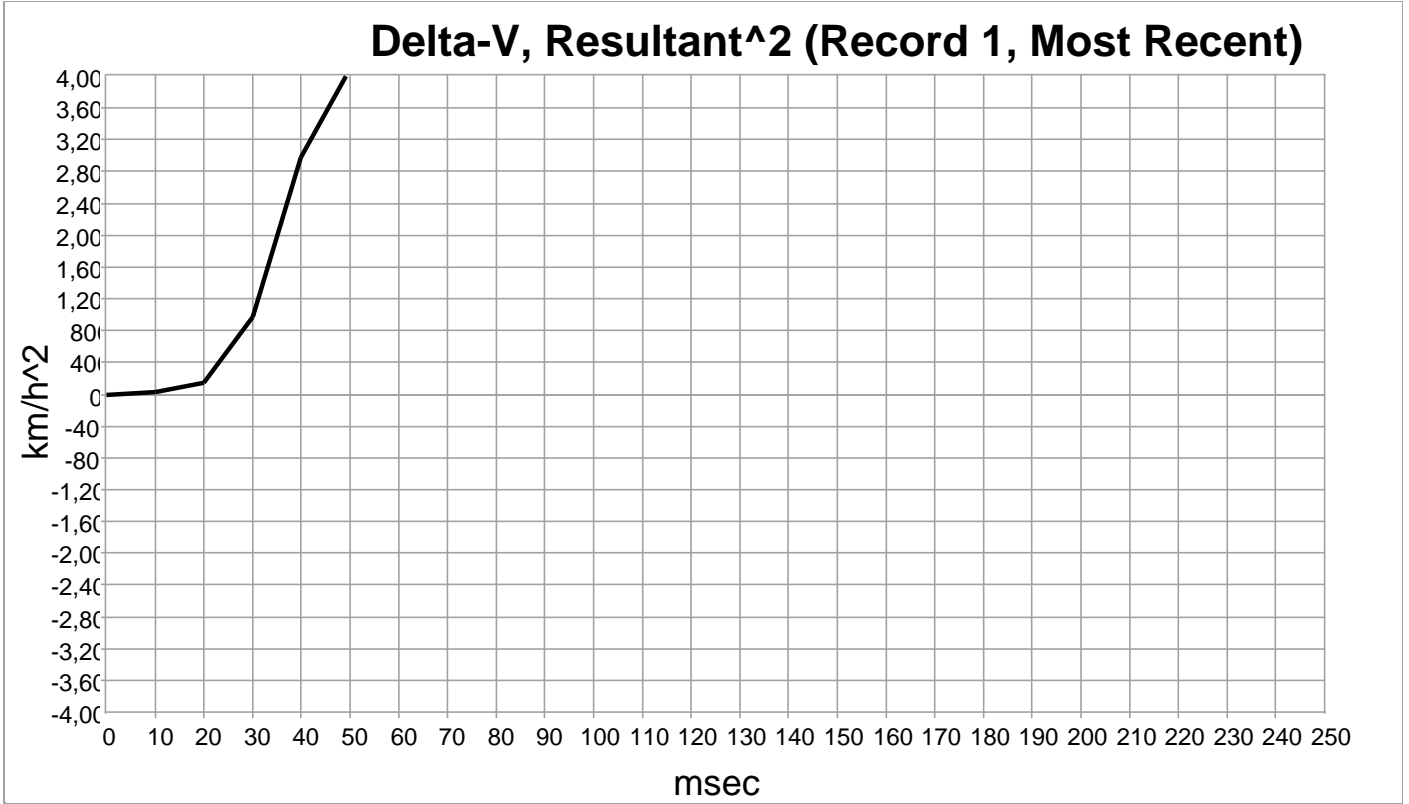
Resultant Crash Pulse (Record 1, Most Recent)

Time (msec)	Delta-V, Resultant ² (km/h ²)
0	0
10	36
20	145
30	965
40	2,978
50	4,090
60	5,122
70	5,725
80	6,642
90	7,274
100	7,780
110	8,306
120	8,665
130	8,852
140	9,232
150	9,418
160	9,418
170	9,613
180	9,613
190	9,613
200	Data Not Available
210	Data Not Available
220	Data Not Available
230	Data Not Available
240	Data Not Available
250	Data Not Available
