Air and Moisture Control in Building Enclosures

2014 Design & Trade Conference

Marc A. Loranger, P.E., LEED AP
May 29, 2014

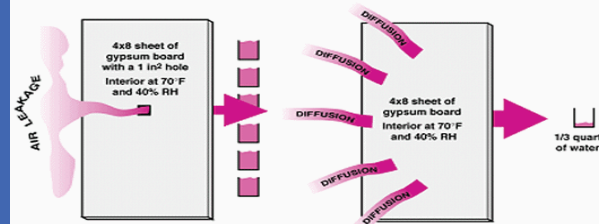
- Air leakage: moisture travels in the air as it freely passes through wall cracks and penetrations
- Vapor diffusion: moisture is driven through a material by vapor pressure

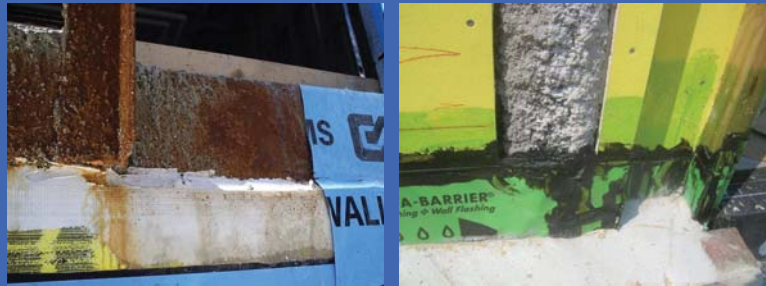
Substrates

- Steel Beams/Columns
 - Debris/overspray/fireproofing
 - Rust/scale

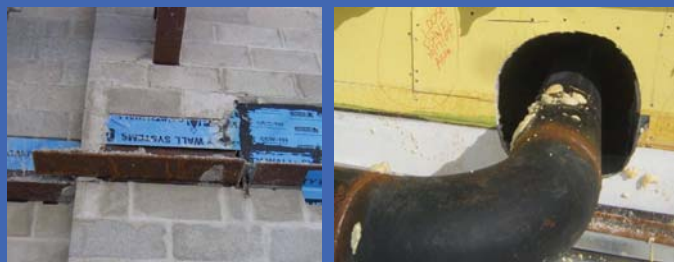
Substrates

- Penetrations
 - Pipes/conduits
 - Structural tails/fins/relieving angles

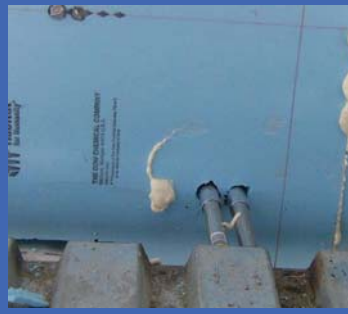
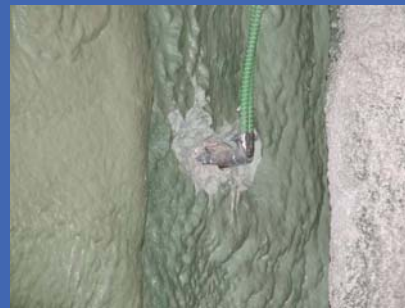
Damages by other trades:

- Mechanical/Electrical/Plumbing
 - *They come in after the fact and cut openings in the wall!*

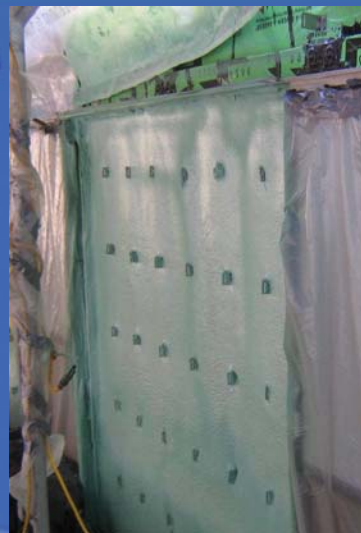
Membranes

- SPF
 - Uniform appearance
 - Penetrations
 - Shrinkage cracking

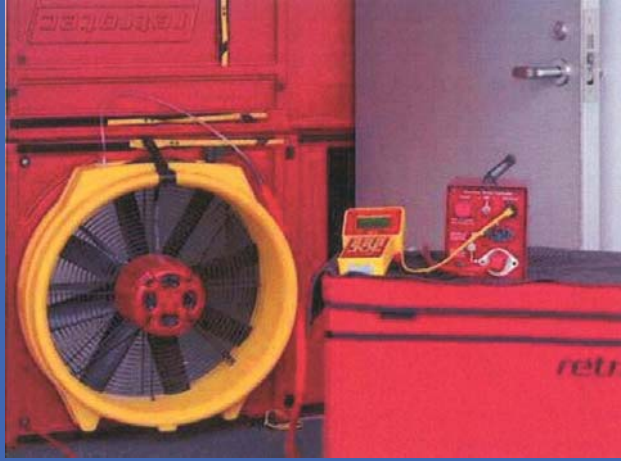
ASTM E 779, Standard Test Method for Determining Air Leakage Rate by Fan Pressurization

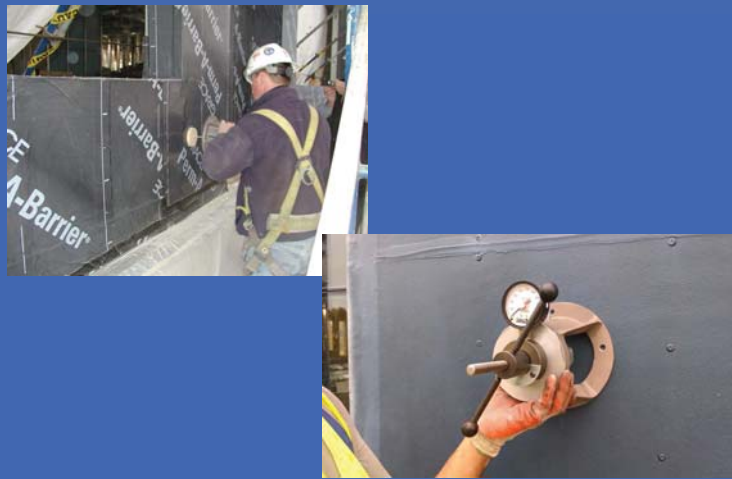
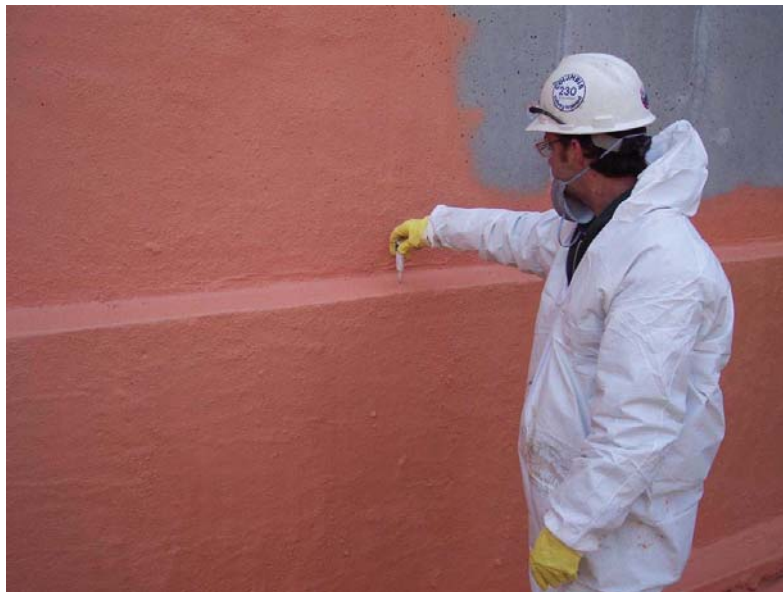
ASTM D 4541 Standard Test Method for Pull-Off Strength of Coatings – Portable Adhesion Testing

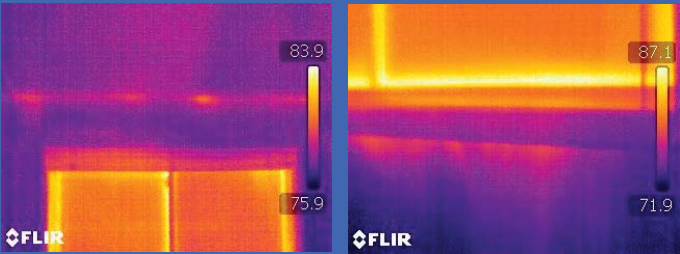
- Air infiltration at penetrations
- At existing building

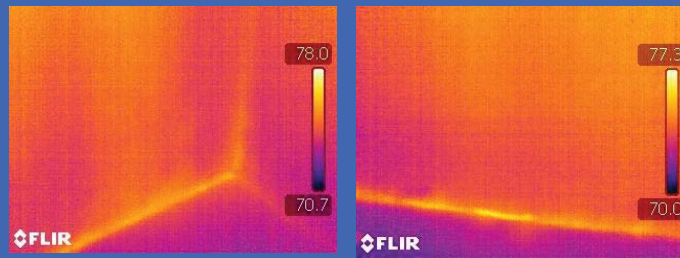
- Air infiltration at floor
- At existing building

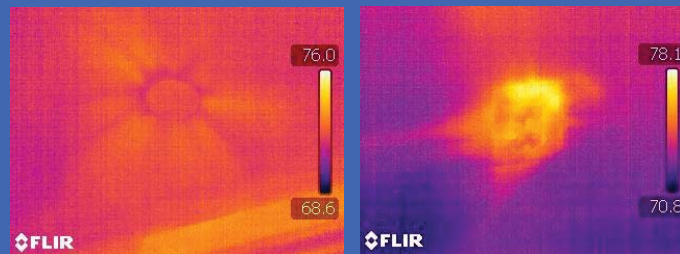
- Air infiltration at penetrations
- At existing building

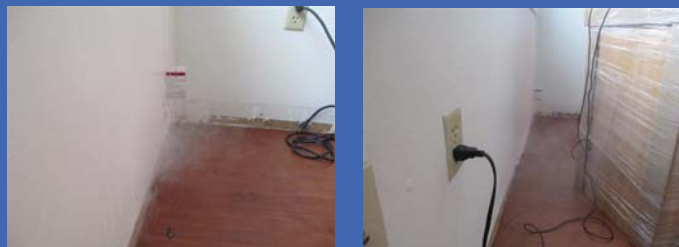
- Smoke entry under wall sill plate

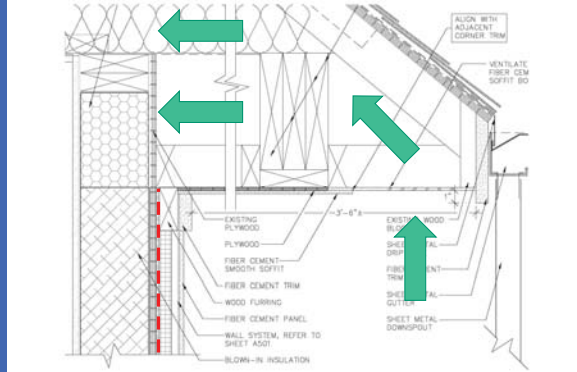
Potential Air Infiltration

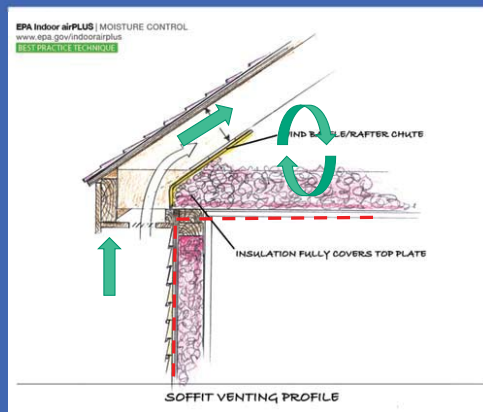
Preferred Design Detail

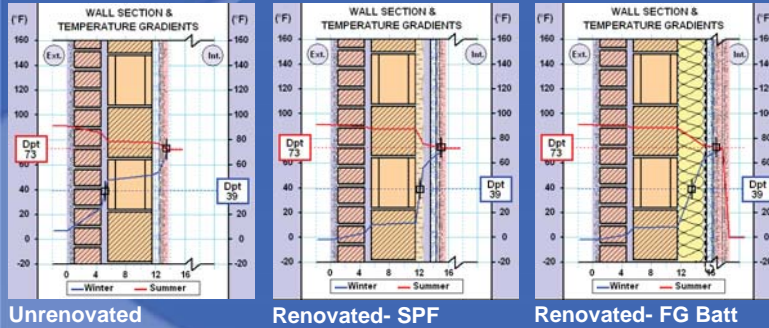
Static Dewpoint Analysis

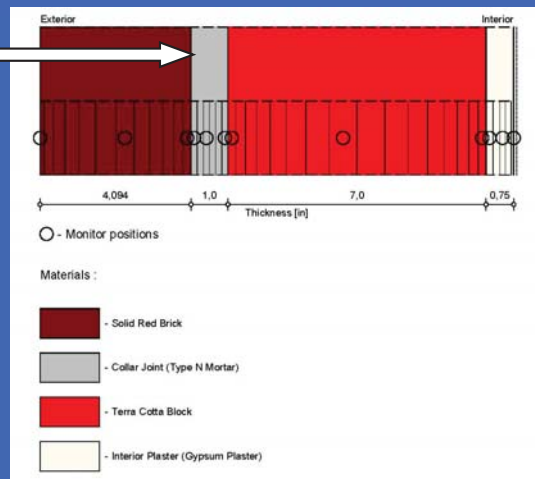
Additional Exterior Factors

Moisture source
to account for
penetration due to
driving rain

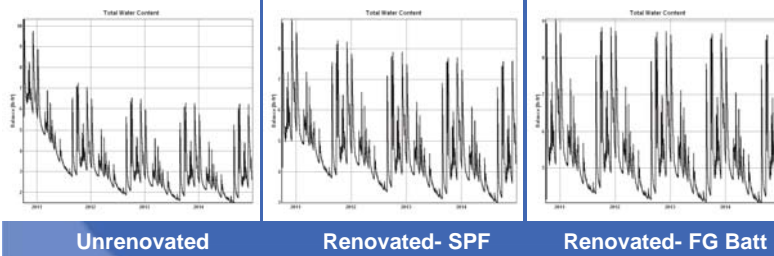
Water Content of Wall Assembly
