2016 Safe Routes to School Walk Audit Findings Report

Bielefield Elementary School Middletown, CT

Submitted By:
VN Engineers, Inc.
116 Washington Avenue
North Haven, CT 06473
Phone (203) 234-7862

June, 2016

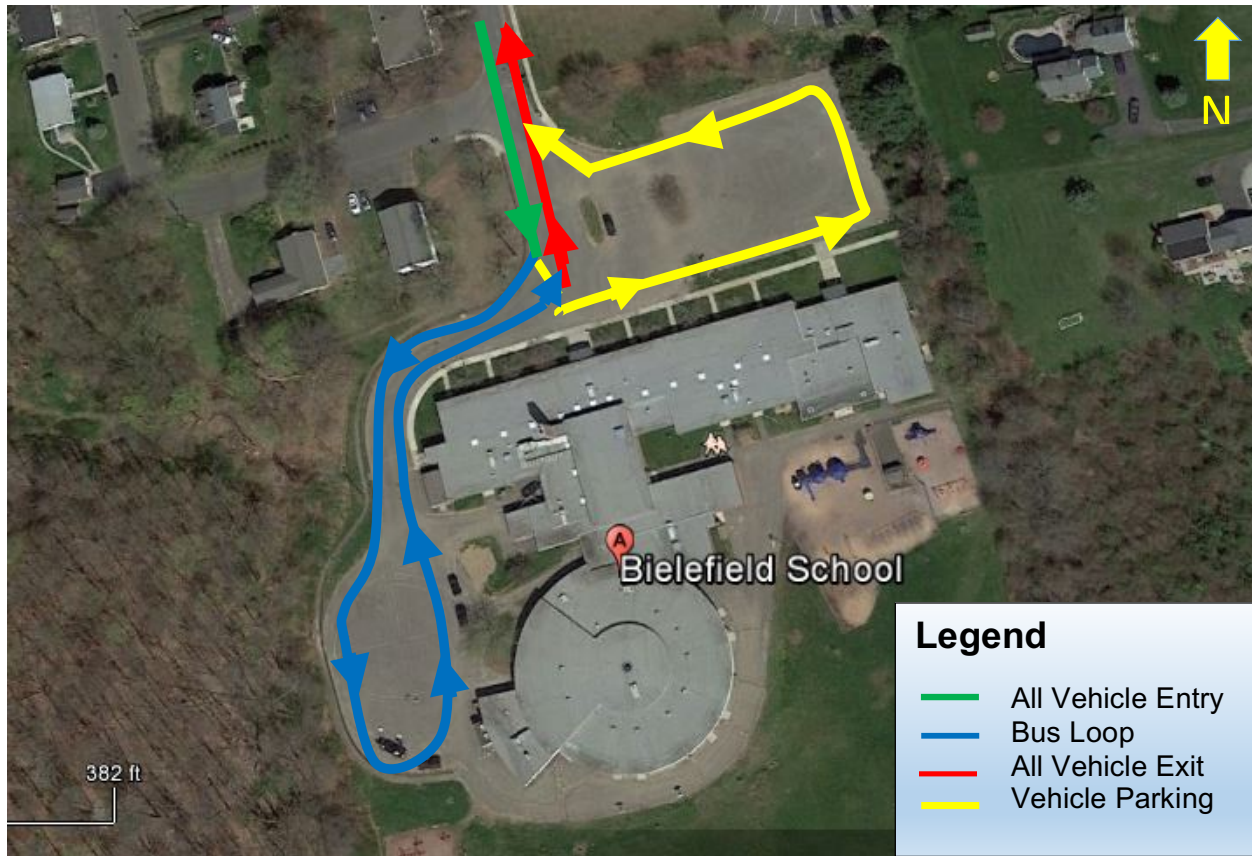
Figure 3: Aerial View of school arrival and dismissal patterns

The car drop-off and pick up area is directly in front of the main entrance with no designated curb side area for passengers to unload, see **Figure 3**. Buses proceed to the rear to drop-off passengers. Individual cars park perpendicular to the curb in front of the main entrance to allow the students to disembark from their respective vehicles. The drivers are then only able to reverse their vehicles to turn around and exit. Simultaneously, the buses are entering, which can pose a potential vehicular conflict.

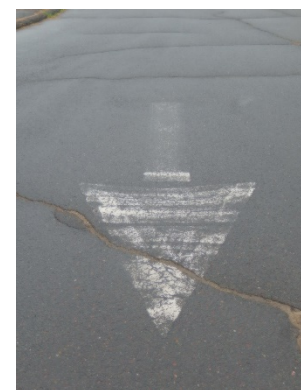
Figure 4: Faded Pavement Marking in School Lot

Middletown uses yellow painted curb to indicate *No Parking* areas. The yellow curb paint is significantly faded in most areas as are the pavement markings on the school grounds, see **Figure 4**.

- Repaint the directional arrows and pavement markings on school grounds.
- Update the signing in a few areas. The stop sign at Maynard Street and Bidwell Terrace is positioned in the wrong orientation and in poor condition.
- Streamline the informational signs that tell the parent where to park and not to park.
- Install a crosswalk at the intersection of Maynard Street and Hillside Avenue.
- It is recommended that all signage around the school be updated to meet MUTCD current specifications, particularly with regards to size, reflectivity, and the fluorescent yellow-green color. There are currently no school zone signs in the vicinity of the campus, **Figure 28**.

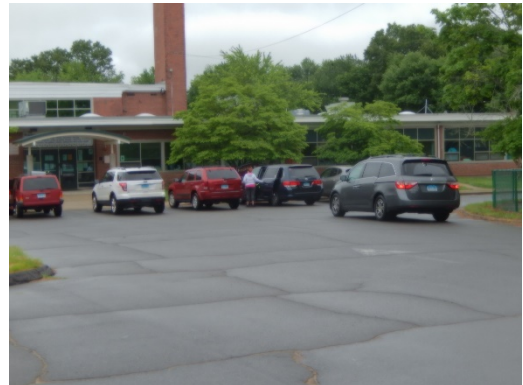
Figure 6: Parent Drop-off

Parents also drop-off students at Bidwell Terrace, which is located to the west of the campus. Students then proceed along the asphalt path to the west side bus loop and enter the side doors. This path is separated from vehicular traffic with a chain link fence.

Parent drop-off begins at the same time as the bus drop-off, with doors opening at 8:40 am, (**Figure 6**). There is no designated school drop-off and pick up lane, so parents pull up to the school campus via the sole entry point off of Maynard Street and then locate a temporary spot to unload their passengers. Most parents attempt to pull up perpendicular to the curbside where they unload their kids. Then the drivers reverse out of parking spaces to exit the lot.

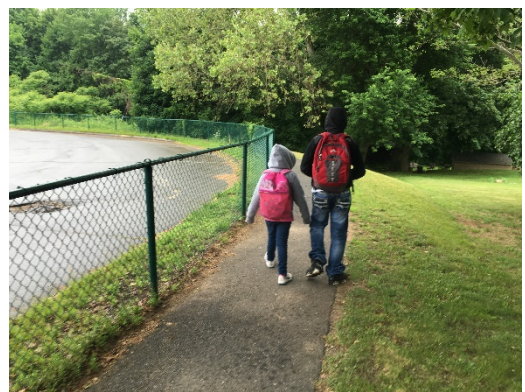
Figure 7: Pedestrians Along Campus Sidewalk

Some parents dropped off their students along side streets and students walked the remainder of the way along the fenced off sidewalk (**Figure 7**) adjacent to the driveway, crossing over midway at the crosswalk in the driveway (**Figure 8**) or proceeding until the bus unloading zone and entering the school building there. There are two staff members monitoring this process and they do not wear personal safety gear.

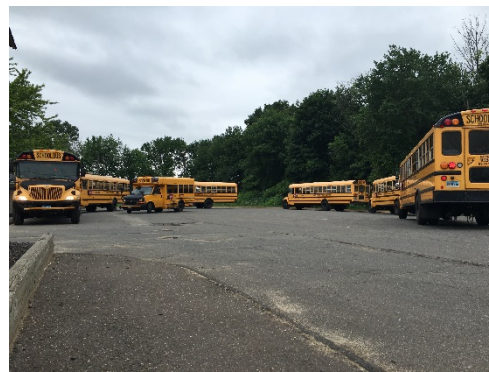
Figure 9: Bus Dismissal

The bus pick up process begins at 3:00 PM when the first bus arrives on campus. The buses queue up until students are dismissed at 3:25 PM, see **Figure 9**. There are two staff members who monitor this process, as in the morning drop-off operation. Despite the lack of pavement markings or signs, the pick up and drop-off process was more orderly than expected.

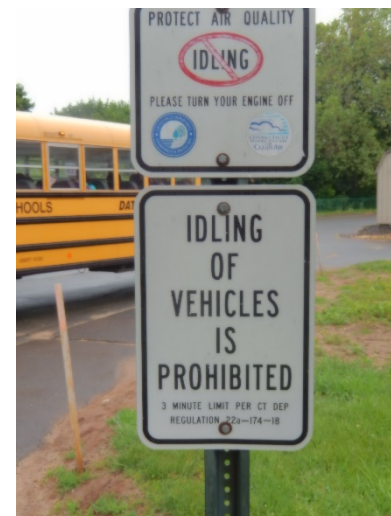
Figure 10: No Idling Sign on Campus

- Cars idling despite a no idle policy, **Figure 10**.
- Conflict between arriving and departing cars and arriving and departing buses.
- Limited parking.
- Parents allowing other parents in the building despite a controlled entry policy.
- Lack of or faded pavement markings.

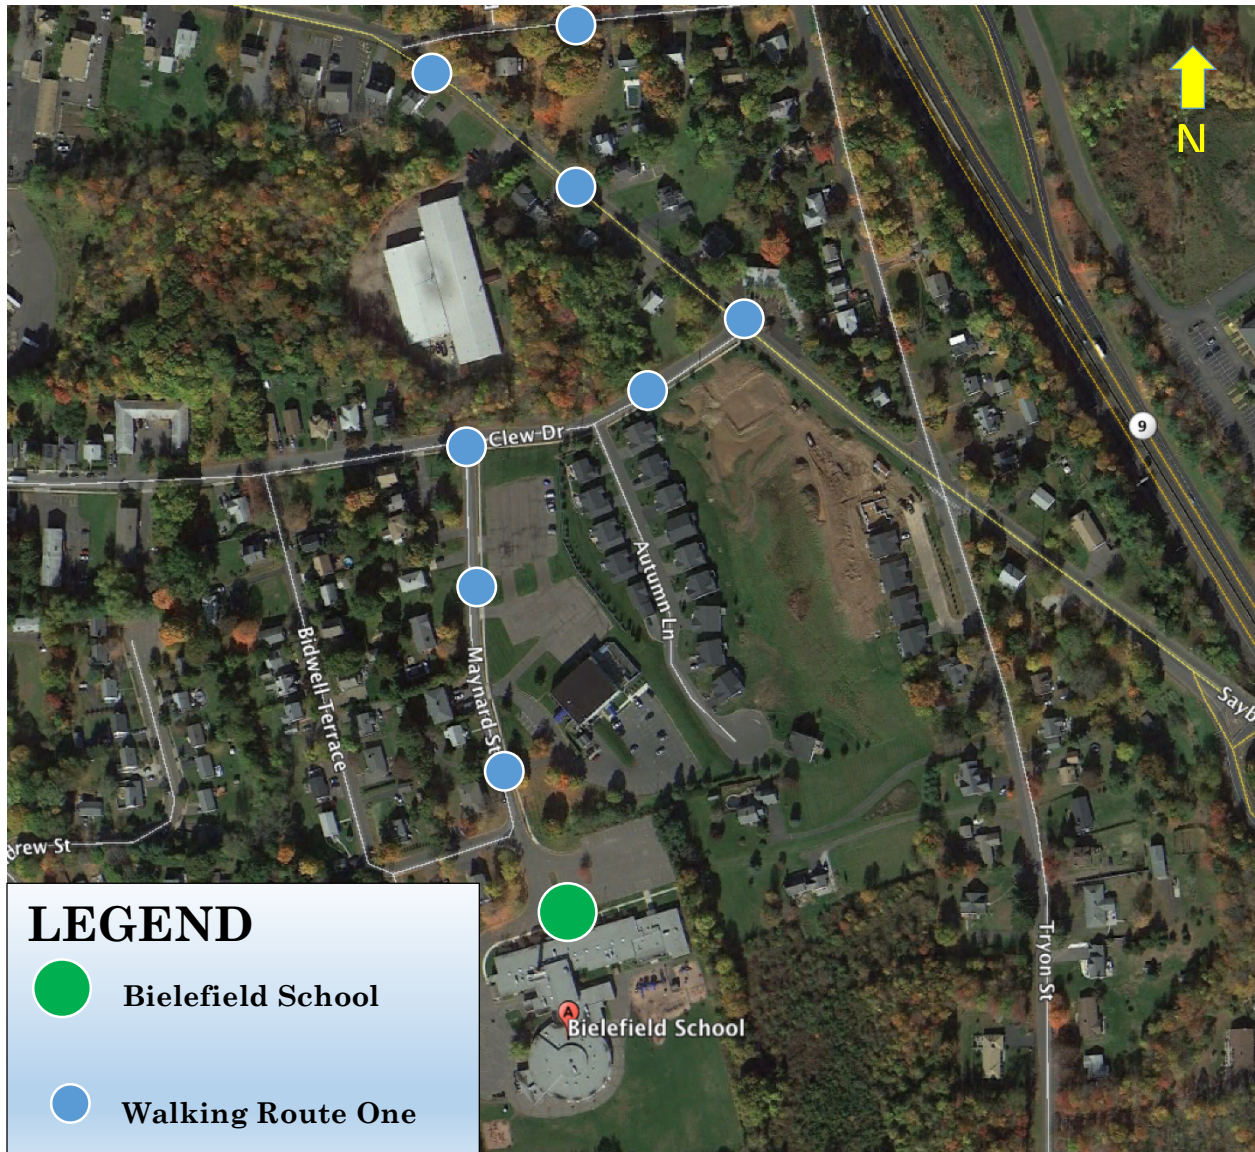
Figure 12: Walking Route One

Walking Route One (**Figure 12**) starts along Maynard Street and continues on to Clew Drive, to Saybrook Road, and to Bow Lane (0.68 miles).

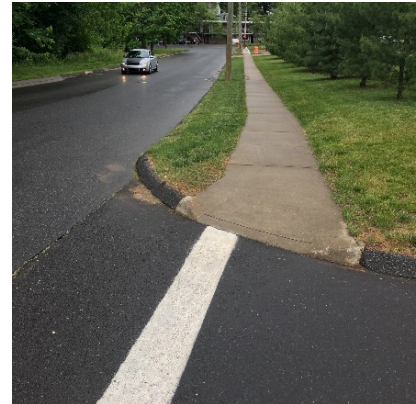
Figure 13: Clew Drive

In general, the pavement markings and pavement quality are in good condition, **Figure 13**. According to the MUTCD:

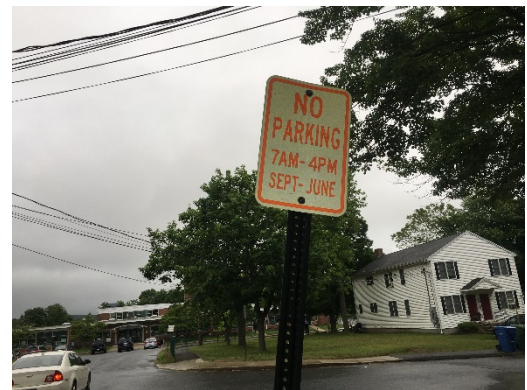
Figure 14: No Parking on Maynard

There are *No Parking* signs along Maynard Street (**Figure 14**) on both sides in the vicinity of the school campus. According to the MUTCD, "Parking and stopping regulatory signs may be used to prevent parked or waiting vehicles from blocking pedestrians' views, and drivers' views of pedestrians, and to control vehicles as a part of the school traffic plan."

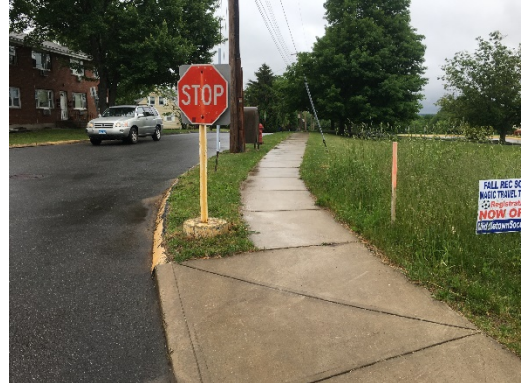
Figure 15: Sidewalk Along Maynard Street

The sidewalks along this route are intermittently constructed. There is connectivity along Maynard Street and Clew Drive with sidewalks running along the eastern side of Maynard Street (**Figure 15**) and the southern side of Clew Drive. However, there are no sidewalks on Saybrook Road or Bow Lane. The denser traffic along Saybrook Road and the lack of sidewalks and shoulder striping make the option of walking or biking very challenging. Pedestrians have opted to walk along the grass noted by the goat trail that runs along the southern side of this highly travelled corridor.

- Consider constructing sidewalks along these three routes where they are currently lacking.
- Consider constructing edge lines along all streets in the school vicinity.

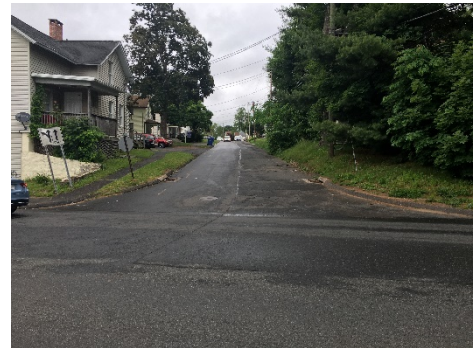
Figure 18: Intersection of Wall Street and Saybrook Road

All these roads are for two-way travel; Saybrook Road measures 32' in width, Bidwell Terrace is 30' wide, and the others are 24' wide. There are no crosswalks along this route and no shoulder lines, however, Saybrook Road does have double center lines. The pavement along Saybrook Road, Frisbie Street, and Wall Street is fair. Maynard Street and Bidwell Terrace are in better condition, see **Figure 18**.

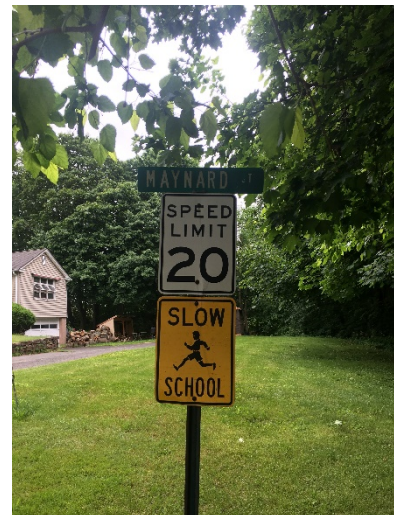
Figure 19: Slow School Sign

There are stop signs along Maynard Street and a 20 mph speed limit sign with an outdated *Slow School* sign on the south side where Bidwell Terrace transitions into Maynard Street, **Figure 19**. As mentioned in section 2.3.2, there are *No Parking* signs along Maynard Street on both sides in the vicinity of the school campus. According to the MUTCD "Parking and stopping regulatory signs may be used to prevent parked or waiting vehicles from blocking pedestrians' views, and drivers' views of pedestrians, and to control vehicles as a part of the school traffic plan."

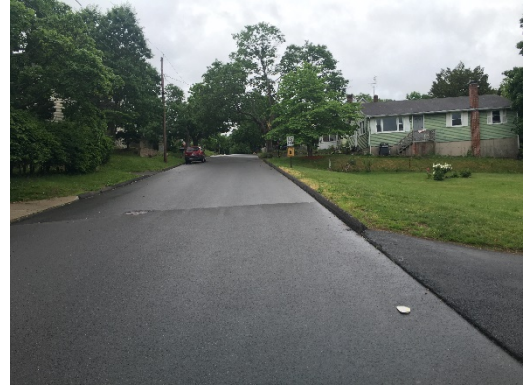
Figure 20: Bidwell Terrace

There are no sidewalks along the section of Maynard Street that connects to Bidwell Terrace, nor along Bidwell Terrace, see **Figure 20**. The southern section of Frisbie Street, adjacent to Saybrook Road has sidewalks. There are newer sidewalks along both sides of Frisbie Street, east of the intersection with Evergreen Avenue. There are no sidewalks along Wall Street that provide continuous connectivity, although there are a few intermittent segments. And as noted above, there are no pedestrian accommodations along Saybrook Road.

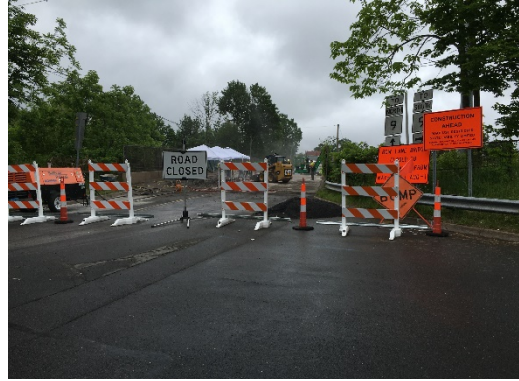
Figure 22: Construction at Top of Bow Lane

through corridor for travelers. Tryon Street is low in travel density, primarily residential, and Bow Lane was cordoned off for a bridge construction project so we could not properly assess the traffic volume, see **Figure 22**.

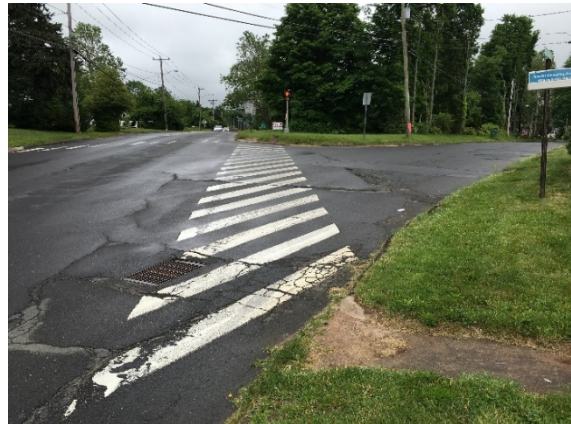
Figure 23: Crosswalk at the Intersection of Saybrook Road and Tryon Street

At the intersection of Tryon Street and Saybrook Road, there is a crosswalk on the south and east side. There are no sidewalks along either Saybrook Road or Tryon Street, so the markings are not ideal as there is no pedestrian connectivity. According to the SRTS Engineering Guide, “locations chosen to have marked crosswalks should be convenient, accessible and in the direct pedestrian route,” [AASHTO, 2004]. This is not the current state of this intersection, see **Figure 23**. Here is a list of current issues at this particular crossing:

- Crosswalks are not connected to any sidewalks.
- Pedestrian beacon on the west side is not functional.
- Button on the pedestrian beacon is broken.
- Light bulb in pedestrian beacon is burnt out.
- The pedestrian beacon is not MUTCD Compliant.

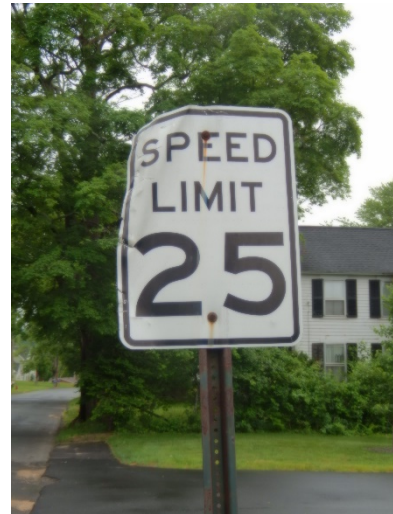
Figure 24: Speed Limit on Tryon Street

The sign inventory for Maynard Street, Clew Drive, and Saybrook Road has already been detailed in section 2.4.2. Tryon Street has a 25 mile per hour posted speed limit on the western side (**Figure 24**), south of Saybrook Road and on the eastern side north of Saybrook Road. There is also a *Children at Play* sign under the 25 posted speed limit, **Figure 25**. This sign is not recommended by the MUTCD.

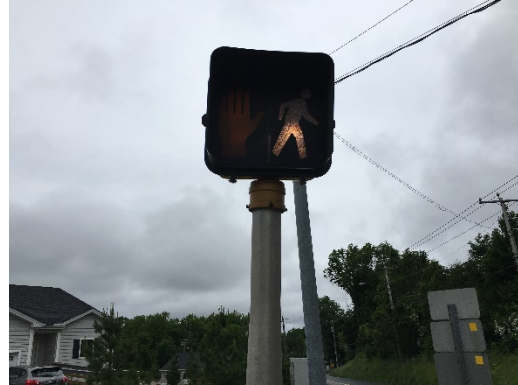
Figure 26: Pedestrian Beacon at Tryon Street and Saybrook Road

There are pedestrian features at the intersection of Saybrook Road and Tryon Street. The pedestrian bulbs are dimmed and the button is broken, (**Figure 26**) and there are no sidewalks to connect walkers along this route.

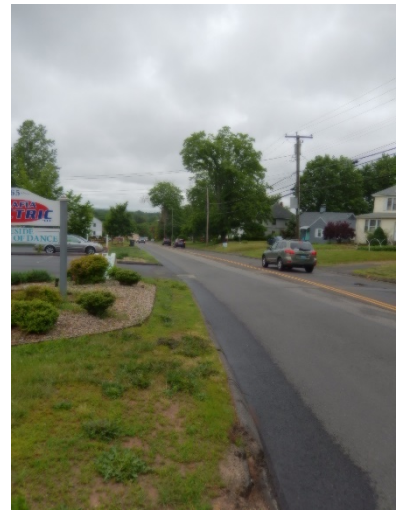
Figure 27: Saybrook Road

- All roadways within the immediate area of the school lack edge lines which can help with bicycle accommodations along potential bike routes, **Figure 27**.

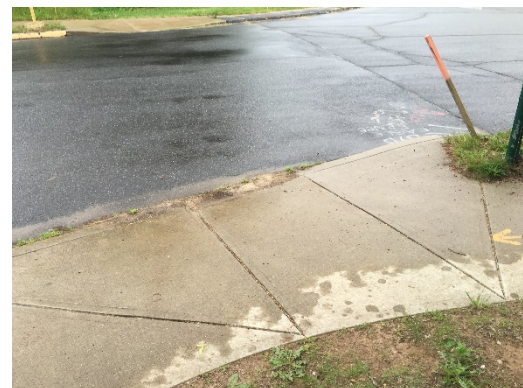
Figure 30: Current Non-ADA Compliant Ramp

- There are currently no crossing guards along any of the selected routes.
- Lack of ADA Compliant ramps on campus and along routes.
- The school has a low number of walkers or bikers.

- Consider installing a crosswalk at the intersection of Maynard Street and Hillside Avenue and Clew Drive.
- Update all ramps to comply with ADA Requirements, **Figure 30**.
- It is recommended that all signage around the school be updated to meet MUTCD current specifications, particularly with regards to size, reflectivity, and the fluorescent yellow-green color. There are currently no school zone signs in the vicinity of the campus.
