Introduction

As part of the Safe Routes to School non-infrastructure grant program administered by the Connecticut Department of Transportation, staff from Fitzgerald & Halliday, Inc. (FHI) coordinated with staff of Frank T. Wheeler Elementary School in Plainville, Connecticut and subsequently conducted a site audit of the school on May 3, 2011.

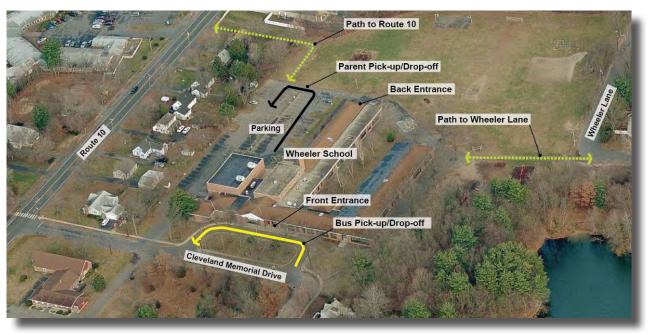
Figure 1: Existing Conditions.

During the site audit, both on and off campus activity was observed by the FHI team. Figure 1 illustrates the existing conditions around Wheeler School.

Parent drop-off occurs in a variety of locations on and off the school property. The first of these drop-off locations is in the school driveway / parking lot area on the west side of the school. Here, parents are encouraged to drive counterclockwise all the way around the parking spaces and drop off their children at the end closest to the rear playground. The students are supposed to congregate on the playground, which is supervised, until the 8:40 AM bell rings.

The third drop-off location is at the corner of Cleveland Memorial Drive and Trumbull Avenue. Here, parents were observed parallel parking on both sides of the roadway. Students exit their vehicles and cross two lanes of traffic, in addition to the cars pulling and and out of parking positions. In addition, a number of students were observed being dropped off earlier than the allowed 8:30 AM time, which is when staff begins supervising the grounds and students. There is no supervision in before or after school at this particular location and parents have been asked not to drop off at this location.

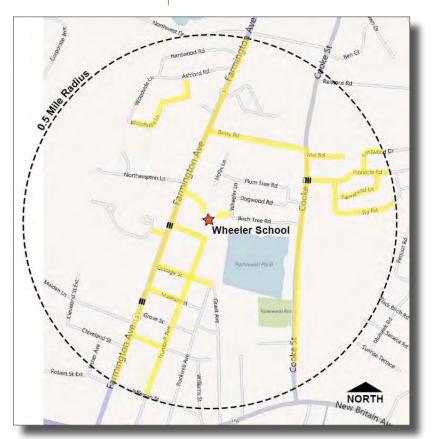
Figure 2: Pedestrian facilities within 0.5 mile radius of Wheeler School. Sidewalks and pathways are shown in yellow. Crosswalks are shown in black.

Wheeler School has a strong network of connections to surrounding neighborhoods. Trumbull Avenue has sidewalks extending greater than half a mile south from Wheeler School. Neighborhoods to the west are accessible via sidewalks on Route 10 and a crosswalk located at Cleveland Memorial Drive.

Additionally, a pathway extends from the southern limit of a sidewalk on the east side of Route 10 to Wheeler School's athletic field. A pathway also connects the school to Wheeler Lane and subsequently to Cooke Street and neighborhoods

both north and east of the school. Cooke Street has a sidewalk on the west side of the road from Betsy Road south past Paderewski Park, with a marked crosswalk to Pinnacle Road. Figure 2 highlights facilities within a 1/5 mile radius of the school, a feasible 15-minute walk for a student.
