Introduction

As part of the Safe Routes to School non-infrastructure grant program administered by the Connecticut Department of Transportation, staff from Fitzgerald & Halliday, Inc. (FHI) conducted a site audit of the school on March 11, 2010. Robertson School is an elementary school with about 440 students. School begins at 8:10 AM and dismissal occurs at 3:10 PM. The school principal, Mr. David Petrone, suggested that the FHI team observe dismissal as this is when there is the most congestion around the school.

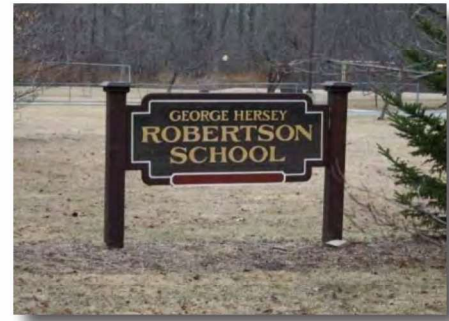
On and off campus activity was observed by the FHI team. On campus activity primarily involved issues related to pick-up/drop-off, while off campus activity was notable due to speeding on Cross Street and the use of a crosswalk on Cross Street directly in front of the school.

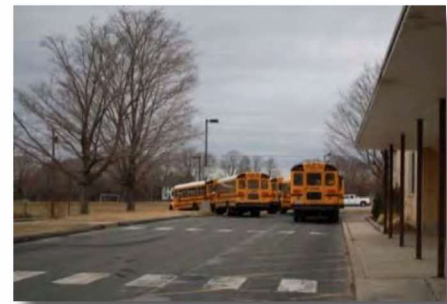
The largest percentage of students (over 80%) is transported to Robertson School by bus. These students come from various locations in Coventry and given the rural nature of the town, any student who requests busing will usually be accommodated. About 20 buses transport students in three distinctive waves. At dismissal, the principal calls the buses in each wave as they arrive. Students board those buses and all buses subsequently leave together. Buses are the only vehicles allowed to use the school's front driveway and circle at drop-off and pick-up time (see Figure 1). This reduces conflicts with other vehicles and allows buses to load and unload safely and efficiently.

Bus loading at front of school.

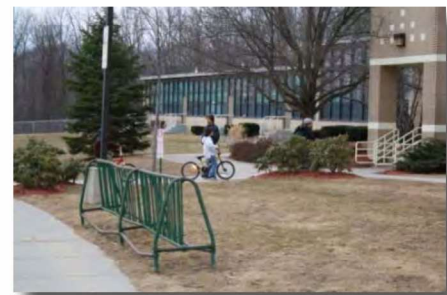
A bicycle rack is located in front of the school adjacent to this sidewalk. Both sidewalk and bicycle rack appeared adequate to support the number of users that exist.

Bicycle rack is located in front of school. While no bikes were on the rack, a cyclist is present.

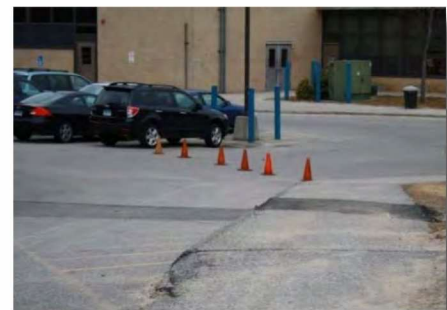
Parent drop-off/pick-up area at back of school.

up and drop off. They are instead directed to use the back parking lot and access the school through the doors by the gymnasium. Parents must enter school and sign their children out at dismissal time. Parents are not required to sign in children at the morning drop-off.

During arrival and dismissal, the school custodian places traffic cones in the parent pick-up/drop-off area. These cones are intended to prevent parents from parking in the area directly in front of the school's doors. This procedure has the inadvertent effect of blocking cars in and thus increases congestion, especially in the afternoon when parents must sign children out of school. To avoid this congestion, the school directs parents to a larger adjacent lot. During observation, a number of parents disregarded the traffic cones and double parked their vehicles directly outside the school doors. The cones were also observed to be run over and damaged by parents.

4. Develop an ongoing program to educate parents on the accepted drop-off and pick-up procedures detailing the safety issues created by violating these practices. This program could be promoted through various measures such as on-line announcements, emails, flyers, social media, and periodic campaigns such as posting personnel at school entrances for periodic enforcement/education.

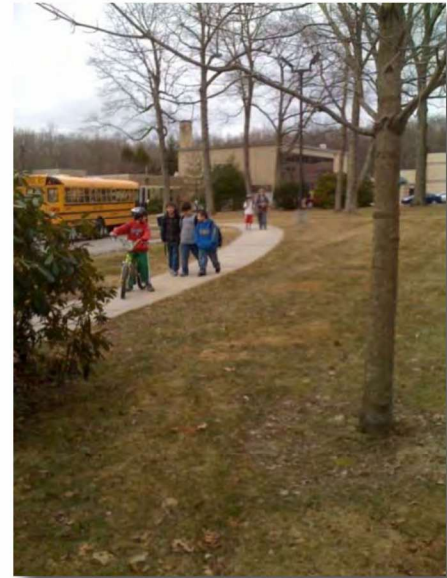
In addition to students travelling by bus, the front doors of the school are used by students who walk or bike to and from school. There were approximately 12 students that walked home from school during the observed dismissal. A concrete sidewalk leads from the school's front doors to the roadway at Cross Street.

Students walk and ride from school, down sidewalk, towards crosswalk.

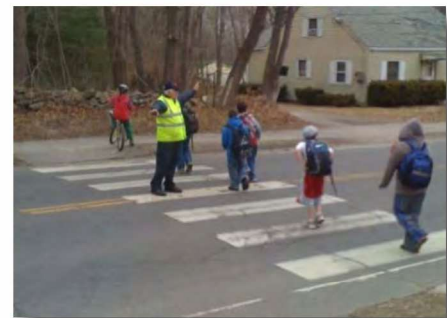
Crossing guard on Cross Street.

There is a marked crosswalk on Cross Street at the end of the school's sidewalk. The crosswalk lacks signage directly at its location. The crosswalk is also located in a shaded area thereby decreasing its afternoon visibility. A crossing guard stops traffic at this location for students arriving at and leaving school. While the speed limit on Cross Street is 25 miles per hour, actual speeds were observed to be higher. Speeding motorists were observed failing to stop for the crossing guard. The principal cited complaints from the crossing guard about cars almost hitting him.

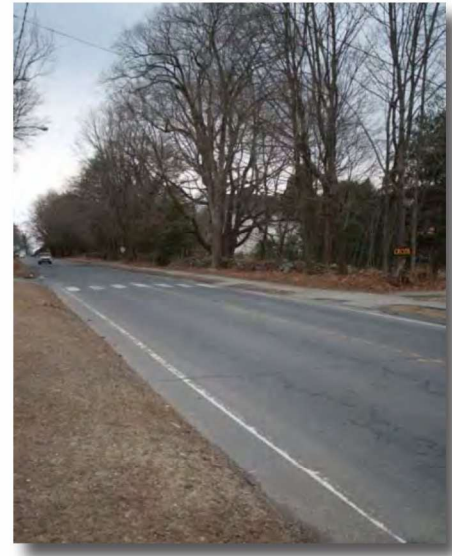
View of crosswalk on Cross Street. Crosswalk is hardly visible given lack of signage.

1. Improve/install additional school zone speed limit and crossing signage on Cross Street near the entrances and exits of the school driveway and school crosswalk. These signs should be large, bright (retro-reflective) school zone signs with speed limits of 20 miles per hour. In addition, "School" pavement marking should be repainted. These markings should be maintained and repainted regularly. Additional information can be found in the Manual on Uniform Traffic Control Devices (MUTCD, 2009 edition, http://mutcd.fhwa.dot.gov/pdfs/2009/pdf_index.htm). Part 7 of the manual provides guidance on a variety of traffic control signs for transition areas into schools.
2. The Town of Coventry should consider adopting a uniform signage system, similar to that suggested above. This system should be implemented at all school areas in town

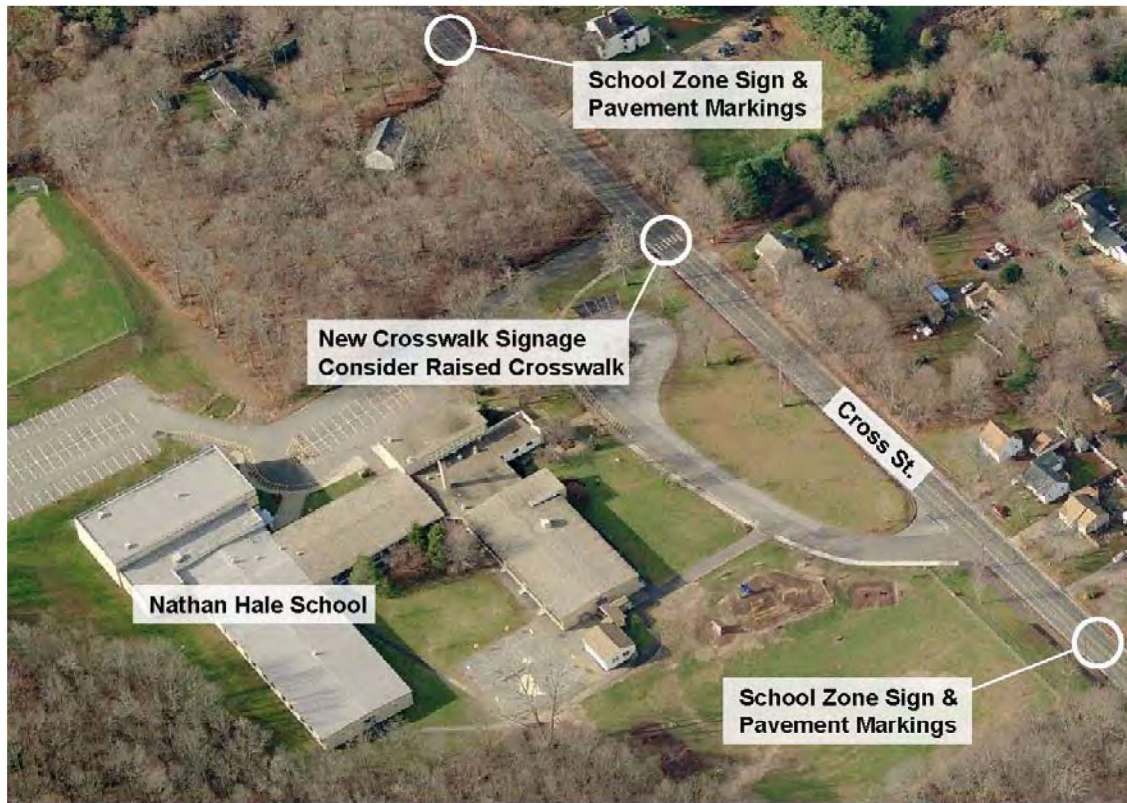
Figure 2: Proposed improvements include new crosswalk signage, new school zone signage and markings, and a potential raised crosswalk.

3. Investigate the installation of traffic calming features on Cross Street. Relatively low-cost techniques such as a raised crosswalk should be considered. It is recommended that the Town of Coventry consider conducting a full traffic calming study for this roadway. This study should involve the community in decision making related to the most appropriate and acceptable traffic calming measures. Resources for information on traffic calming can be found at the following websites: www.fhwa.dot.gov and www.ite.org.

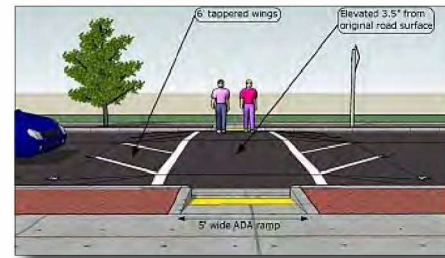
Sketch of a raised crosswalk. This device slows traffic and increases visibility of pedestrians on crosswalk.
