2015 Safe Route to School Walk Audit Findings Report

Washington Elementary School Waterbury, CT

Submitted By:
VN Engineers, Inc.
116 Washington Avenue
North Haven, CT 06473
Phone (203) 234-7862

November 2015

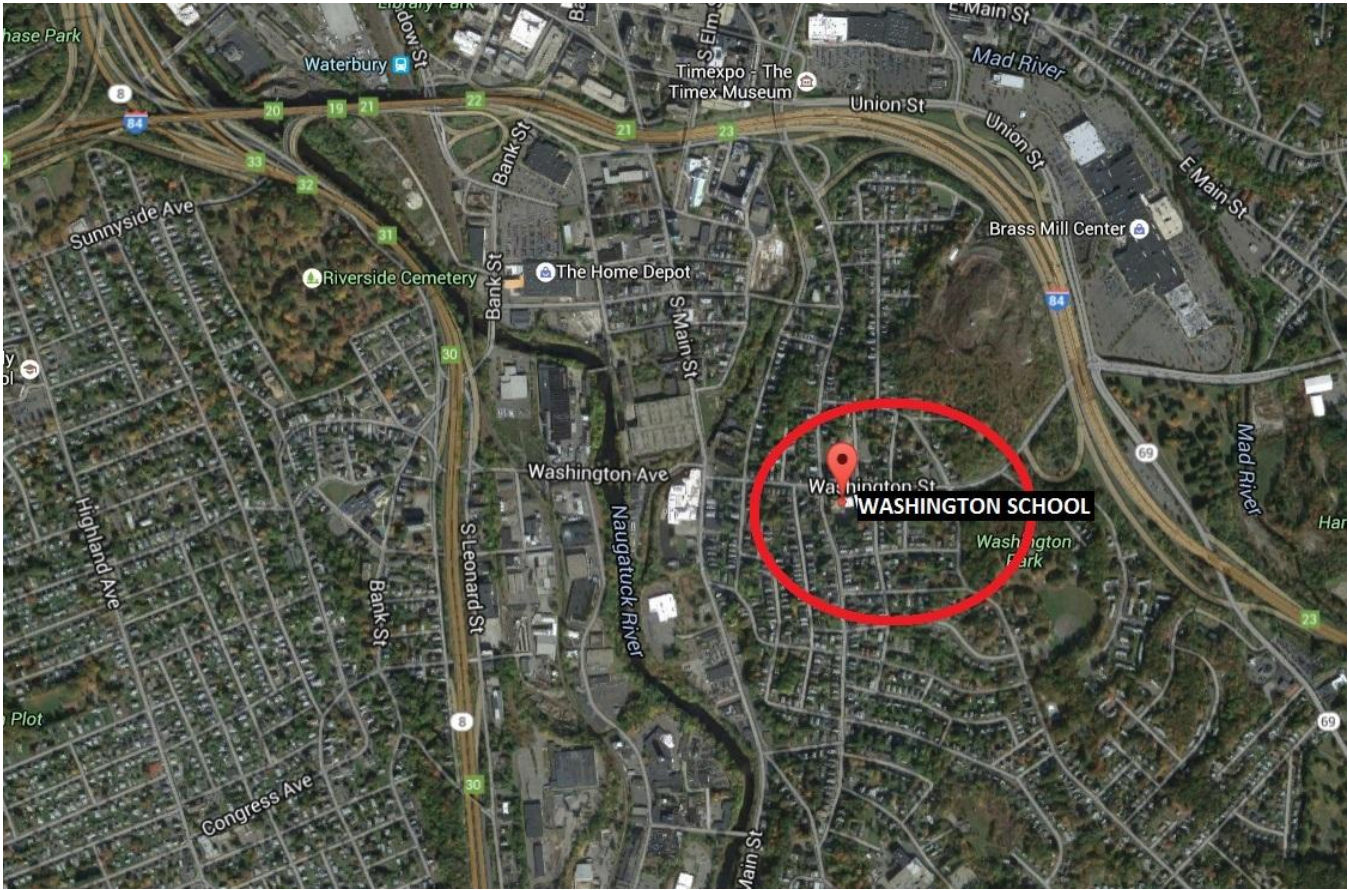
Figure 1: Washington Elementary School

Figure 1 shows an overview of the Washington Elementary School study area.

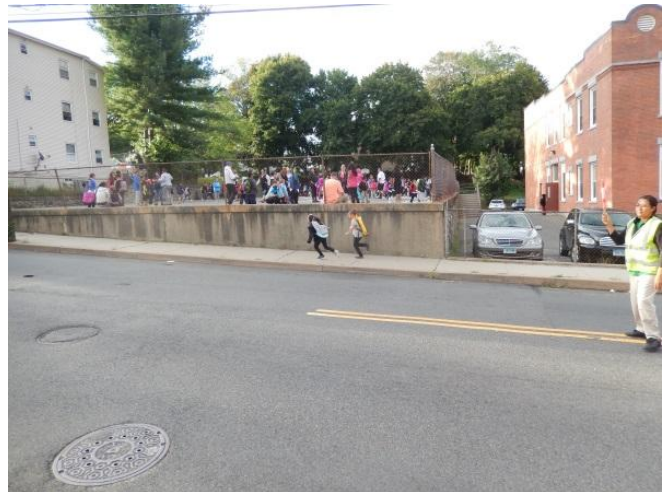
Figure 2: Student Drop-off Location at East Side Paved Playground

Most parents walk their children to the school's paved playground where students play before school day commences. Some parents drive their children to the school, parking mainly along Washington Street, Xavier Street and Fairmount Street east of the paved playground and a few parked on Baldwin Street. A total of 14 vehicles were observed parking on Washington Street to drop-off children, causing conflicts with vehicles passing through. Some parents were observed parking on the sidewalk and obstructing the ability to walk on the sidewalk as seen in **Figure 3**.

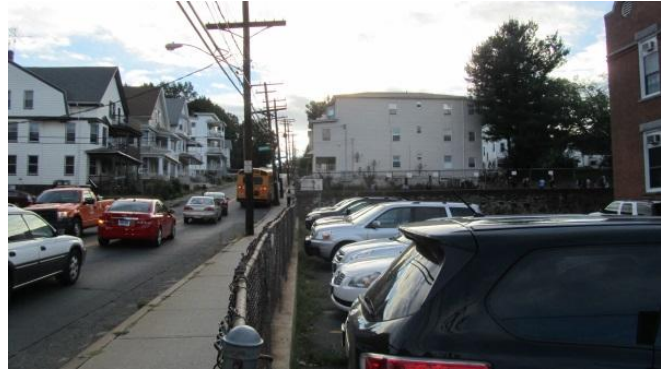
Figure 4: Vehicles driving around a stopped bus

During the morning drop-off, one full-sized bus and one mini-bus arrived in front of the paved playground on Washington Street. The traffic was not heavy during drop-off, but there are few locations for the bus to wait until students are allowed off the bus. This causes confusion for some drivers who then attempted to move around the bus as seen in **Figure 4**. In general, the bus drop-off process with buses lining up along Washington Street and waiting for the first bell to sound to let the students off the buses is fairly quick and functions rather well.

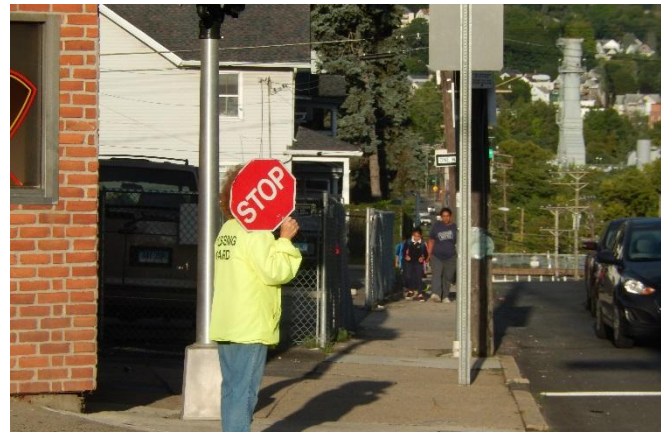
Figure 5: Crossing Guard holding STOP sign in upward position when not in use

During the arrival and dismissal, crossing guards were often seen holding the stop signs in an upward position when not in use (**Figure 5**). They were also observed stepping out into traffic before motorists were alert and at an appropriate speed to stop. Most children walking north towards the school on Baldwin Street squeezed between two fences at the corner of the school lot (**Figure 6**). A few parents followed the children between these two fences.

- Crossing guards should be trained by the City of Waterbury for their own safety and to safely cross students to school.
- SRTS has programs involving crime prevention that can make students and parents aware of troubled areas and techniques for walking and biking safely. The SRTS committee could contact the SRTS team to explore and implement some of these strategies.

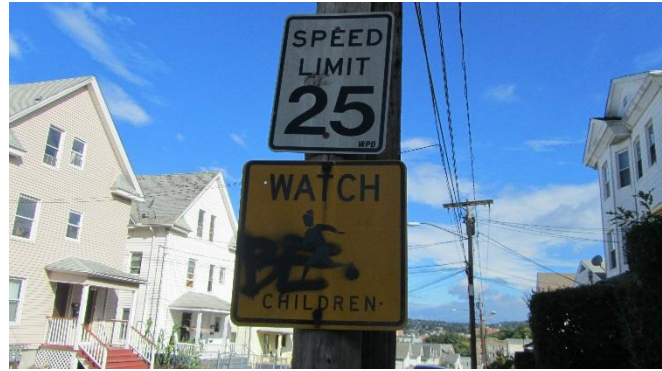
Figure 11: Speed Limit and Watch Children Sign on South Street

There are no posted speed limit signs in the eastbound direction along Washington Street in Pedestrian Zone # 1. There is a 25 mph sign on Lounsbury Street at Lounsbury Avenue and on South Street north of Rye Street with an outdated "WATCH CHILDREN" sign as seen in **Figure 11**. On Washington Street there are no school warning signs on the eastbound approach towards the school in this pedestrian zone. There are also a number of NO PARKING ANYTIME signs and a CRIME STOPPERS warning sign.

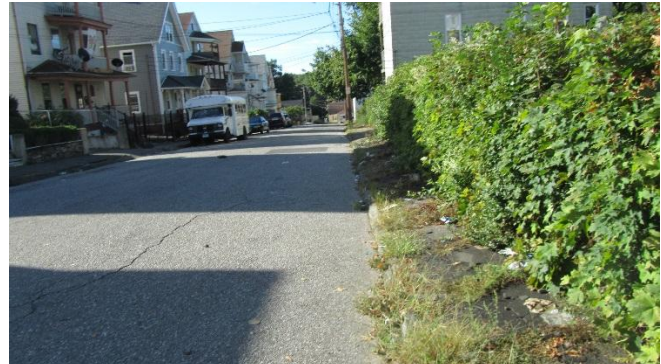
Figure 12: Deteriorated Sidewalk on South Street

With the exception of a portion of Madison Street at Southview Street, all streets within Pedestrian Zone #1 have sidewalks on both sides of the road. None of these sidewalks have grass buffers between the sidewalk and the roadway. Sidewalks in Pedestrian Zone #1 are typically 5-6 feet wide. The sidewalk pavement at all locations along potential walking and biking routes were in poor condition. Most were deteriorated, upheaved with vegetation overgrowth between the cracks. The sidewalk on the west side at South Street south of Lounsbury Street is completely deteriorated as seen in **Figure 12**. There are areas with utility poles obstructing the width of the walking path, and at some locations there were two utility poles side-by-side. There are also no ADA compliant handicap ramps with detectable warning strips within this pedestrian zone.

- Curbing on Baldwin Street (from Washington Street to Keefe Street).
- Replace sidewalk on both sides of the roadway with the most degradation such as (1) South Street; (2) Fairmount Street; and (3) Lounsbury Street on the south side and a portion of the north side between Baldwin Street and Fairmount Street.

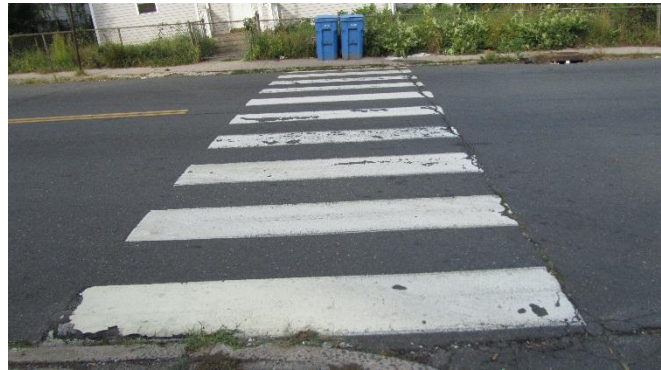
Figure 14: Mid-block Crosswalk at Keefe Street without handicap ramps

In general, the sidewalk pavement quality in Pedestrian Zone # 2 is in poor condition. Pavement markings along this route are comprised of stop bars and crosswalks with double yellow center lines on Baldwin Street. There are no edge lines along any roadways within this pedestrian zone. There are no designated “SCHOOL ZONE” pavement markings or “SCHOOL SLOW” pavement markings within this pedestrian zone. The intersection of Baldwin Street at Washington Street has recently been updated with newly installed pedestrian push buttons on all approaches.

None of these mid-block crosswalks had handicap ramps. Vehicles traveling along this road did not stop unless pedestrians were already in the street.

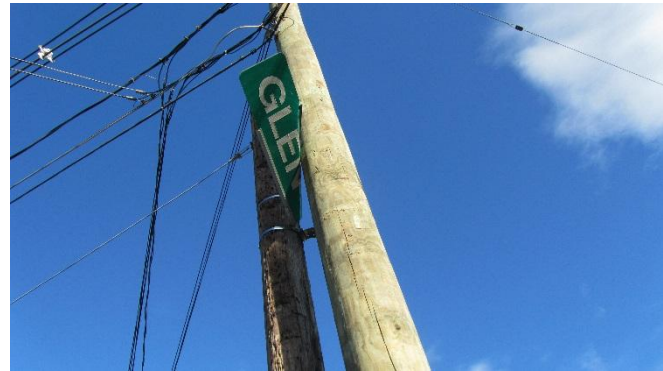
Figure 15: Glen Street Sign Bent between Two Poles

There are also a number of NO PARKING ANYTIME signs, NO PARKING FIRE LANE signs and NO PARKING SNOW ROUTE warning signs on Baldwin Street. Ideally, these signs prevent cars from parking in the vicinity of the school, which should positively impact the visibility and travel space for both walkers and bikers. There is a one way sign for the portion of Madison Street that is west of Baldwin Street. There is a bus route along Baldwin Street that has bus route stops at Glen Street, Rye Street and Washington Street for both approaches. The street name sign for Glen Street has been bent between two poles as seen in **Figure 15**. Along this route, there is a fire station at the intersection of Baldwin Street and Luke Street with a "SAFE PLACE" sign on the front of the building facing Baldwin Street.

- Install a new street sign for Glen Street that was bent between two poles, and reinstall the S1-1 sign on Xavier Street located between two utility poles onto one sign post.
- Install a bicycle rack within the school grounds.
- Restripe all crosswalks that are faded or missing within the immediate vicinity of the school, such as Washington Street at Xavier Street. There appears to have been an existing crosswalk before Washington Street was repaved.
- Trim vegetation along the west sidewalk of Fairmount Street within the school area; Madison Street along the north sidewalk; and Baldwin Street on the west sidewalk south of Laval Street to improve visibility of the posted 25 MPH sign.
- Remove unsafe wire that is hanging low over the sidewalk on South Street.

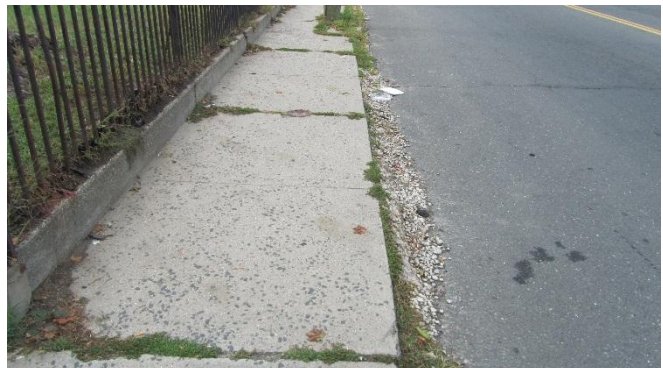
Figure 16: Completely deteriorated curb along Baldwin Street

There are sidewalks on both sides of the street throughout Pedestrian Zone # 2 with the exception of Madison Street east of Baldwin Street which has sidewalk only on the north side. There are no grass strips throughout this pedestrian zone, which typically serves as a buffer between traffic and pedestrians using the sidewalk. The sidewalks are typically 4-6 feet wide. Sidewalks in the immediate vicinity of the school on Baldwin Street are in fair condition, with the exception of the completely deteriorated curbing along the sidewalk in front of the school as seen in **Figure 16**. The remaining sidewalks

throughout this pedestrian zone are in poor condition; particularly the deteriorated sidewalks on the side streets between Baldwin Street and Fairmount Street.

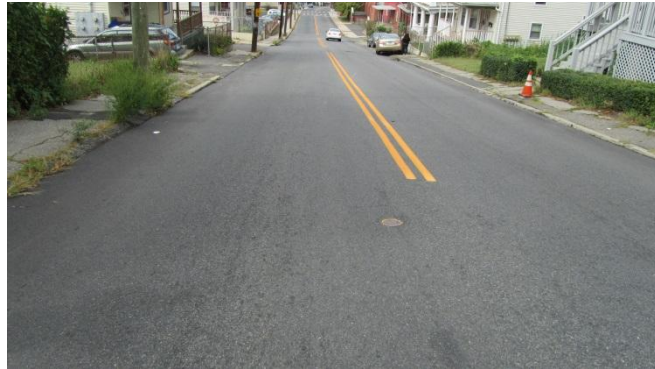
Figure 18: New Pavement Markings Along Washington Street

Pavement markings along this route are comprised of stop bars, crosswalks and double yellow center lines on Washington Street. Double yellow center line pavement markings along Washington Street are fairly new as seen in **Figure 18**. There are no edge lines along any roadways within this pedestrian zone. There are few crosswalks in this pedestrian zone. They are limited to Xavier Street and the intersection of Fairmount Street and Luke Street. The crosswalk on Xavier Street was paved over and not repainted as seen in **Figure 19**. The crosswalk pavement markings on the east and west leg of Fairmount Street and Lounsbury Street were recently painted. There are no designated “SCHOOL ZONE” pavement markings or “SCHOOL SLOW” pavement markings within this pedestrian zone.

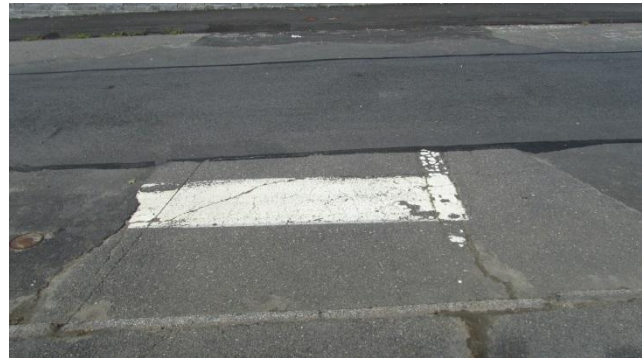
Figure 19: Crosswalk Paved Over on Xavier Street

Location	Leg of Approach(es)	Issue	Quantity
Xavier Street	Mid-Block	Crosswalk painted over school crossing sign blocked by pole Crosswalk missing at Washington St	3
Xavier Street/ Washington Street	W	No mid-block crosswalk across busy street where crossing guard is stationed	1
Fairmount Street/ Washington Street	S	No detectable warning strips on handicap ramps No crosswalk along major route	1
Fairmount Street	Mid-Block	Low hanging vegetation	1
Madison Street	Mid-Block	Overgrown hedges onto sidewalk	1
TOTALS			7

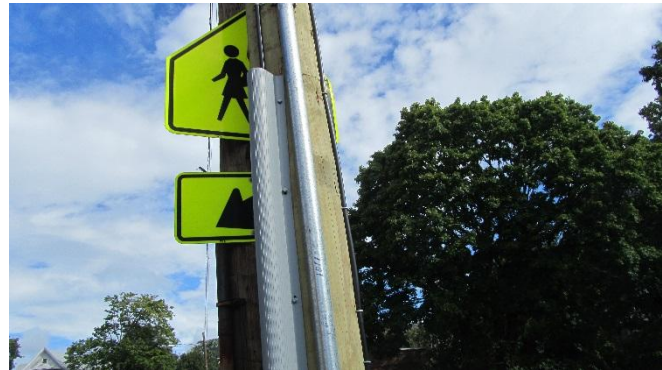
Figure 20: School Crossing sign hidden behind pole

The posted speed limit for Washington Street in the immediate area of the school within Pedestrian Zone # 3 is 25 mph. There is a REDUCE 25 MPH SPEED sign for the westbound direction on Washington Street west of Merry Street. East of Xavier Street is a SCHOOL CROSSING sign; this sign is missing an AHEAD sub-plate. On Xavier Street there is a one way sign for the northbound direction at the intersection of Washington Street. Further north of this intersection is a SCHOOL CROSSING sign. This sign is missing an AHEAD sub-plate and it is no longer perpendicular to the ground; it is angled towards the street. Directly behind the St. Francis Xavier School main building on Xavier Street is another SCHOOL CROSSING sign with a downward arrow sub-plate. This sign is obscured by a utility pole that was installed directly in front of the sign as seen in **Figure 20**. These two SCHOOL CROSSING assemblies are new MUTCD specified yellow-green fluorescent. There are also crime alert signs such as the one at the intersection of Fairmount Street and Lounsbury Street where there is a NEIGHBORHOOD WATCH sign on the pole at the northwest corner.

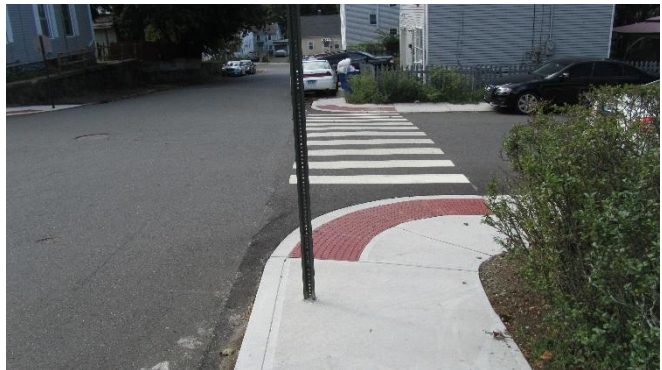
Figure 21: New Handicap Ramps at Lounsbury Street/ Fairmount Street

Most of the handicap ramps in this zone are either deteriorated or have raised curb in place of a ramp. There are two handicap ramps with no detectable warning strips at the intersection Washington Street and Fairmount Street. There is also a newly installed handicap ramp at all corners on Fairmount Street and Lounsbury Street as seen in **Figure 21**.

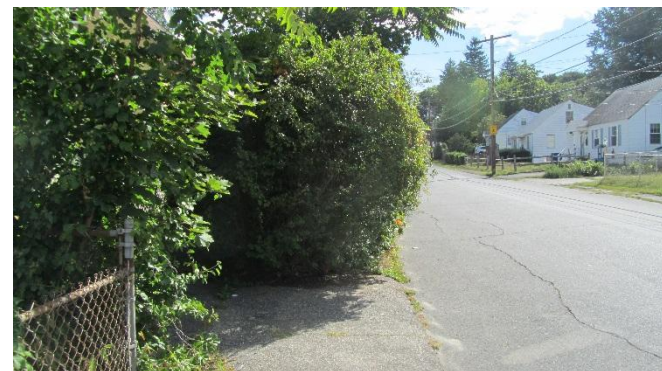
Figure 22: Overgrown Hedges on Madison Street

There are not as many obstructions on the sidewalk in this zone caused by residents. There is a section of vegetation on Madison Street that is blocking the sidewalk as seen in **Figure 22**.

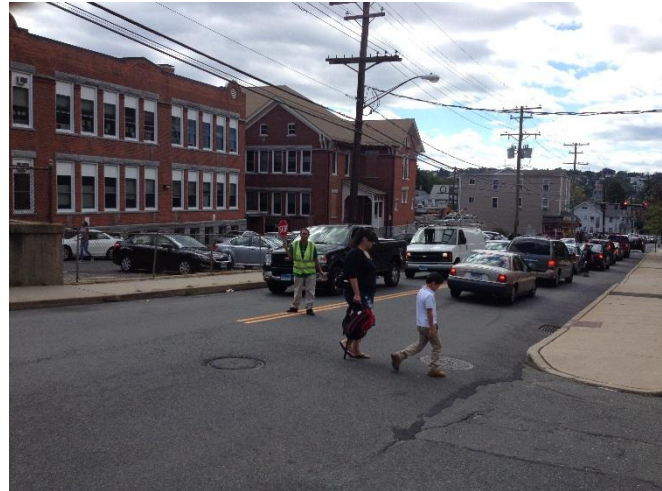
Figure 23: Crossing Guard with Appropriate Gear

- Crossing guards were stationed at high density traffic areas and walking routes. These crossing guards wore proper safety vests and used handheld stop signs (**Figure 23**).

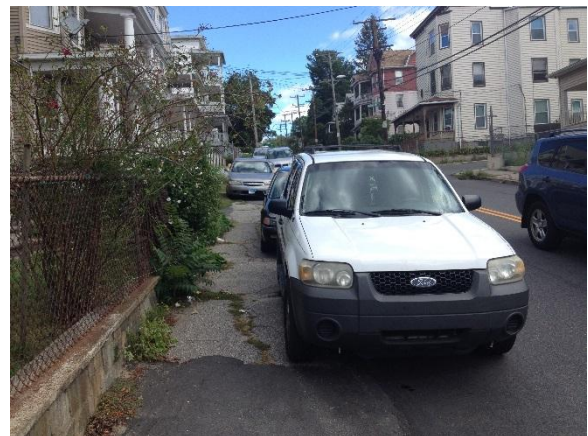
Figure 24: Residents and Parents Parking on Sidewalk within School Area

- The majority of the sidewalks and curbing within all of the pedestrian zones are deteriorated.
- Residents and parents were parked on the Washington Street sidewalk during drop-off, making it difficult for walkers to use the sidewalks (**Figure 24**).
- There are five mid-block crosswalks along Baldwin Street as noted previously in **Table 3**, all of which do not have crosswalk signs to alert the drivers where pedestrians may be crossing.

- Attend a Driver and Passenger Educational program to clarify drop-off/ pick-up procedures to new parents at the beginning of the school year, taking into account the arrival of the buses during drop-off. This will reduce issues with parents parking on sidewalks along Washington Street or in no parking areas.

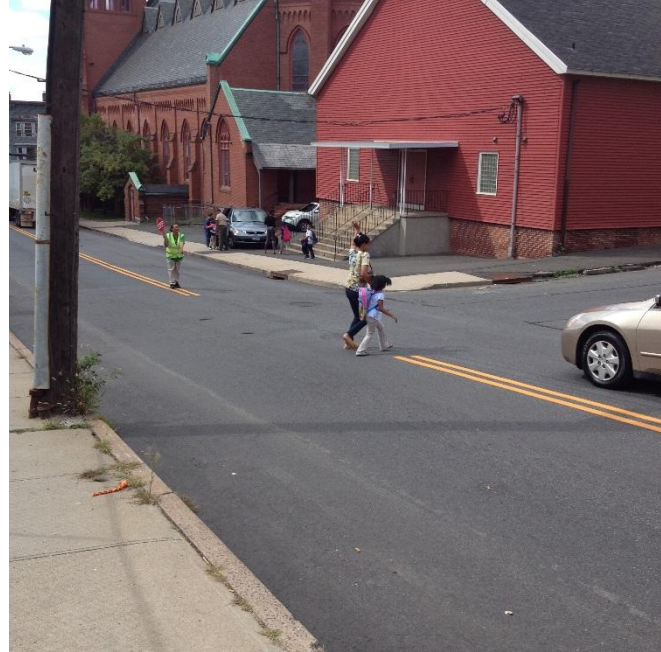
Figure 25: Crossing Guard Crossing Pedestrians Over Long Distances

- Crossing guards were seen entering traffic not at the optimally safest point in time, and parents and students were seen crossing at long distances away from the crossing guard as seen in **Figure 25**.
