**Enhancements to ConnDOT's
Pavement Friction Testing Program**

Research Project: SPR-2243

Final Report

Report No. CT-2243-F-10-4

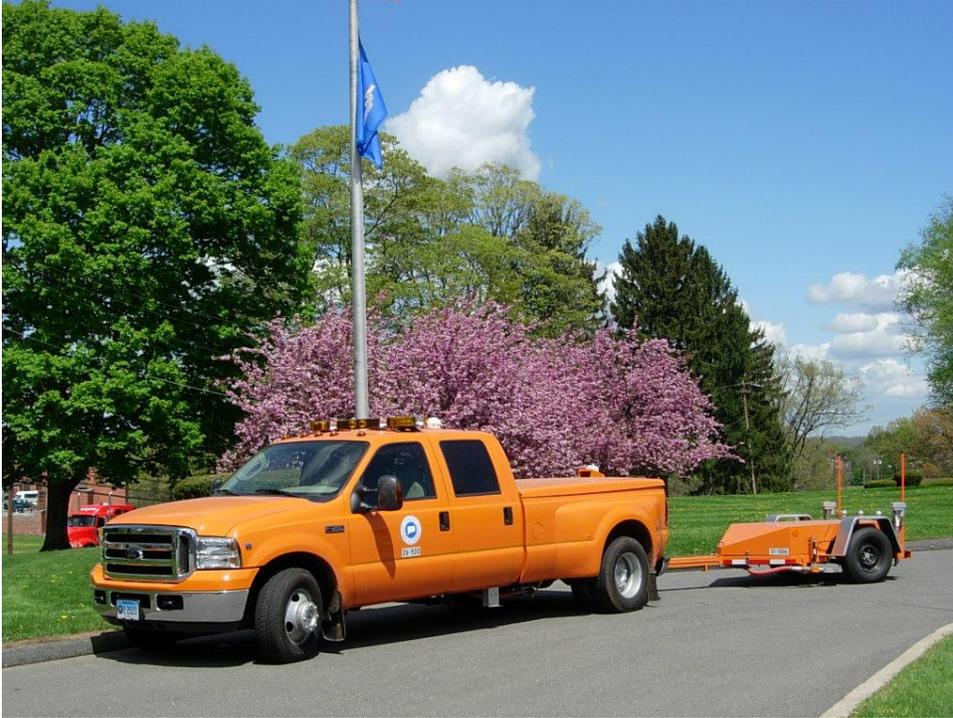
FIGURE 1 Dynatest 1295 Pavement Friction Tester.

The project started on September 1, 2004, and a new Dynatest 1295 Pavement Friction Tester (Figure 1) was purchased in 2005. It is capable of performing dry or self-wetted locked wheel and peak incipient testing between 20 and 70 mph, while computing the dynamic friction number (4). It uses an on-board computer to calculate this number from one or two Model 1270 two-axis force transducer(s) mounted to the trailer's axle assembly.

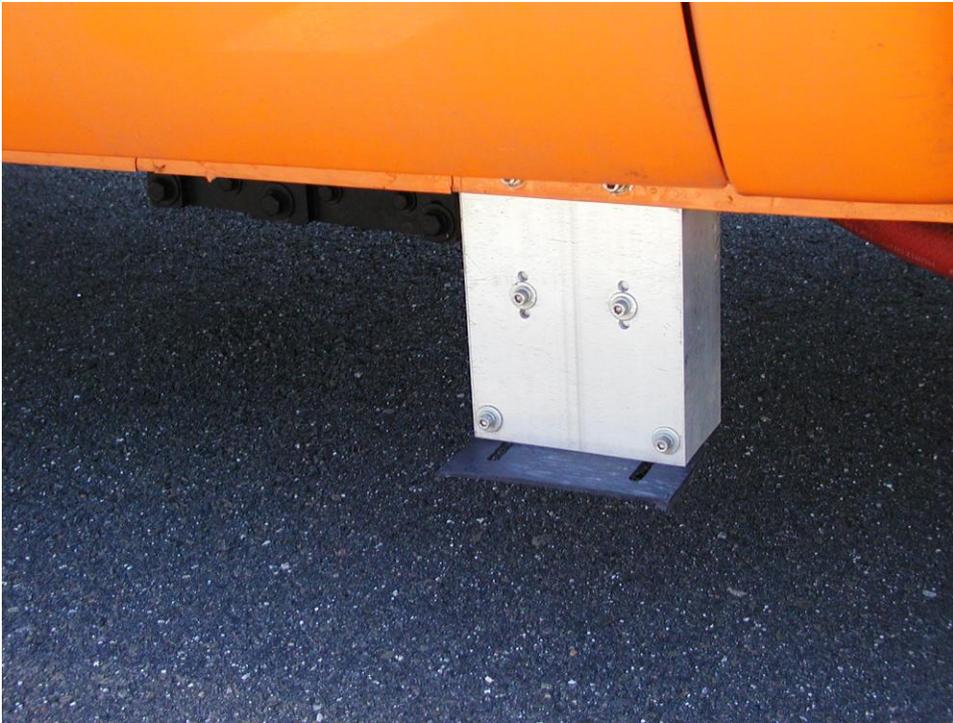
FIGURE 2 Housing for High-Speed Selcom Optocator/SLS5000 Laser Sensor.

Upgrades from the previous tester include the addition of a High-Speed Selcom Optocator/SLS5000 Laser Sensor (Figure 2) for measuring pavement texture at high speeds (high-speed laser), and a Trimble Model AgGPS 33300-00 global positioning system (GPS) for tracking coordinates (longitude and latitude) (Figure 3).

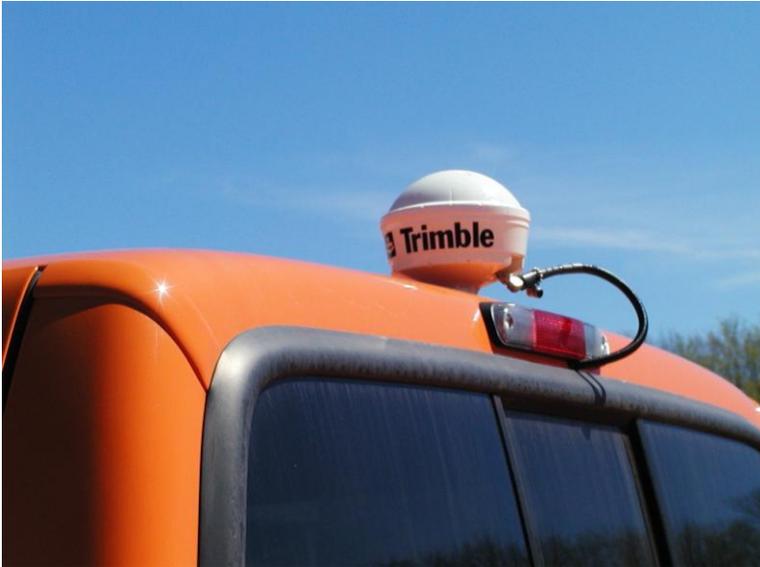
FIGURE 3 Trimble Model AgGPS 33300-00 Global Positioning System.

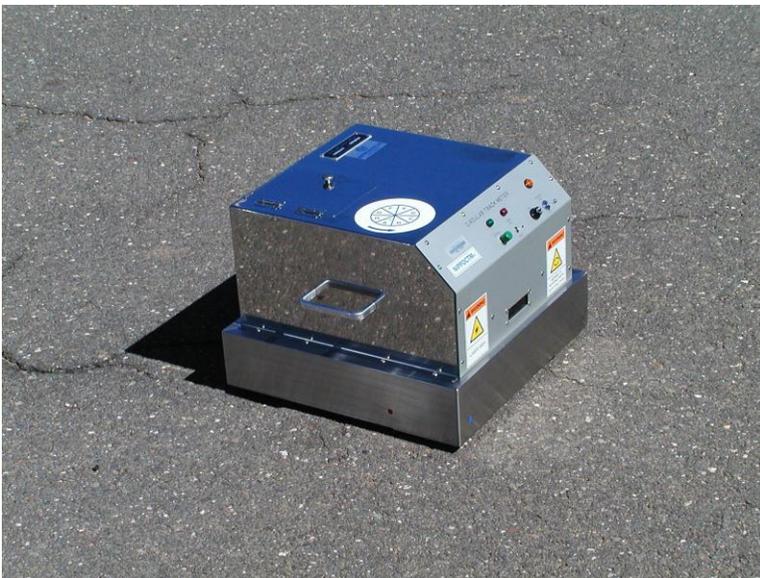
FIGURE 4 Nippo Sangyo Co., Ltd. Circular Track Meter purchased in 2006.

For comparison to the aforementioned laser profiler, a Nippo Sangyo Co., Ltd. Circular Texture Meter (CTMeter) (Figure 4) was purchased in 2006. Pavement macrotexture profiles were measured with the CTMeter in accordance with ASTM Standard E 2157. The purpose of comparison was to determine if the high-speed laser profiler macrotexture measurements correlated well with the CTMeter measurements obtained in accordance with the above ASTM test method, and whether or not the high-speed laser profiler could provide viable results.

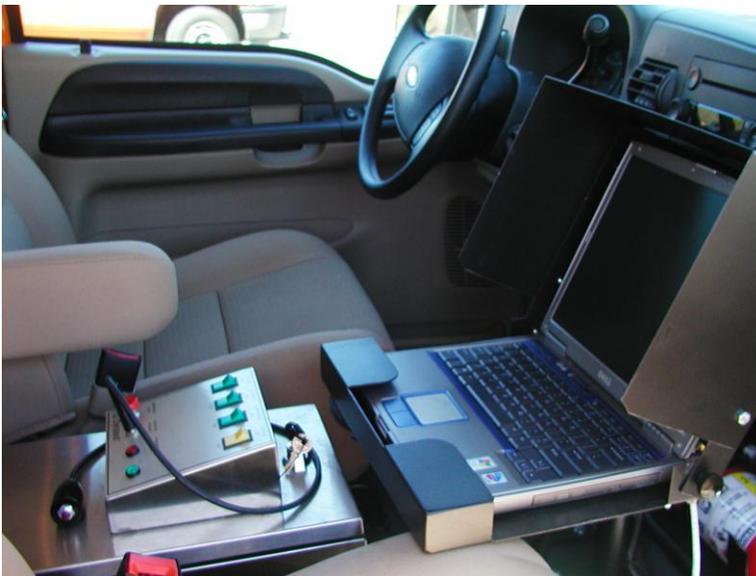
FIGURE 5 Inside the cab of the Dynatest 1295 Pavement Friction Tester purchased in 2005.

Additional components include a computer and electronics (Figure 5), a 300-gallon water tank, and an Ohio State University water nozzle (Figure 6).
