COMMUNITY
connectivity program

Deming Road – Road Safety Audit

July 6, 2016

AECOM

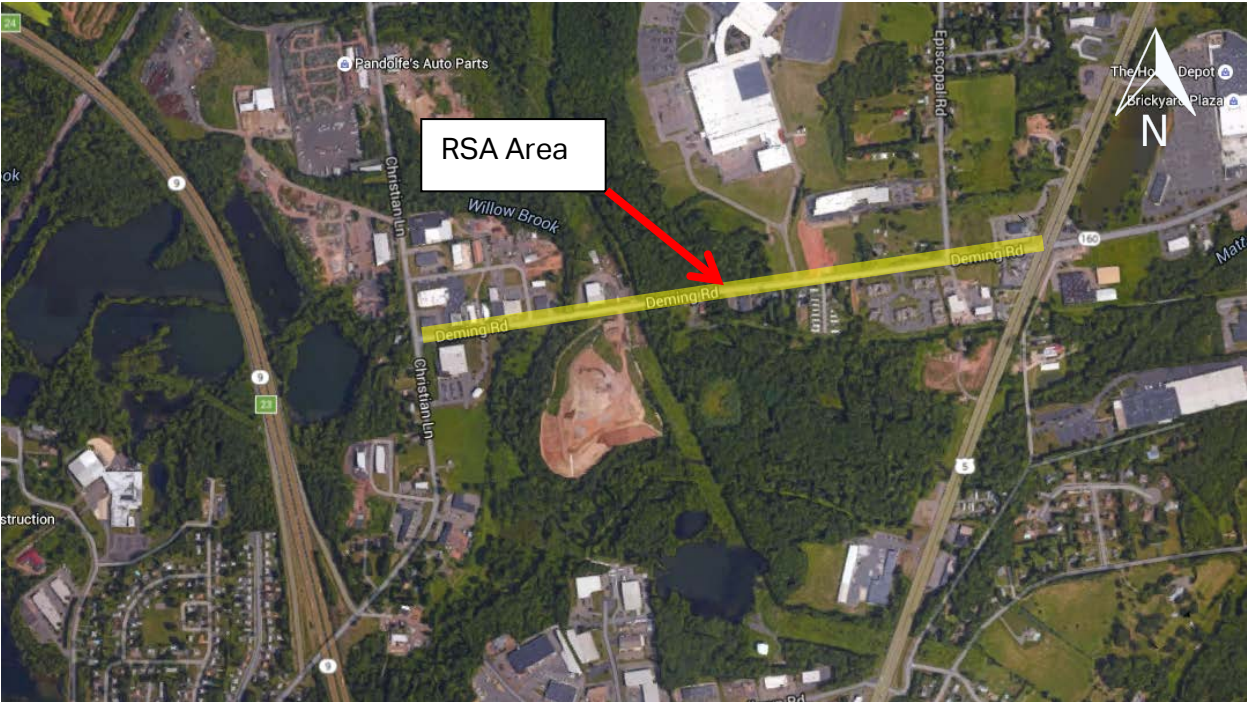
Figure 1. Deming Road Berlin

The site is the section of Deming Road between the Berlin Turnpike and Christian Lane in the Town of Berlin (Figure 1.). Deming Road Average Daily Traffic (ADT) is 13,500 vehicles per day (vpd). The ADT on Christian Lane just north of the intersection with Deming Road is 6,800 vpd, just south it is south is 16,000 vpd. This indicates that many vehicles are turning onto Christian Lane northerly from Deming Road. These are significant volumes of traffic for a local road to process.

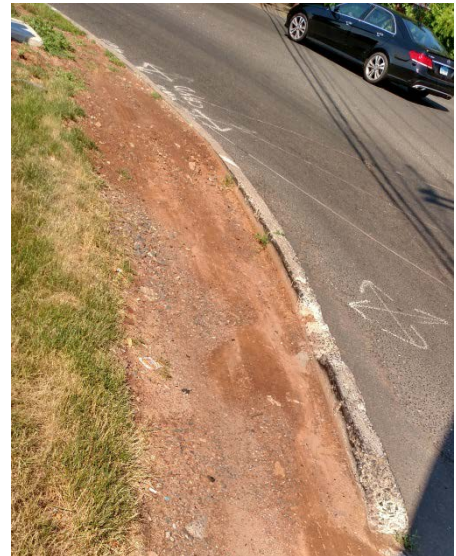
Figure 5. Tire Track Marks Going Over the Curb

- Utility poles are on the south side of Deming Road and are close to the curb.
- Large vehicles are cutting the curb to turn right onto Deming Road from Christian Lane (Figure 5).

8. Trucks have difficulty turning to and from Christian lane. The curb radii are small and the stop bars are too far forward. Any redesign would require relocating utility poles.

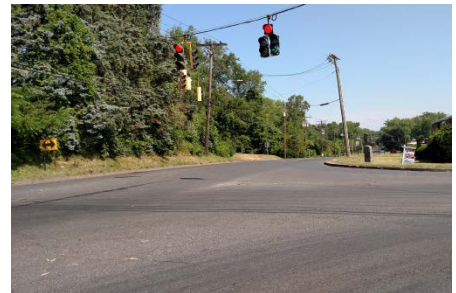
Figure 6. Lack of Pedestrian Amenities

- There are no pedestrian amenities (sidewalk, crosswalk, signal phase) at this intersection (Figure 6).
- There is significant truck traffic turning right onto Christian Lane from Deming Road. The radius of the curb at this location is small and many trucks stop ahead of the stop bar to make the turn.

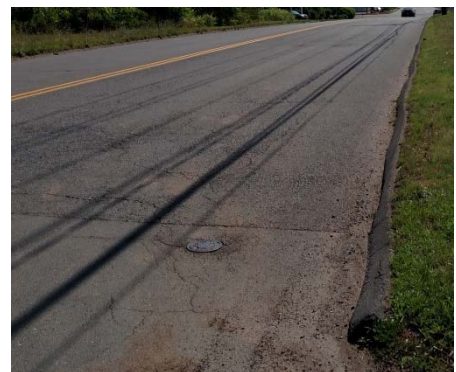
Figure 7. No Shoulder Lines

- There are no shoulder lines on either Deming Road or Christian Lane (Figure 7).
- There is a dedicated left turn lane.
- Long term, the town envisions this area as all industrial.

1. Paint shoulder lines on Deming Road (Figure 14).
2. Trim back the bushes blocking the sight line on Episcopal Road.
3. Examine town right-of-way at Episcopal Road.

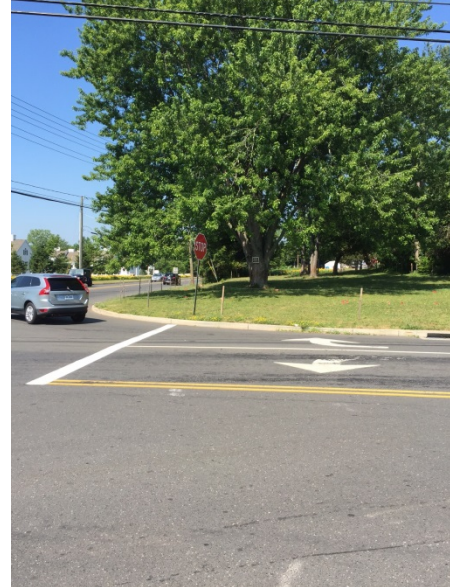
Figure 8. Intersection with Episcopal Road

- The driveway opposing Episcopal Road is being relocated east of the fire hydrant by the property owner as part of an expansion project.
- Episcopal Road is 41 feet wide. Each turn lane is 12 feet wide, and the northbound lane is 15 feet wide with a 2 foot shoulder. It is a stop controlled (Figure 8).

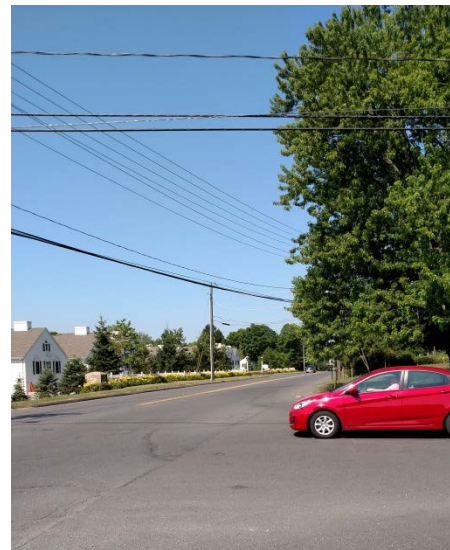
Figure 9. Vehicle Pulls Past Stop bar to Gain Sight Distance

- There are shoulder lines on Episcopal Road
- Sight lines in both directions at the stop sign on Episcopal Road are poor. Vehicles turning in both directions must pull completely past the stop bar to see. The visibility is poor due to the grade in the road and overgrown vegetation west of the intersection (Figure 9).

4. Work with the property owner at Episcopal Road to relocate the fence.
5. Raise signage to meet the current minimum of 5 feet.
6. Clear vegetation blocking all signage.

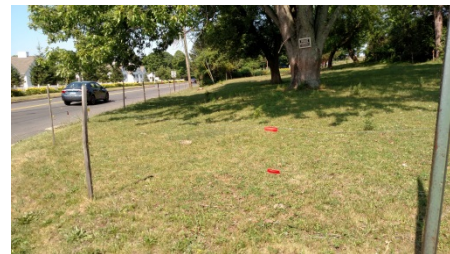
Figure 10. Fence Possibly in Town Right-of-way

- Episcopal Road has a posted speed limit of 30 MPH.
- Deming Road is 40 feet wide, with the westbound and eastbound lanes at 20 feet in width.
- The fence on the corner property (on the north-west corner) is close to the curb and may be within the town's right-of-way (Figure 10).

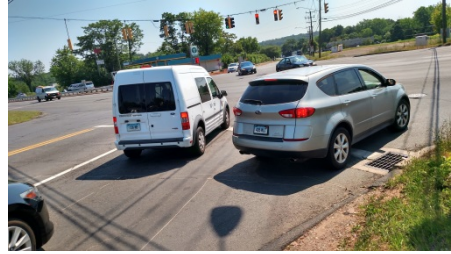
Figure 11. Vehicle Creates Own Right Turn Lane

- There is a left and a right/through turn lane on Deming Road. Each turn lane is 10.5 feet wide. The westbound lane is 26 feet wide (Figure 11).
- There are no crosswalks. There is a pedestrian “push for green” button to call up the side street (Deming Road) phase so that pedestrians can cross the Berlin Turnpike. There are no pedestrian signal heads (Figure 12).
- Would it be feasible to restripe Deming road to accommodate a dedicated right turn lane?
- Route information signs did not meet the minimum height requirement of 5 feet per the MUTCD and vegetation completely blocked the lowest sign (Figure 13).

12. Restripe to add a third lane at the Deming Road and Berlin Turnpike intersection to create a dedicated left, through and right turn lanes.
13. Add a left turn lane on Deming Road for Episcopal Road.

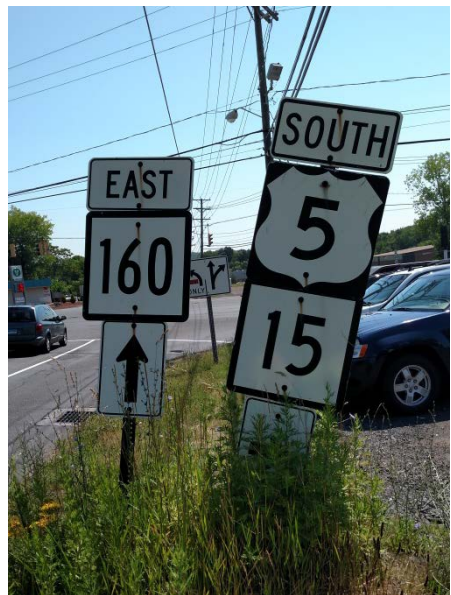
Figure 13. Signs Blocked by Overgrown Vegetation

4. Roadway signage is too close to the ground and blocked by vegetation.
5. Traffic speeds along Deming Road are a concern. If traffic data is collected it would provide information such as the 85th percentile.
