Re: Petition No. 1354 – Chatfield Solar Fund, LLC, petition for a declaratory ruling, pursuant to Connecticut General Statutes §4-176 and §16-50k, for the proposed construction, maintenance and operation of a 1.98-megawatt AC solar photovoltaic electric generating facility located in Killingworth, Connecticut

As mentioned during the hearing on March 26, 2019, Chatfield Solar Fund is submitting Petitioner's Exhibit 15 which is an excerpt from a 2015 German study entitled "Assessing Fire Risks in Photovoltaic Systems and Developing Safety Concepts for Risk Minimization", which discusses certain photovoltaic system fire statistics in connection with Germany's 1.3 million solar installations. This study was translated by the U.S. Department of Energy in 2018. The original and fifteen (15) copies are enclosed.

Assessing Fire Risks in Photovoltaic Systems and Developing Safety Concepts for Risk Minimization

3.3 Damage and fire event analysis of PV systems

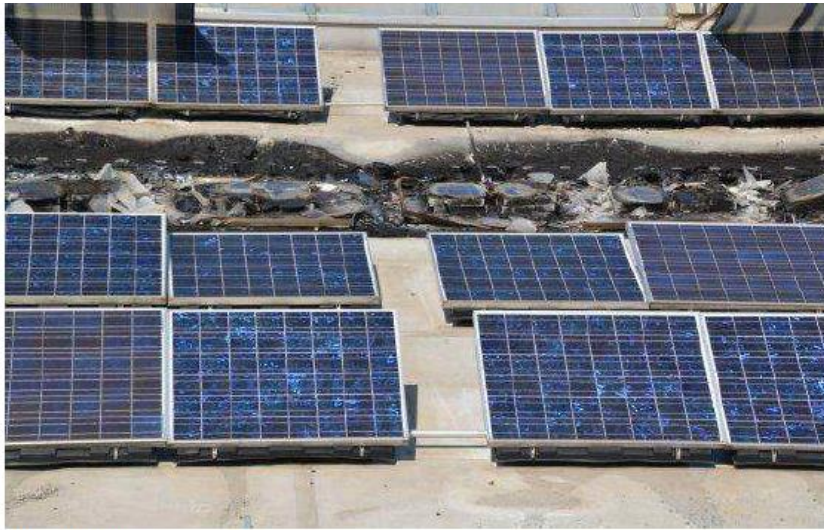
Figure 3-8: Incinerated PV modules on a flat roof, substructure here with plastic trays(!)

In June 2014 PV modules in the system in question caught fire on a flat roof owing to a technical defect, resulting in property damage amounting to several thousand euros. Firefighters were able to promptly extinguish the fire, without it spreading to the building. As can be seen on the photo, the elevation was provided by plastic trays. These plastic trays are generally *normally flammable* (class E as per EN13501-.1). When selecting installation materials, especially for roof-mounted systems, attention must be given to the significant **potential for ignition and propagation of fire** if plastic is to be used.

1. Fire incident in Walldorf: fire in a photovoltaic system on a warehouse roof

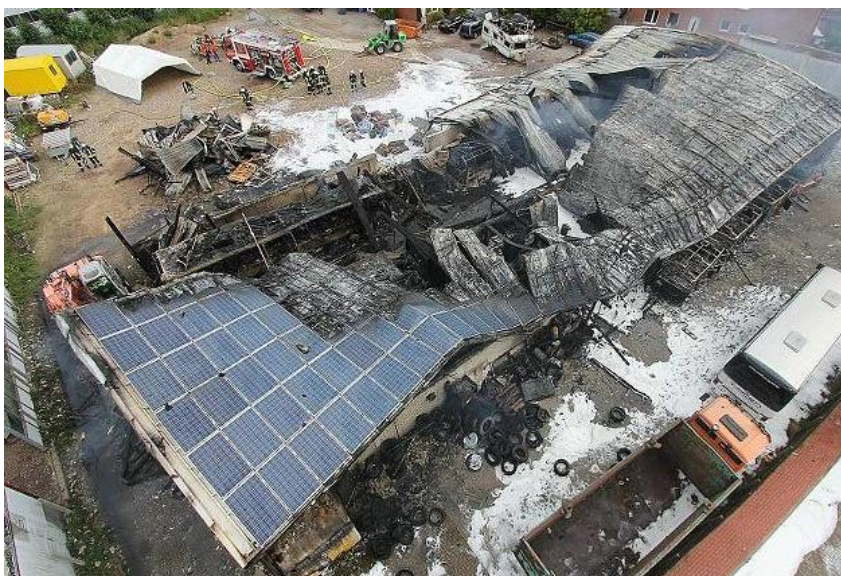
2. Fire incident on Norderney: In August 2013, a fire started here in a workshop with adjoining vehicle depot. The fire spread rapidly, the roof structure and entire PV system collapsed, and the damage amounted to several million euros.

Figure 3-9: After a fire in a workshop with warehouse and depot (photo: Norderney Fire Department)

These examples demonstrate the scenarios basically to be distinguished among fire incidents at buildings with PV installations: on the one hand, the origin of the fire lying in the PV system itself, and on the other hand the “collateral fire” at a PV system caused by an external source (in this case, a building fire).
