Re: Petition No. 1150-SolarCity Corporation Petition for a Declaratory Ruling that no Certificate of Environmental Compatibility and Public Need is Required for the Proposed Construction and Operation of a 3.1 Megawatt Community-Shared Solar Photovoltaic Electric Generating Facility Located on Brush Hill Road in Bozrah, Connecticut

RESPONSE TO CONNECTICUT SITING COUNCIL STAFF QUESTIONS

SUPPLEMENTAL WETLAND INVESTIGATION

**Re: Proposed 3.1 Megawatt Solar Facility
80 Brush Hill Road
Bozrah, Connecticut**

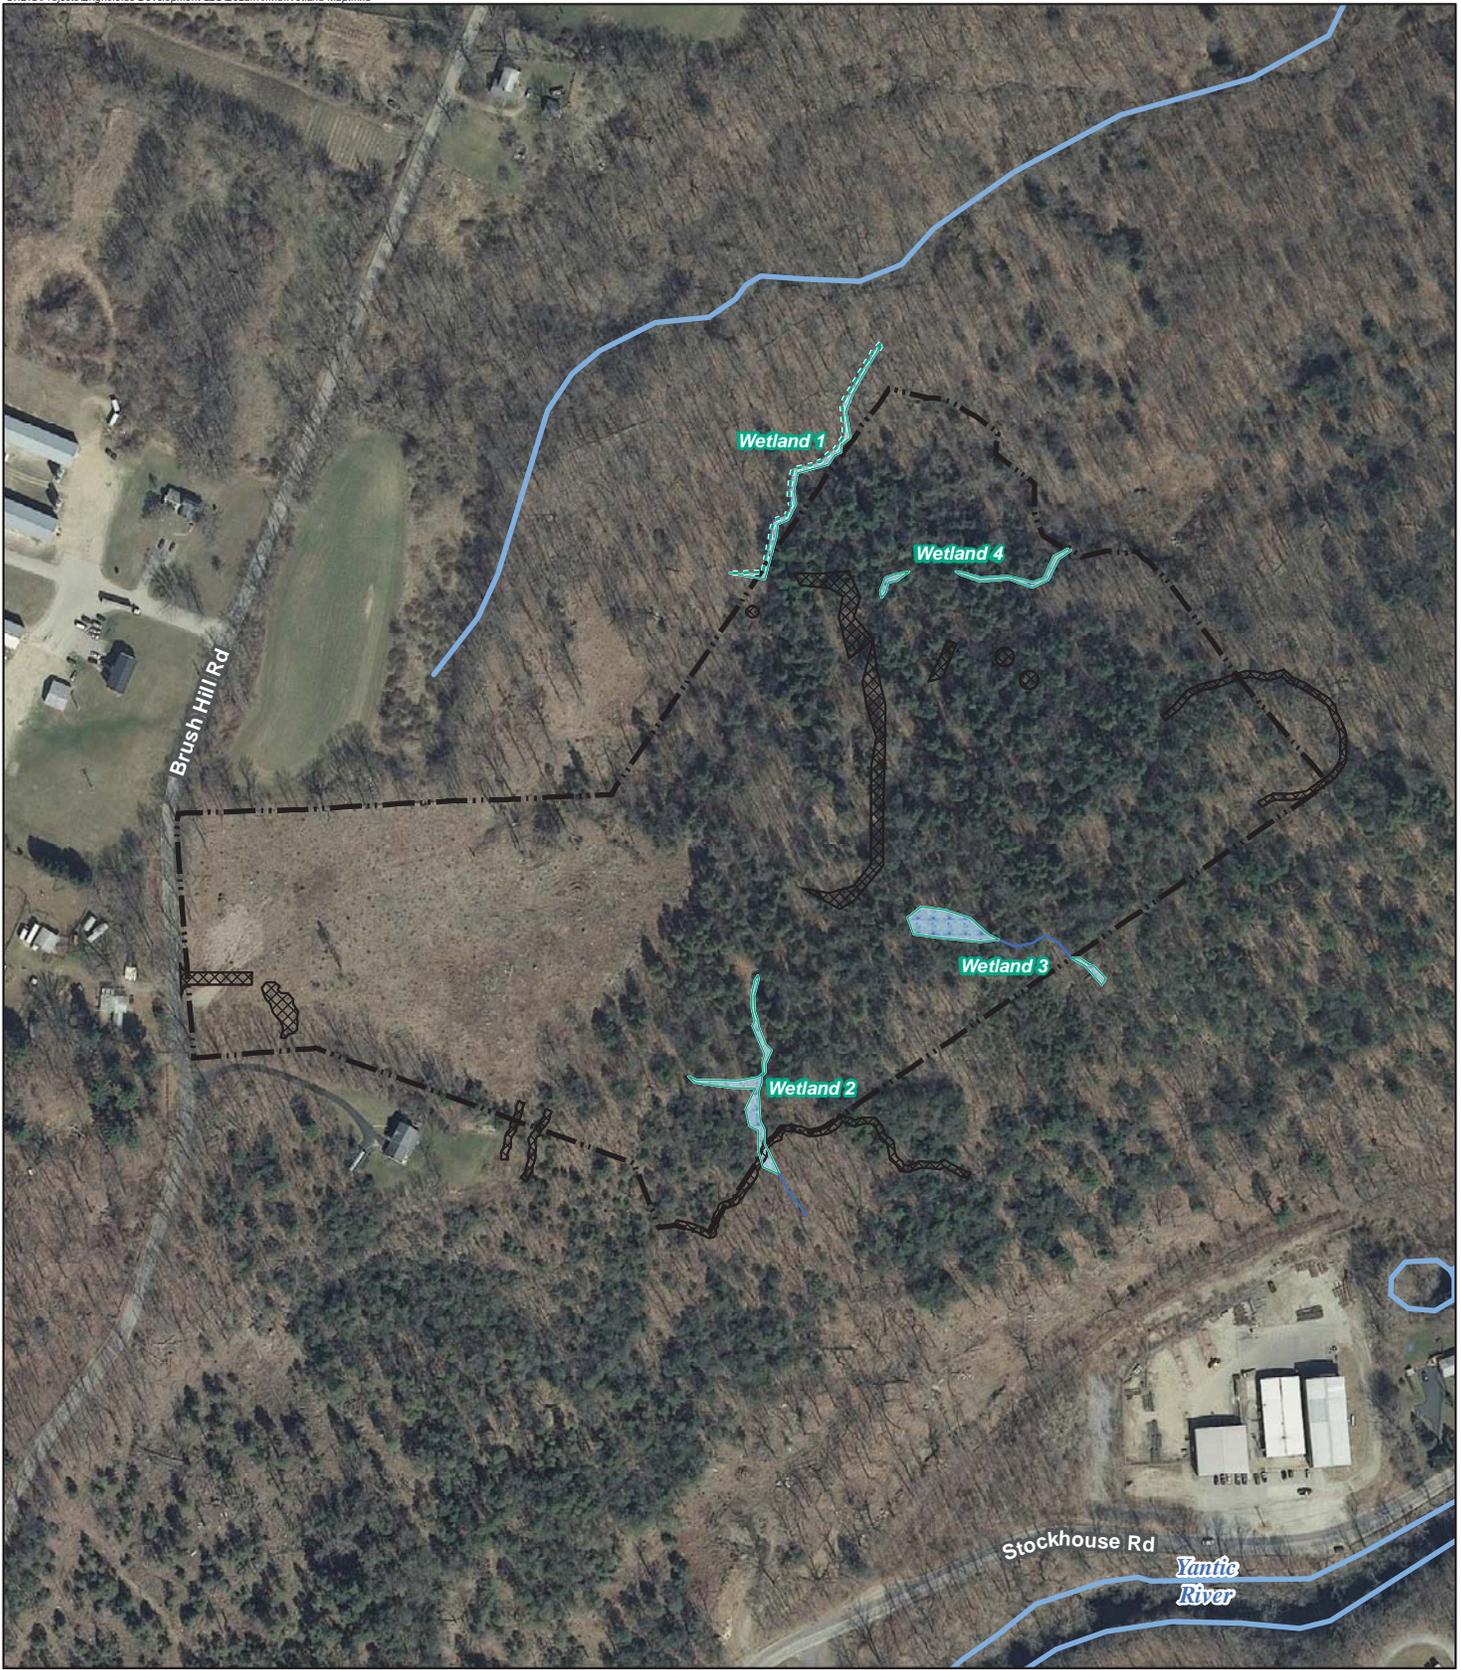
All-Points Technology Corporation, P.C. ("APT") understands that a solar array project ("Project") is proposed by Brightfields Development, LLC ("Brightfields") at 80 Brush Hill Road in Bozrah, Connecticut ("Subject Property"). Soil Scientists with APT originally conducted an inspection of the Subject Property on August 23, 2014 to review and confirm wetland boundaries identified during a previous inland wetlands investigation/delineation performed in 2007 by Demian A. Sorrentino of Boundaries LLC. Mr. Sorrentino identified four (4) regulated areas, consisting primarily of seasonal intermittent watercourse channels formed in moderately to steeply sloping, thin glacial till and exposed bedrock. Please refer to the attached Wetland Map for the locations of these features.

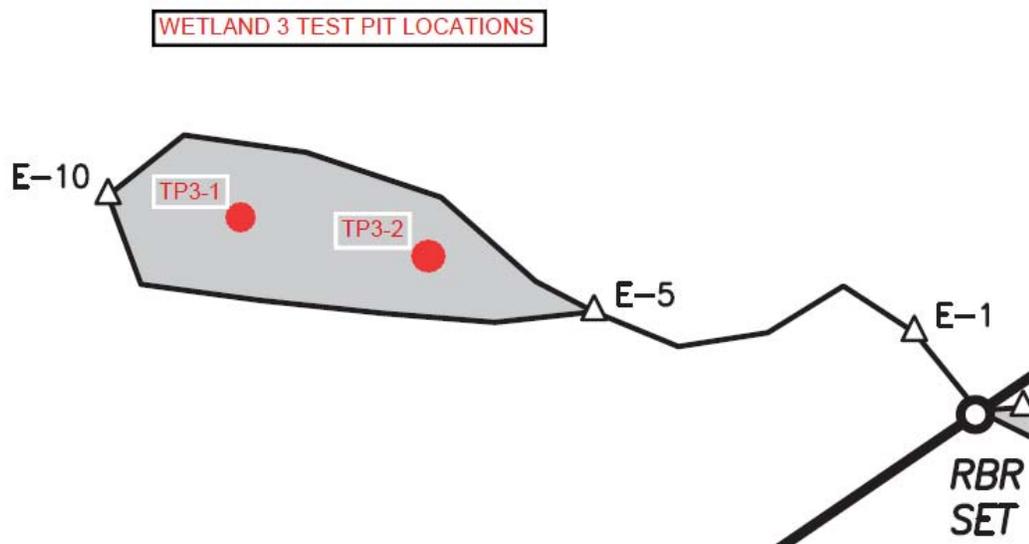
Sketch: TP3-1 located in lowest elevation of topographic depression.

Horizon	Depth	Description
Oe	2 to 0 inches	Partially decomposed leaf litter
A	0 to 2 inches	Very dark Brown (10YR 2/2) fine sandy loam, weak fine granular structure, friable; common fine and medium roots; clear wavy boundary.
Bw1	2 to 14 inches	Yellowish Brown (10 YR 5/6); fine sandy loam; moderate medium subangular blocky structure, firm; clear wavy boundary.
Bw2	14 to 28 inches	Dark yellowish Brown (10 YR 3/6); fine sandy loam; moderate medium subangular blocky structure, firm; clear wavy boundary.
C	28 to 37 inches	Dark yellowish Brown (10 YR 4/4); fine sandy loam; moderate medium subangular blocky structure, firm; clear wavy boundary.
R	37 inches	Competent schist bedrock.

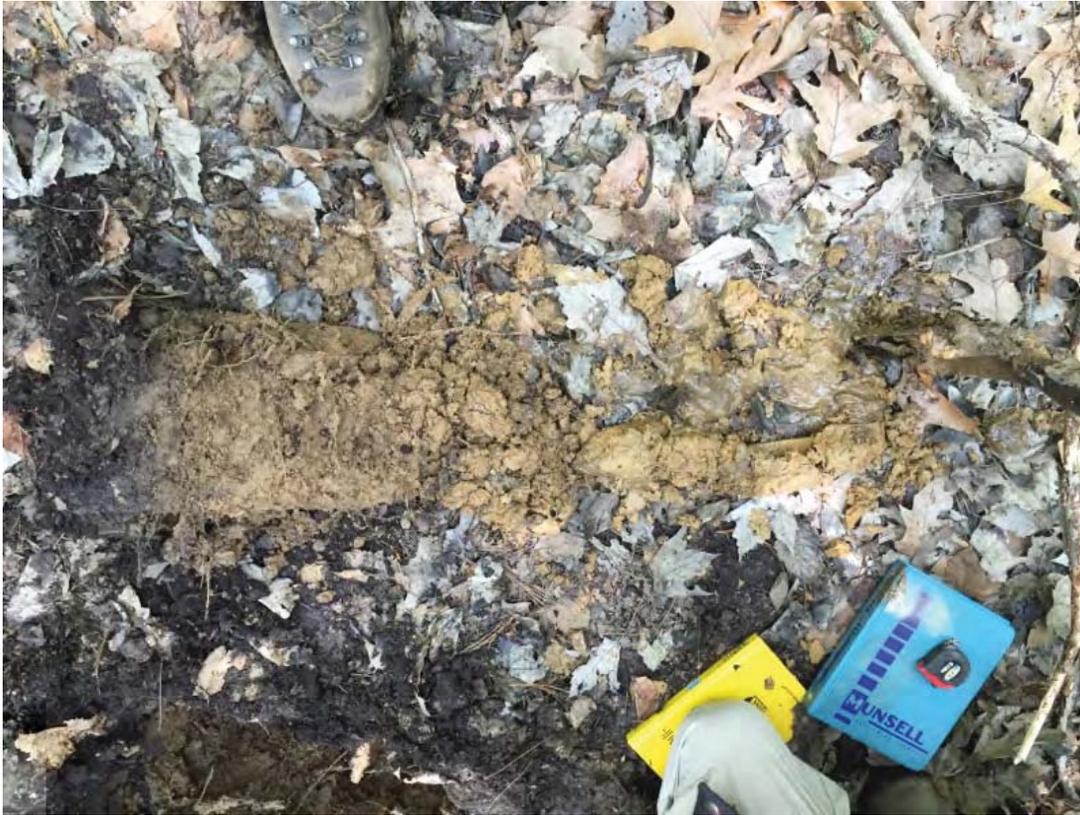
Photo 1: View of soil profile TP3-1.

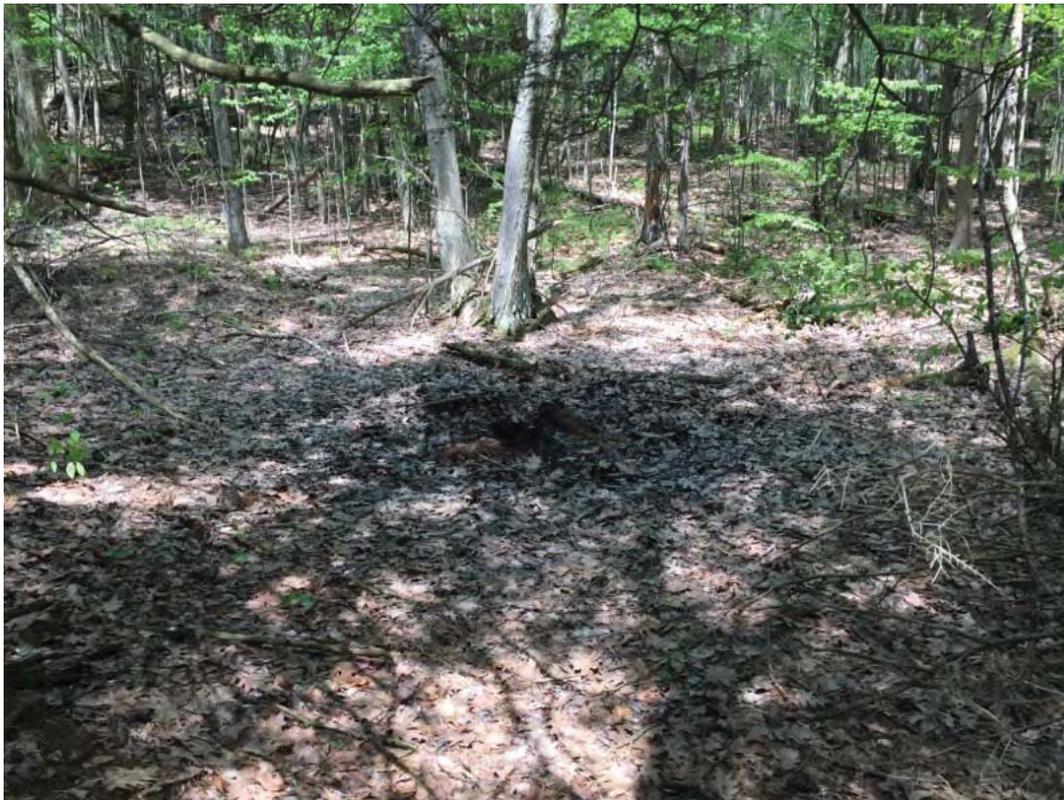
Photo 2: View of TP3-1 soil test pit, looking northwest from between wetland flags WF E-12 and E-13.

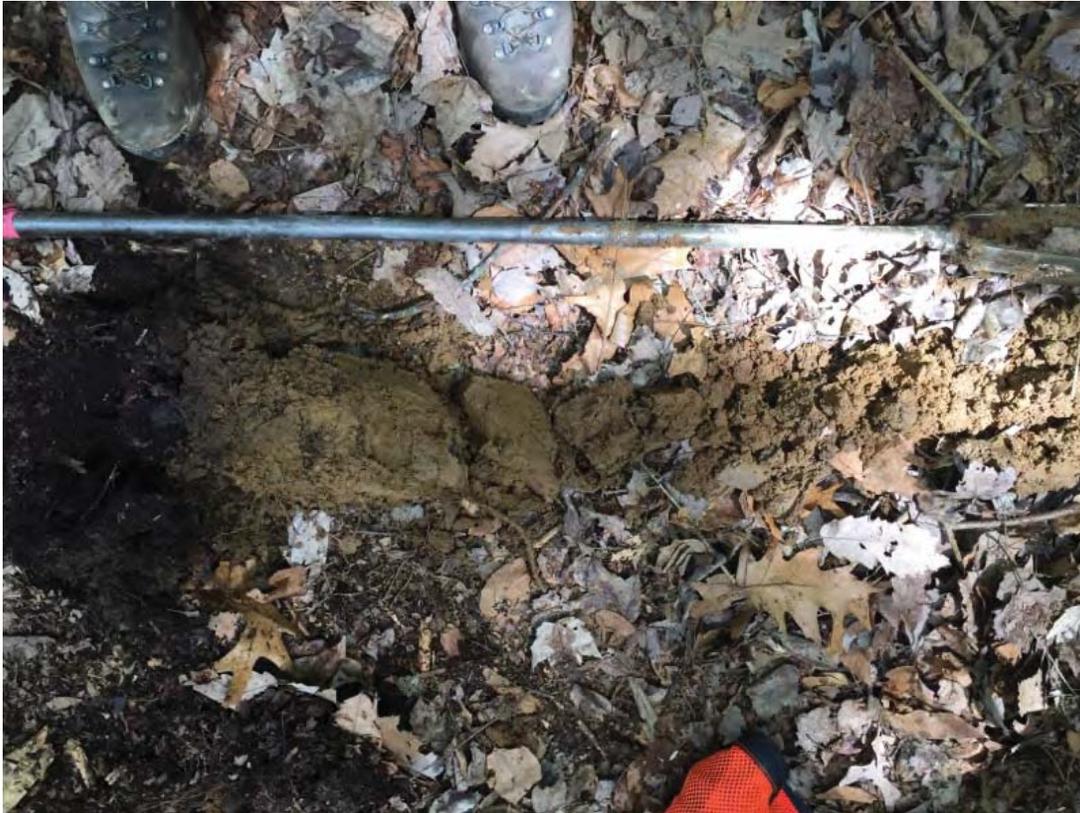
Photo 3: View of soil profile TP3-2.

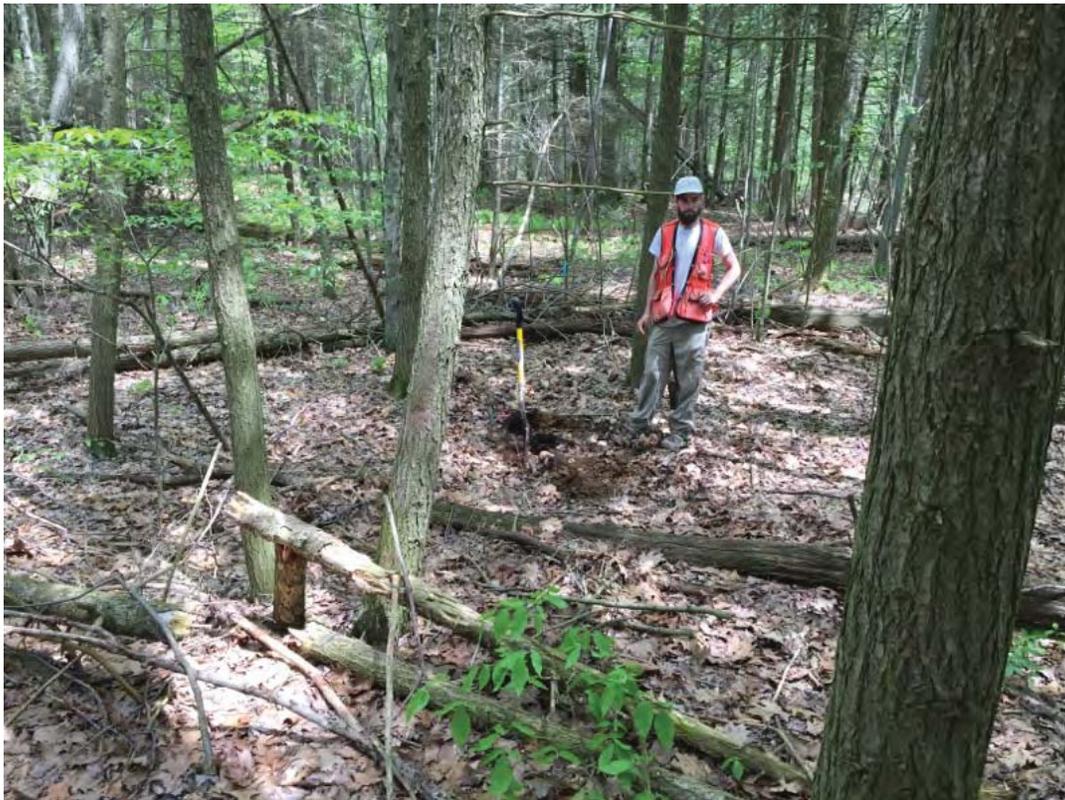
Photo 4: View of TP3-2 soil test pit, looking northwest from wetland flag WF E-13.

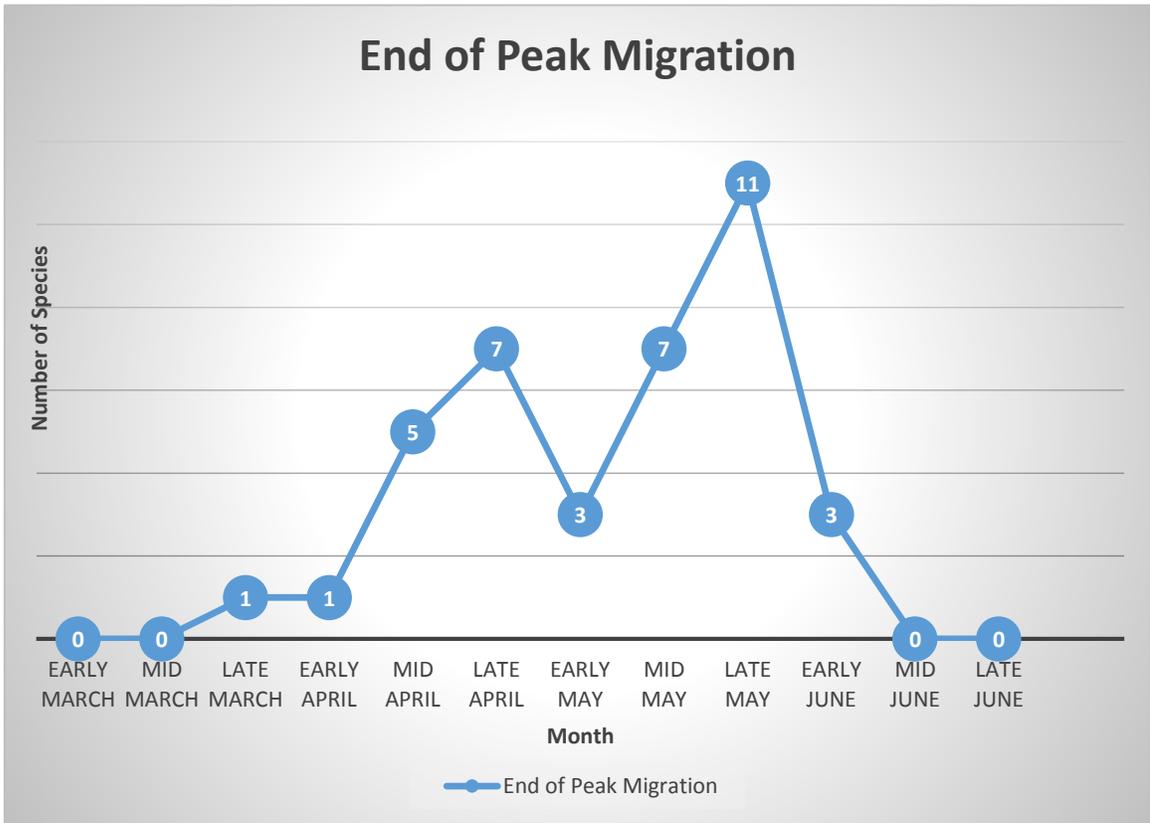
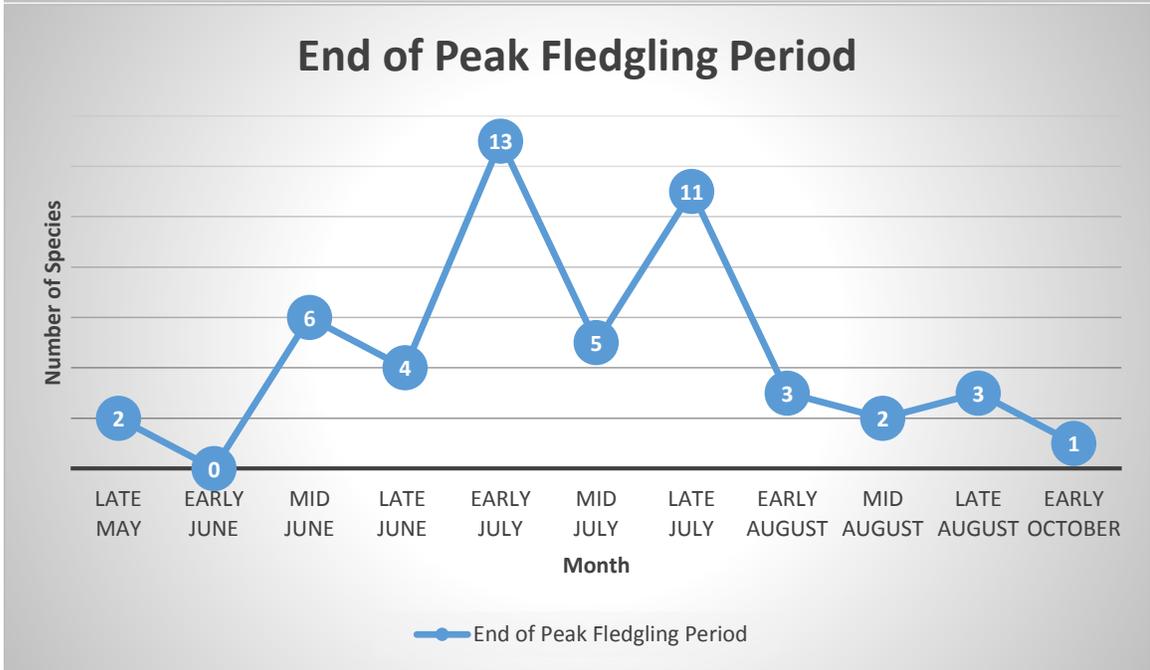
Figures 1 (top) and 2 (bottom): Line graphs showing the end of peak migration indicating the period in which the majority of migratory birds are expected to be present on the site and the end of the peak fledgling period, indicating the period when young-of-the-year birds have fledged and are mobile.

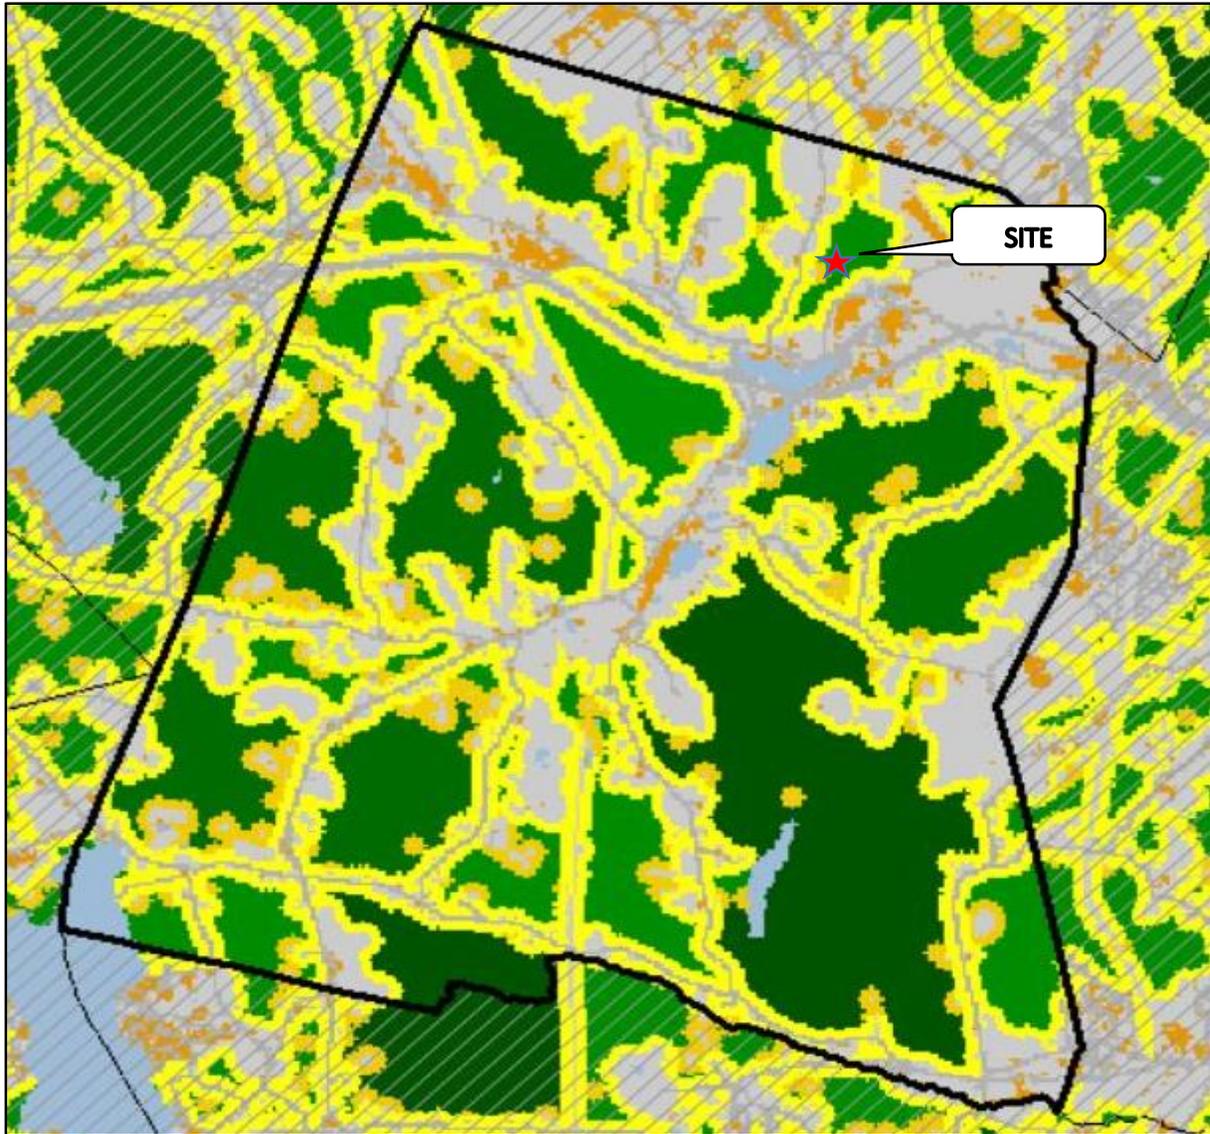
Figure 3: Center for Land Use Education and Research (CLEAR) 2006 forest fragmentation analysis for the Town of Bozrah. Core forest pixels are sub-classified into three categories (and three shades of green) - small core, medium core, and large core. The largest core patches, shown in the darkest green color, are over 500 acres in size. The next least-disturbed category, perforated pixels, make up the interior edge of small non-forested areas within a core forest, such as a house built within the woods. These areas, which appear as "holes" or perforations, are shown in light orange. Edge pixels, shown in yellow, make up the exterior periphery of core forest tracts where they meet with non-forested areas. The most disturbed category, patch pixels (dark orange), are small fragments of forest that are completely surrounded by non-forested areas.

The forest within and adjacent to the Project Area was evaluated using the methodology described in the Center for Land Use Education and Research's (CLEAR) Forest Fragmentation Study³. The goal was to analyze the level of forest fragmentation present to determine whether the Project Area's forest would be considered valuable to forest-interior birds. Forest-interior birds favor the interior of the forest away from non-forested "edge" habitat. Such conditions are optimized in forests with a low level of habitat fragmentation. The literature suggests that total forest cover within the landscape as well as forest patch size are significant and therefore both factors were assessed (Lee *et al.* 2002; Mortberg, 2001; Villard *et al.* 1999; Andren 1996).

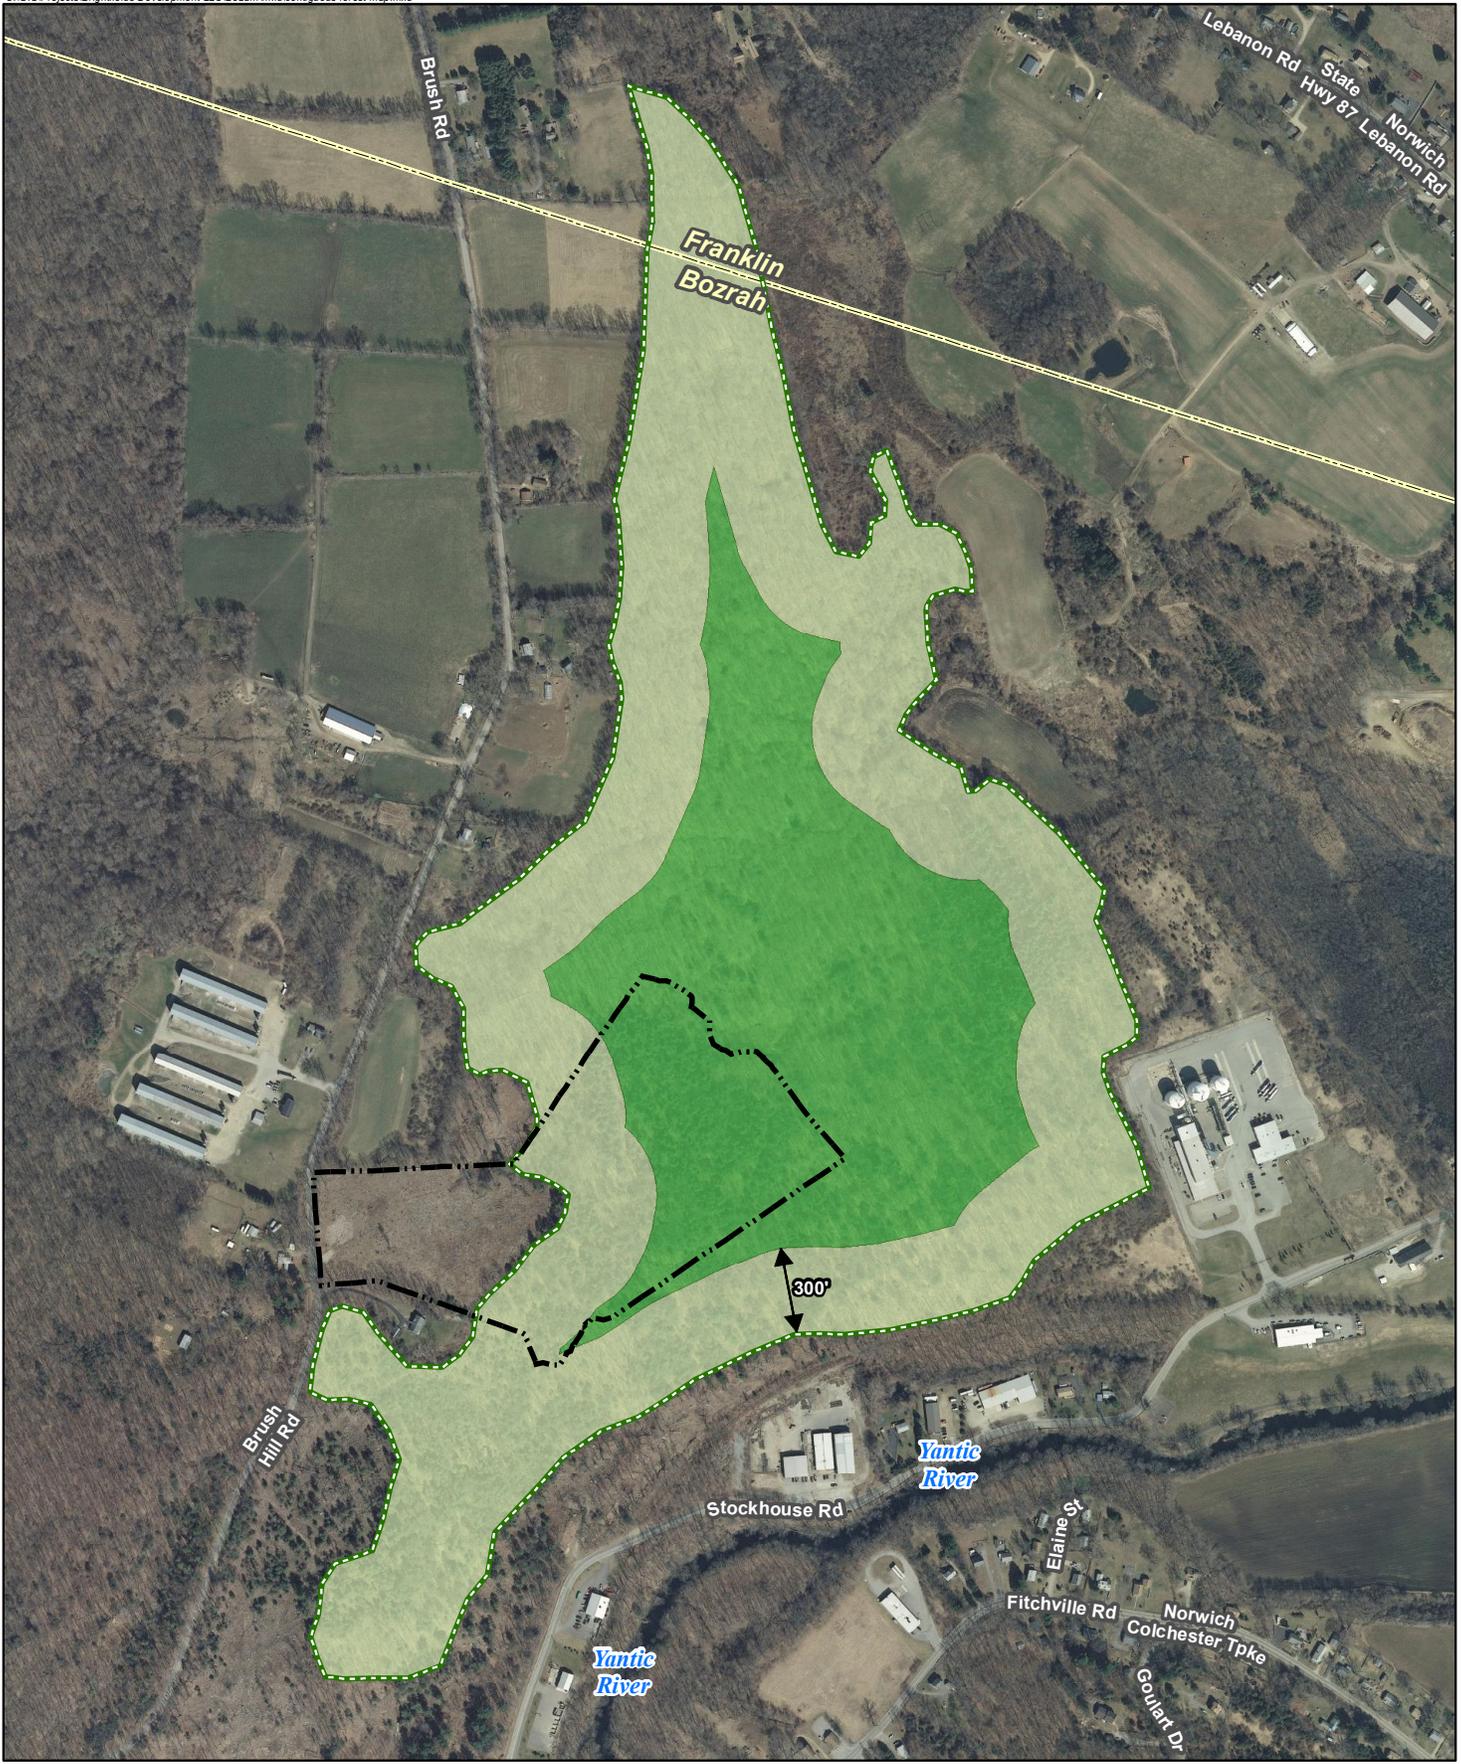
- Legend**
- Site (+/- 25.20 Acres)
 - Forest Block (+/- 139.5 Acres)
 - Forest Block Type:
 - Edge Forest (+/- 88.3 Acres)
 - Interior Forest (+/- 51.2 Acres)
