Re: **Petition No. 1178 – Fusion Solar Center, LLC – Environmental Monitoring Daily Site Observation Form Report No. 7**

ENVIRONMENTAL MONITORING
DAILY SITE OBSERVATION FORM

Report No. 7

Project: DEPCOM Power, Fusion Solar Center
 Address: Potash Hill Road, Sprague, Connecticut

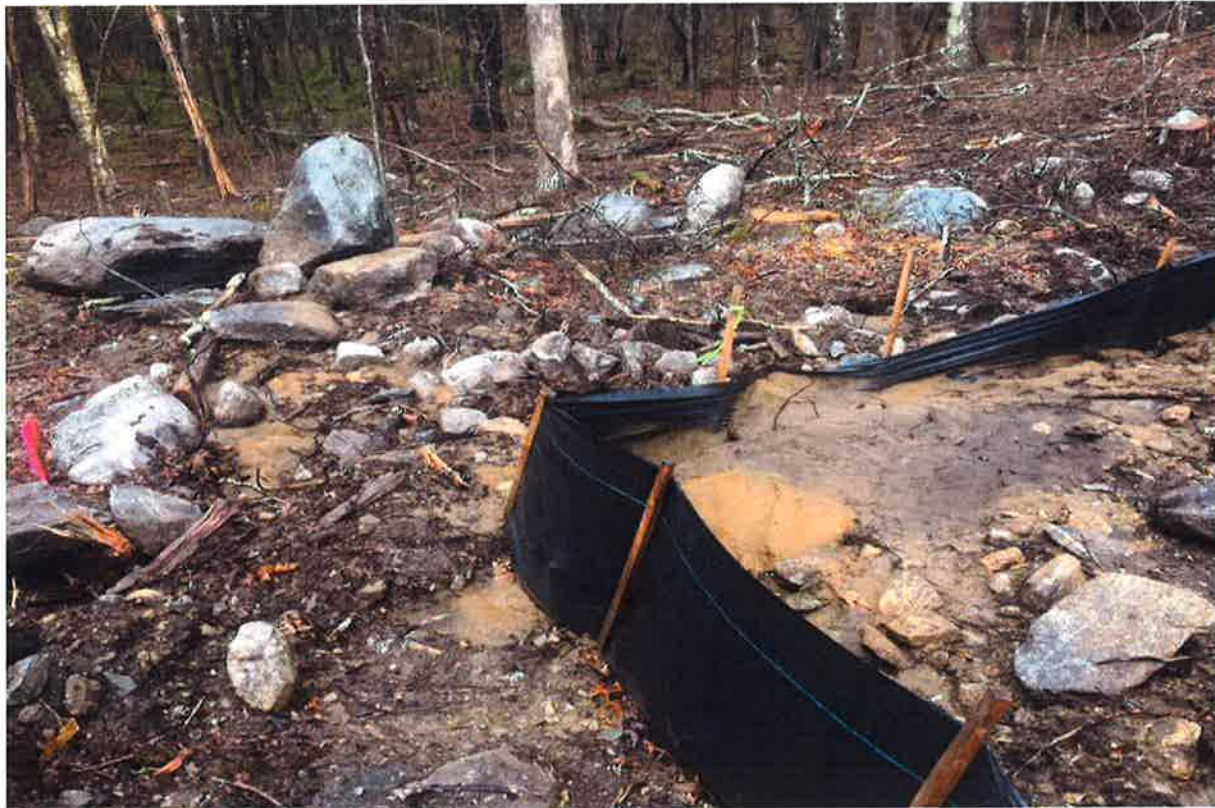
Photo 2: View of CA #8, breach in silt fence looking west.

Corrective Action #6 – one area of insufficient silt fence height due to sagging.	3/7/17
Corrective Action #7 – numerous areas of silt fence have separated from staking or ripped resulting in sagging and disconnected silt fencing needing repair. (4/3 previous areas fixed CA #4 – new areas have been identified as of this inspection date).	Majority of areas repaired on 4/26/17 New areas identified requiring repair
Corrective Action #8 – Two areas identified where gaps in silt fence formed underneath due to focused erosion from stormwater flows. Small sediment release in uplands with little risk of migration off-site or into wetlands.	Original areas repaired by 4/26/17 Same locations resulted in silt fence failure requiring repair. Consider adding additional reinforcement to these locations (haybale backing, straw wattle check dams, diversion channels etc.)

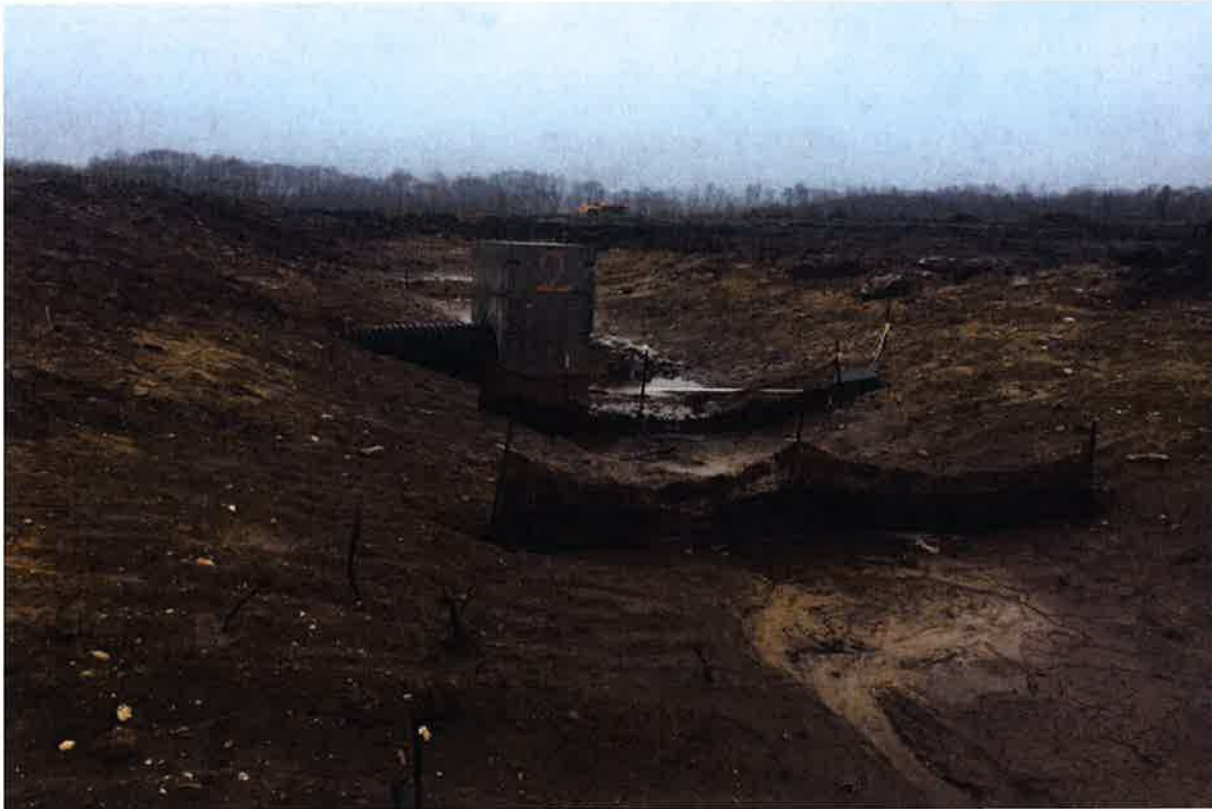
Photo 3: View of SB-2 functioning properly, looking west.

Corrective Action #9 – SB-2 and SB-3 not retaining volume due to low flow outlet pipe not closing, blocked entry to temporarily allow for basin to fill up and outlet via armored outlet or skimmer outfall.	SB-2 has been repaired 4/26/17 Consider raising SB-3 skimmer elevation to allow for increased storage volume/time
Corrective Action #10 – add new armored swale in southwest project corner to protect outlet flows from SB-3, add check dams to all problem drainage/diversion channels (maintain after each rain storm).	4/26/17 Repaired Consider adding stone to swale leading to and out-letting from SB-3 for surface protection
Project Modification Requested:	
Extra work space requested <input type="checkbox"/> Change to work area <input type="checkbox"/> Change to stormwater feature <input type="checkbox"/> Description of Modification: N/A	
Notes:	
<p>1/17/17 – construction entrance road with anti-tracking pad installed; land clearing activities 50-60% complete; initial grubbing started in southeast end of project in preparation of silt fence installation (to begin 1/18/17); minor brush pile with logs placed in wetlands in southeast portion of property by property owner - materials properly removed by DEPCOM Power on 1/20/17.</p> <p>2/3/2017 - A majority of the project area has been cleared. A small patch in the northern end of the project remains to be cleared. Silt fence has been installed in most of the project limits minus the northern limits of the project.</p> <p>2/14/17 – Received notification from Victor Menor, DEPCOM, that corrective actions #2 and #3 were made prior to heavy snow storm on February 9, 2017; APT will verify areas during next inspection.</p> <p>3/3/17 – APT discussed CA #4, 5 & 6 with Chance Combs, DEPCOM. Mr. Combs indicated to APT that corrective actions were already scheduled for the western side of the project on Friday (3/3) afternoon and all corrective actions would be completed on Monday (3/6). Tree clearing activities have been completed for the entire project. Temporary sediment traps are currently under construction.</p> <p>3/7/17 – Grubbing on the project is ongoing. Temporary sediment traps and drainage swales are currently under construction. Silt fence deficiencies are currently under repair (CA#4). An on-site meeting between the Connecticut Siting Council (“CSC”) staff, DEPCOM, and neighbors to the project was held to address concerns regarding the project construction. All environmental awareness posters are still intact.</p> <p>4/3/17 – Neighbor (to the south) observed and reported silt laden stormwater leaving site and flowing through their property. No clear cause identified onsite during inspection due to dry site conditions. Two possible locations identified where sediment accumulation has occurred in front of perimeter controls and reviewed with DEPCOM. With the rain forecasted 4/4/17, the site will be reviewed and additional control installation will be evaluated and implemented, as necessary.</p> <p>4/4/17 – breach in diversion swale repaired, silt fence knocked over by overflow in south end of project repaired and stormwater released during 3/31 to 4/1 rain storm and again on 4/4 resulted in silt laden water released off site at two locations (one of which is a wetland/IWC and other is</p>

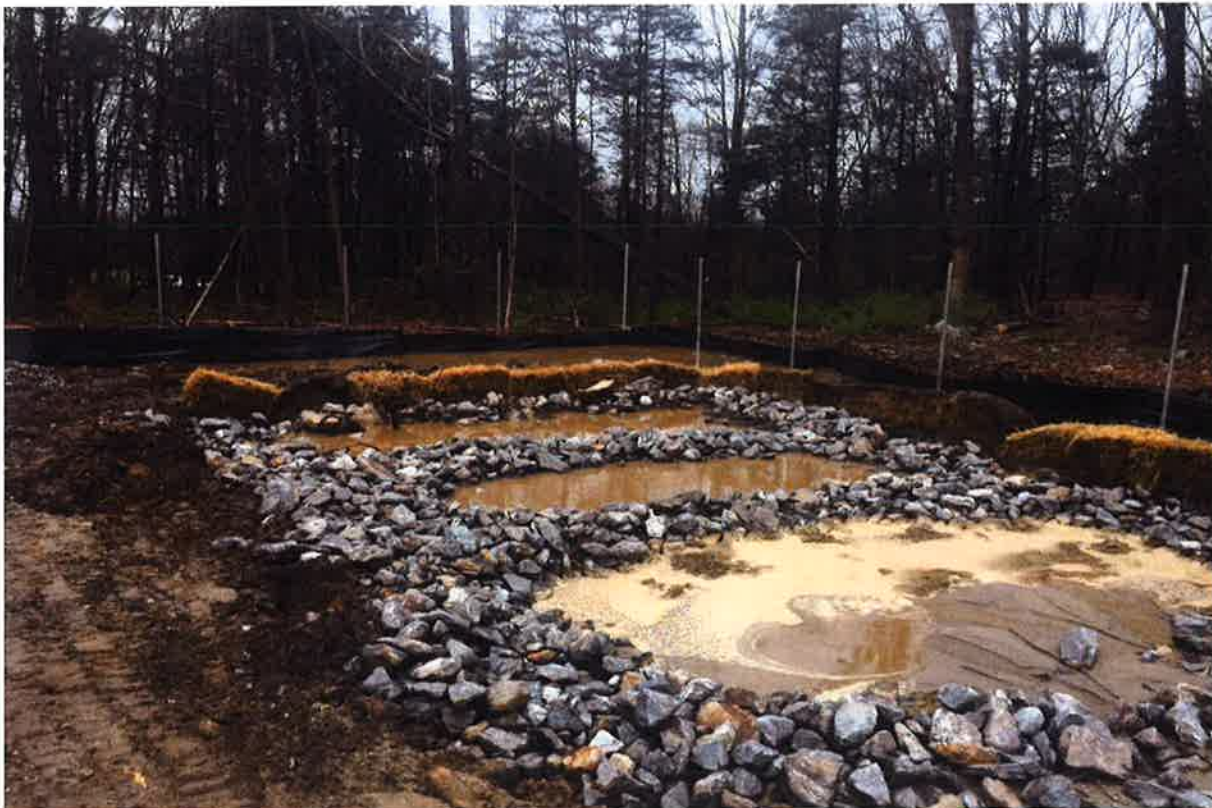
Photo 4: View of drainage from SB-3 build-up in southwest corner of project area, looking south.

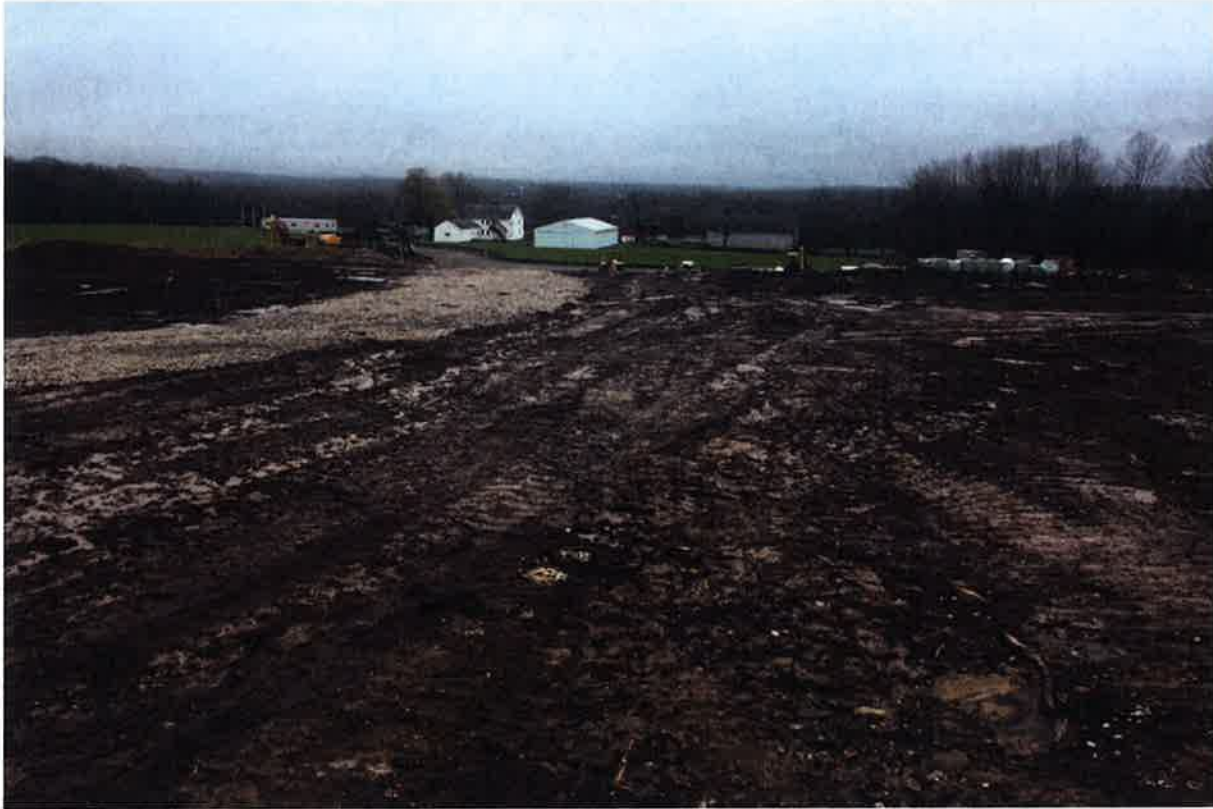
Photo 5: View of drainage leading to SB—3 looking south.

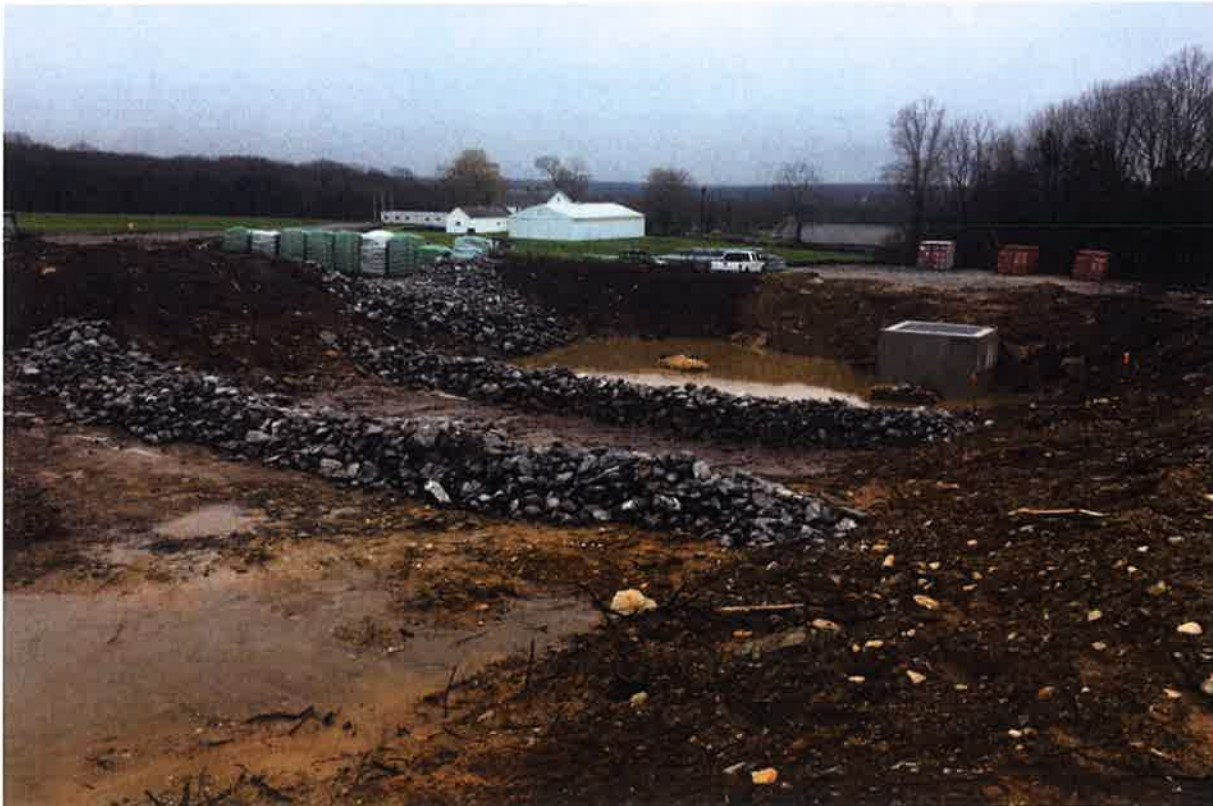
Photo 6: View of SB-3 looking south.
