**Re: Woods Hill Solar, LLC – Petition No. 1224
Supplemental Vernal Pool Evaluation Report**

**Photo Log
Woods Hill Road, Pomfret
Spring 2016 Vernal Pool Survey**

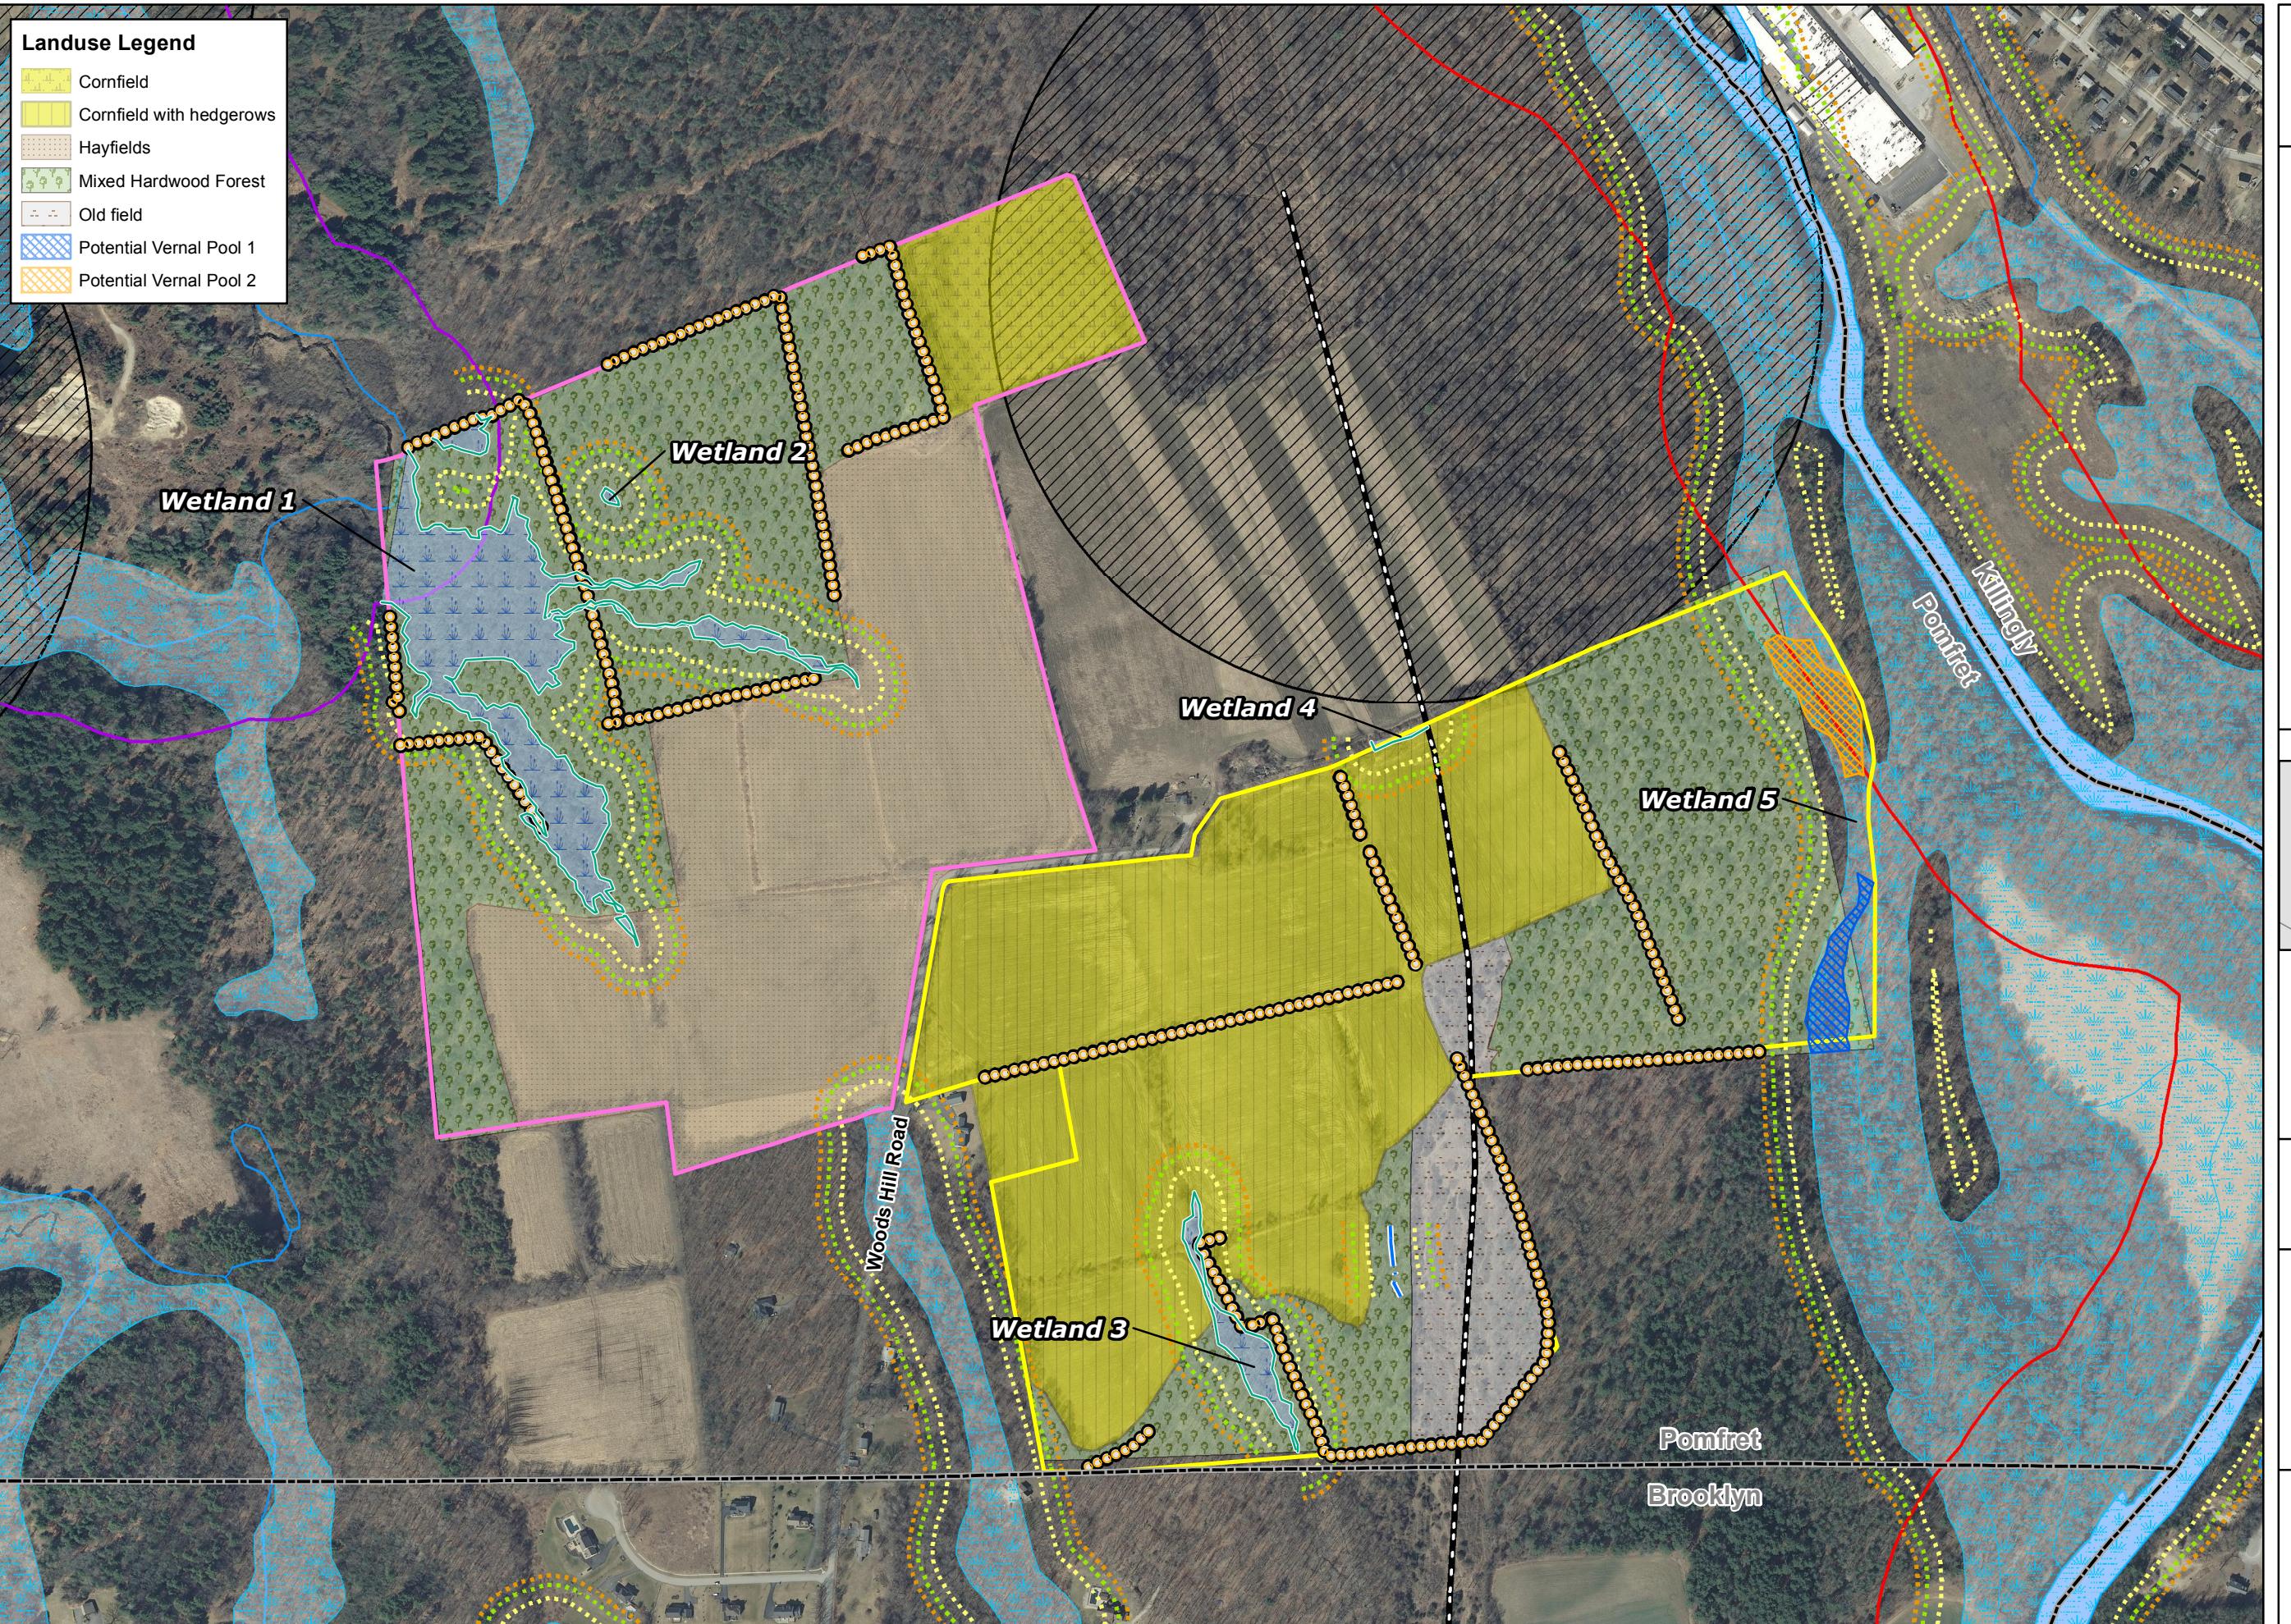
Enclosures: Figure 3 – Habitat Cover Map
Photo Log

In the winter of 2015 Davison Environmental, LLC conducted a *Natural Resource Assessment* in support of Petition No. 1224. The results of the Natural Resource Assessment were provided in the original Petition. That report was based solely on field investigations conducted during the winter, a period in which vernal pools cannot be definitively identified. Those investigations identified two potential vernal pools based on the presence of hydrology suitable to support vernal pool wildlife. These were cryptic vernal pools embedded within Wetland 5. The location of Wetland 5 is depicted on the attached figure.

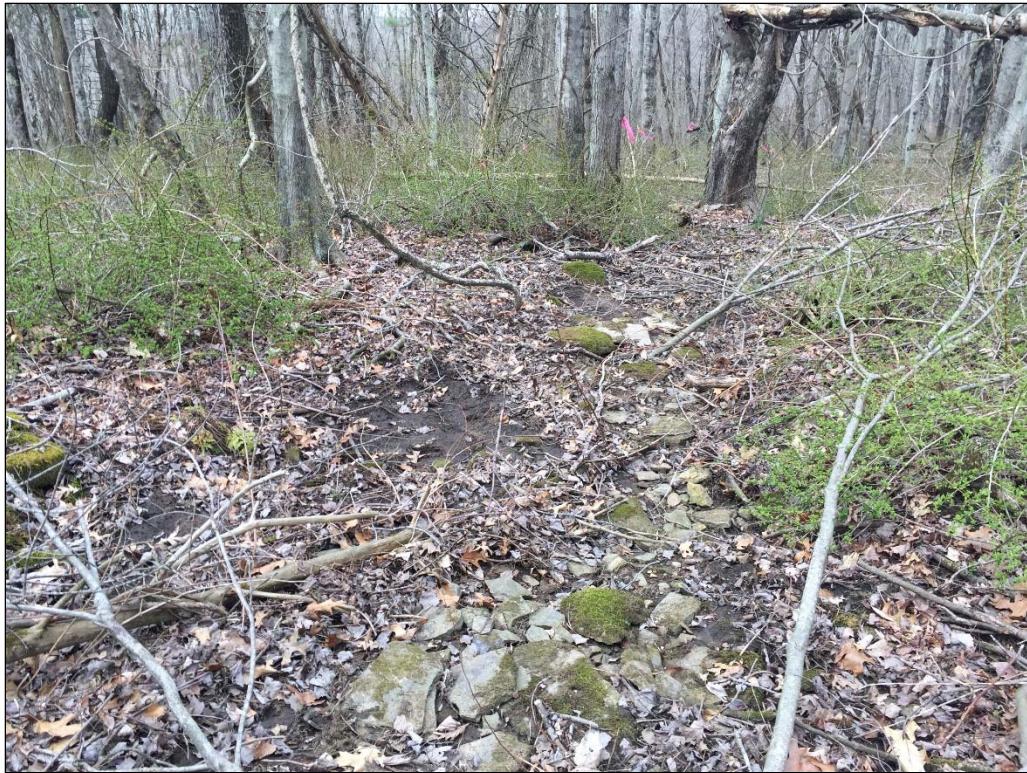
Photo 1: Wetland 1

Due to the fact that Wetlands 1 and 2 are wooded swamps, which most commonly support vernal pools, these wetlands were closely surveyed for areas of standing water that might be vernal pools. No areas of standing water were found within either Wetland 1 or Wetland 2. These observations were consistent with previous predictions made by Davison Environmental based on the December 2016 field work. The lack of standing water in these wetlands is due primarily to the fact that they are steeply sloping. As a result, surface water is restricted to seasonal or storm driven flows in shallow channels and rills. The hydrologic condition of these wetlands is illustrated in the photos taken in March which are appended to this report. Only two-lined salamander (*Eurycea bislineata*) and green frog were observed within Wetland 1. Both were observed in the western portions of the wetland where the headwater stream develops and drains northwest off the site.

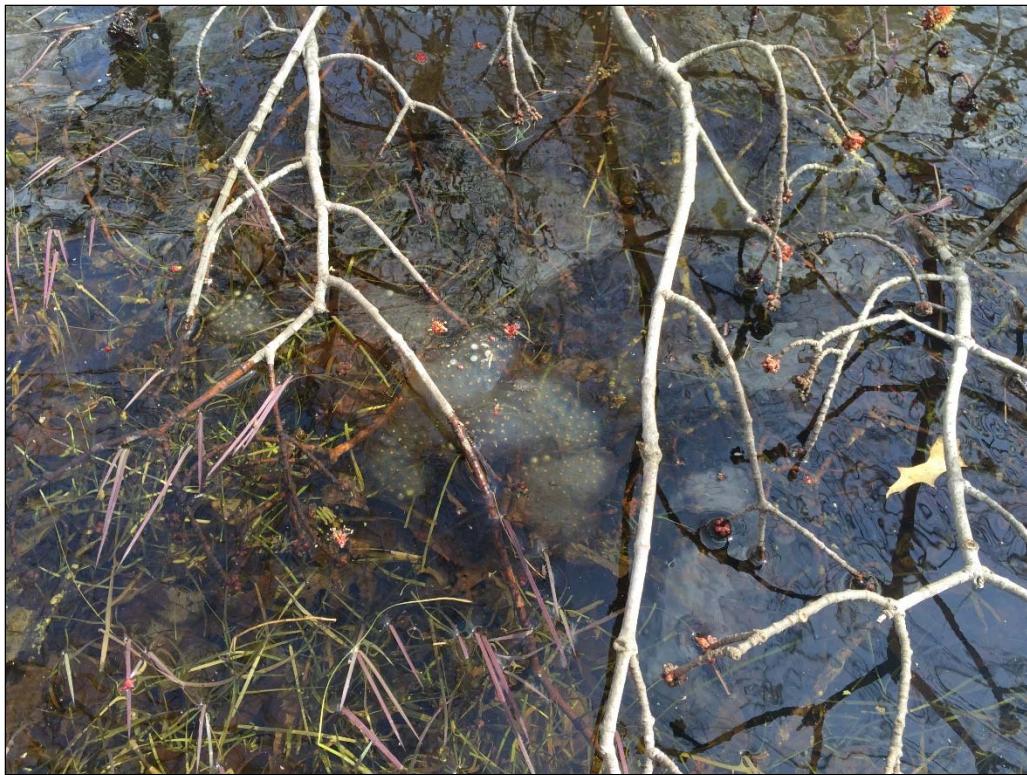
Two vernal pool indicator species were confirmed breeding in both Pool 1 and Pool 2, the wood frog (*Lithobates sylvatica*) and spotted salamander (*Ambystoma maculatum*). Both pools also supported an uncommon invertebrate indicator species, fairy shrimp (*Anostraca*). The total egg masses observed in each vernal pool are listed in Table 1.

Photo 7: spotted salamander egg masses in Vernal Pool 1

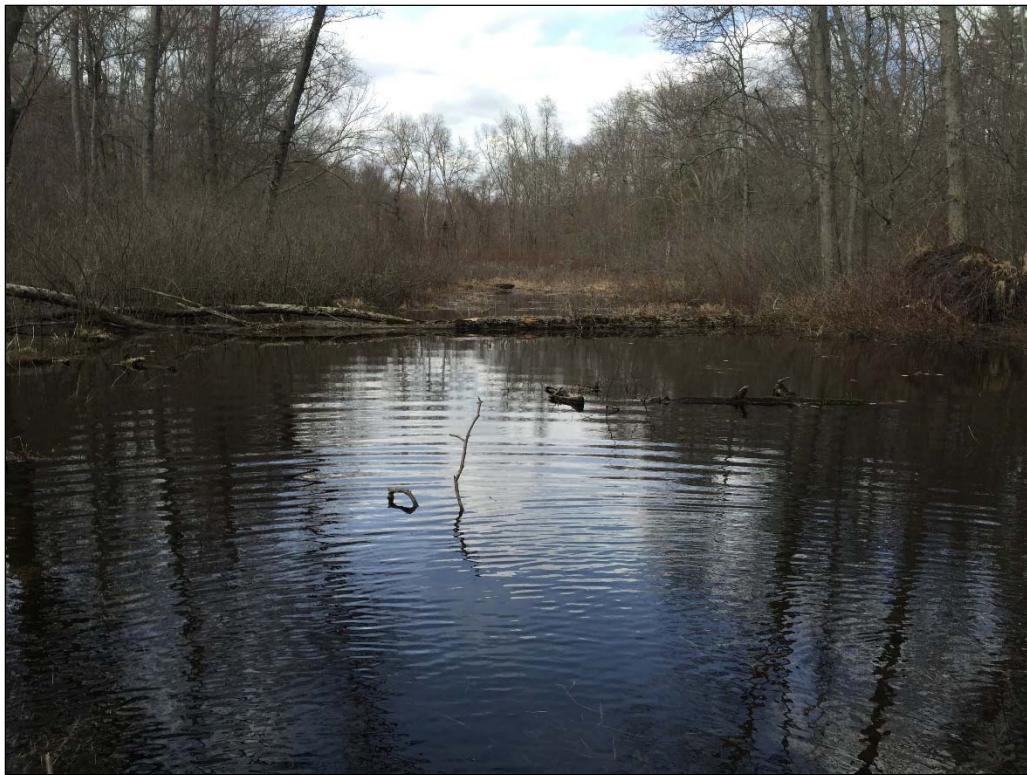
Both Pool 1 and Pool 2 supported two breeding indicator species and therefore are Tier 1 vernal pools according to the assessment methodology described in Calhoun and Klemens (2002). Both pools have a long hydroperiod (both were deeply flooded to a maximum depth of over one foot). Green frog (*Lithobates clamitans*) and spring peeper (*Pseudacris crucifer*) were also observed in the pools.

Photo 9: Vernal Pool 2 (south side of pool)

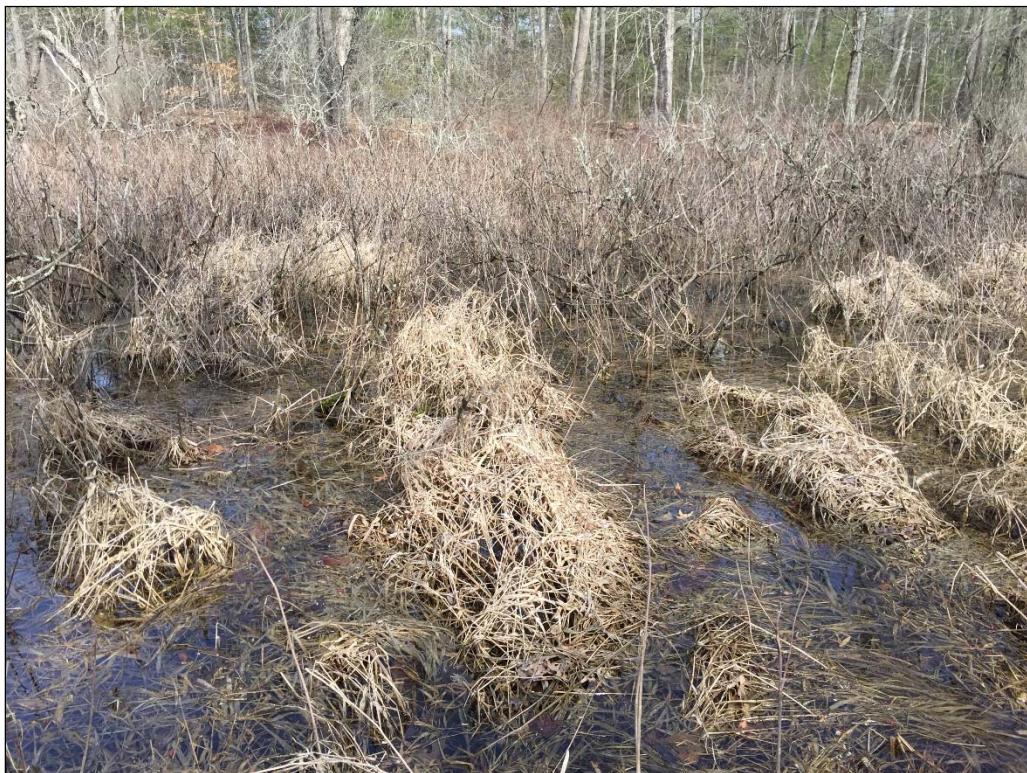
Photo 10: Vernal Pool 2; note dense reed canarygrass and buttonbush
