Memorandum

Project #: 42256.00

Re: Vernal Pool Survey for the Tobacco Valley Solar Project
Simsbury, Connecticut

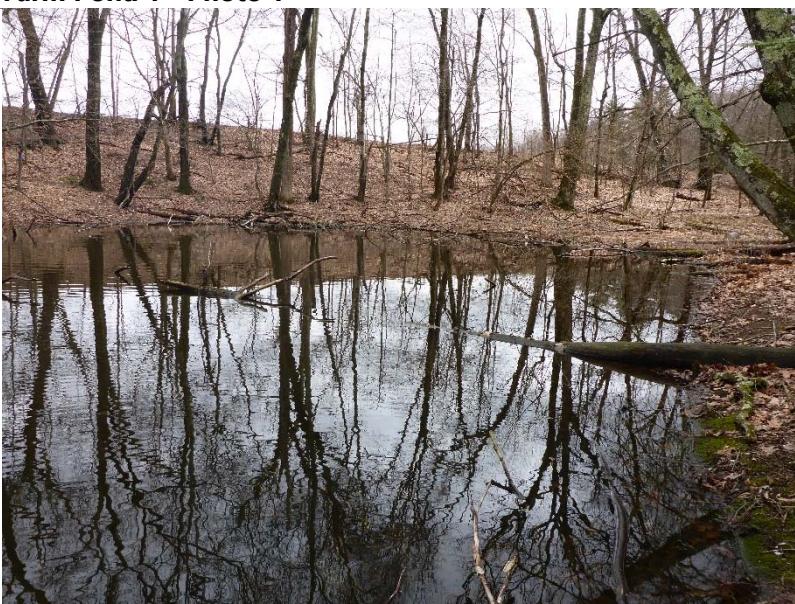
Farm Pond 1 - Photo 1

Description: An intermittent stream enters Farm Pond 1 from the southeast. This area looked likely to provide vernal pool habitat, however no evidence of obligate species was found in this pond. Munnisunk Brook, a perennial tributary to the Farmington River, enters the pond from its northwestern corner that is not visible in this photograph.
Farm Pond 1 - Photo 2

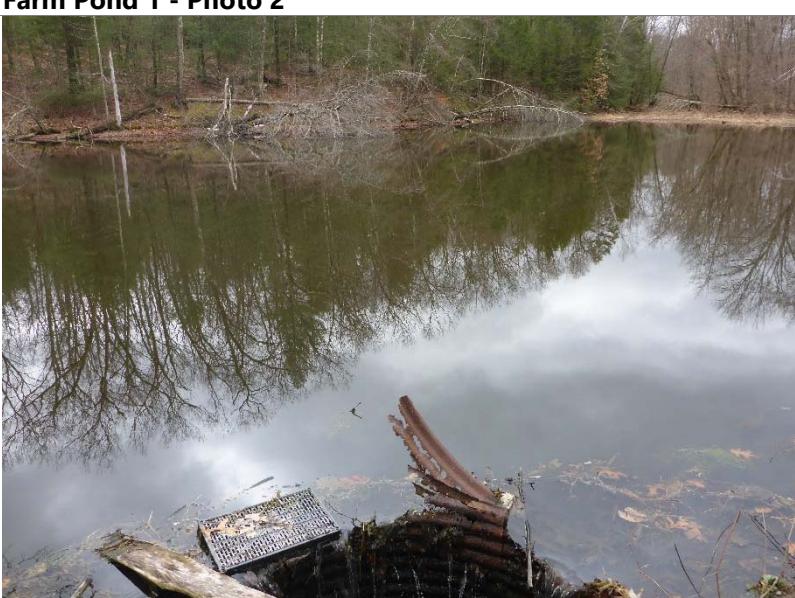
Description: View of the corrugated metal riser pipe that serves as the outlet at Farm Pond 1. The pond is an impoundment of Munnisunk Brook and another intermittent tributary. This photo was taken from the earth dam at the northeast side of the pond looking southwest across the pond.

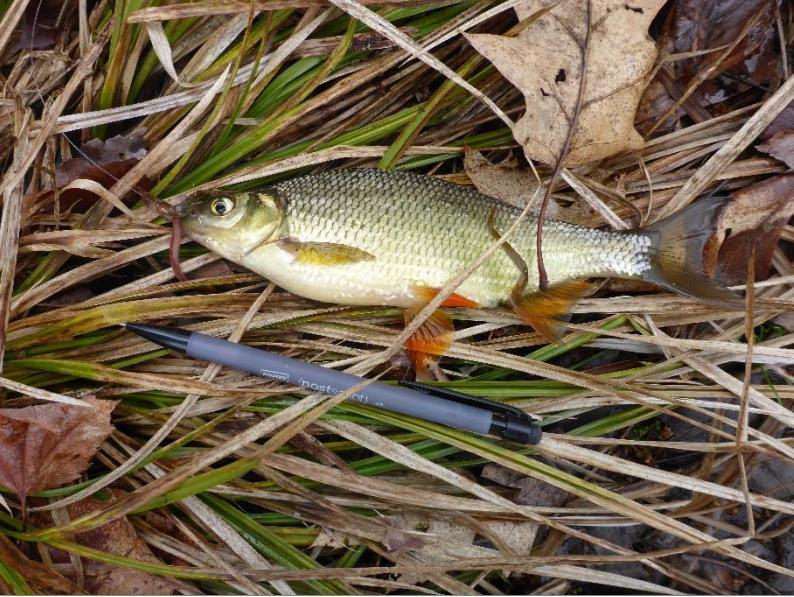
Farm Pond 1 - Photo 3

Description: Adult golden pond shiners are present in Pond 1. The presence of these fish confirms the pond is not a vernal pool.
Farm Pond 1 - Photo 4

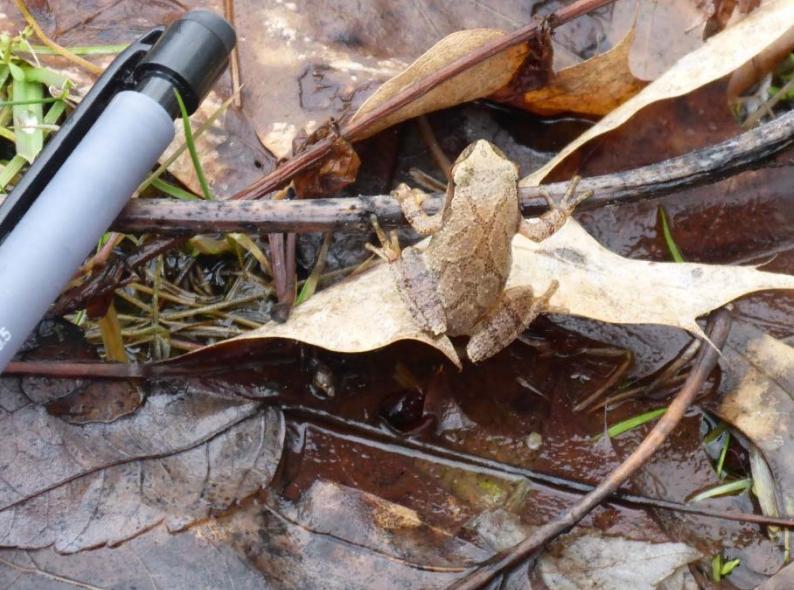
Description: Spring peeper observed along the pond's shoreline. Spring peeper is not an obligate vernal pool species.

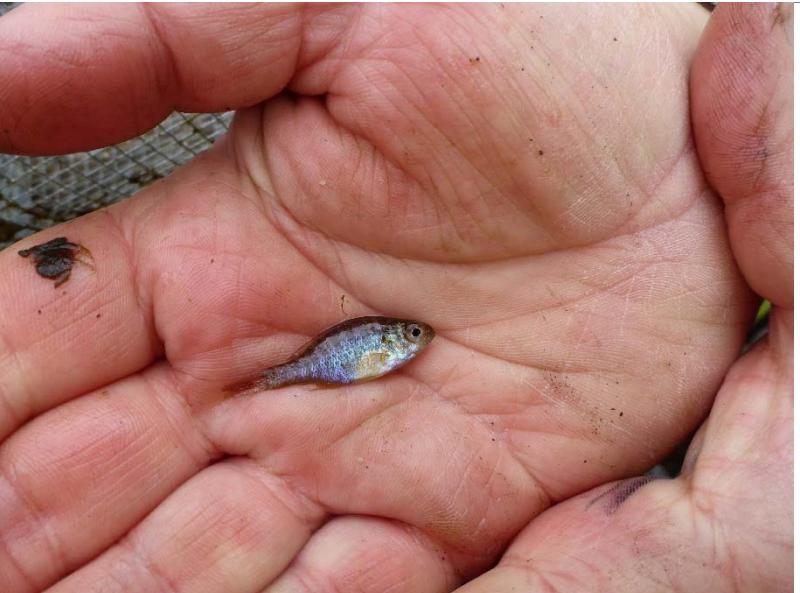
Farm Pond 1 - Photo 5	Description:

A small, blueish juvenile Centrarchid fish is held gently in the palm of a person's hand. The fish is elongated with a dark dorsal fin and a lighter ventral side. The person's hand is visible, with fingers supporting the fish from underneath. The background is slightly blurred.	A juvenile Centrarchid was captured in a minnow trap placed in Farm Pond 1.

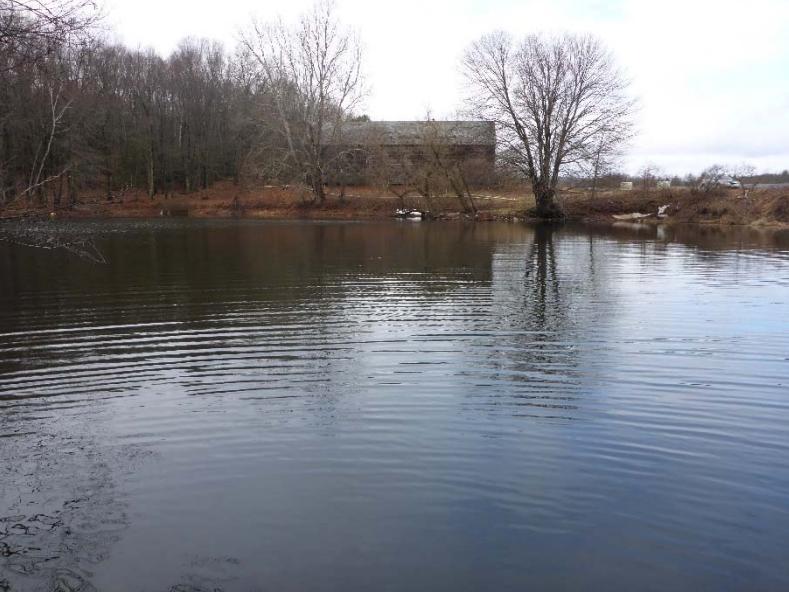
Farm Pond 2 - Photo 1

Description: Farm Pond 2 was excavated below the water table next to tobacco barns. This irrigation pond held fish and second year green frog larvae indicating it does not dry.
Farm Pond 2 - Photo 2

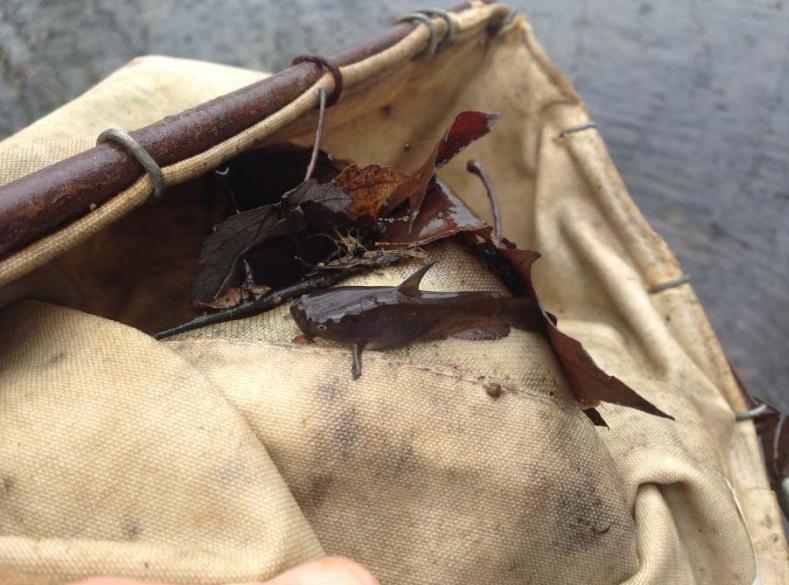
Description: Dip netting did not result in any vernal pool obligate species captures, but three brown bullhead juveniles were captured, all similar in size to the specimen in this photo.

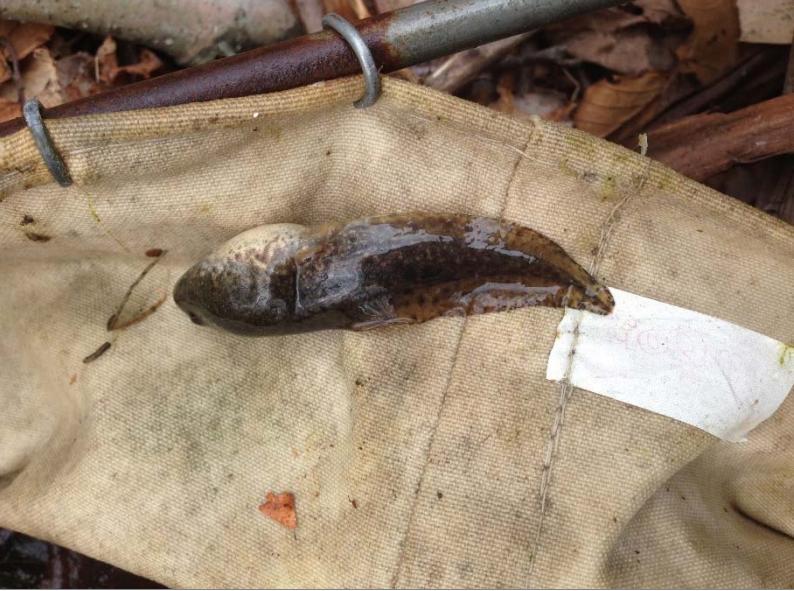
Farm Pond 2 - Photo 3

Description: Second year green frog larvae were also common. This robust individual was beginning to develop hind legs.
Farm Pond 2 - Photo 4

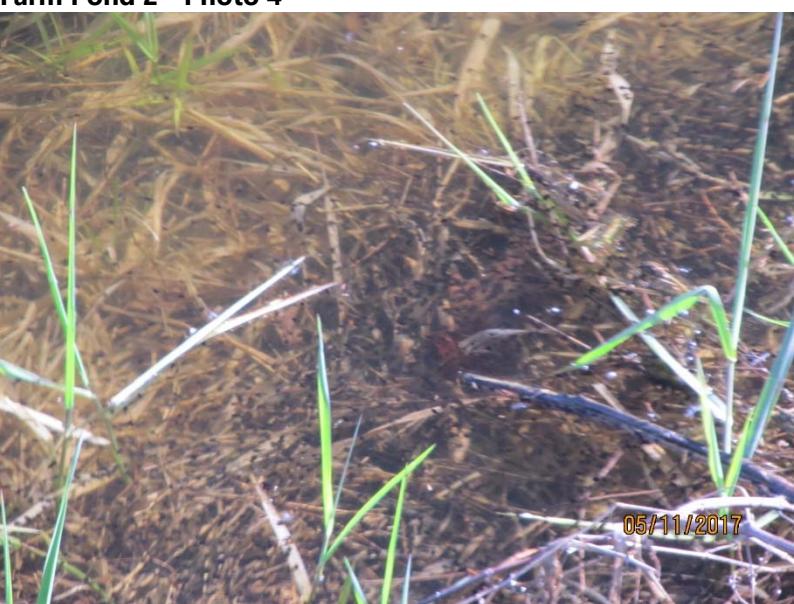
Description: American toad use this pond to spawn, but are not obligate vernal pool species. American toad preferred the submerged reed canary grass found along the north side of the pond as a substrate for egg deposition. Large schools of American toad larvae such as seen in this photographed were present on May 11, 2017.

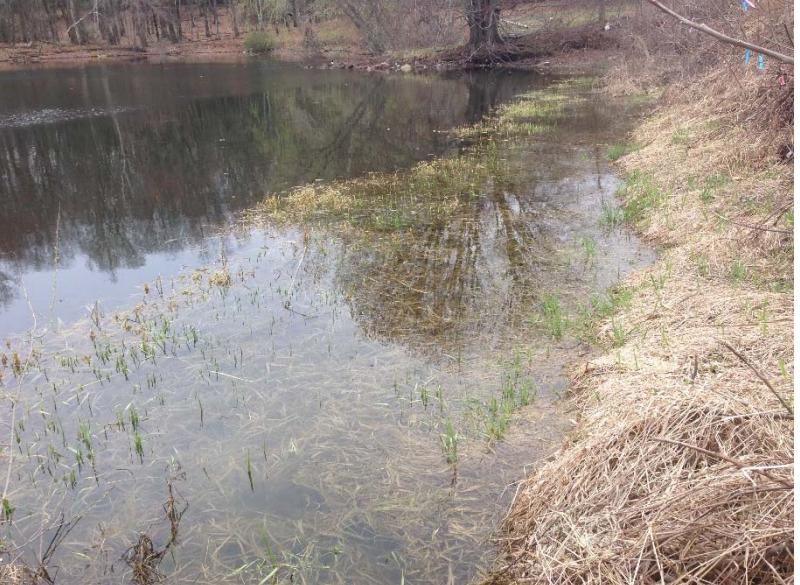
Farm Pond 2 - Photo 5	Description:

A photograph showing the edge of a pond. The water is calm, reflecting the surrounding trees and sky. In the foreground, there is a mix of green and brown vegetation, likely reed canary grass, partially submerged in the water. The bank of the pond is visible on the right, showing more of the same vegetation and some bare ground.	<p>This photo shows the existing condition along the north side of Pond 2 where a shelf of partially submerged reed canary grass attracted spawning American toad.</p>

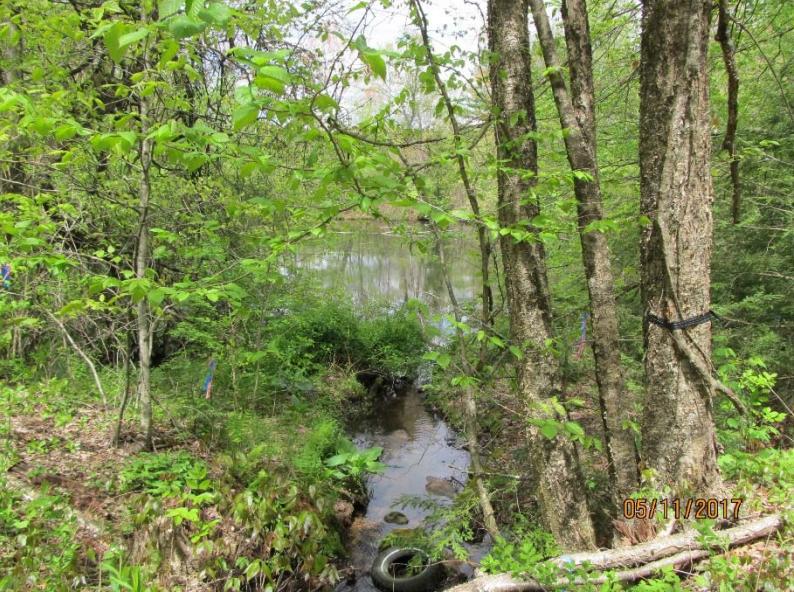
Farm Pond 3 - Photo 1

Description: Farm Pond 3 is an impoundment along Saxton Brook (foreground). It was constructed through a combination of excavation and construction of an earth impoundment.
Farm Pond 3 - Photo 2

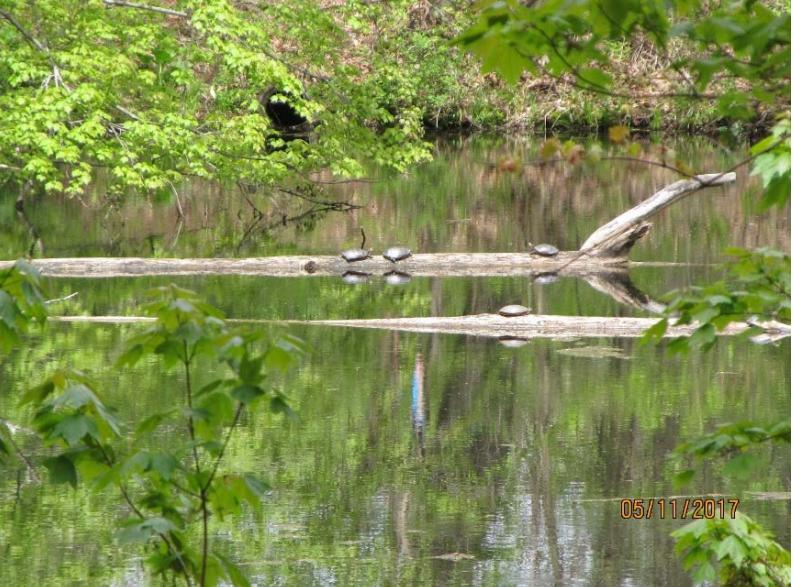
Description: No evidence of use by obligate vernal pool species was found. While we were unable to capture and identify fish in the pond, we did witness a belted kingfisher capture and consume a fish from this pond. Painted turtles were photographed sunning in this pond on May 11, 2017. This instream impoundment is not a vernal pool.

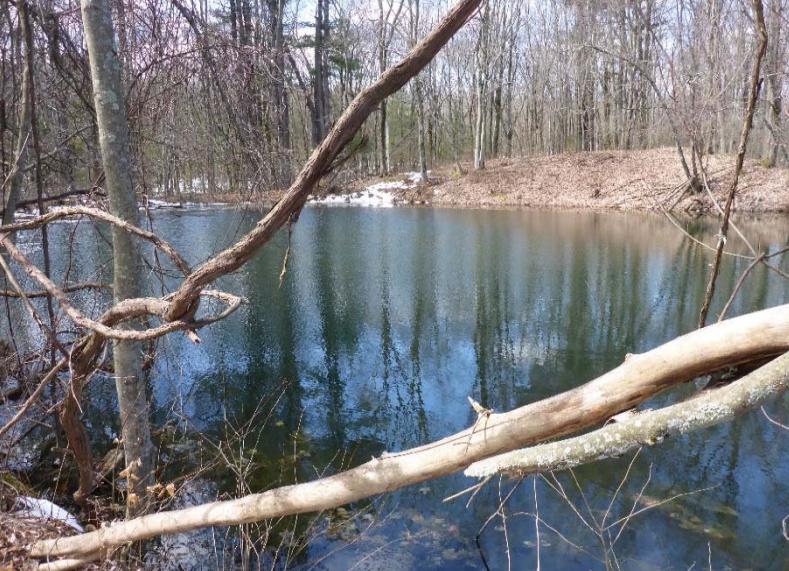
Farm Pond 4 - Photo 1	Description:

View of Farm Pond 4 looking southwest towards outlet. The pond was constructed by cutting into the northern hillside and constructing a berm along the southern half of the pond.
Farm Pond 4 - Photo 2	Description:

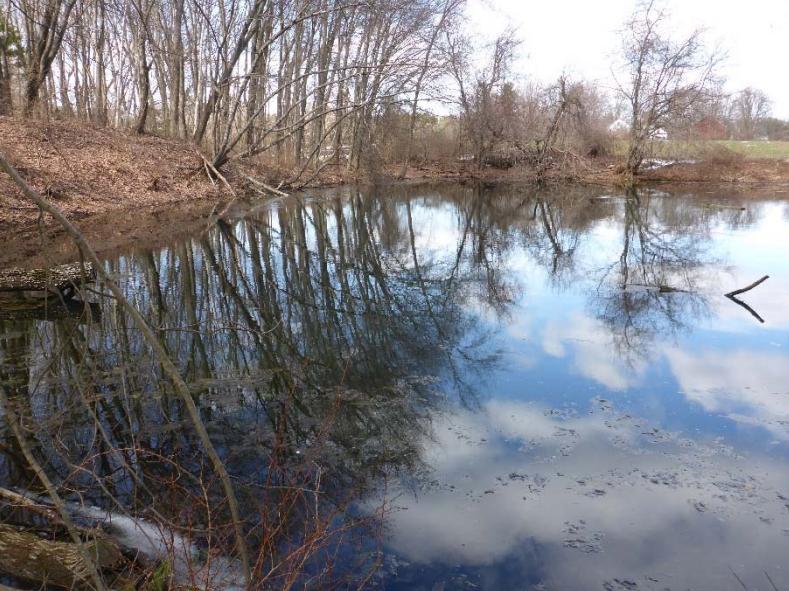
View of Farm Pond 4 looking north along the western bank. A small raft of wood frog eggs was found attached to the downed red maple sapling visible near the far corner of the pond.

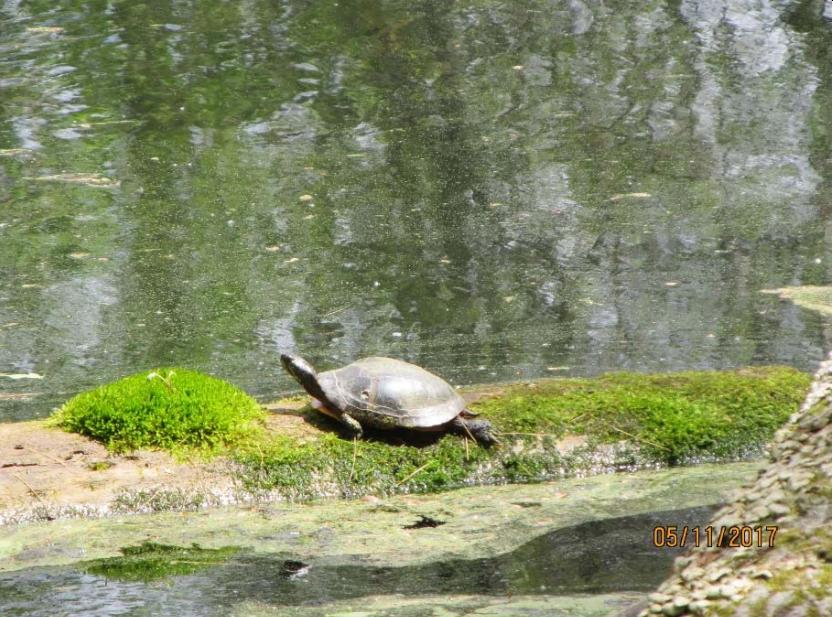
Farm Pond 4 - Photo 5

A photograph of a painted turtle resting on a mossy log in a pond. The water is green and reflects the surrounding trees. The turtle is facing left. The date '05/11/2017' is visible in the bottom right corner of the image.	Description: Pond 4 was found to contain fish and is inhabited by painted turtle.
Farm Pond 4 - Photo 6

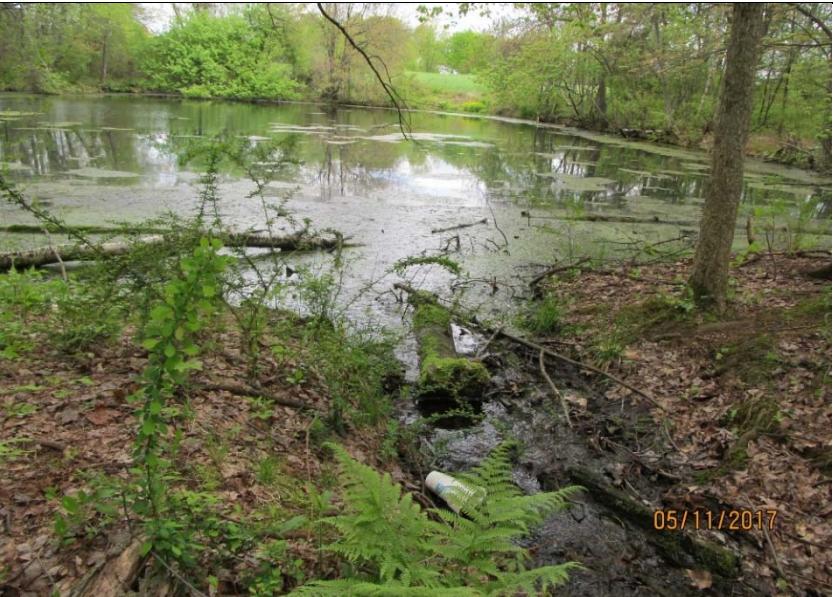
A photograph of Farm Pond 4 viewed from the pond outlet looking north. The water is covered with floating algal mats. The surrounding area is a mix of trees and shrubs. A metal can is visible on the ground in the foreground. The date '05/11/2017' is visible in the bottom right corner of the image.	Description: Farm Pond 4 viewed from the pond outlet looking north. The floating algal mats indicate that the pond is eutrophic.
