Re: Petition No. 1339 – Petition of Wallingford Renewable Energy LLC for a Declaratory Ruling that no Certificate of Environmental Compatibility and Public Need is Required for a 19.99 MW AC Solar Photovoltaic Electric Generating Facility in Wallingford, Connecticut

VERNAL POOL SURVEY REPORT

PROPOSED WALLINGFORD RENEWABLE ENERGY

WALLINGFORD, CONNECTICUT

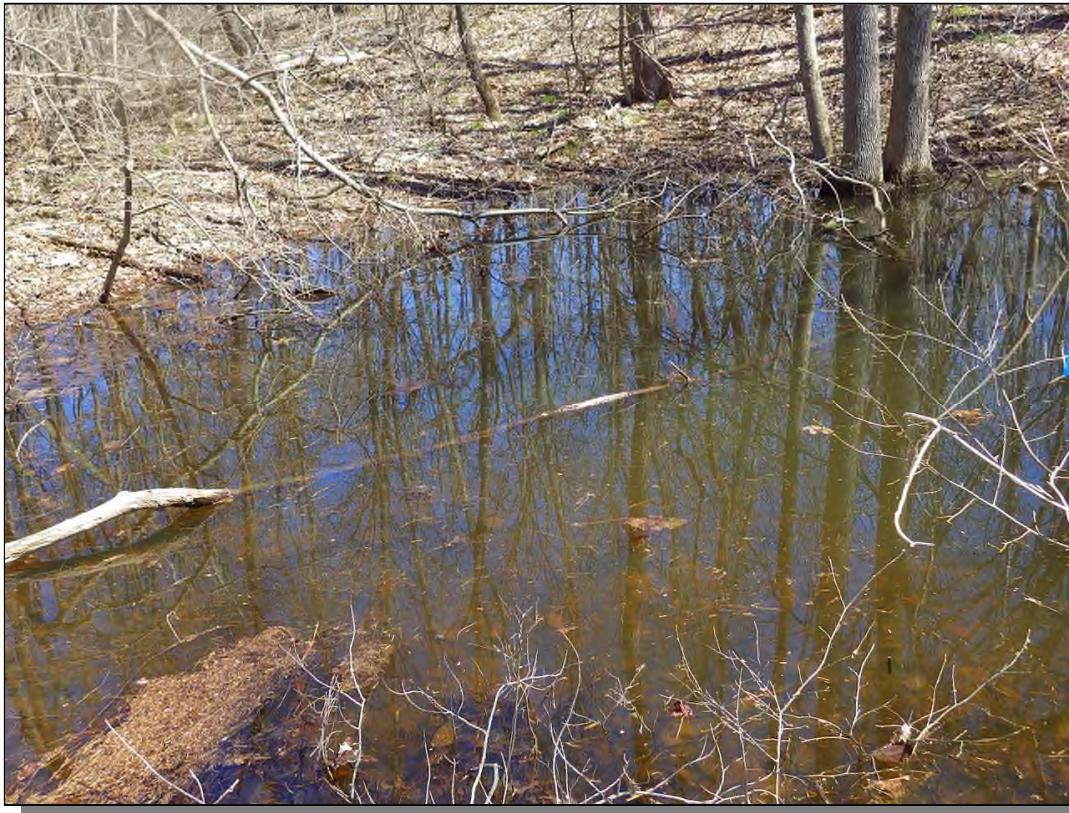
This vernal pool is found embedded with the wooded northern portion of Wetland B1¹ (see Attachment C, Photos 1 through 6). This is a classic, isolated parabolic basin, roughly 430 square feet in size. At maximum flood, the basin is capable of holding approximately 4 feet of water. OA observed a maximum of 42 inches of water on April 11, while REMA documented 32 inches on April 30, 2018. This pool is underlain by about 16 inches of topsoil that is high in organic matter, over glayed medium sand.

Photo 1: VP-1; facing easterly

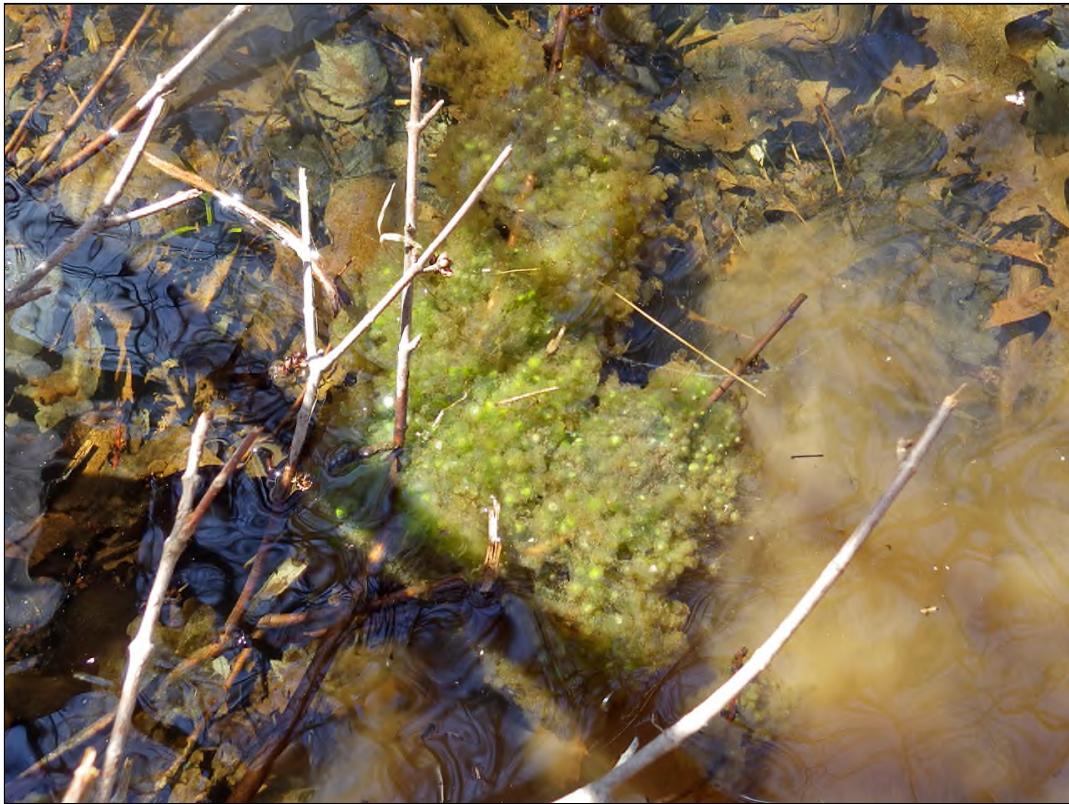
Photo 2: VP-1 with wood frog egg masses

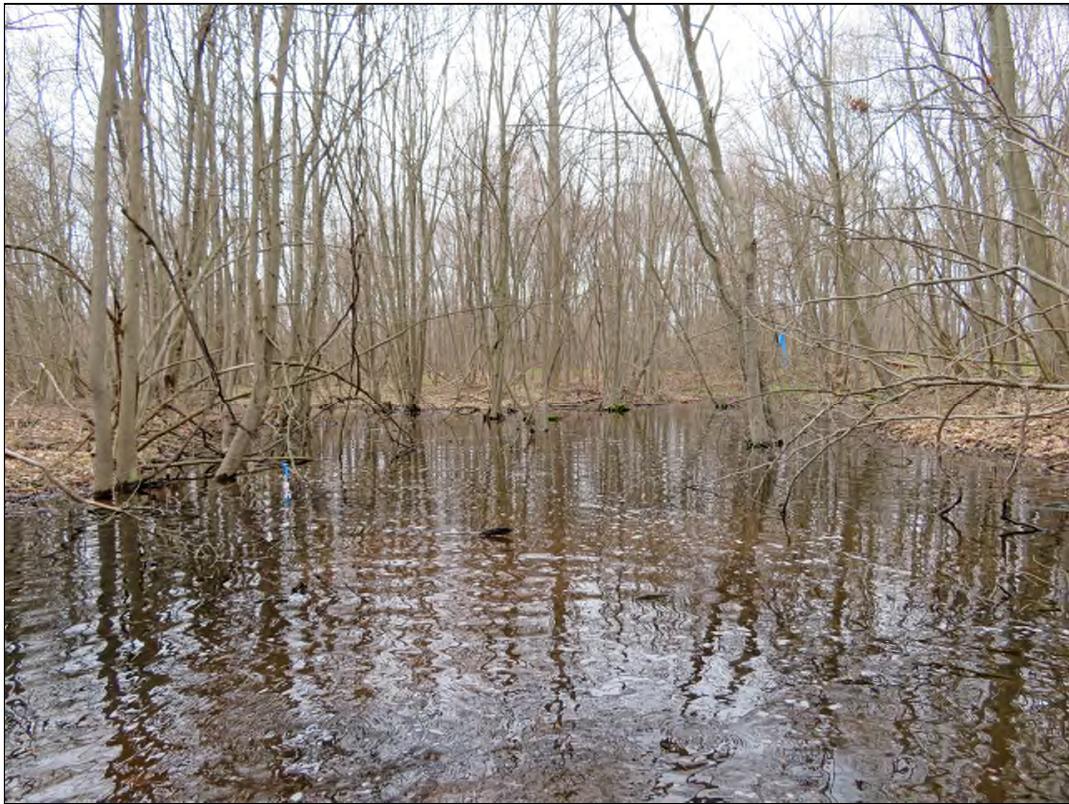
Photo 12: VP-2, April 30, 2018; blue flags indicate location of observed wood frog egg masses; facing northerly

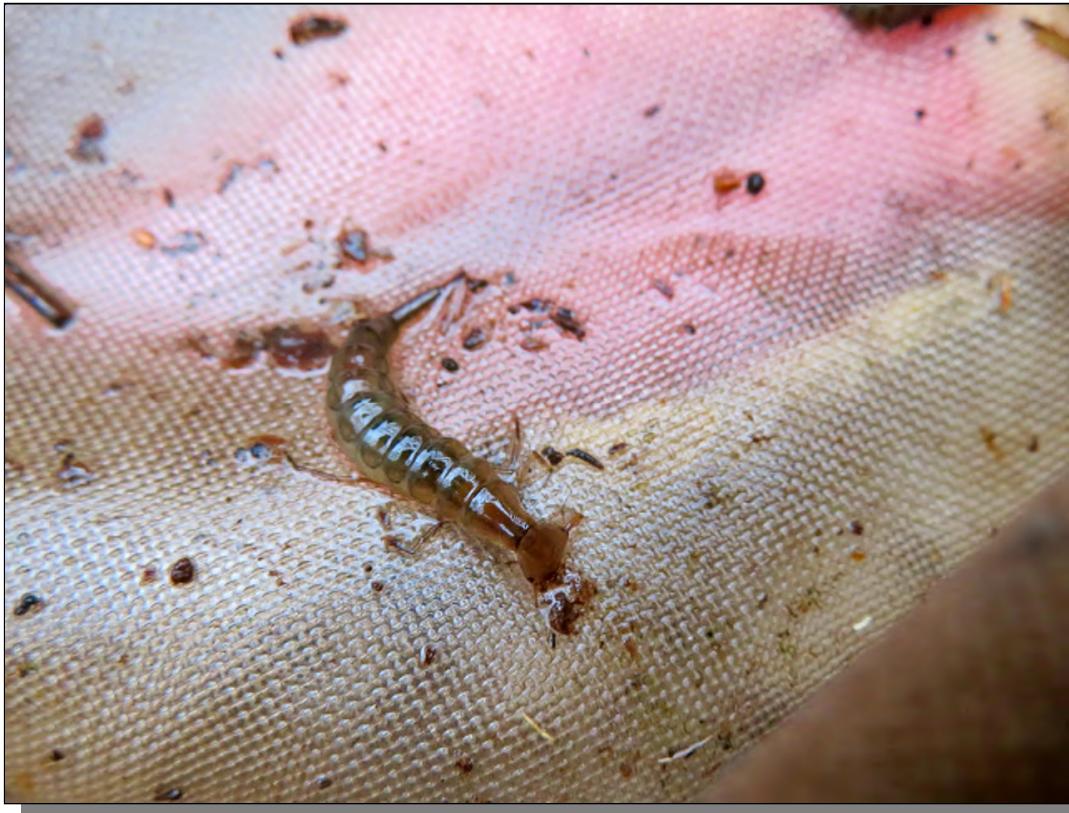
Limnephilid caddis fly larvae, Sphaeriid clams, and other invertebrates were also observed by both OA and REMA. REMA documented a moderate abundance of predaceous diving beetle larva (Dytiscidae), which may have contributed to the lack of wood frog larvae observed by REMA.

Photo 13: VP-2, predaceous diving beetle

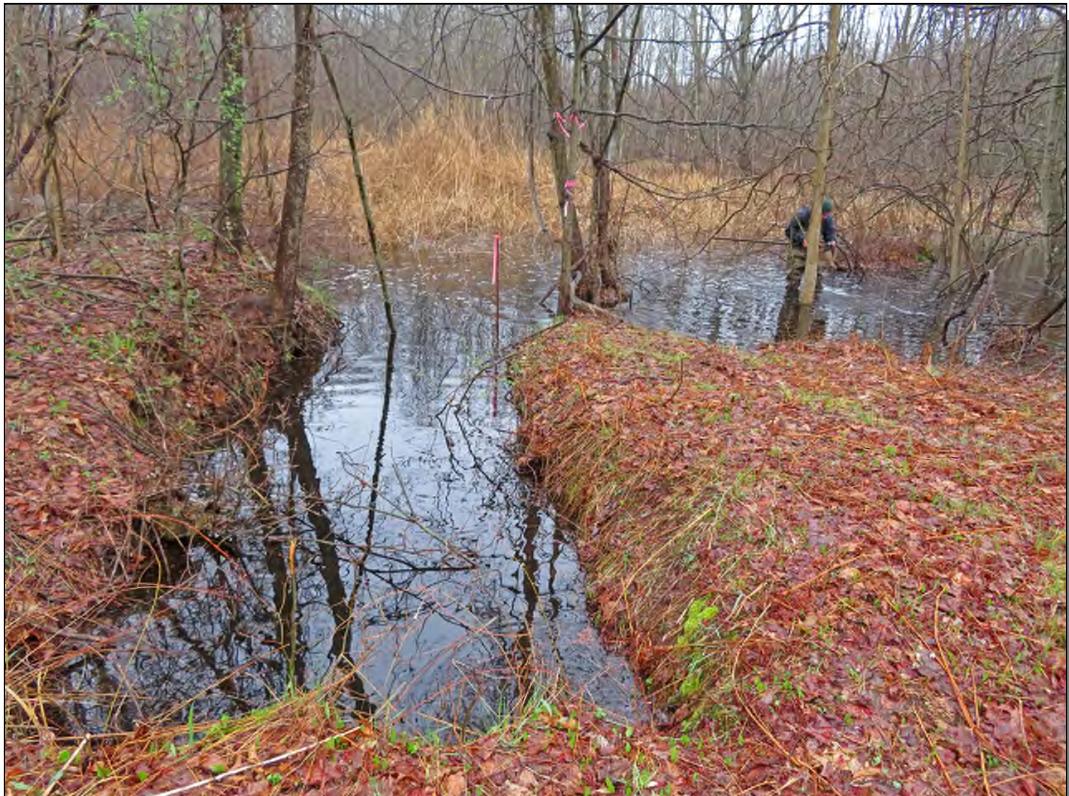
Vernal Pool 2A is unique within the Study Area, in that it has a relatively narrow ditched outlet, which regulates water depths. The ditch is culverted under the adjacent utility corridor, but narrows to the west (see Figure A). On April 27, REMA noted that the ditch, which had been delineated as a wetland, was restricting flows westerly to Wetland B1 and its embedded Vernal Pool 2 due to a woody debris and leaf jam. It also appeared that this artificial restriction had been somewhat larger in the past, but the intense 3.08-inch storm event on April 16 had likely dislodged part of this “dam” (also see climatological data in Attachment B, Table B). This may in part explain the unaccounted-for wood frog egg masses and the lack of wood frog larvae observed on April 27, 2018. It is probable that the OA-observed wood frog egg masses were washed out during the storm and/or were stranded on higher ground, after the “dam” was partially dislodged, lowering water levels. Additionally, predation of larvae by invertebrates and vertebrates could also be involved.

Photo 20: VP-2A viewed from gas line ROW; note outlet ditch; facing southeasterly

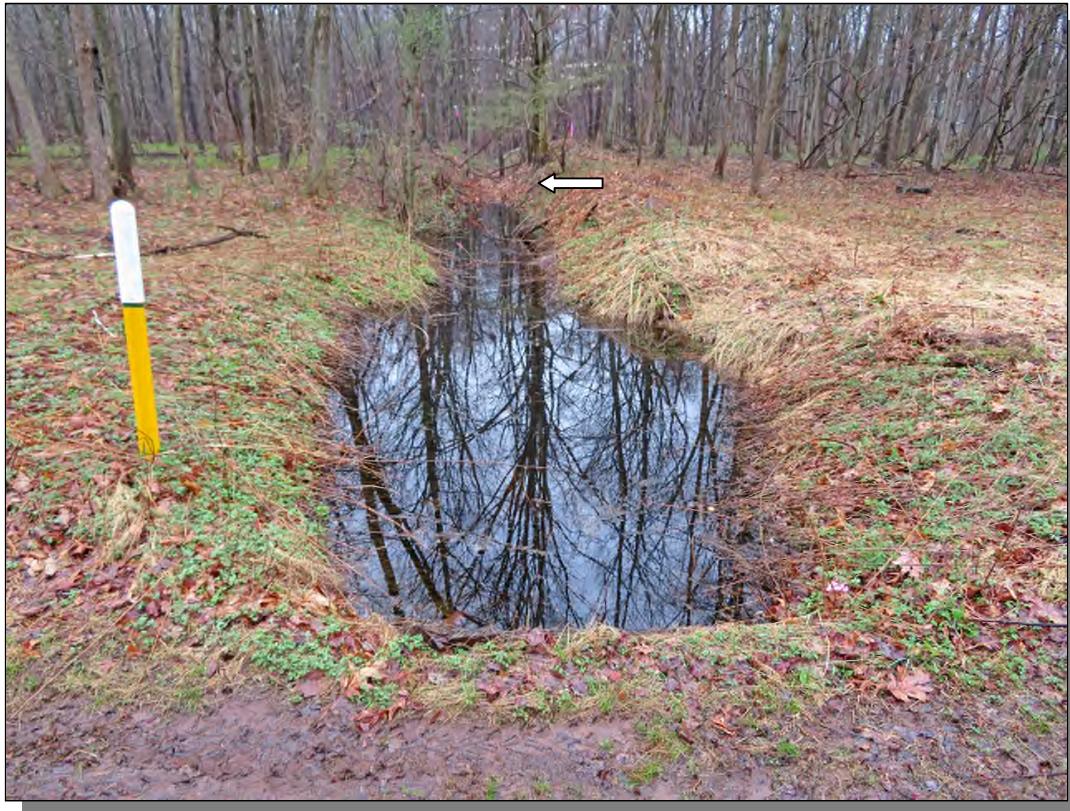
Photo 21: VP-2A outlet ditch with arrow indicating wood debris and leaf jam “dam;” facing northwesterly

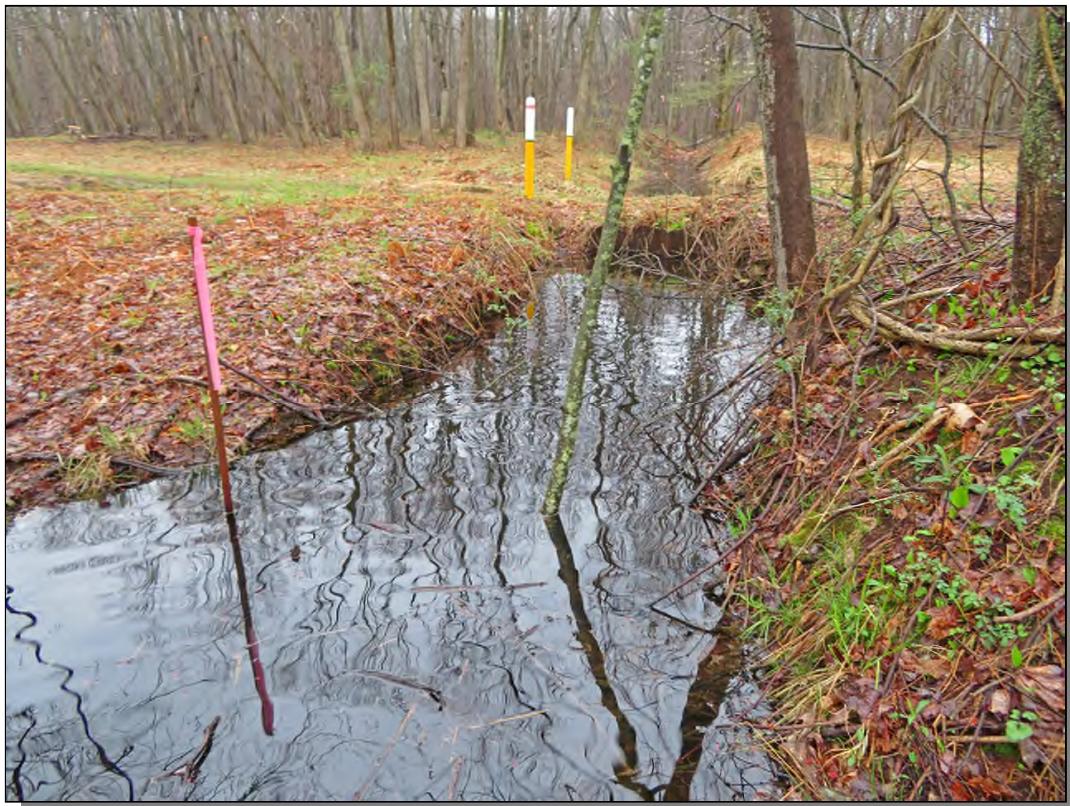
Photo 22: VP-2A outlet ditch with culvert under gas line ROW completely inundated due to artificial/temporary “dam” further downstream; facing northwesterly

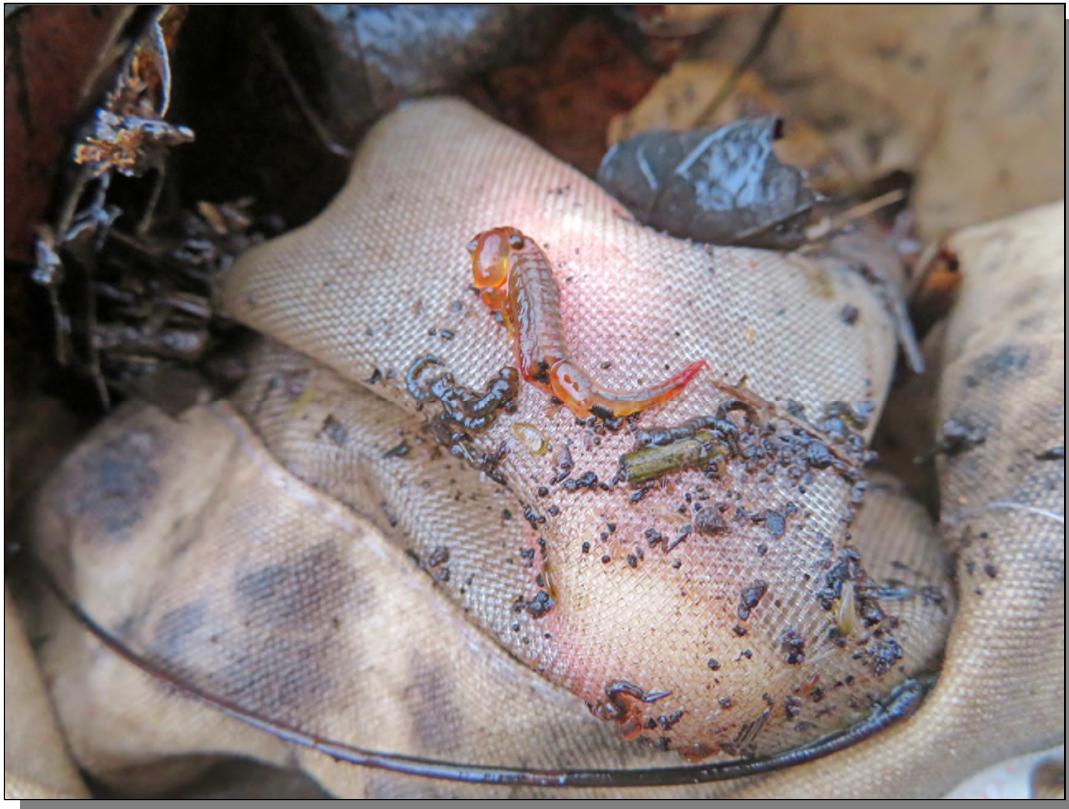
Photo 23: VP-2A fairy shrimp

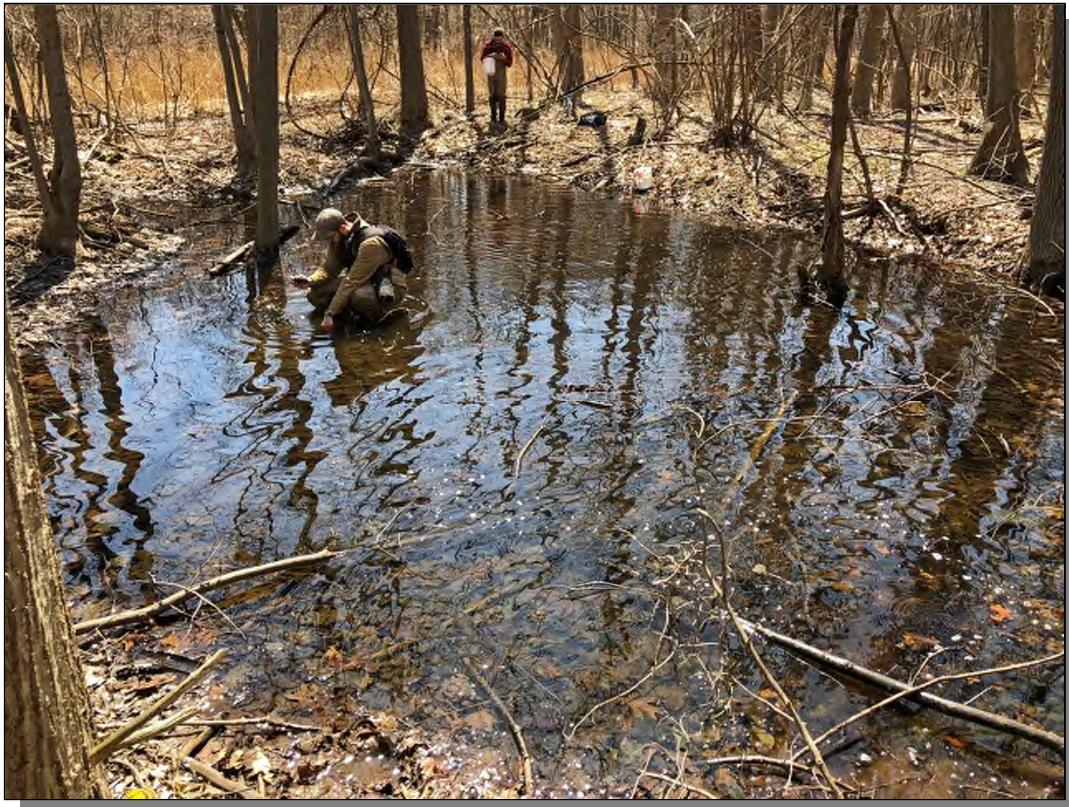
This vernal pool is embedded within Wetland B1, approximately 50 feet to the southwest of Vernal Pool 2, and occurs up against the natural gas pipeline corridor (see Attachment A, Figure A). The pool habitat is approximately 1,300 square feet in size and was observed with water depths of 16-18 inches (see Attachment C, Photos 27 through 31). Its invert is

Photo 27: VP-3 on April 11, 2018; facing southeasterly

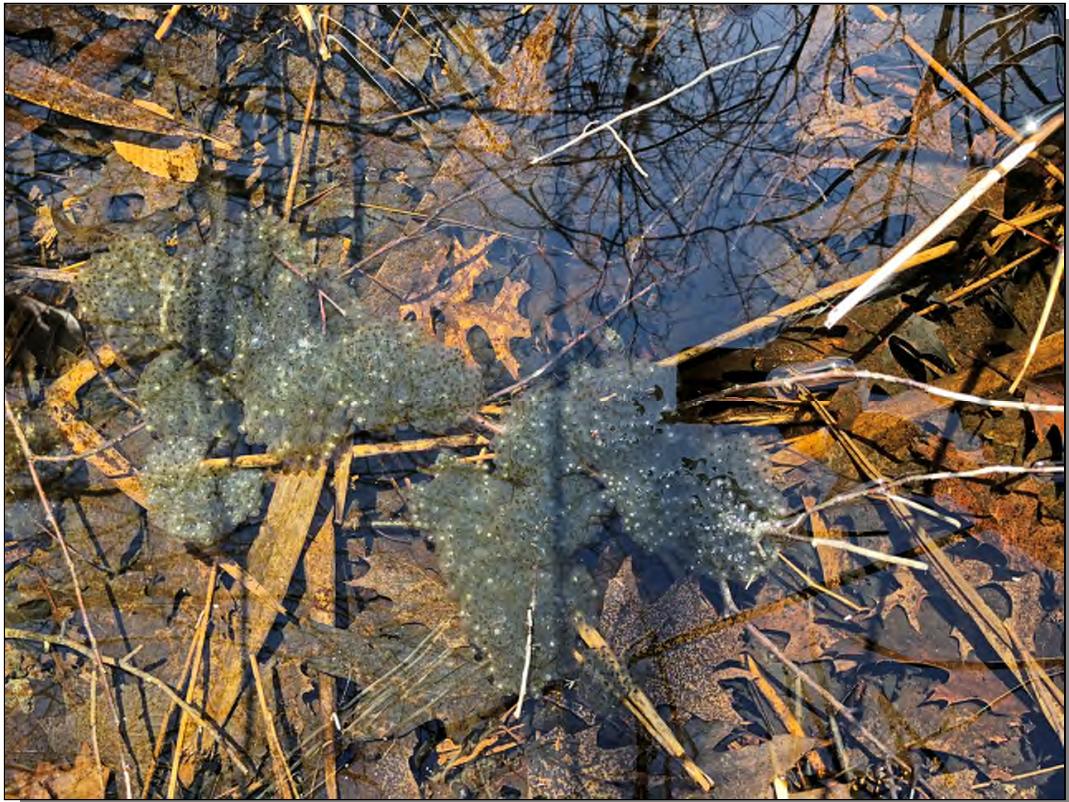
On April 11, OA counted 9 spotted salamander egg masses, along with 13 wood frog egg clusters. Notably, many of the spotted salamander egg masses were inordinately small (+/-3 centimeters), more typical of second depositions by a female. More typical sized egg masses were not observed in the vicinity of the diminutive masses.

Photo 33: VP-4, April 11, 2018; wood frog egg masses

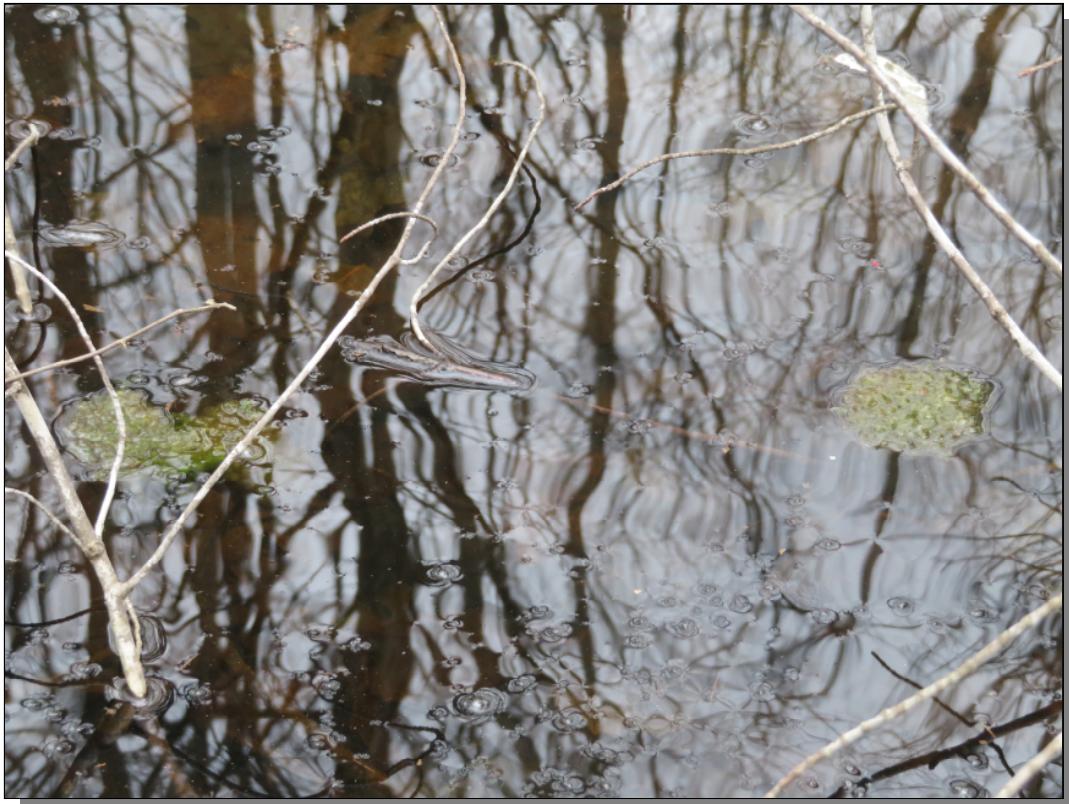
This vernal pool is loosely connected to Vernal Pool 4, especially during high flow periods, and is an additional vernal pool habitat of approximately 260 square feet documented during the 2018 survey (see Figure A; Attachment C, Photos 38 through 41). Maximum depths recorded by OA and REMA were 36 inches and 20 inches on April 11 and April 27, respectively.

OA initially observed five spotted salamander egg masses, while the REMA recount yielded four. On April 11, OA counted four wood frog egg masses, while on April 27 REMA observed two more for a total of six; four of the egg masses were fully hatched, while two had hatched with the larvae still present within the disintegrating egg mass. This would indicate a late arrival to the pool for breeding. The typical invertebrates were observed but fairy shrimp were absent.

Photo 38: VP-4A, April 30, 2018; mostly hatched wood frog egg masses

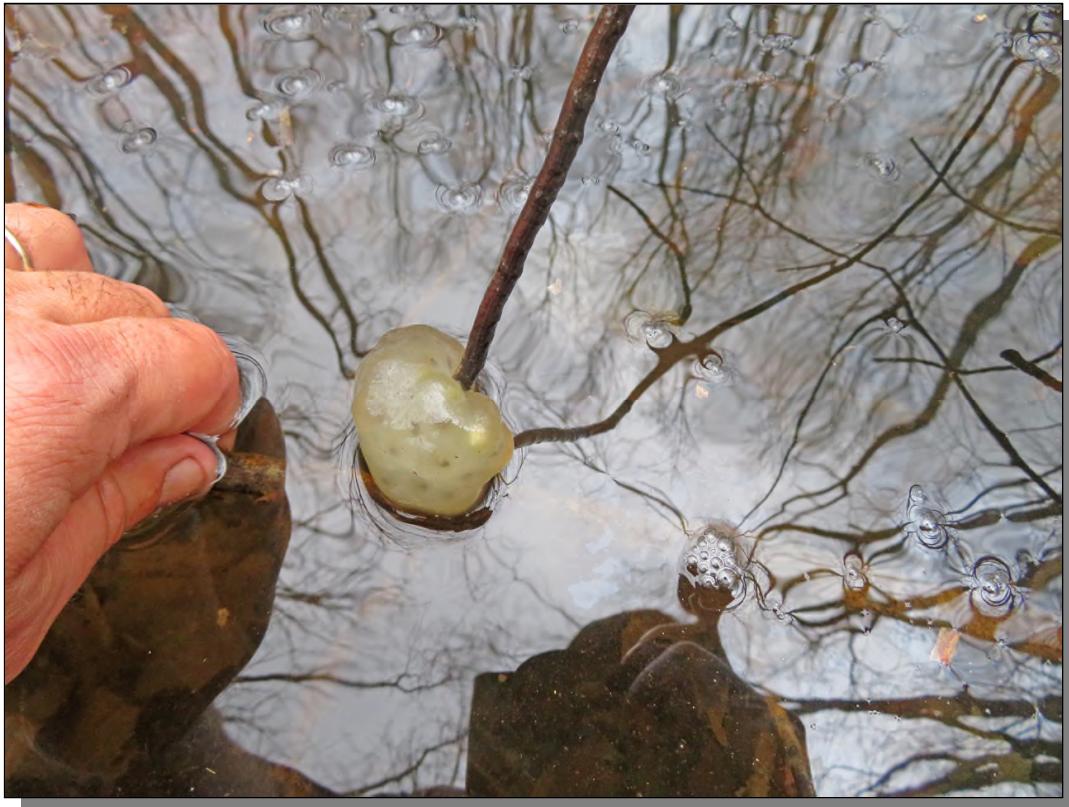
Photo 39: VP-4A spotted salamander egg mass

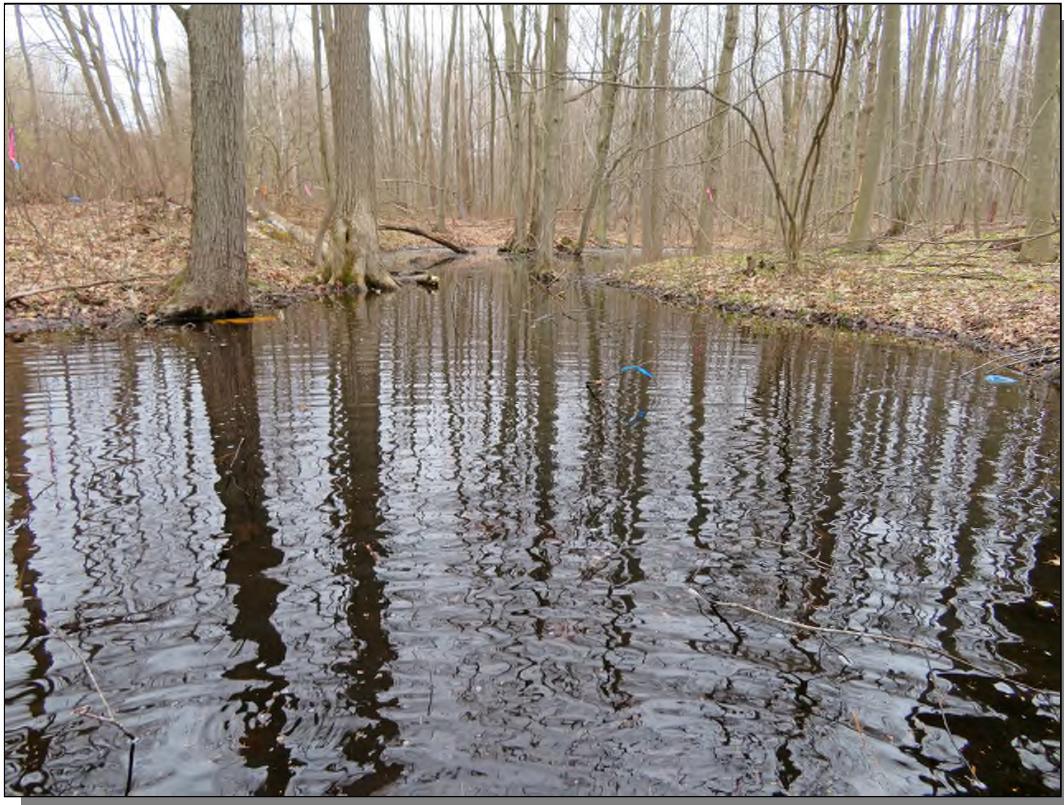
Photo 45: VP-5; April 30, 2018; blue flag indicates presence of egg mass; facing westerly
