**TO:** Gina L. Wolfman, Senior Project Developer, Clean Focus Renewables  
**FROM:** Megan B. Raymond, MS, PWS, Senior Project Manager, Environmental Science  
**RE:** 35 Taugwonk Spur Road Vernal Pool Impact Assessment  
**DATE:** July 30, 2019  
**MMI #:** 6763-05

**RE: Wetland and Watercourse Delineation  
Stonington PV Solar Facility Property  
35 Taugwonk Spur Road  
Stonington, Connecticut  
MMI #6763-05**

**RE: Wetland Delineation Report  
Taugwonk Road, Stonington, CT  
SWCA Job Number: 52669**

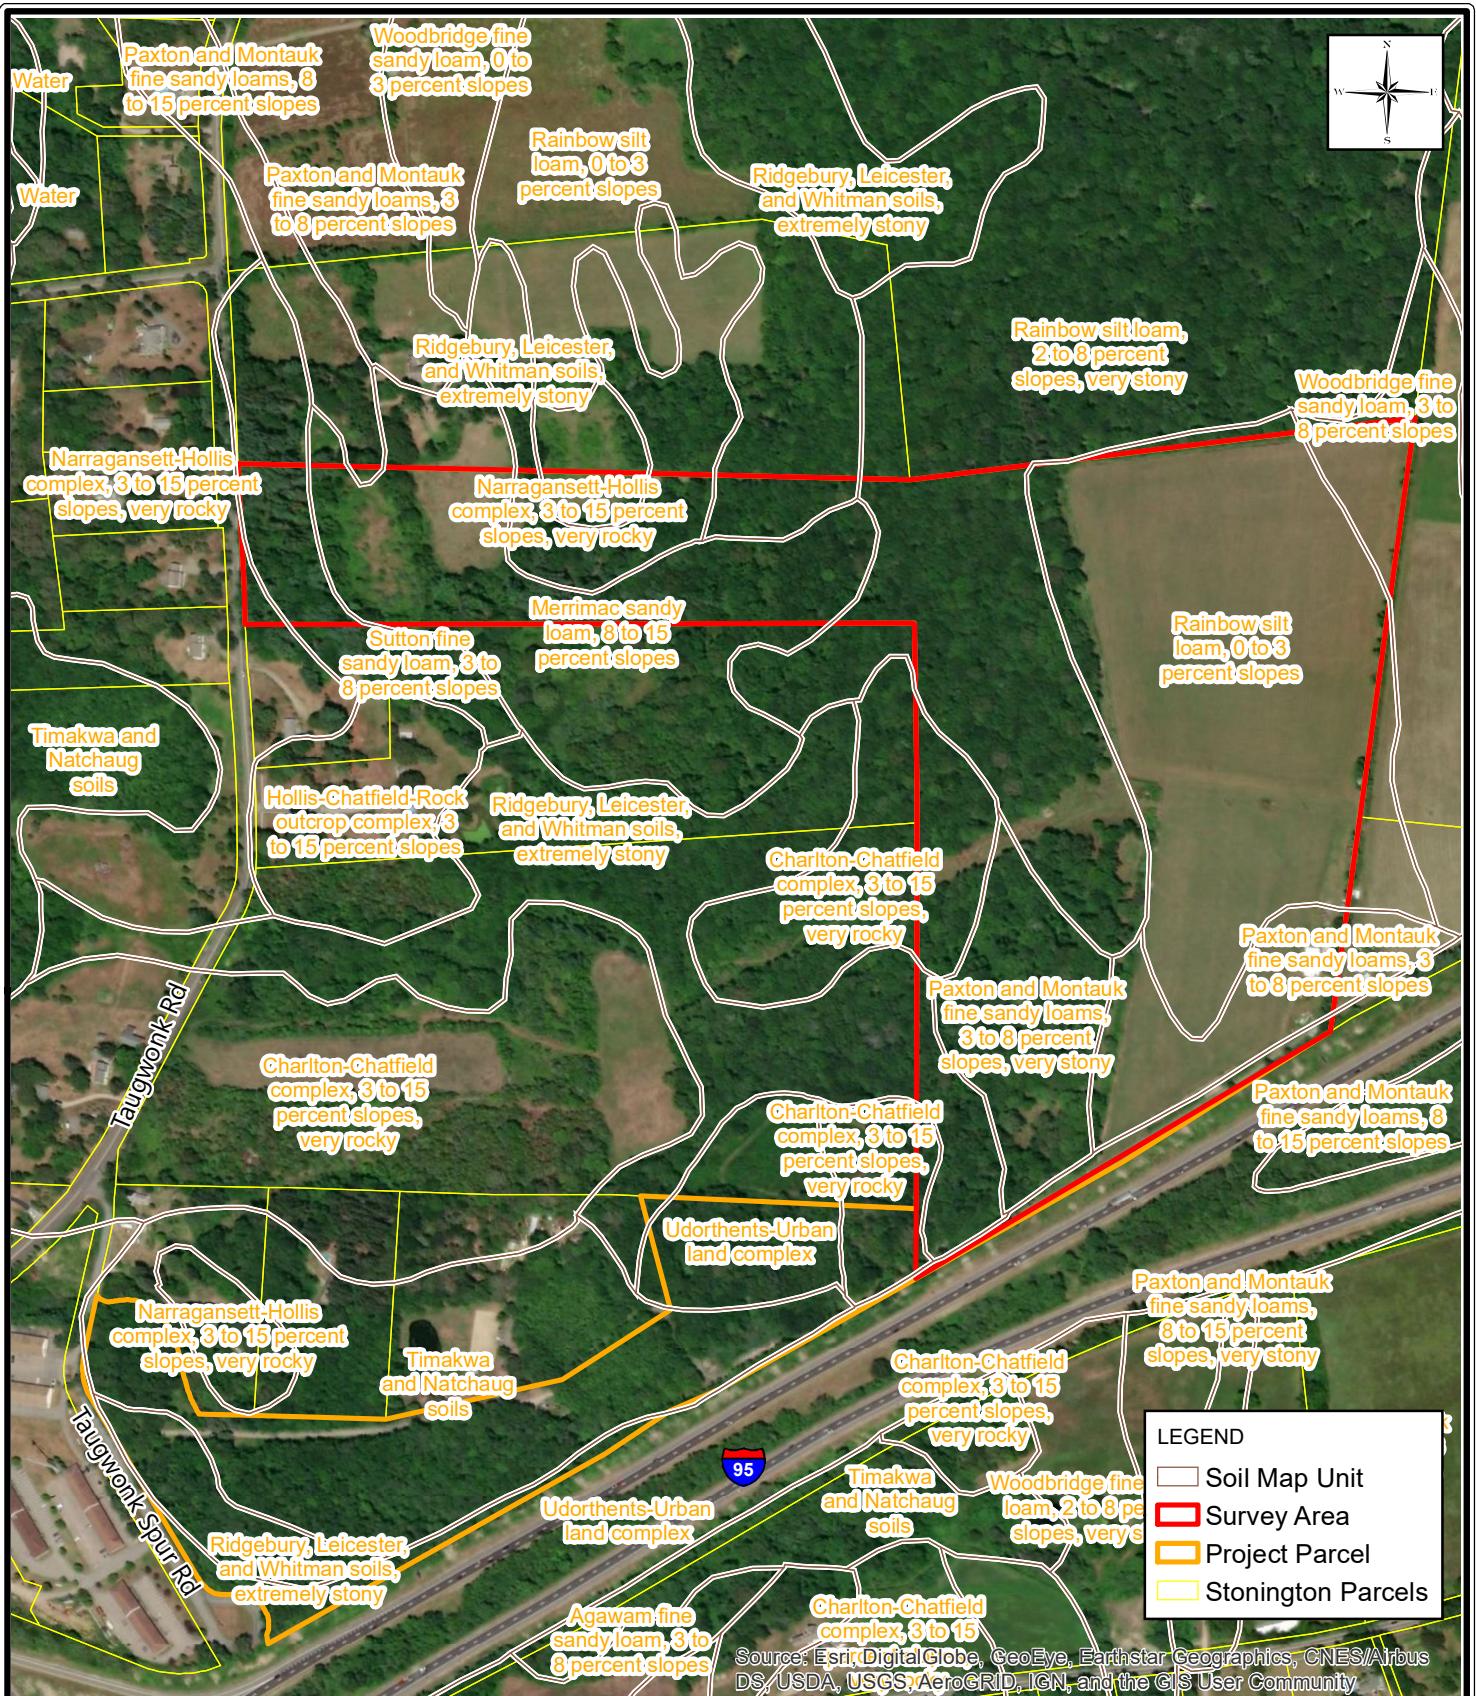
**FIG. 3**

In the 65.12-acre survey area, 12 soil map units were identified (11 upland and one wetland; Figure 3). Each map unit represents a specific area on the landscape and consists of one or more soils for which the unit is named. Other soils (inclusions that are generally too small to be delineated separately) may account for 10 to 15 percent of each map unit. The mapped units are by name, symbol, and typical characteristics (parent material, drainage class, high water table, depth to bedrock, and slope) (Table 1). These characteristics are generally the primary characteristics to be considered in land use planning and management. A description of each characteristic and its land use implications follows the table. A complete description of each soil map unit can be found in the *Soil Survey of the State of Connecticut* (USDA, 2005) and at <http://soils.usda.gov/technical/classification/osd/index>.

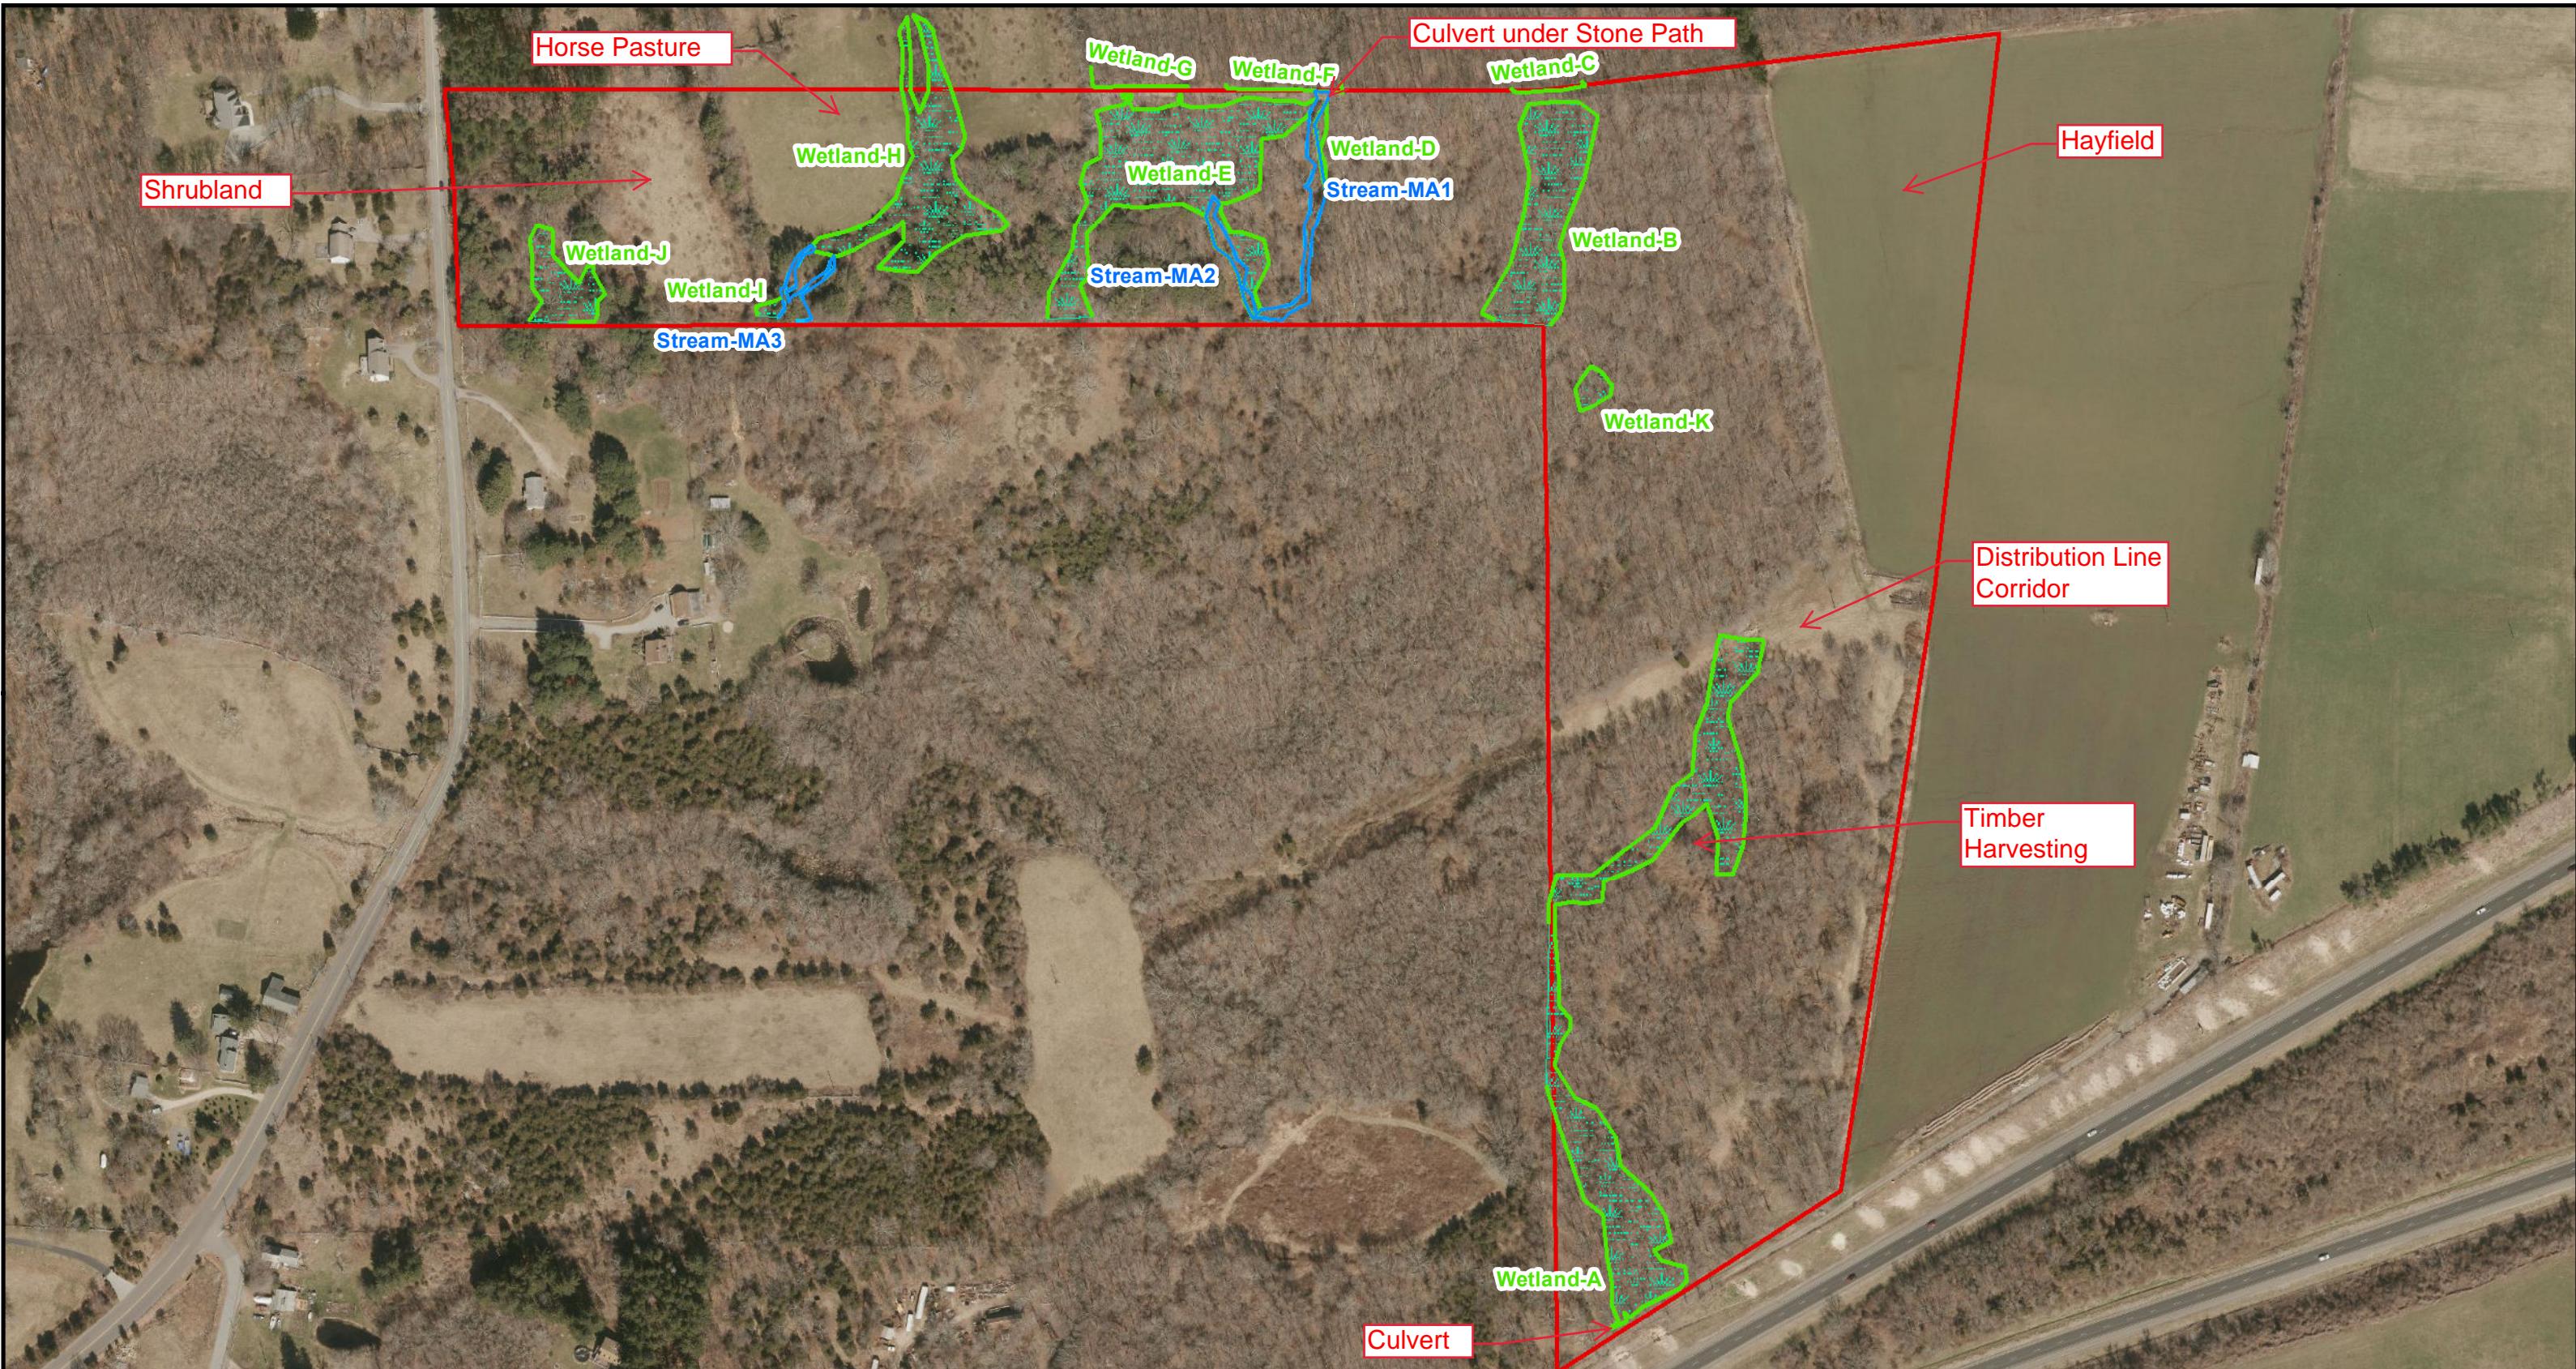
**Delineated Features**

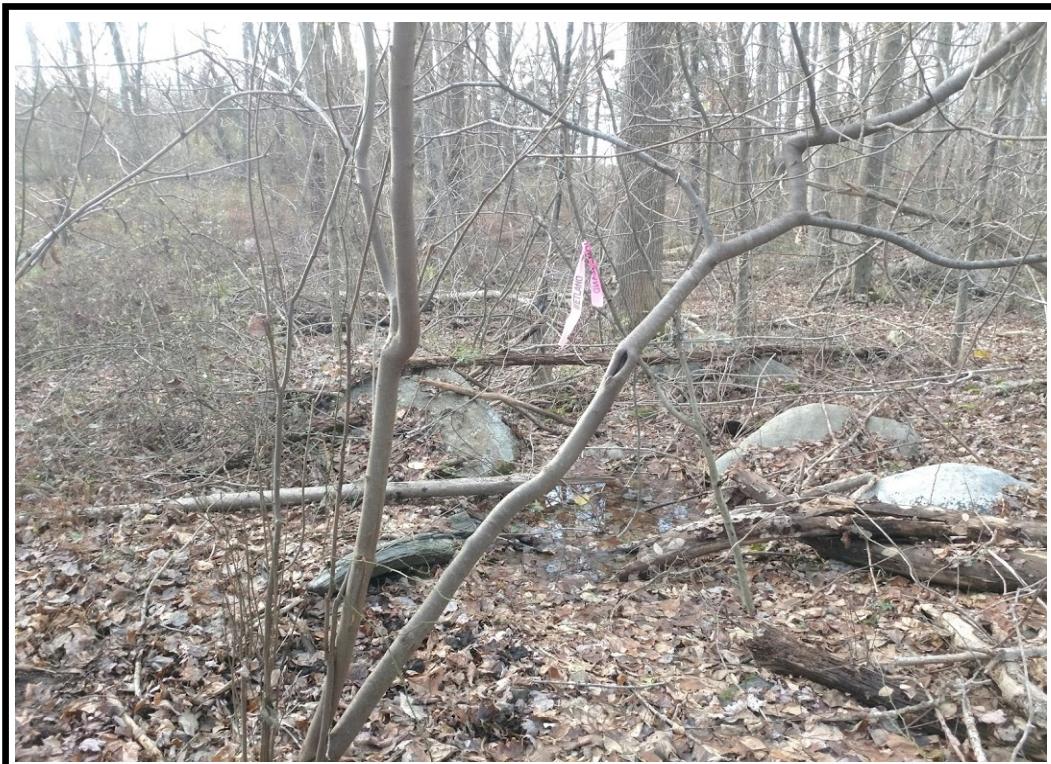
Photo 1: Data plot for Wetland A by flag A13 characterizing a wetland forest community (photo taken 11/15/18).

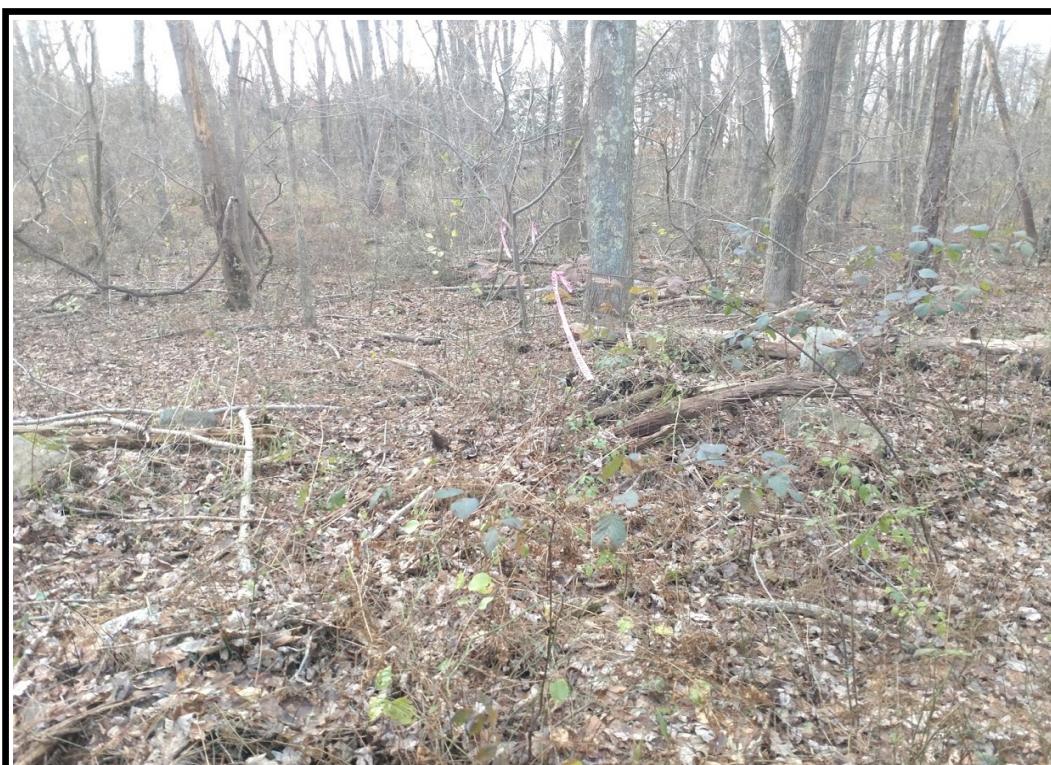
Photo 2: Data plot for Wetland A by flag 13 characterizing the adjacent upland forest community (photo taken 11/15/18).

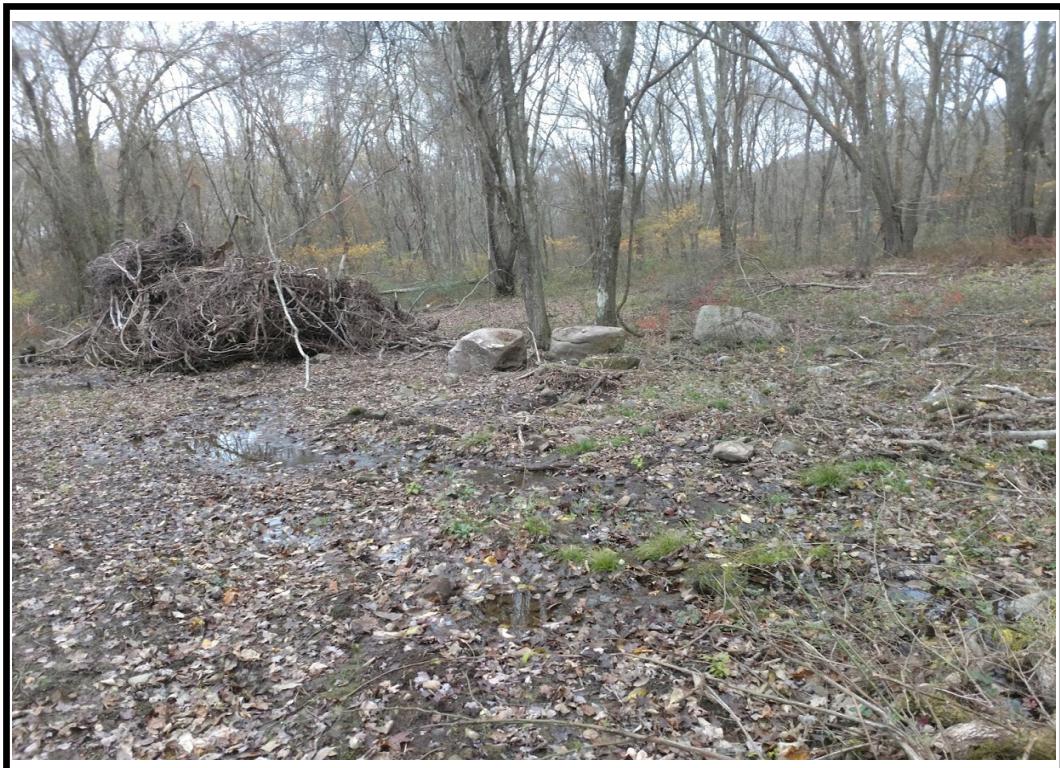
Photo 3: Tree clearing in portion of Wetland A by flag A31 (photo taken 11/14/18).

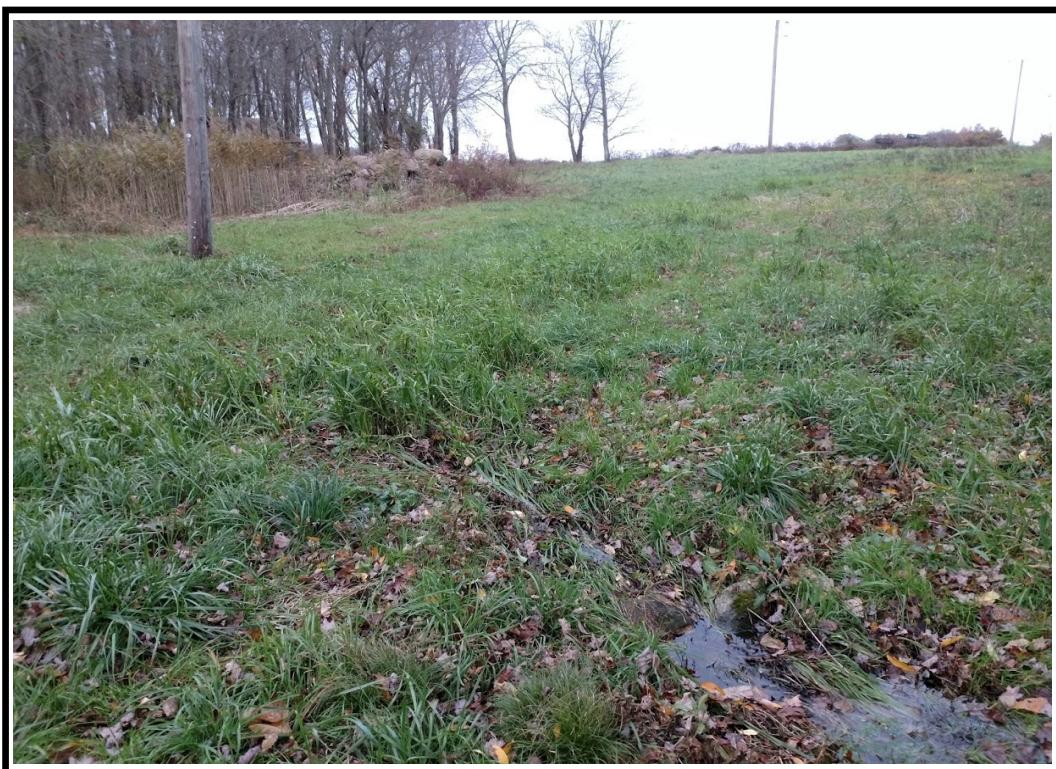
Photo 4: Wetland A in maintained distribution line corridor by flag A-42 that is in emergent cover (photo taken 11/14/18). View is looking northeast.

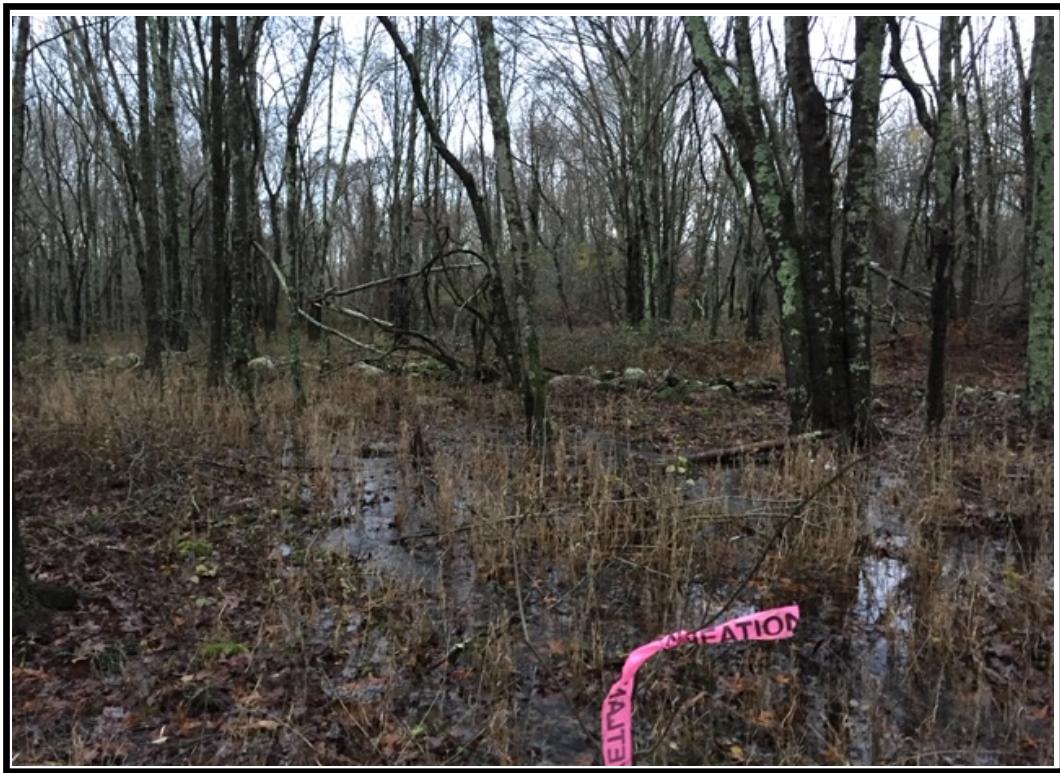
Photo 5: Data plot for Wetland B by flag B7 characterizing a wetland forest community (photo taken 11/14/18).

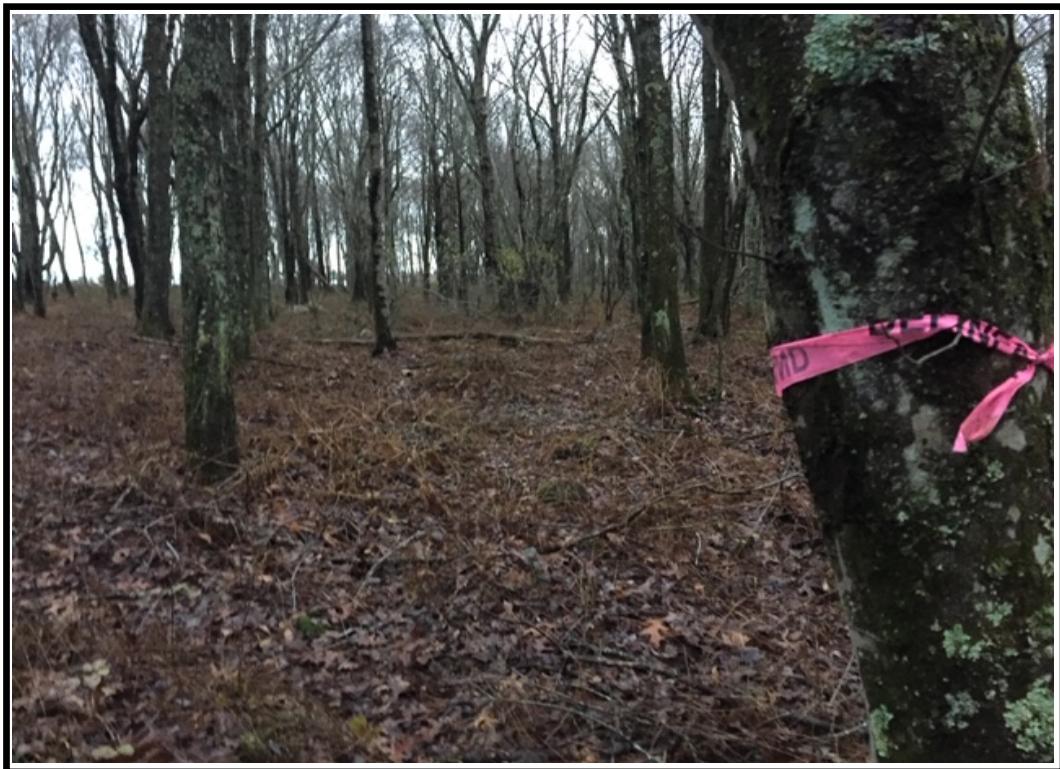
Photo 6: Data plot for Wetland B by flag B7 characterizing the adjacent upland forest community (photo taken 11/14/18). View is east towards the hayfields.

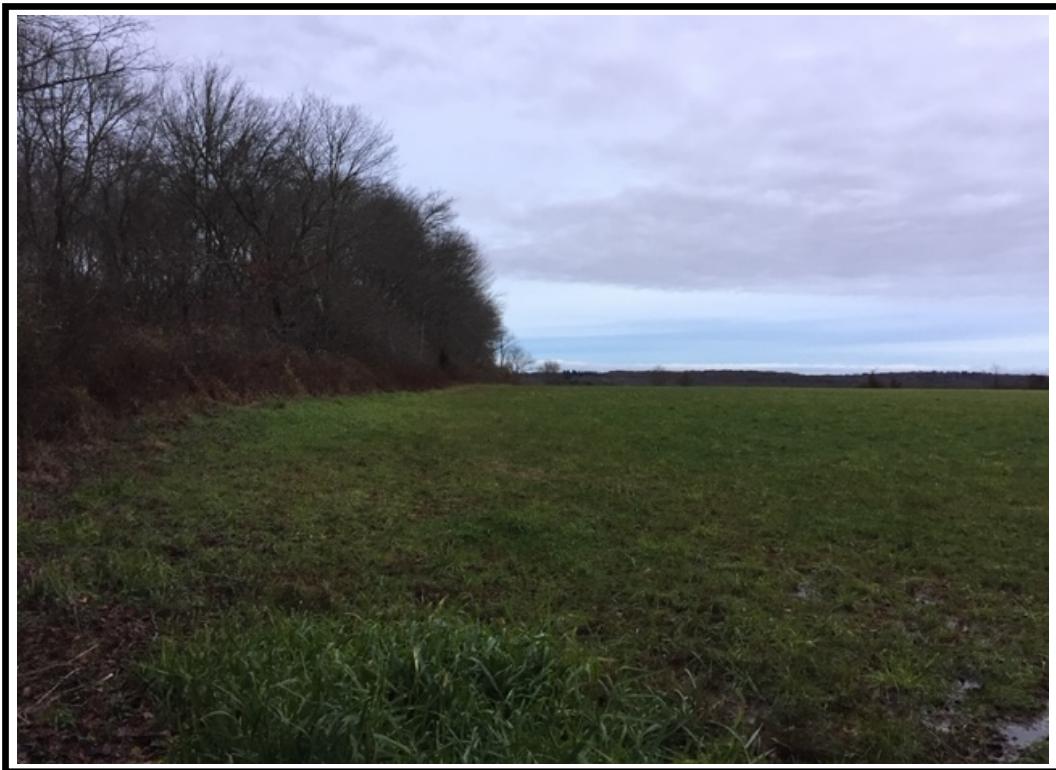
Photo 7: Hayfield located in the northeastern corner of the survey area looking east from the beginning of maintained path/tree line (photo taken 11/14/18).

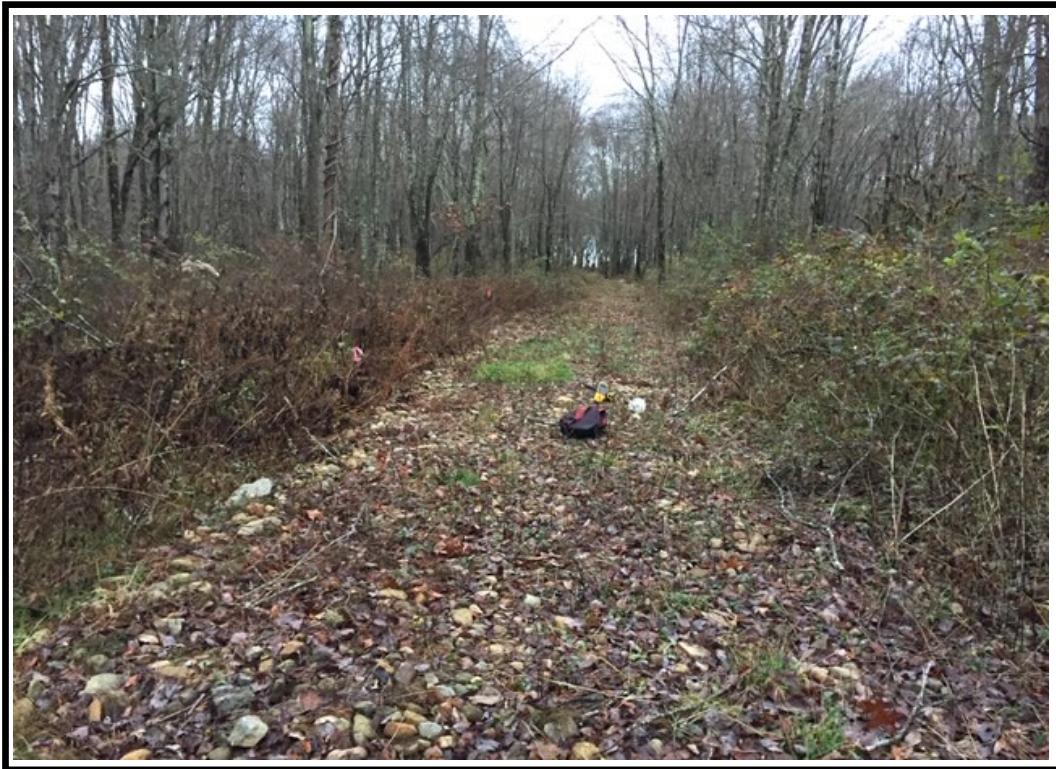
Photo 8: Maintained path looking northeast towards the hayfield (photo taken 11/5/18). The path is raised approximately one to two feet and comprised of stones where adjacent to Wetlands C, D, E, F and G.

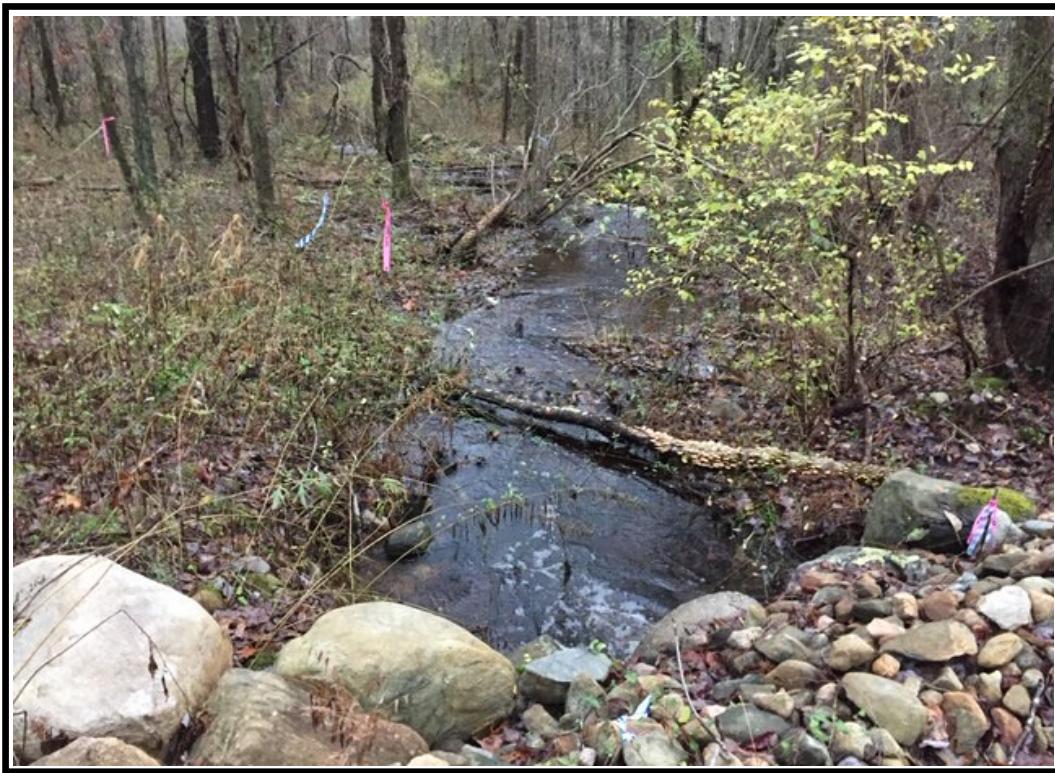
Photo 9: Intermittent stream (Stream MA1) where it discharges via culvert south of the stone path (photo taken 11/5/18). Wetland D, a forested wetland, borders the stream in this location.

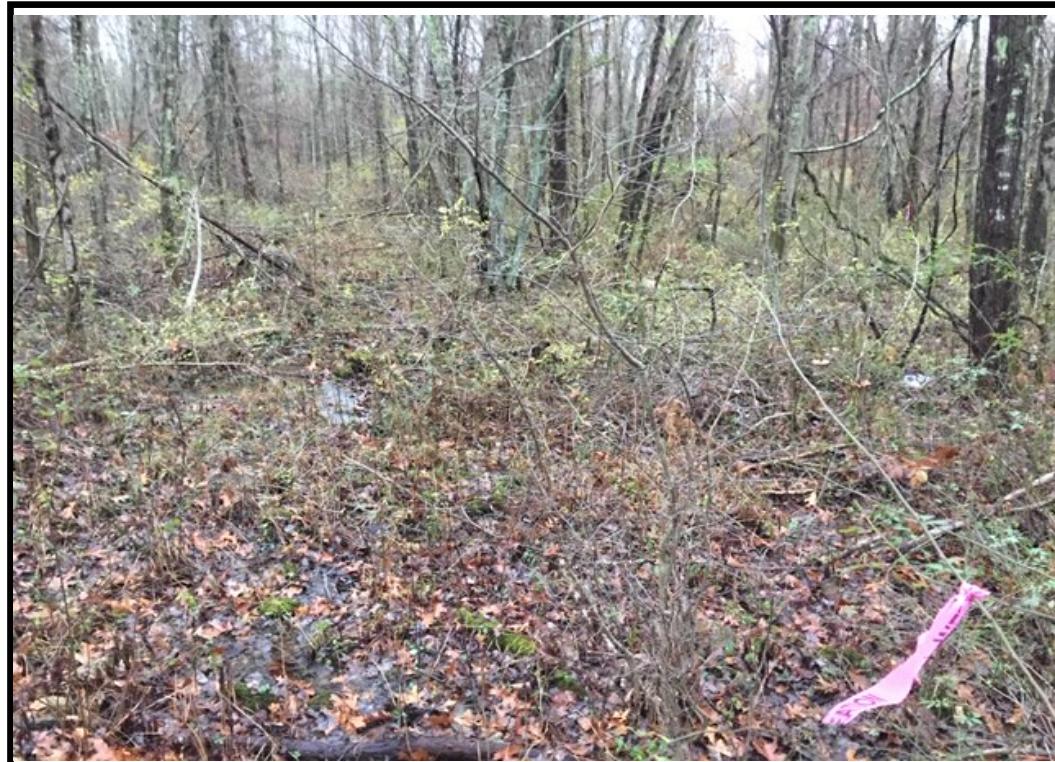
Photo 10: View of Wetland E, a forested wetland, looking south by flag E104 from the stone path (photo taken 11/5/18).

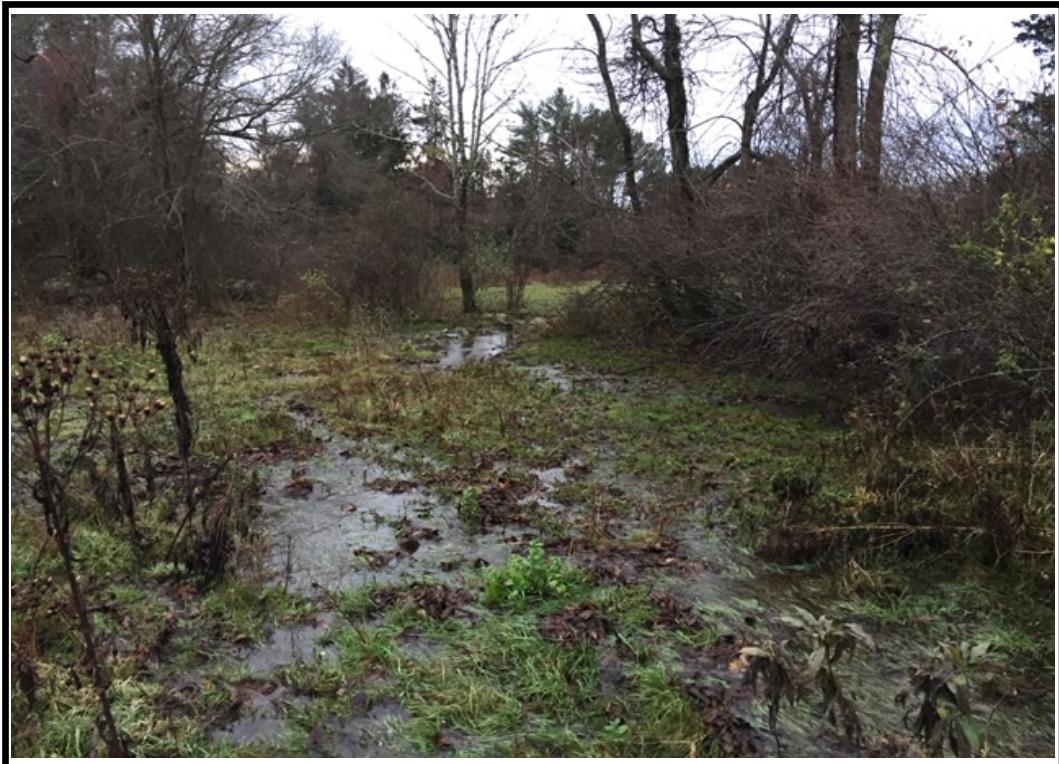
Photo 11: An emergent portion of Wetland H in a horse pasture looking southwest from flag H4 (photo taken 11/14/18).

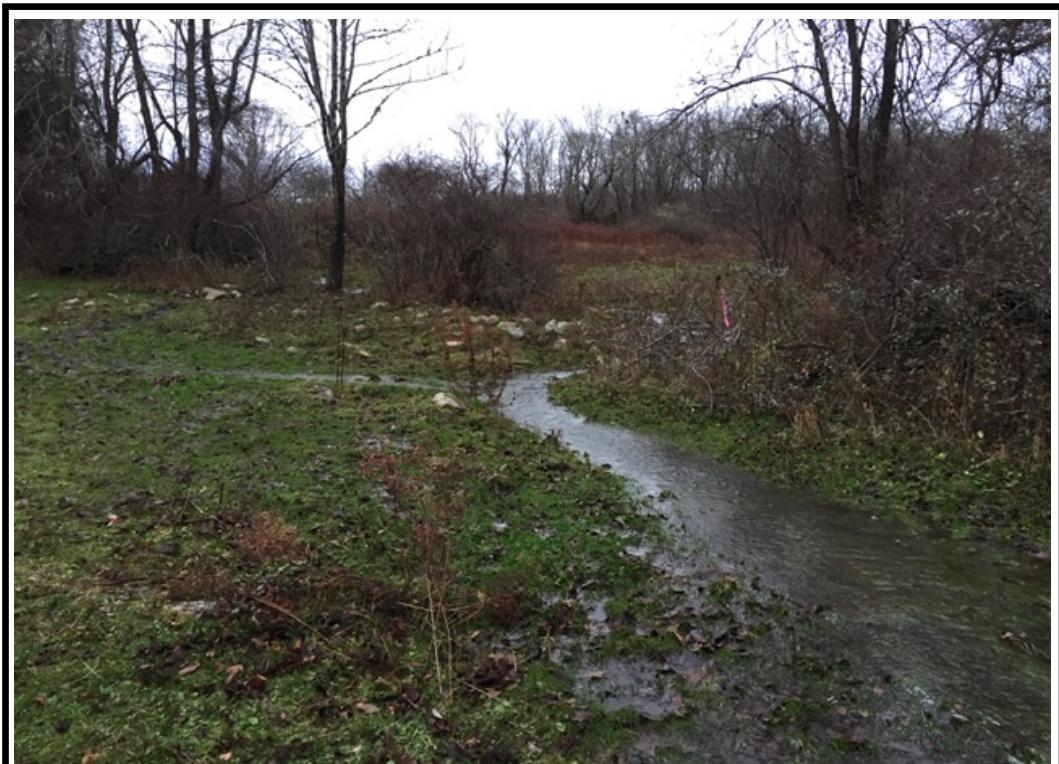
Photo 12: Wetland H in the horse pasture looking northward from flag H33 (photo taken 11/14/18).

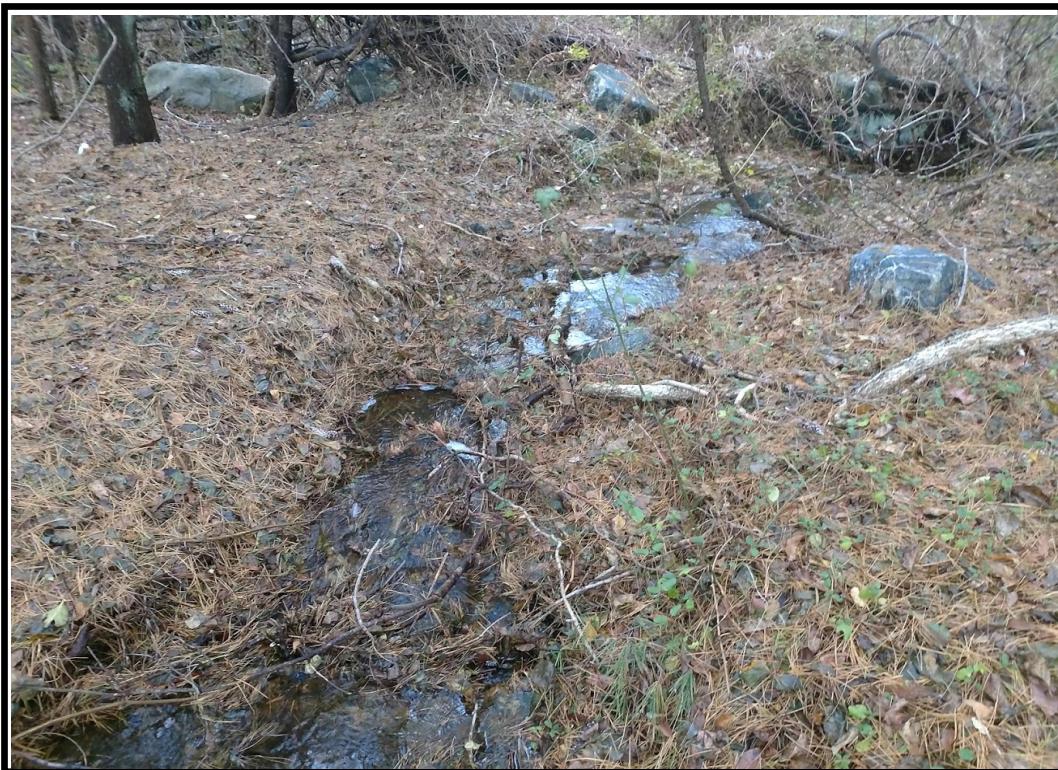
Photo 13: Intermittent stream (Stream MA3) looking southward from flag MA3-205 (photo taken 11/14/18). The stream receives drainage from Wetland H.

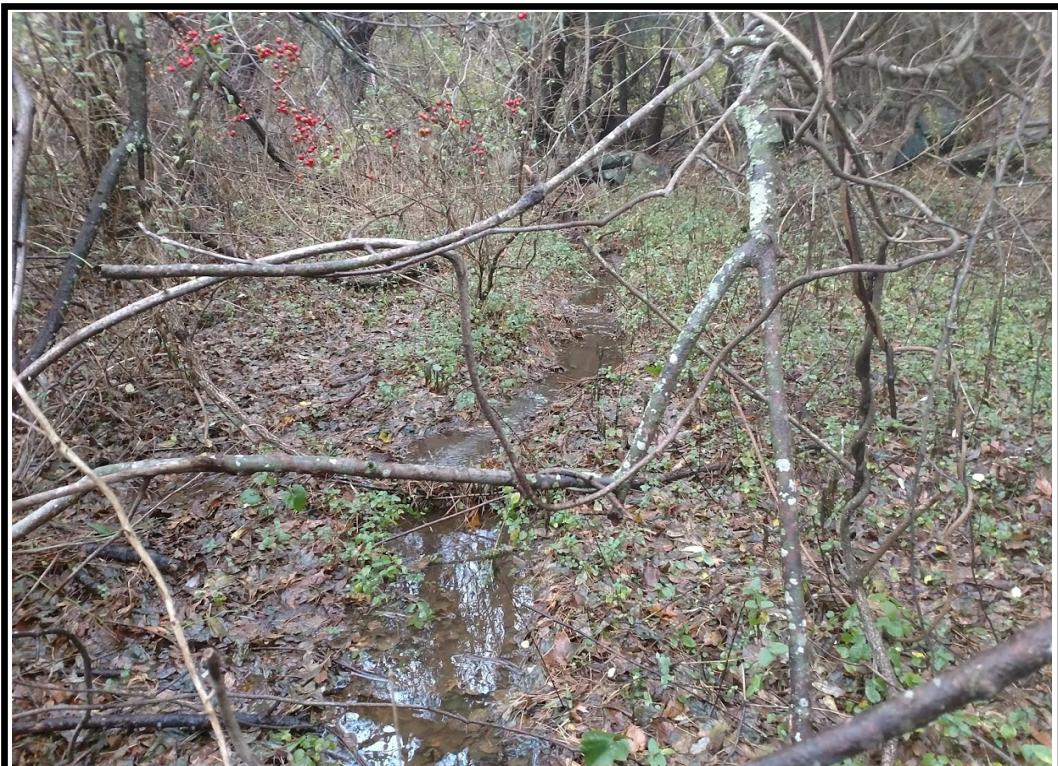
Photo 14: Wetland I, a forested wetland, looking eastward from flag I2 (photo taken 11/14/18). Wetland receives overflow from Stream MA3.

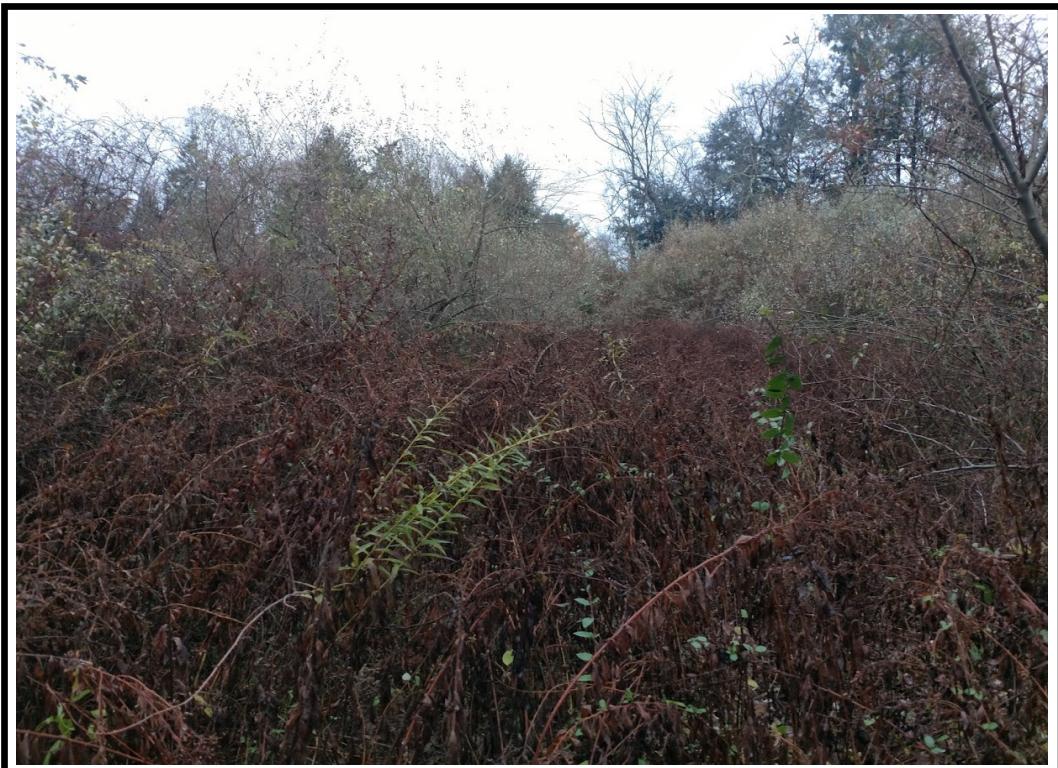
Photo 15: Representative view of a shrubland community located in the survey area west of the horse pasture (photo taken 11/14/18).

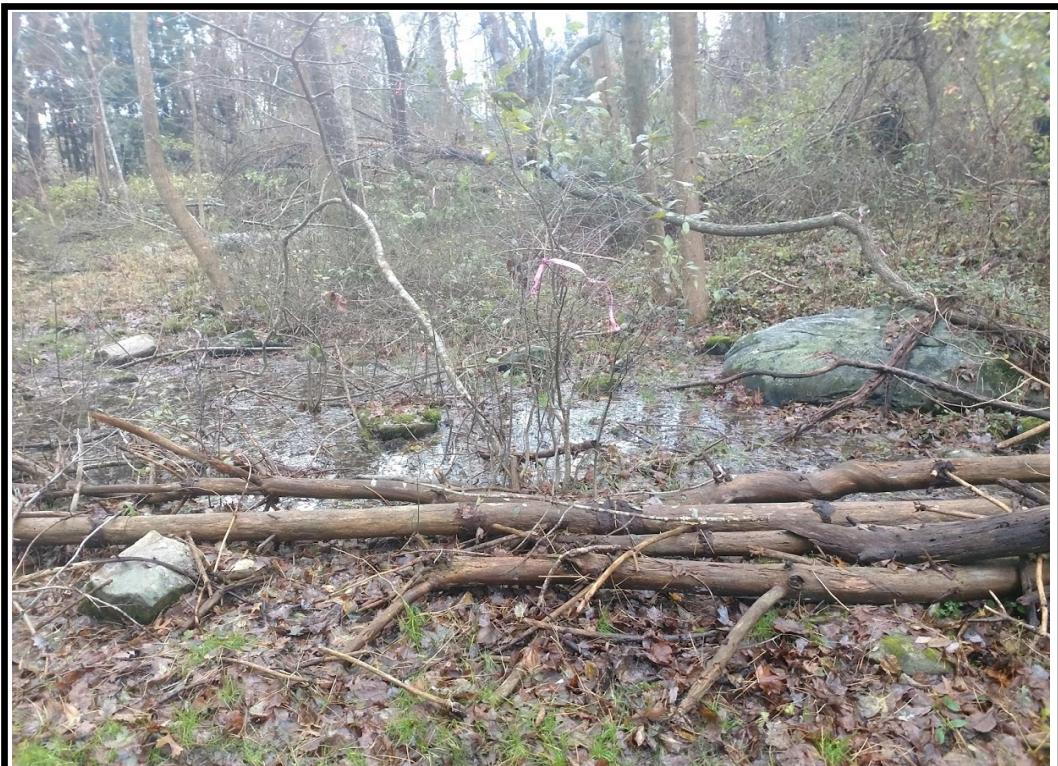
Photo 16: Data plot for Wetland J by flag J6 characterizing a wetland forest community (photo taken 11/14/18). Wetland J is located by Taugwonk Road.

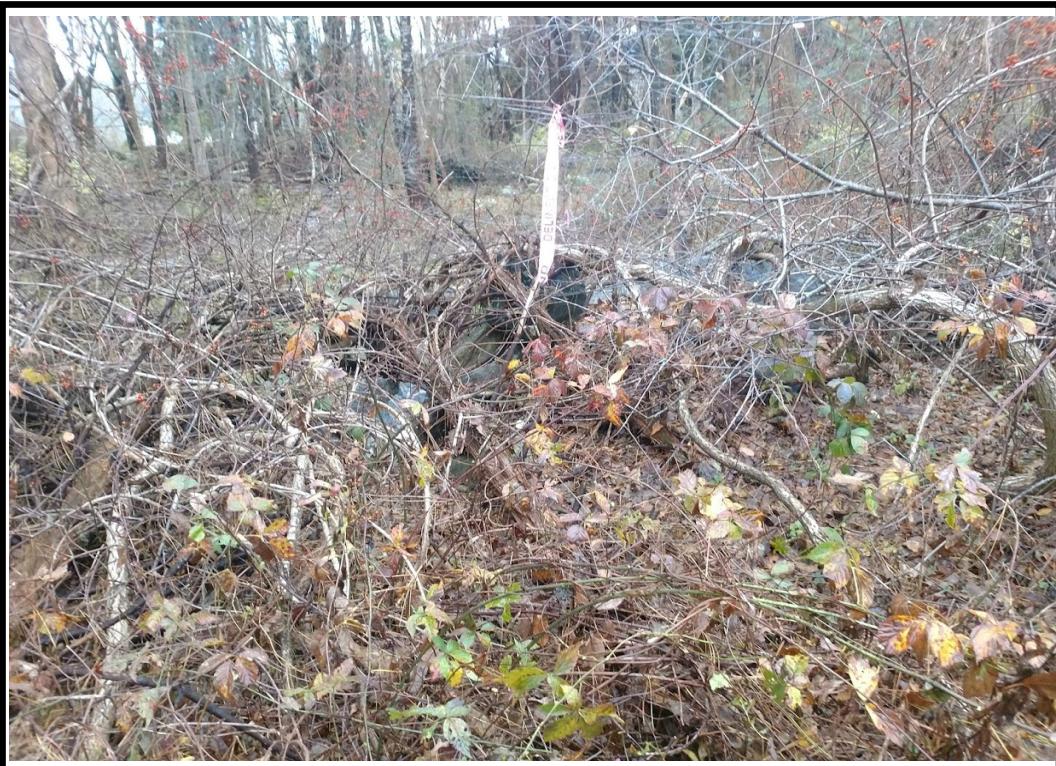
Photo 17: Data plot for Wetland J by flag J6 characterizing an upland forest community (photo taken 11/14/18).
