Technical Memorandum

United Illuminating Renewable Energy

Wetland Delineation and Impact Assessment Report

FITZGERALD & HALLIDAY, INC.
72 Cedar Street
Hartford, CT 06106

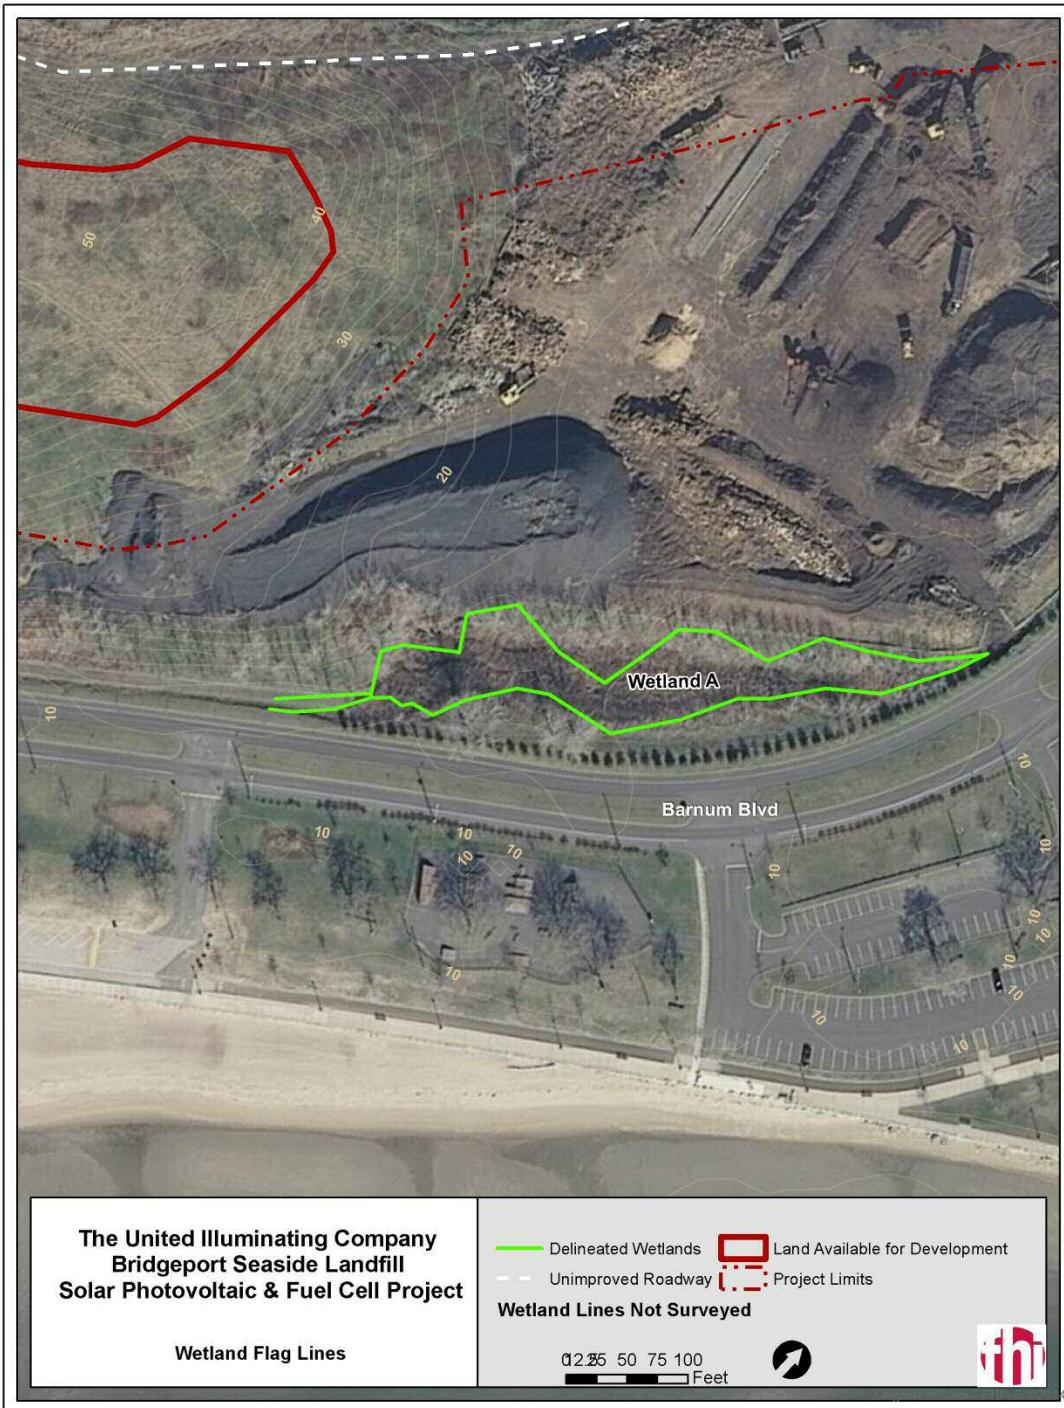
Figure 2a – Delineated Wetlands

Wetland A (Flag Numbers A1 to A32, C1 to C3 and D1 to D2)

Wetland A is located along the south east property adjacent to Barnum Blvd. This palustrine emergent and palustrine open water state and federal wetland is situated at the toe of a slope created from piles of landfill debris and recyclable materials southeast of the Seaside Landfill. The northern portion of the wetland is wider with areas of emergent vegetation and open water (delineated by wetland line A).

The wetland flows northeast to southwest and connects with a state and federal wetland, before transitioning into a long linear storm water ditch to the south (delineated by wetland lines C and D) which parallels Barnum Blvd and the landfill's perimeter. Flag line C delineates the southern side of the system, while Flag line D delineates the northern side of the system. This palustrine emergent state and federal wetland was delineated on site for approximately 60 feet before it transitions into a storm water retention ditch outside the scope of this project. This wetland is directly connected to flag line A at a 6-foot metal fence. The upland area around this wetland consists of maintained grass (lawn) area.

The NRCS mapped soil associated with Wetland A is Smoothed Udorthent. Vegetation in the drainage ditch is dominated by common reed (*Phragmites australis*) along the northern shared edge with Wetland A, and horsetail (*Equisetum arvense*) in the middle. The principal function of this wetland is groundwater recharge and sediment/toxicant retention.

Wetland A is located outside the project area, and there will be no direct or indirect impacts to this wetland from the proposed installation of solar panel arrays.

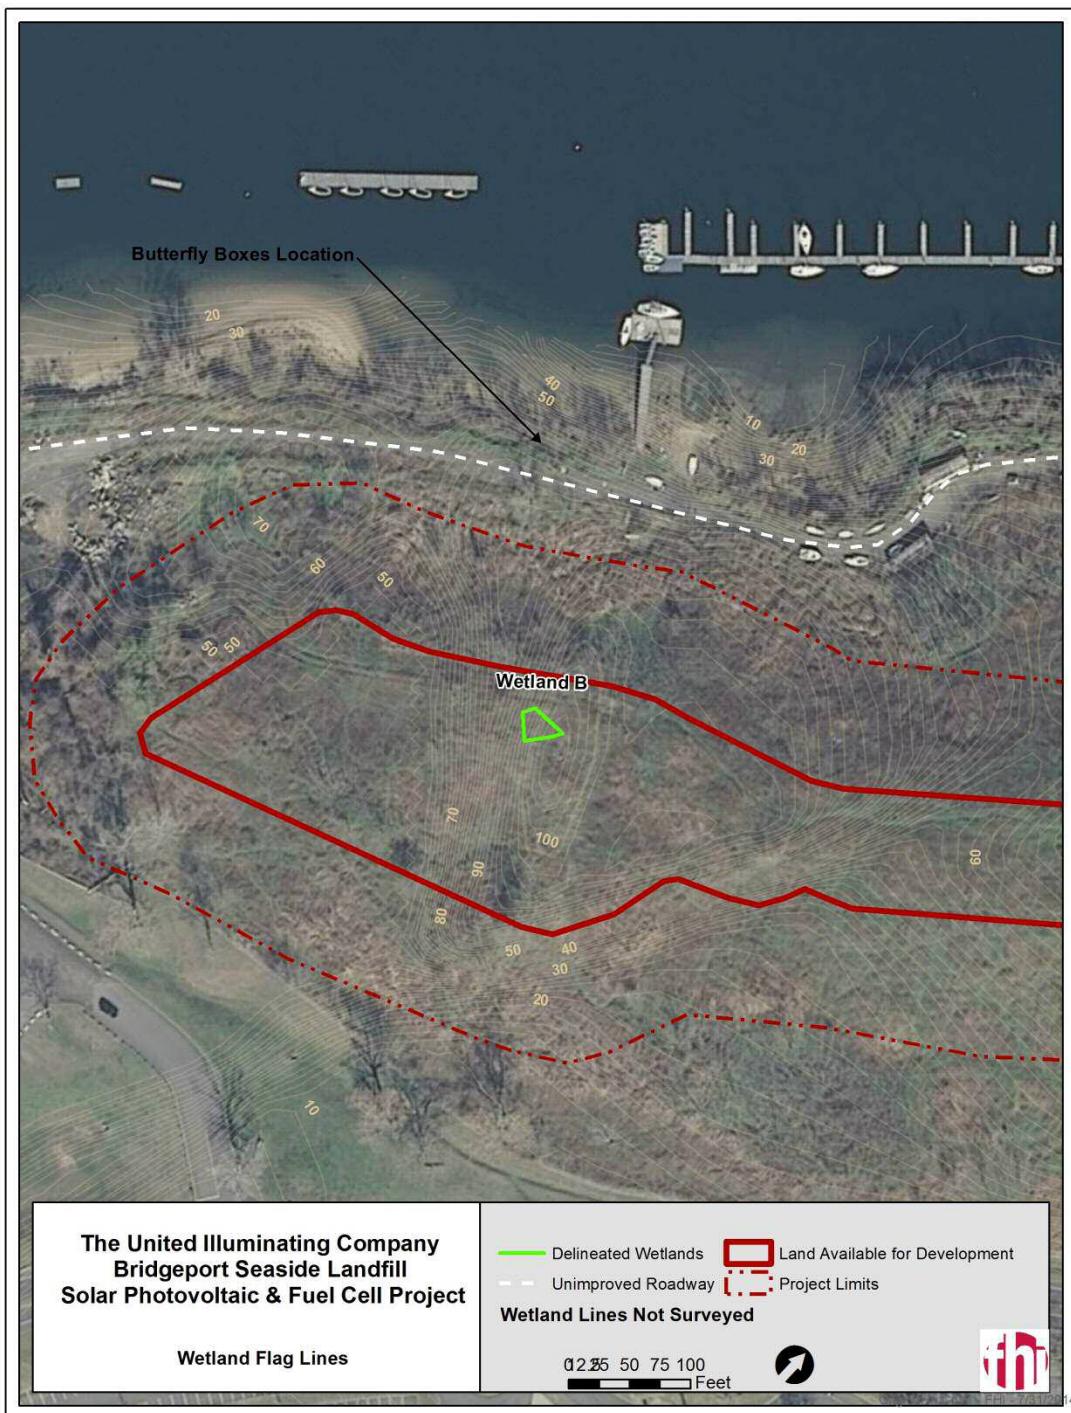
Figure 2b - Delineated Wetlands

Wetland B (Flag Numbers B1 to B5)

Wetland B is located at the north western end of the landfill. It is located within a depression atop of the landfill, at a lower elevation than the peak of the landfill (see Figure 2b above). This depression was created when the landfill was capped and graded. This palustrine emergent wetland meets the definition of both a state and federal wetland. During a June 16, 2014 site visit, the presence of water in the wetland was visually detected at approximately 5 inches below the surface in the soil. However, on a subsequent site visit (on June 26th), evidence of water in the wetland was not visually observed; although indicators of hydrology present for substantial amounts of time at or near the surface were identified.

The NRCS mapped soil associated with Wetland B is “Dump”. Vegetation is dominated by path rush (*Juncus tenuis*) and mugwort (*Artemisia vulgaris*). The principal function of this wetland is sediment/toxicant retention.

Wetland B is located where the solar array is proposed to be installed. The current design would include filling of the 529.3 square foot wetland and grading of the land prior to installation of the solar panels. This filling and grading would constitute a direct impact and complete taking of the wetland. Avoidance measures will be considered, including locating the solar panels elsewhere on the landfill site. However, if avoidance is not feasible, then the loss of the wetland will be mitigated for elsewhere on the landfill site. Due to the low function and value and very small area of Wetland B, mitigation, rather than avoidance or minimization, may ultimately be pursued by the project proponent.

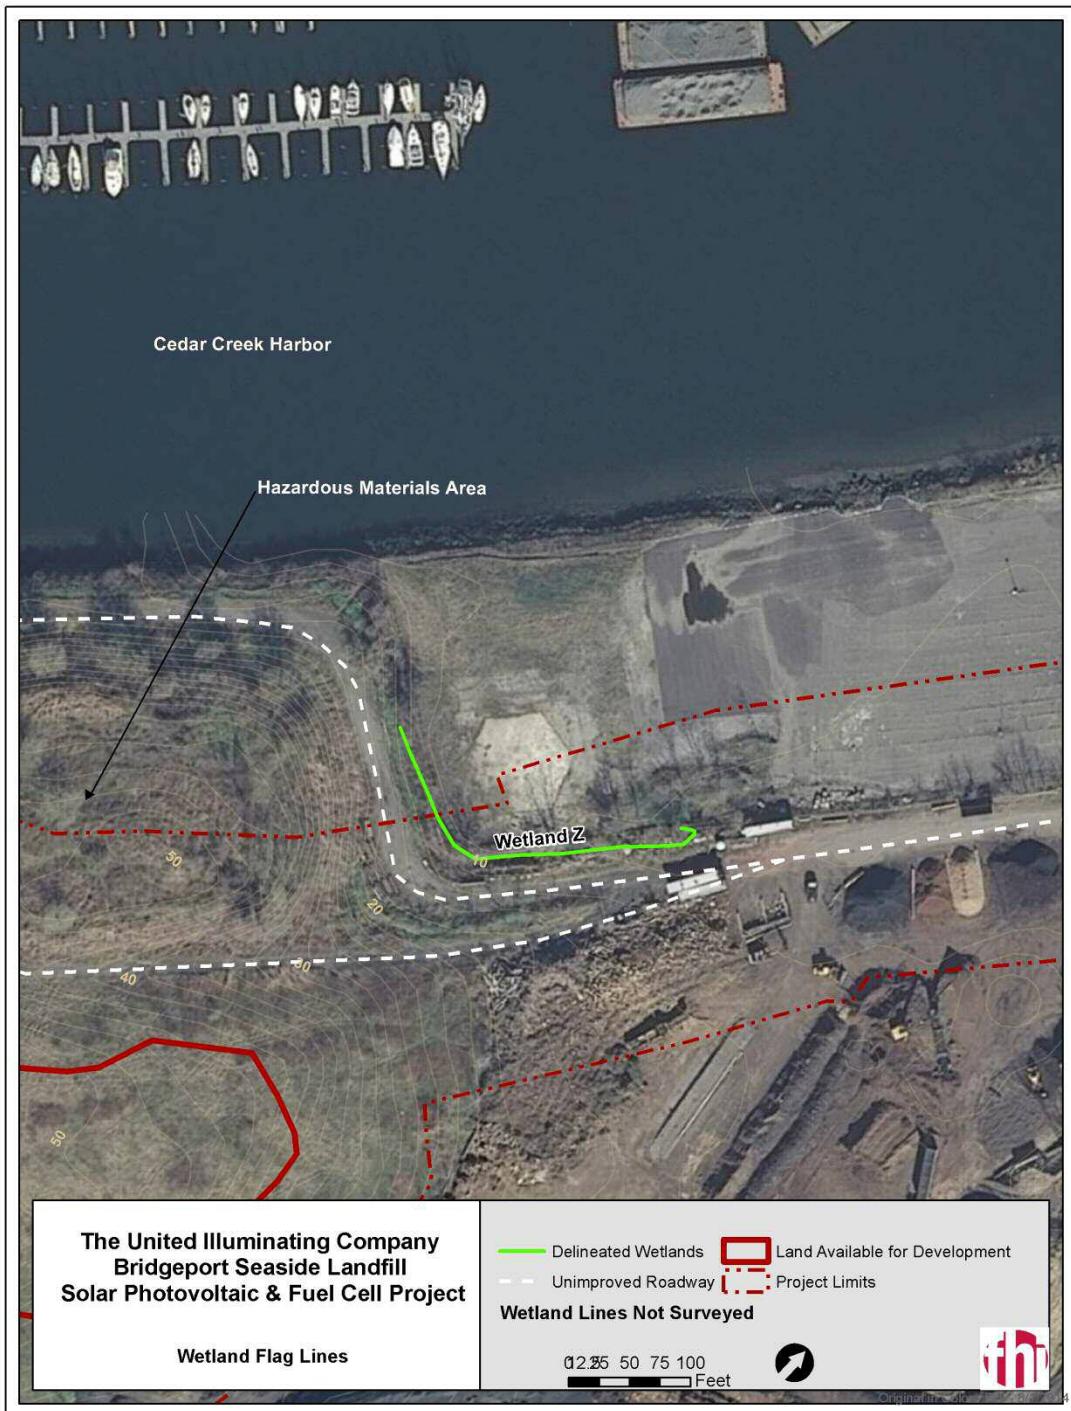
Figure 2c - Delineated Wetlands

Wetland Z (Flag Numbers Z1 to Z13)

Wetland Z is located between a vacant paved area surrounded by a fence, and a gravel access road on the northeastern corner of the Seaside Landfill property (see Figure 2c). This palustrine emergent and palustrine open water wetland meets the definition for a state and federal wetland.

The NRCS mapped soil associated with Wetland B is Smoothed Udorthent. Vegetation is dominated by common reed (*Phragmites australis*) in the eastern half, and mugwort in the western half. The principal functions of this wetland are groundwater recharge and sediment/toxicant retention.

Although Wetland Z is located outside the area proposed for installation of the solar panel area, this wetland is located adjacent to an access road which will be used during the temporary construction period. Therefore, to avoid direct and/or indirect impacts to this wetland during the construction period, the wetland will be identified on project plans and a temporary protective silt fence placed between the access road and the wetland for the duration of the project. The silt fencing will be removed when the project is completed.

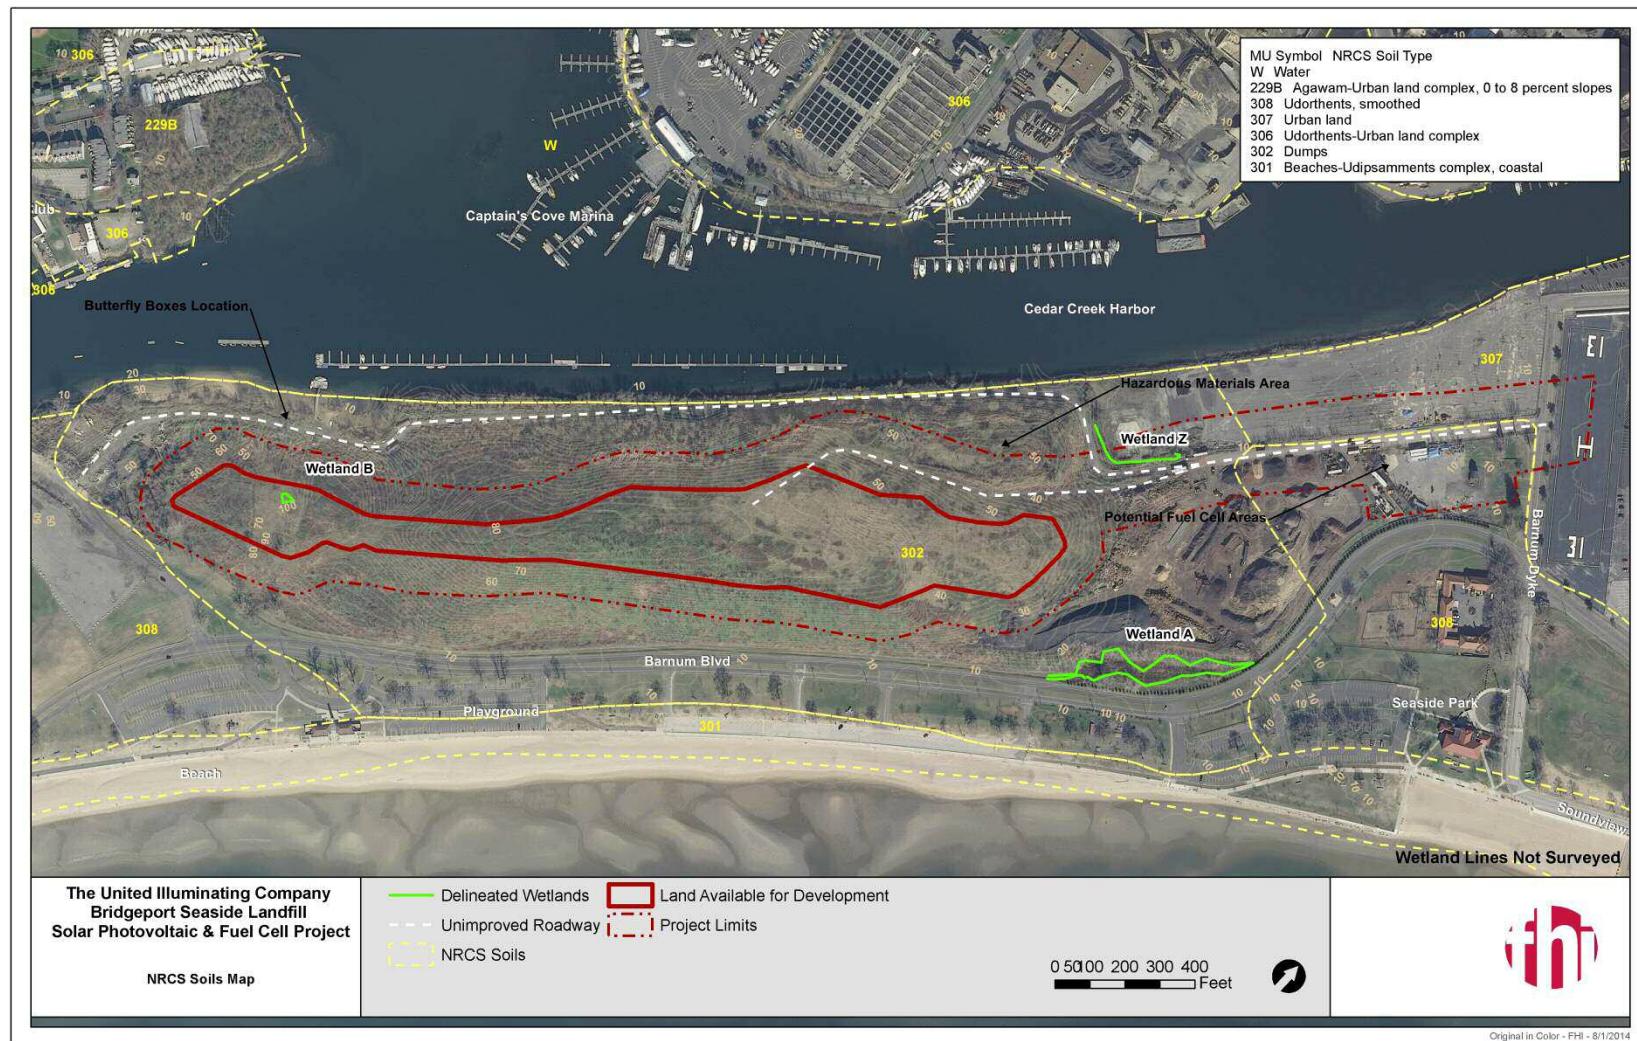
Figure 3 – NRCS Mapped Soils

NRCS soils classifications on the project site are depicted in Figure 3 by their soils number. Only those on the project site are described below.

Dumps (302)

Dumps are those lands where the native soils are either built upon, mixed with non-native soils, or otherwise disturbed by human activities, typically resulting from purposeful deposition of assorted manmade waste materials. Slopes range from nearly level to strongly sloping.

Urban Land (307)

Urban land is land mostly covered by streets, parking lots, buildings, and other structures of urban areas. Slopes range from 0 to 45 percent. Onsite investigations are required for interpretations.

Udorthents, smoothed (308)

Udorthents consist of earthy materials that have been shaped or otherwise disturbed by man. Slopes range from 0 to 25 percent. Onsite investigations are required for interpretations.

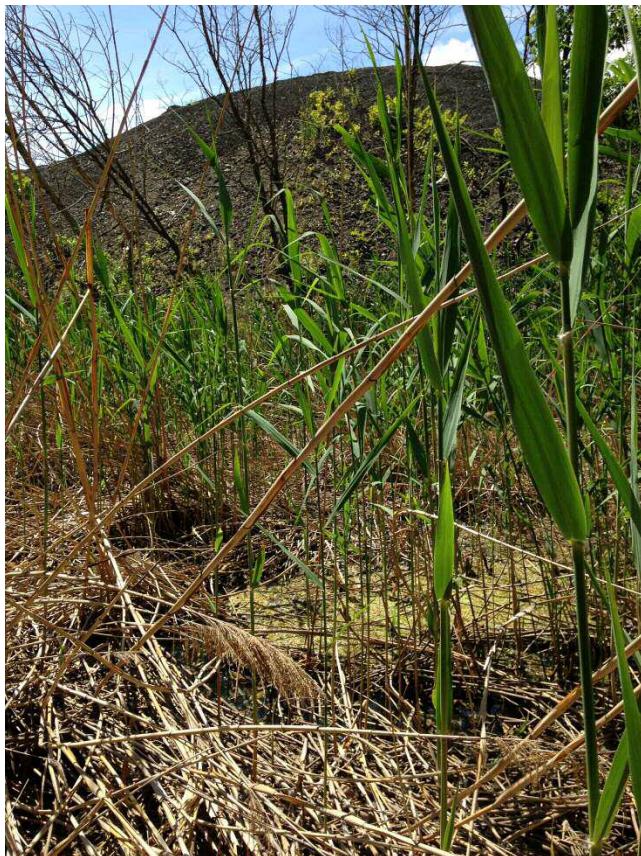
Wetland A – Facing West

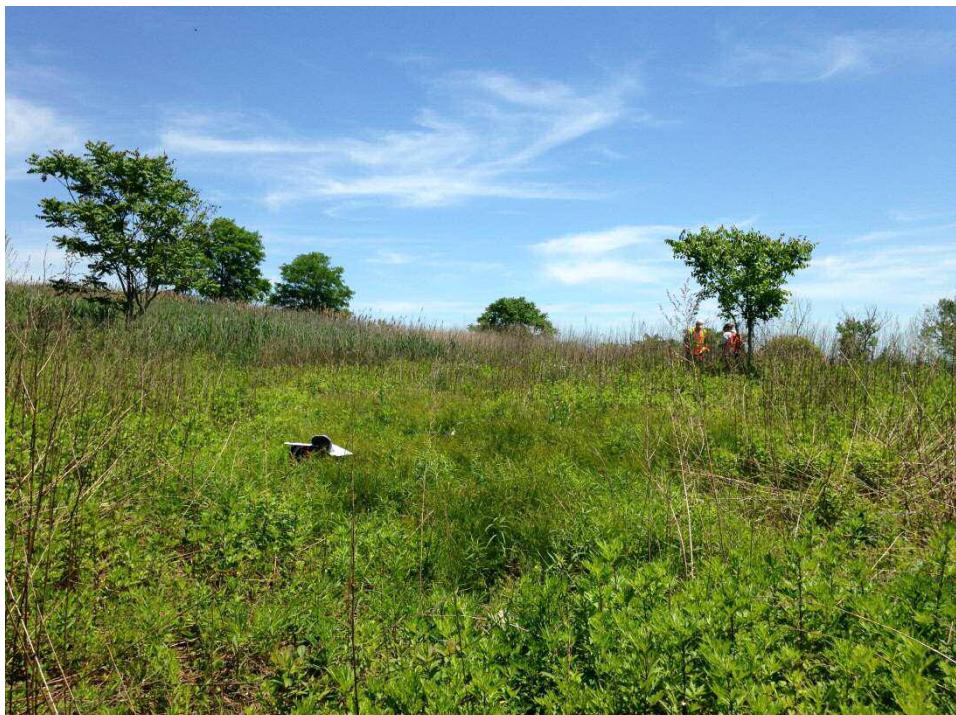
Wetland B – Facing East

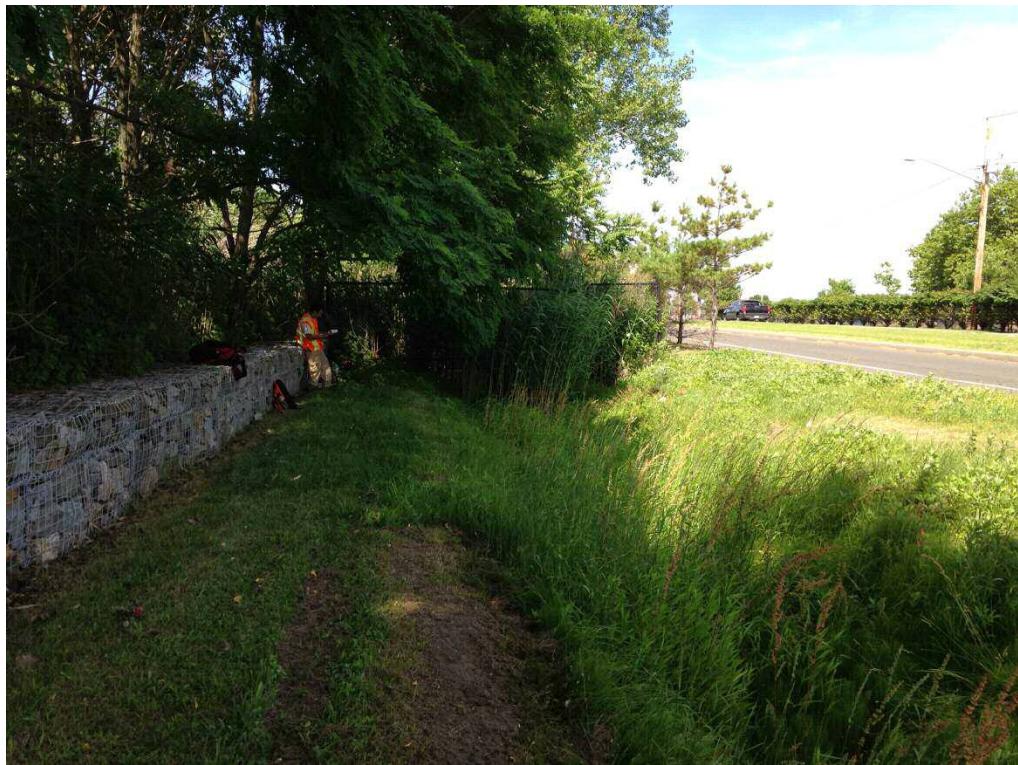
Wetland C/D – Facing Northeast

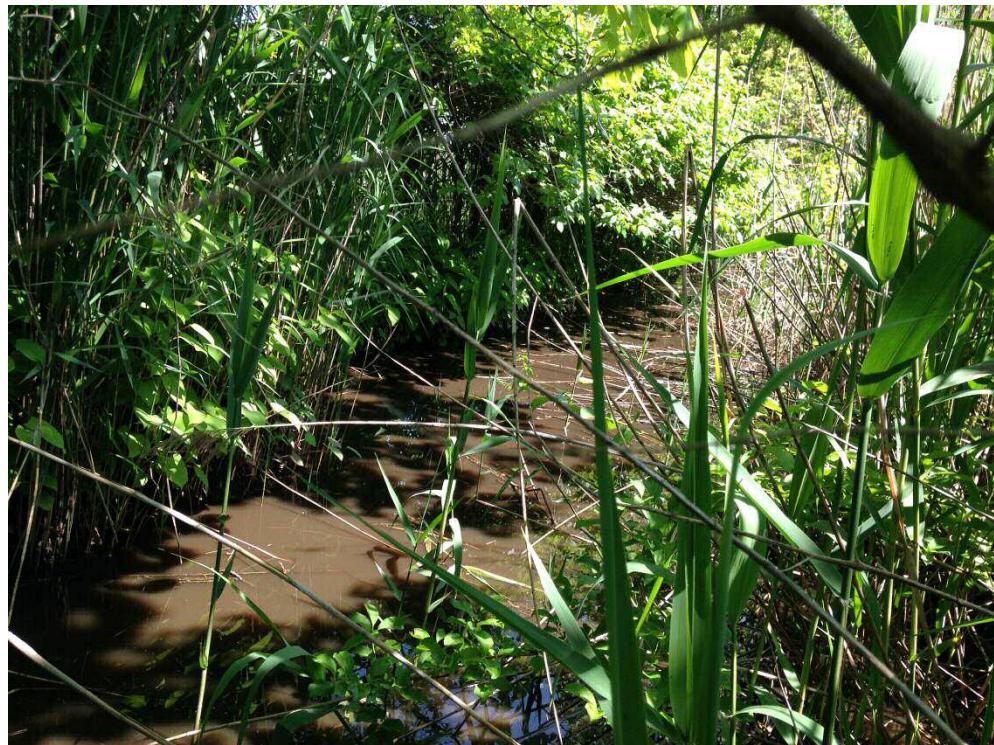
Wetland Z – Facing North
