ENVIRONMENTAL MONITORING
DAILY SITE OBSERVATION FORM

Report No. 3

Project: Verizon Wireless Tariffville Facility
 Address: St. Andrews Road, Bloomfield, Connecticut

APT Project #: CT1412210

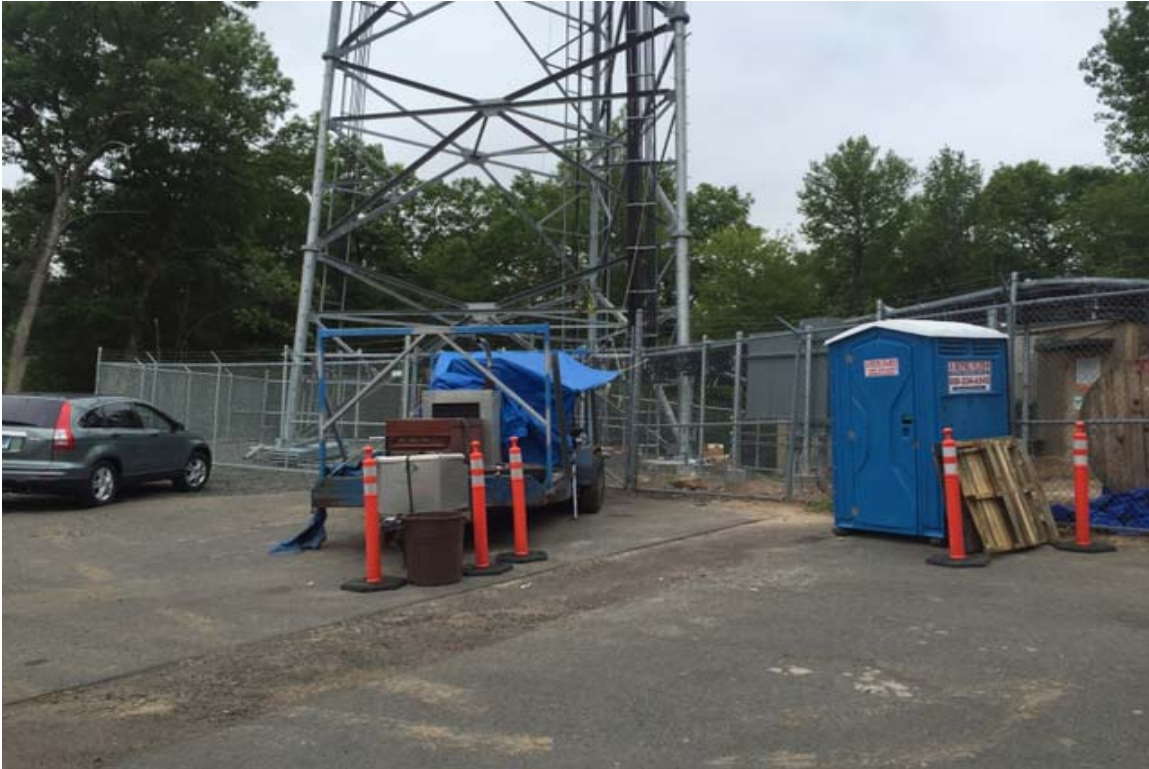
Photo 1: View of site under construction with new tower looking northwest.

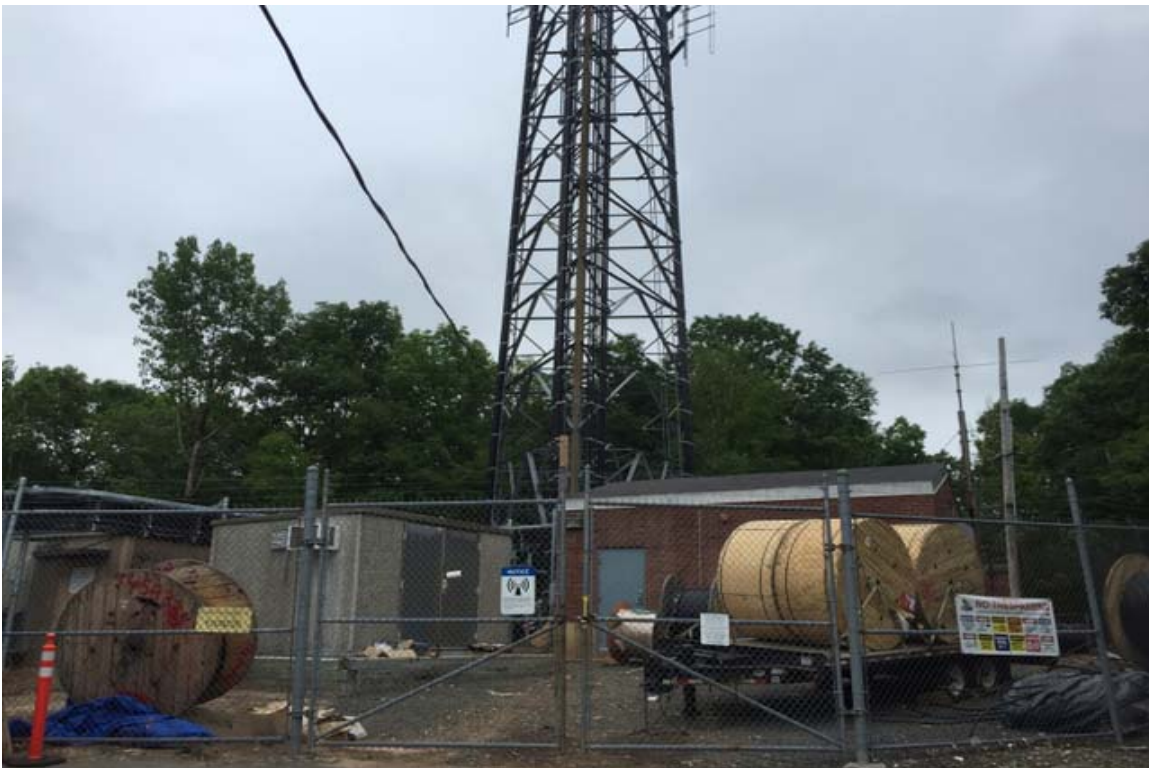
Photo 2: View of existing tower looking north.

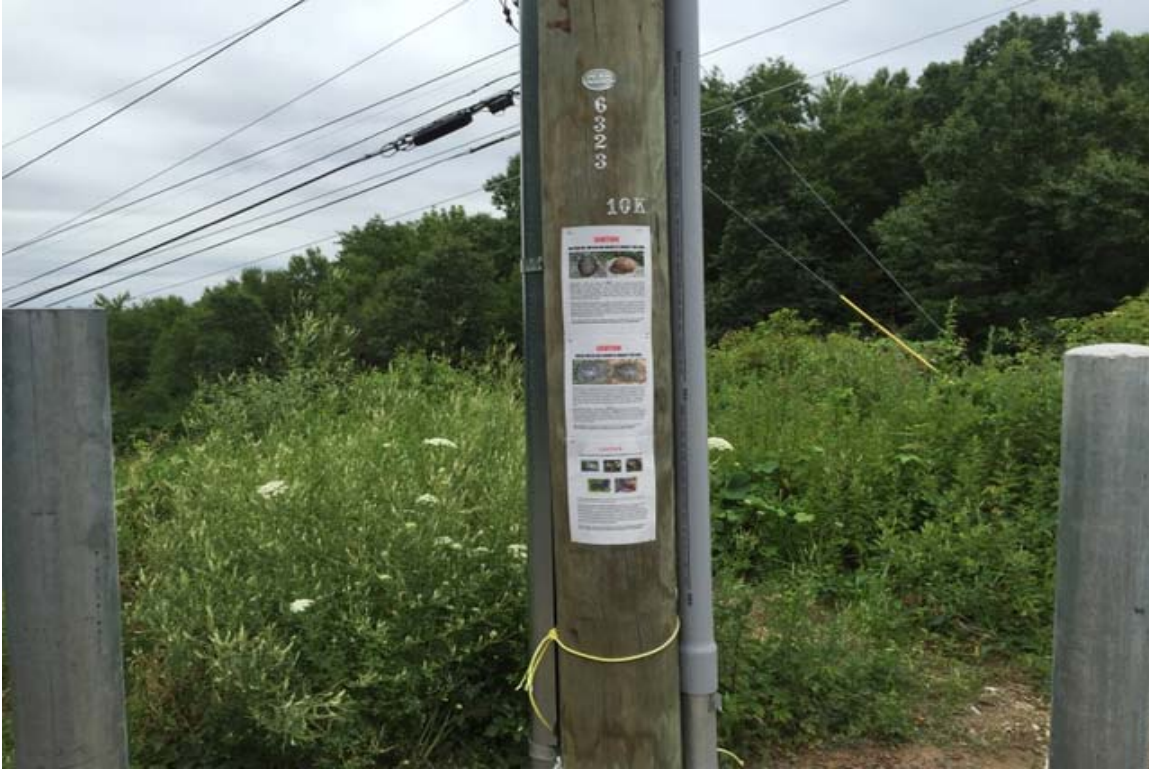
Photo 3: View of turtle protection signs at site looking southeast.

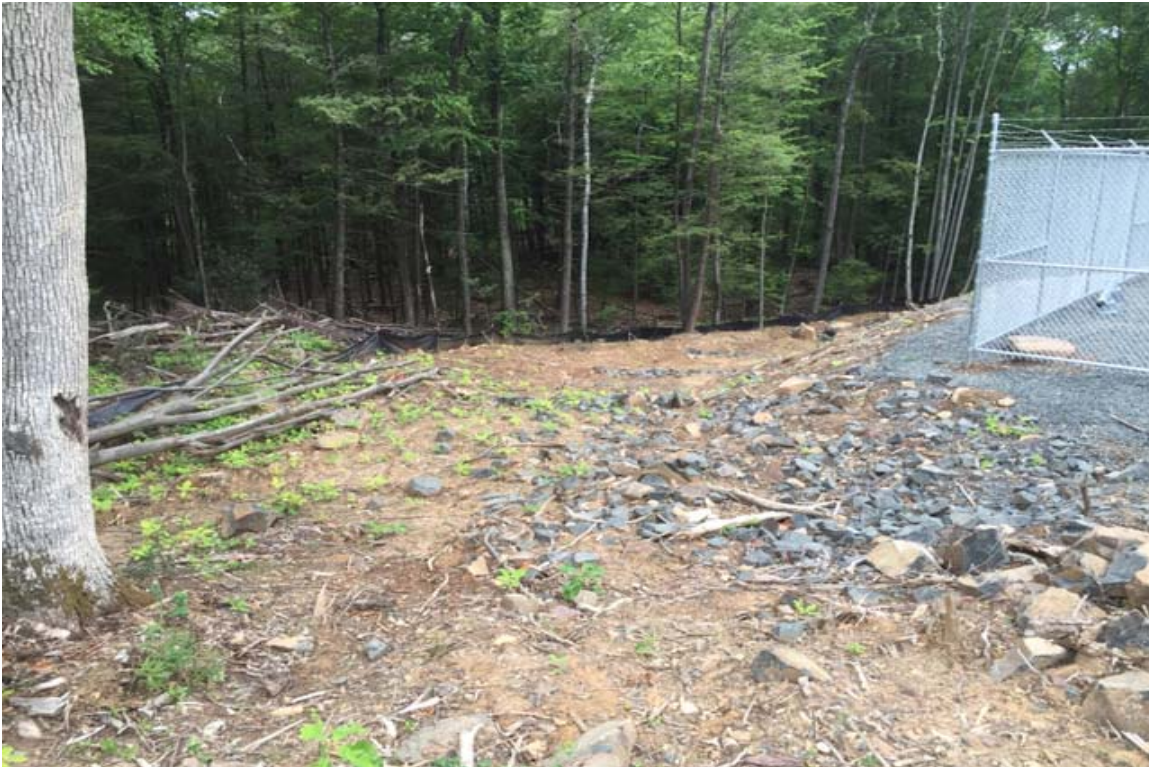
Photo 4: View of south end of drainage swale looking northwest.

DESCRIPTION OF OBSERVED ACTIVITY	
Compliance Level:	
Communication <input type="checkbox"/> Acceptable <input type="checkbox"/> Problem Area <input checked="" type="checkbox"/> <ul style="list-style-type: none"> <input type="checkbox"/> Minor Exclusion Fencing Repair <input type="checkbox"/> Additional Exclusion Fencing Required <input type="checkbox"/> Sediment release into upland habitat without risk of resource impact <input checked="" type="checkbox"/> Soil stabilization required Non-Compliance <input type="checkbox"/> <ul style="list-style-type: none"> <input type="checkbox"/> Sediment release into upland habitat with risk of resource impact <input type="checkbox"/> Sediment release into wetland habitat <input type="checkbox"/> Sediment release into watercourse 	
Issues Requiring Corrective Action	Corrective Action Implemented
Corrective Action #1 – drainage swale – install erosion blanket and seed per construction drawings requirements

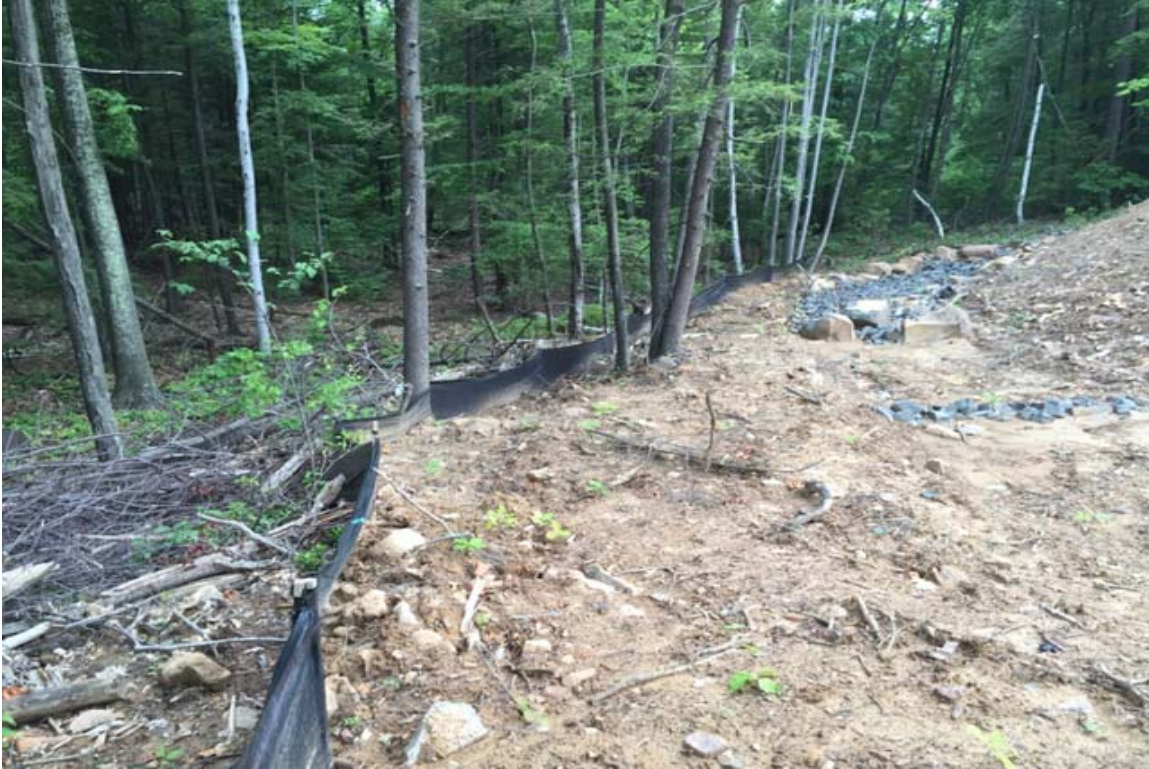
Corrective Action #2 – west slope of compound – install erosion blanket and seed per construction drawings	
Project Modification Requested:	
Extra Work Space Requested <input type="checkbox"/> Change to Work Area <input type="checkbox"/> Description of Modification:	
NOTES: Silt fence in good condition along west side of compound and drainage swale/level spreader, no erosion or sediment issues observed. The level spreader is working properly.

Photo 5: View of silt fence in good condition looking north.

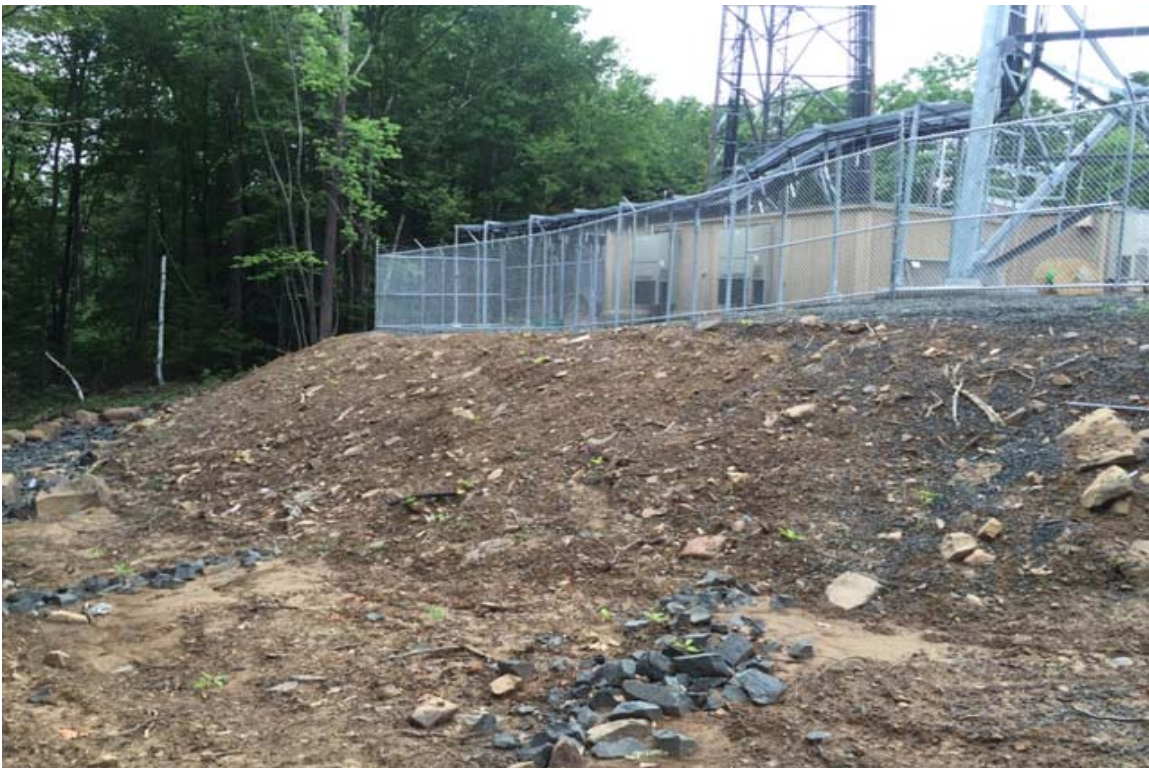
Photo 6: View of western slope looking north – requires installation of erosion blanket and seeding.

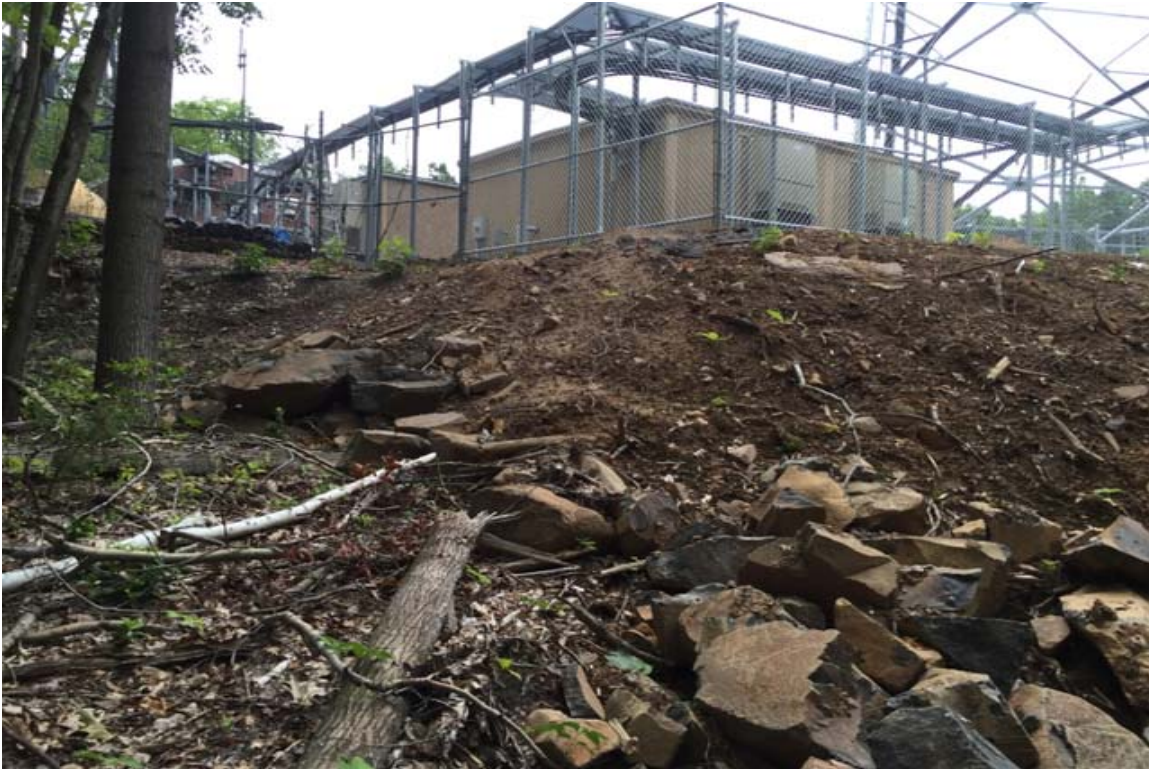
Photo 7: View of northwest corner of compound slope looking east – requires installation of erosion blanket and seeding.

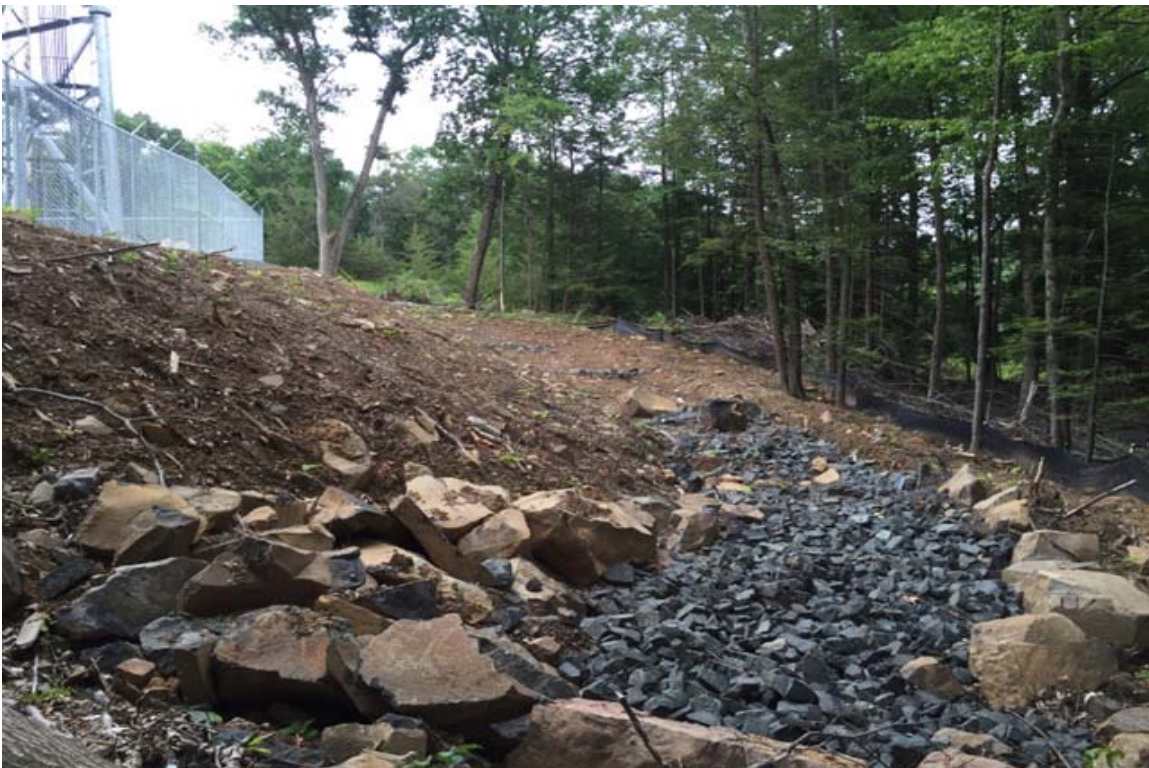
Photo 8: View of compound west slope and level spreader looking south – slope and drainage swale requires installation of erosion blanket and seeding.
