STATE OF CONNECTICUT
CONNECTICUT SITING COUNCIL

APPLICATION OF NEW CINGULAR WIRELESS PCS,
LLC (AT&T) FOR A CERTIFICATE OF
ENVIRONMENTAL COMPATIBILITY AND PUBLIC
NEED FOR THE CONSTRUCTION, MAINTENANCE
AND OPERATION OF A TELECOMMUNICATIONS
TOWER FACILITY LOCATED AT THE FIRSTLIGHT
HYDRO GENERATING COMPANY PROPERTY AT
KENT ROAD IN THE TOWN OF NEW MILFORD,
CONNECTICUT

DOCKET NO. 444

NEW CINGULAR WIRELESS, PCS LLC (AT&T) RESPONSES TO CONNECTICUT
SITING COUNCIL PRE-HEARING QUESTIONS SET I

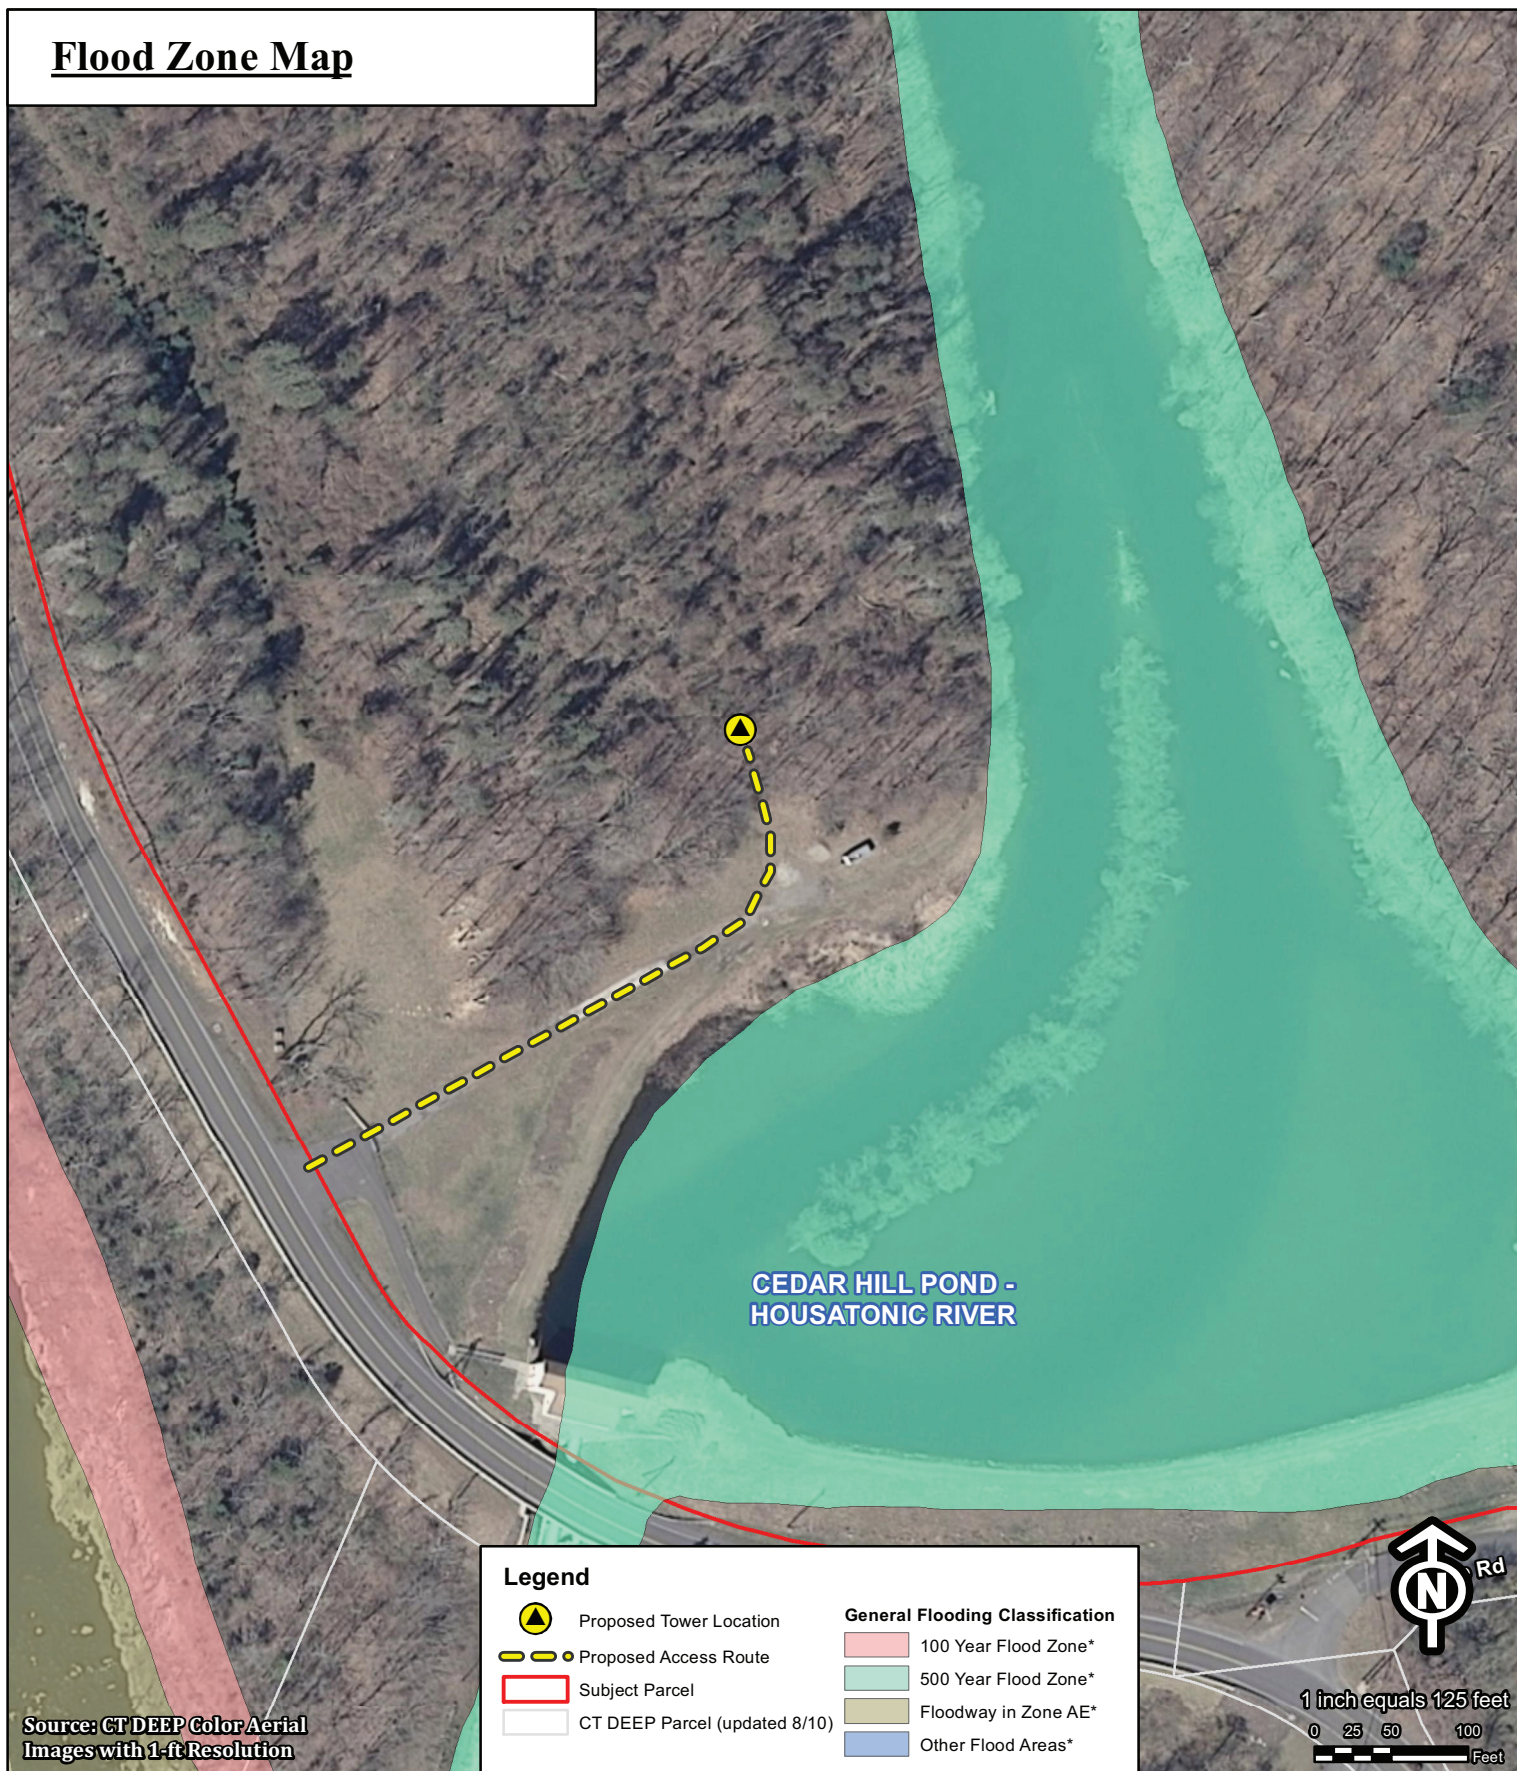
- Q6. Is the proposed site located within a 500-year flood zone?
- A6. *No. The site is located outside of the 500-year flood zone boundary associated with Cedar Hill Pond as shown in the Flood Zone Map included in Attachment 1.*

Proposed AT&T Wireless Communications Facility Kent Road (Map 83 Lot 4) New Milford, Connecticut

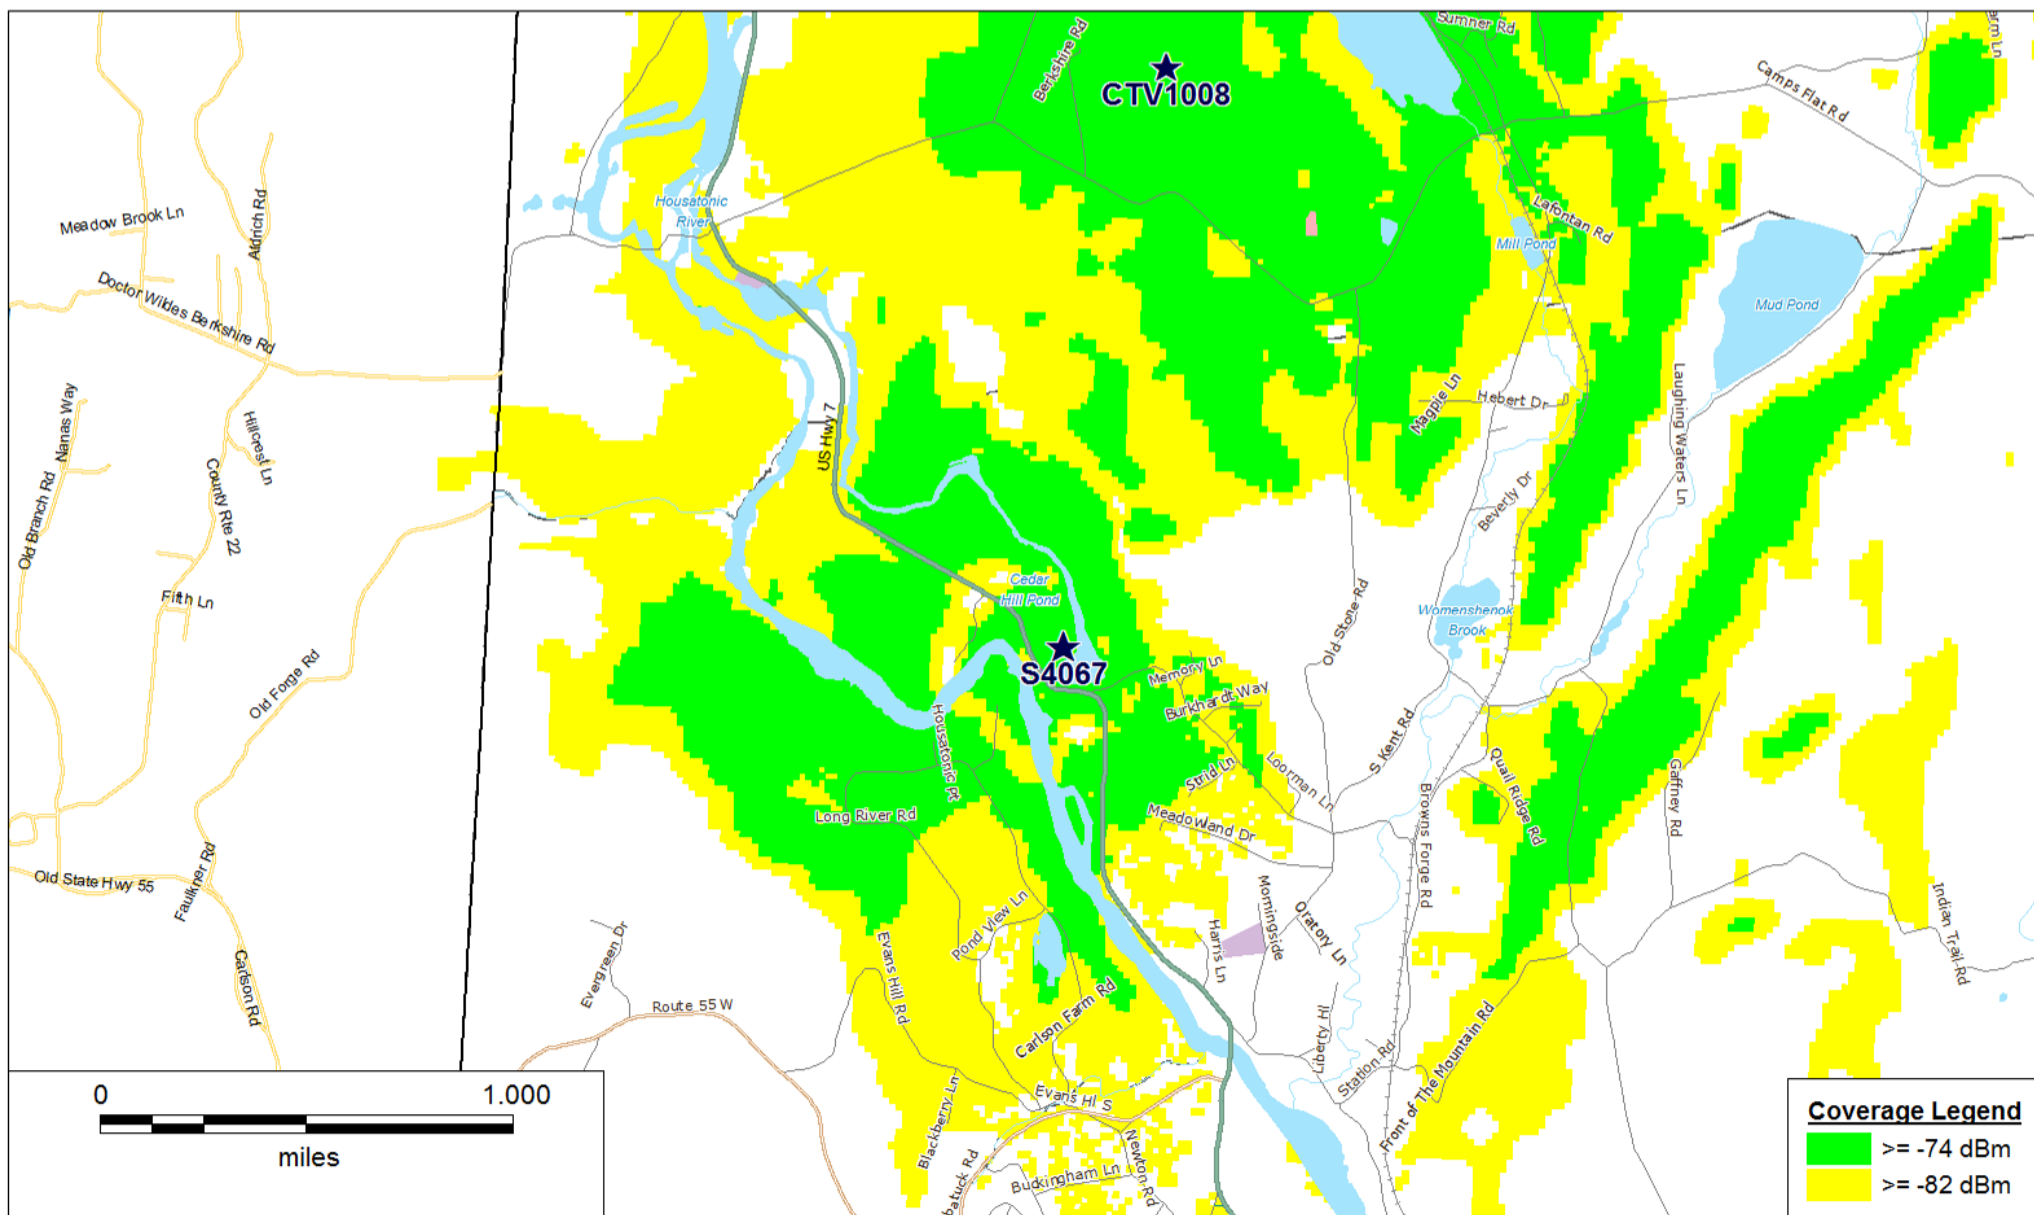
AT&T Proposed Coverage (850 MHz) with S4067 at New Milford, CT @ 136' AGL

A14. *AT&T's coverage objectives are met at an antenna centerline mounting height of 146' AGL. The requested plots are included in Attachment 2.*

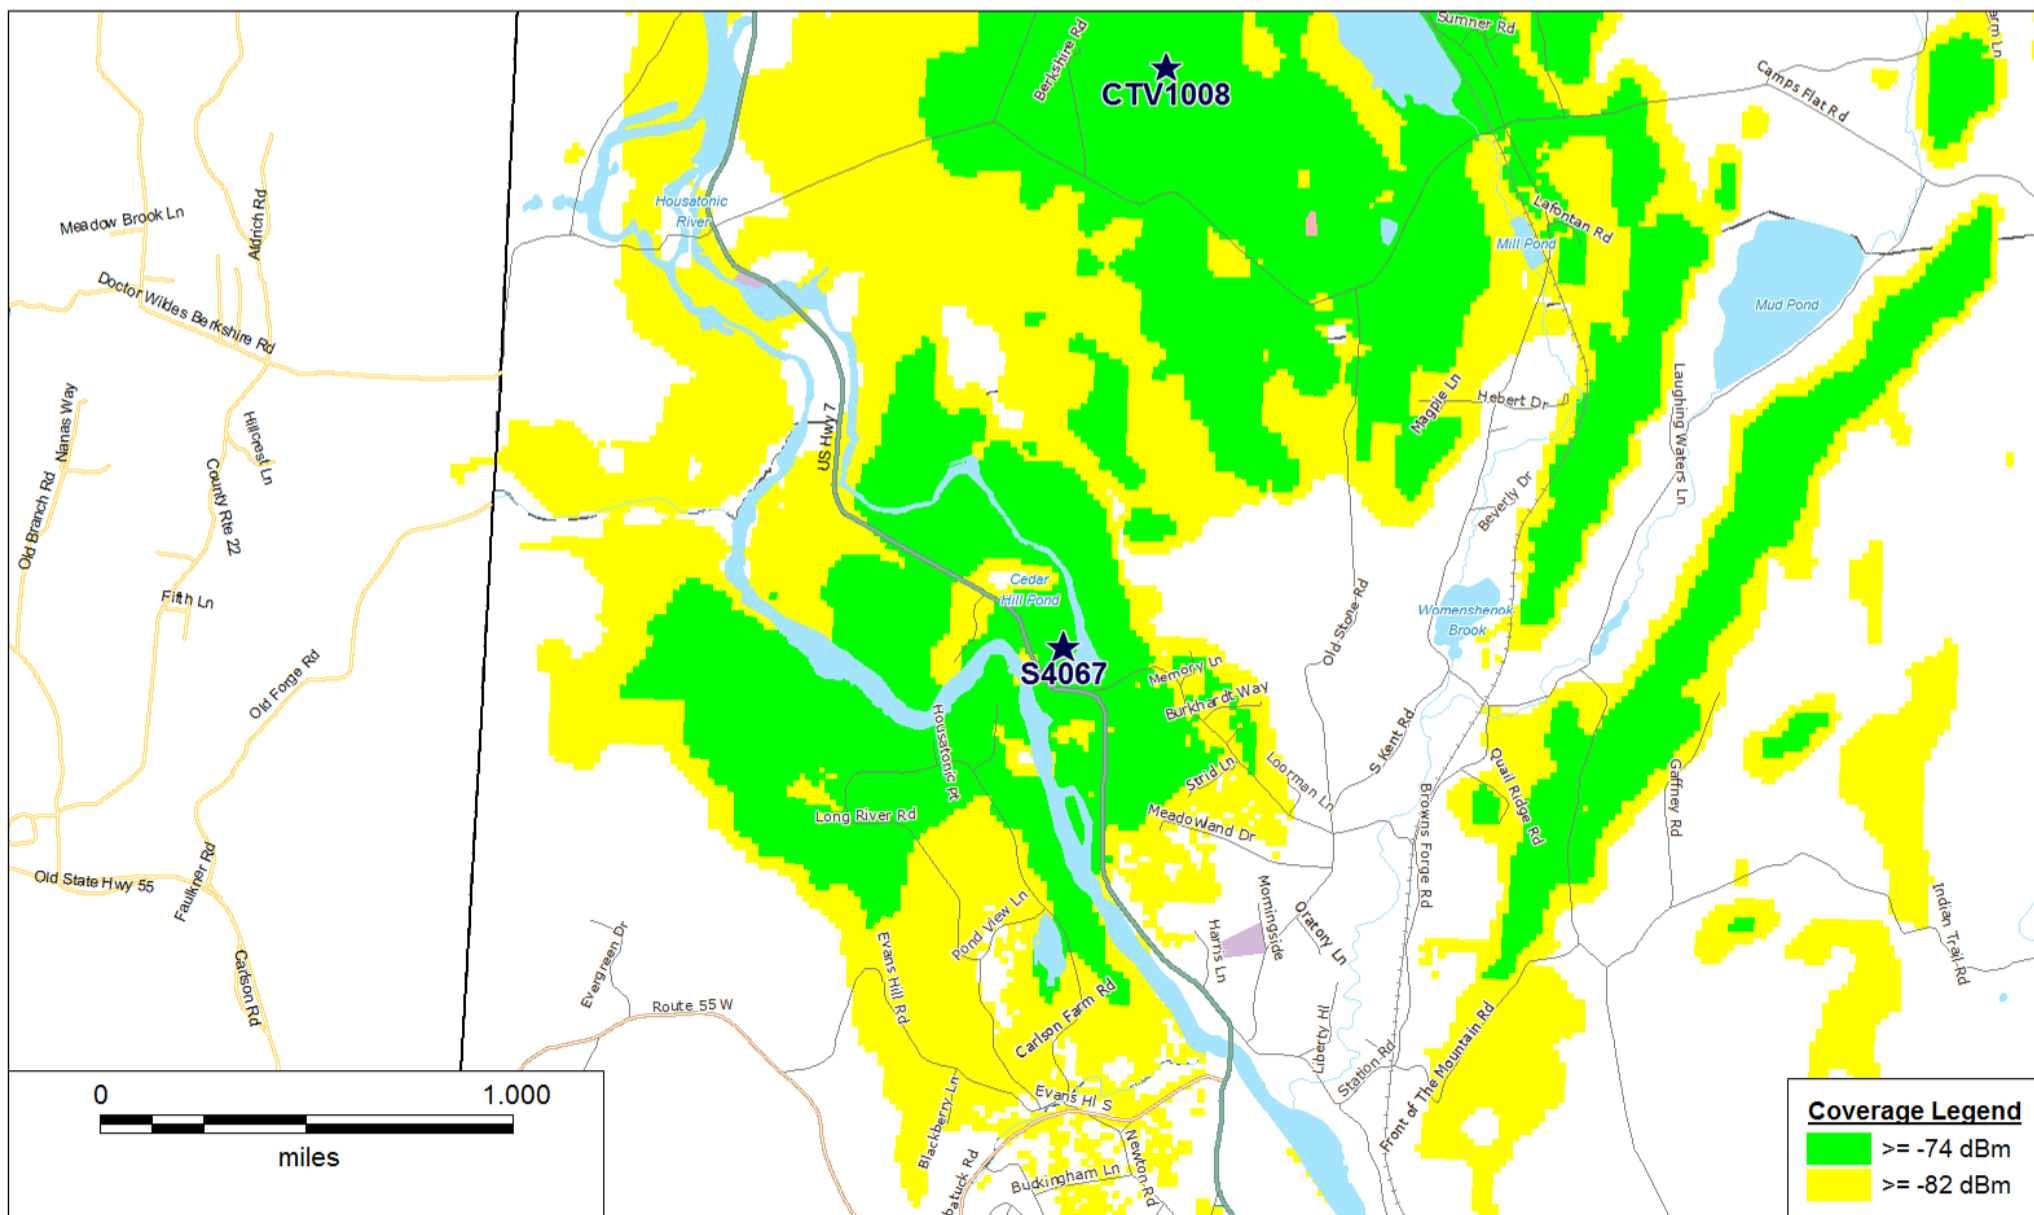
AT&T Proposed Coverage (850 MHz) with S4067 at New Milford, CT @ 126' AGL

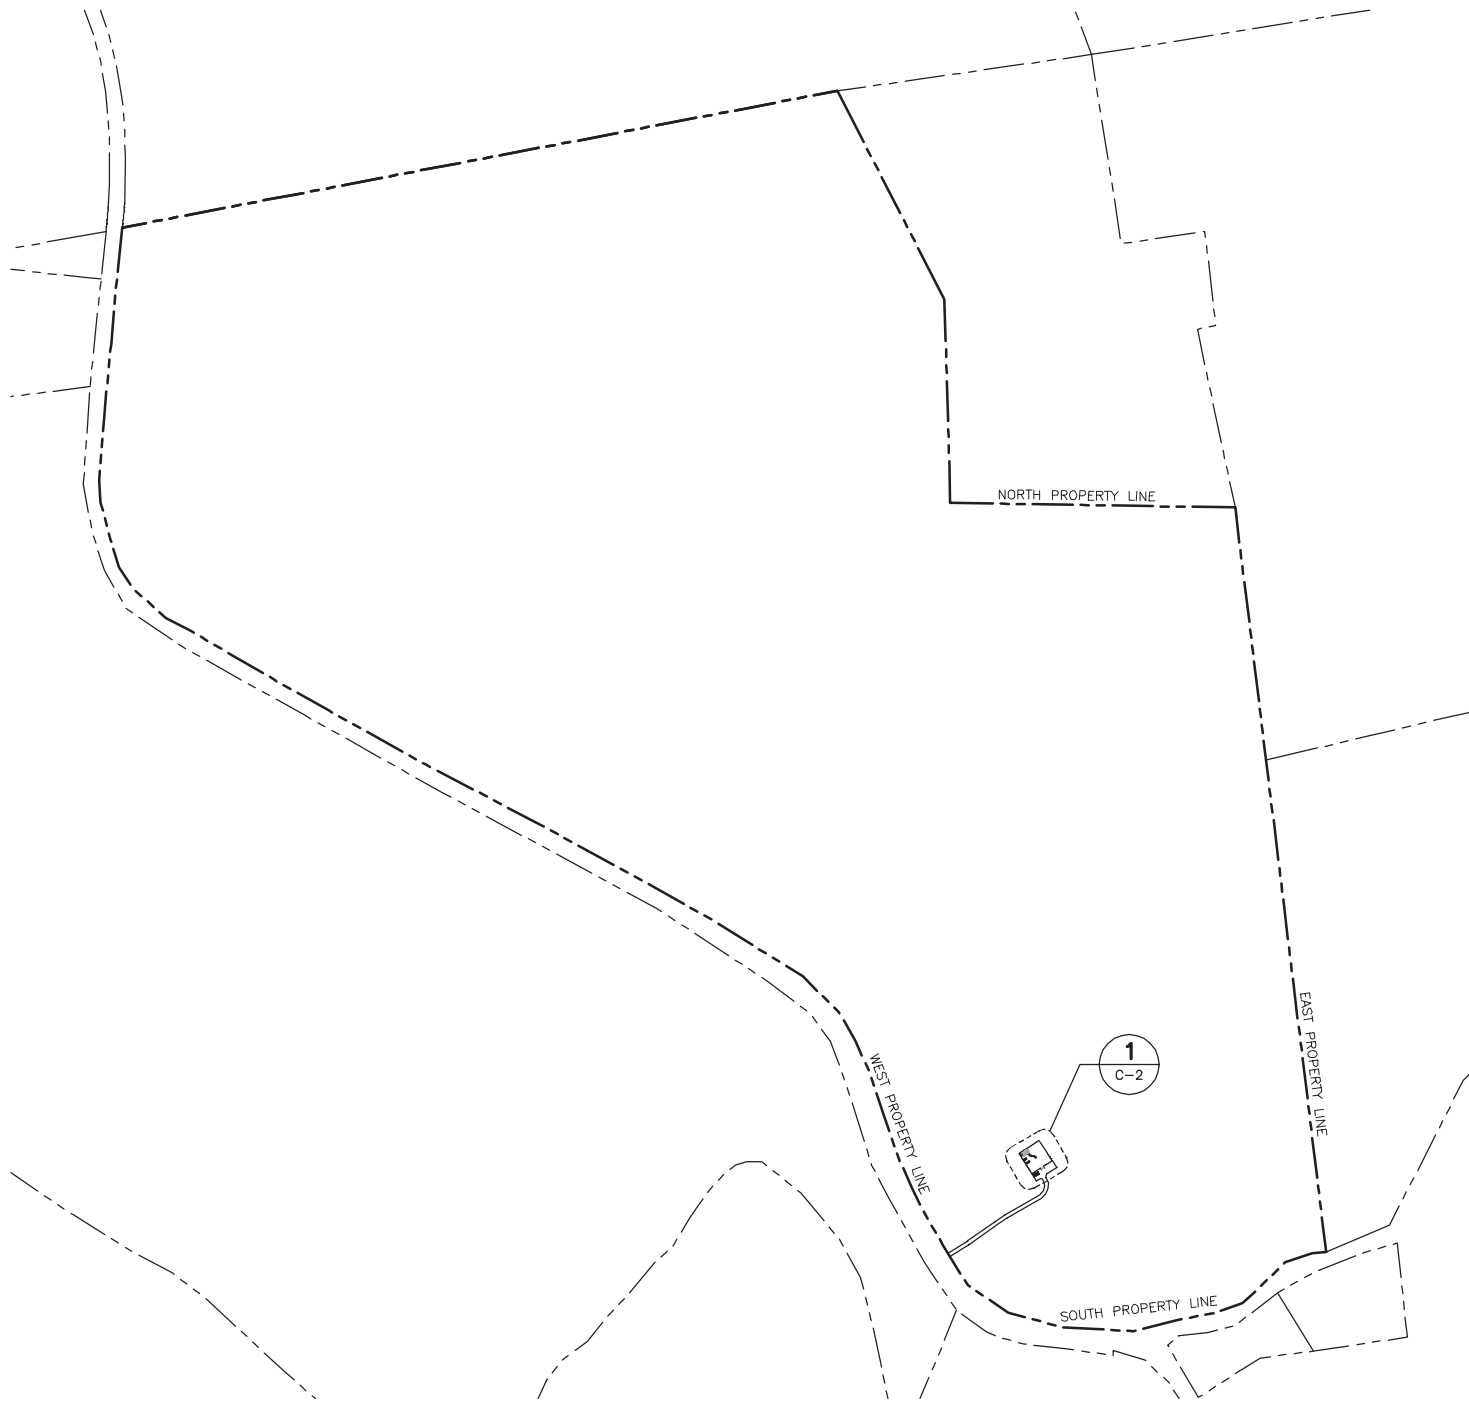
1
C-1
SITE PLAN - PROPOSED
SCALE: 1" = 600'-0"

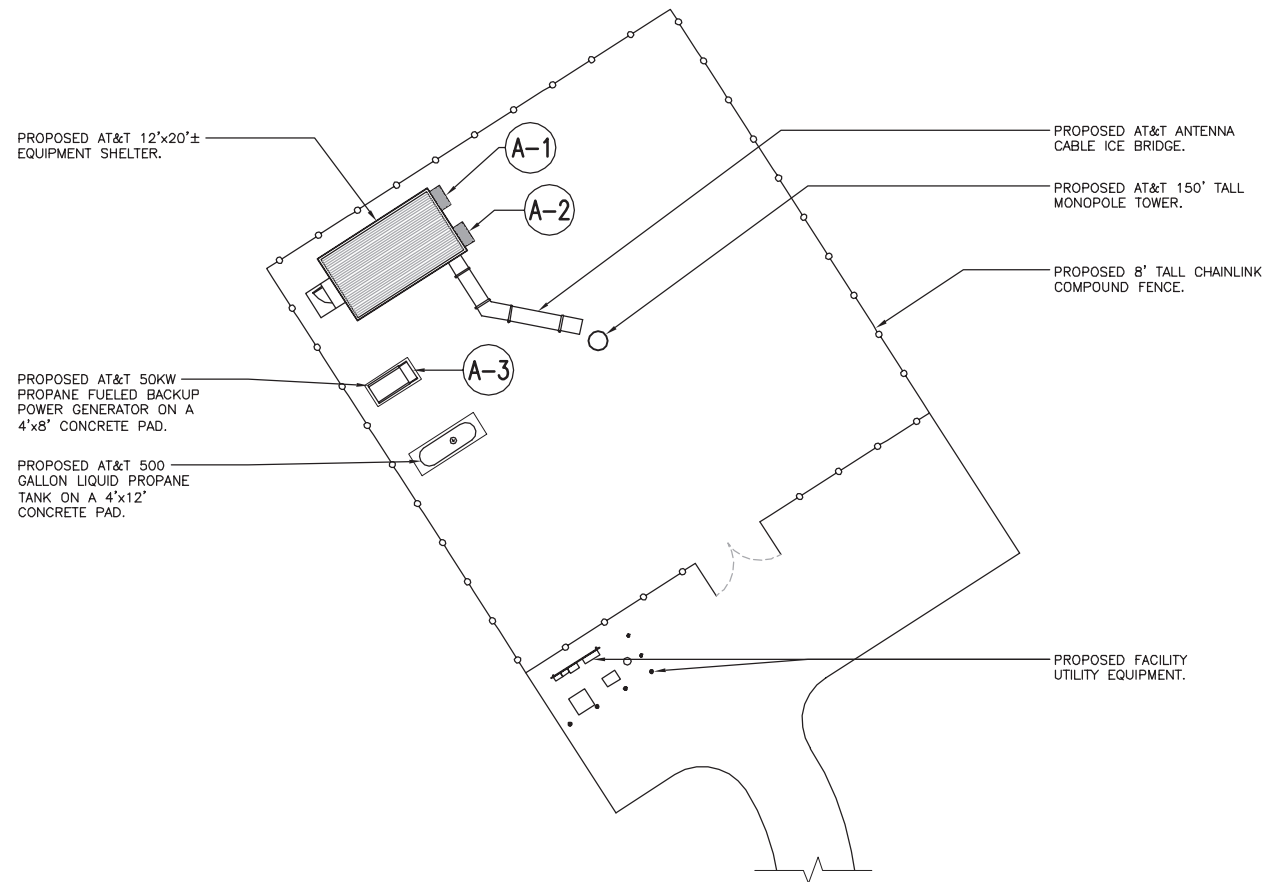
1
C-2

- (A-1) WALL MOUNTED HVAC UNIT, MAKE: MARVAIR, MODEL: ASDCA60
- (A-2) WALL MOUNTED HVAC UNIT, MAKE: MARVAIR, MODEL: ASDCA60
- (A-3) PROPANE FUELED GENERATOR, MAKE: GENERAC, MODEL: SG050

COMPOUND PLAN - PROPOSED
SCALE: 1" = 30'-0"

A39. *The expected noise level at the nearest property line (west) with the generator and air conditioners operating simultaneously is 44 dBA. The expected noise level at the nearest property line of the air conditioners operating without the emergency generator is 32 dBA. Please see the noise study included in Attachment 3. As noted therein, the anticipated noise level of the air conditioners at the nearest property line complies with C.G.S. Sections 22a-69-1 through 22a-69-7 governing noise levels. It should also be noted that while the emergency back-up generator is exempt from compliance with the levels included in C.G.S. Sections 22a-69-1 through 22a-69-7, the attached noise study shows that operation of the emergency generator simultaneously with the air conditioning units also complies with the standards.*

The Regulation allows a noise level of 55 dBA (daytime) and 45 dBA (nighttime), when measured at a Residential Receptor's property line. I found that the two HVAC units running together without the generator; as well as the generator and two HVAC units running together; meet the conditions for compliance as set forth in the Regulation at all property lines.

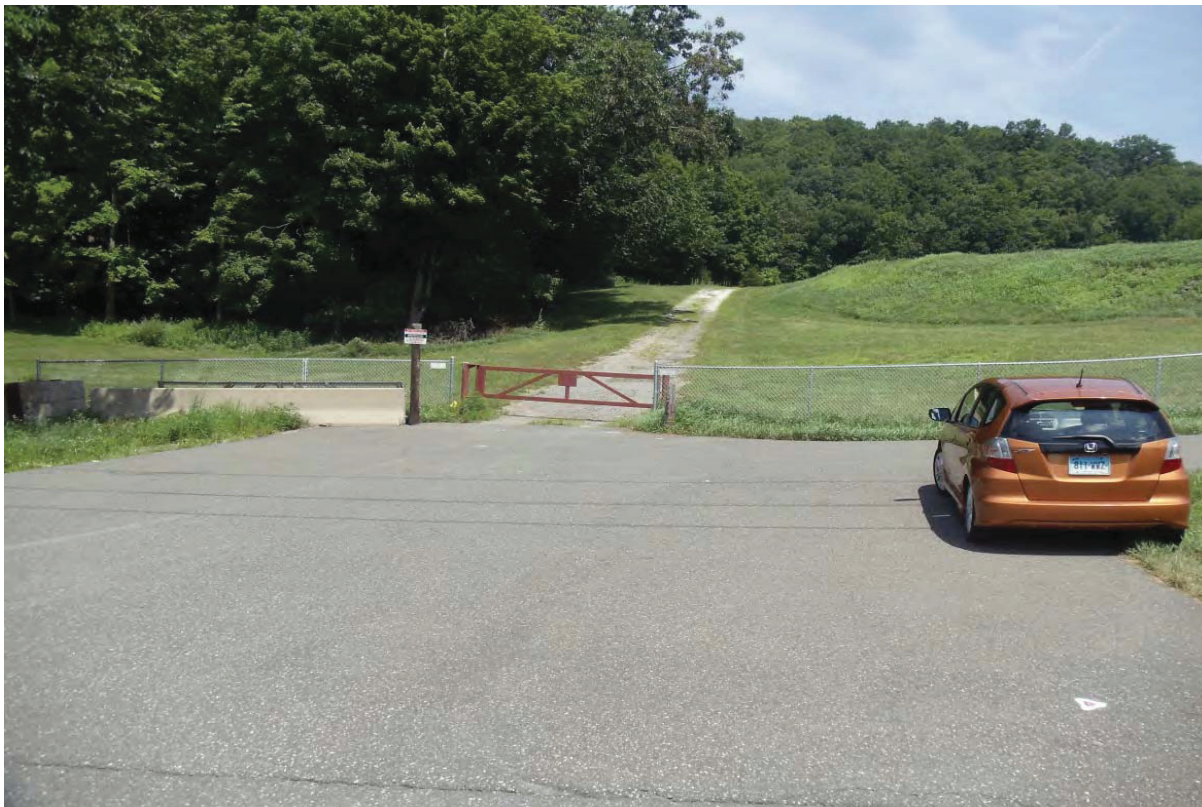
Photo 1: View of the existing maintenance road/proposed AT&T access road entrance off Route 7, looking east.

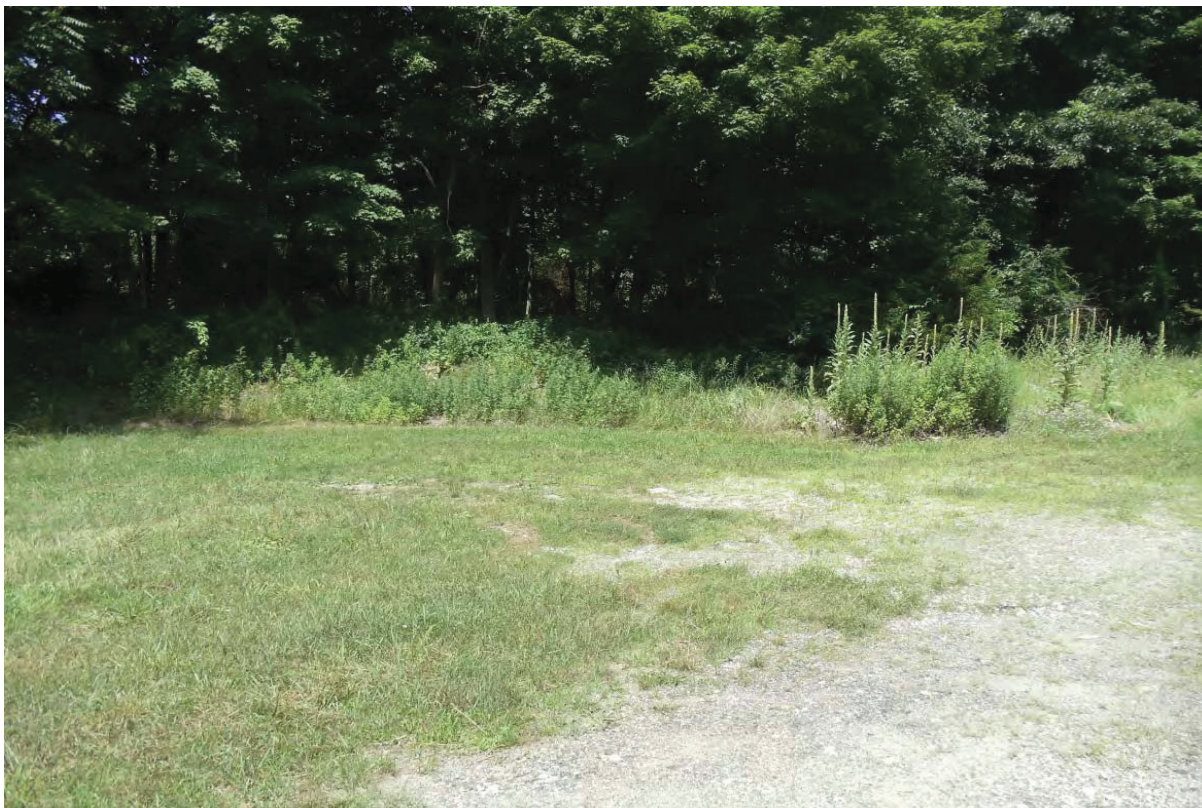
Photo 2: View of the proposed AT&T facility location within a wooded area, looking northwest. Existing maintenance road/proposed AT&T access road in foreground of photo.

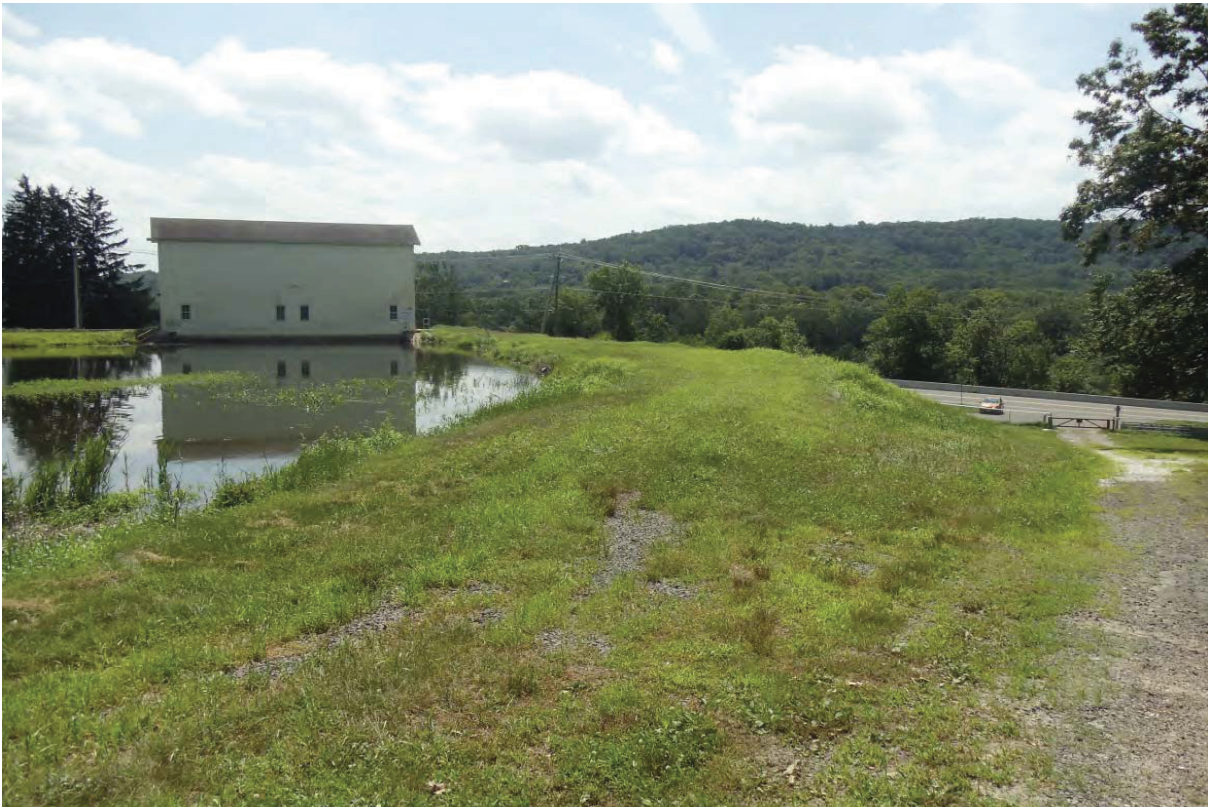
Photo 3: View of existing maintenance road along north side of Cedar Hill Pond Dam in background/left side of photo, looking southwest. Route 7 in background/right side of photo.

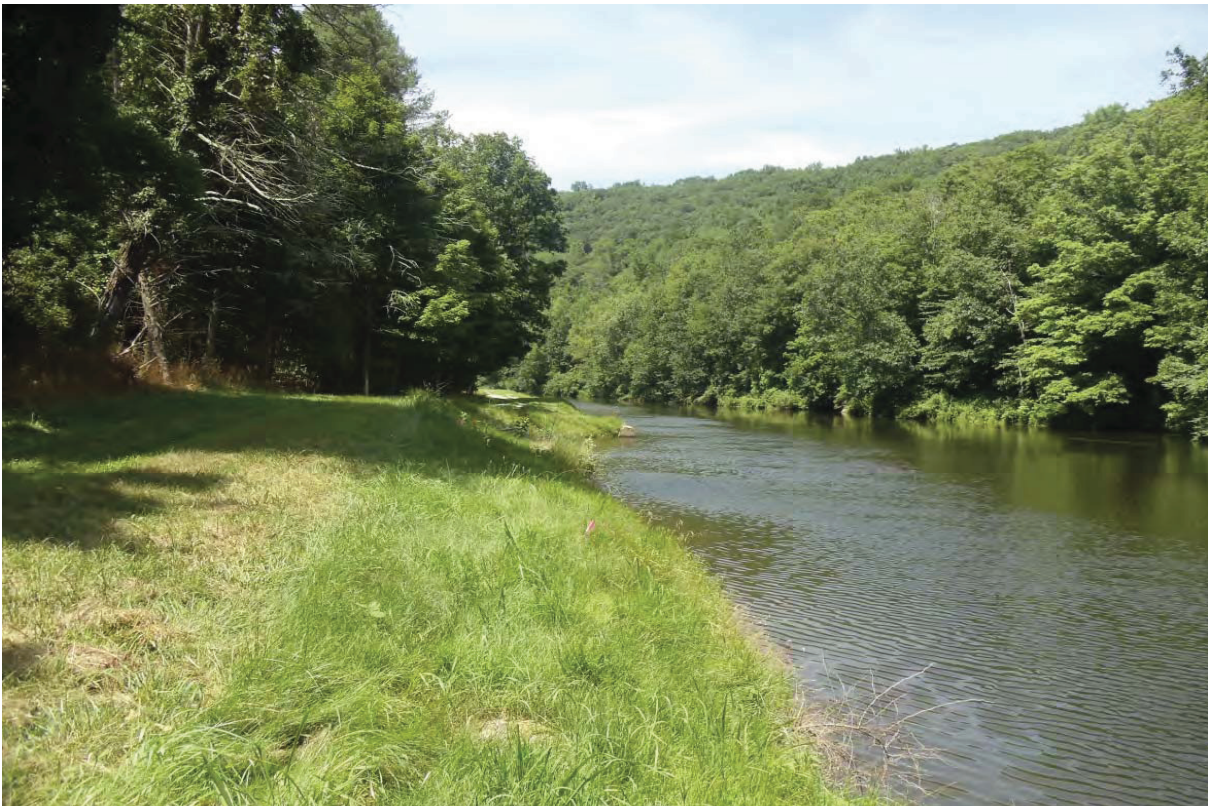
Photo 4: View of Housatonic River diversion channel north of Cedar Hill Pond adjacent to the maintenance road, looking north/northwest.

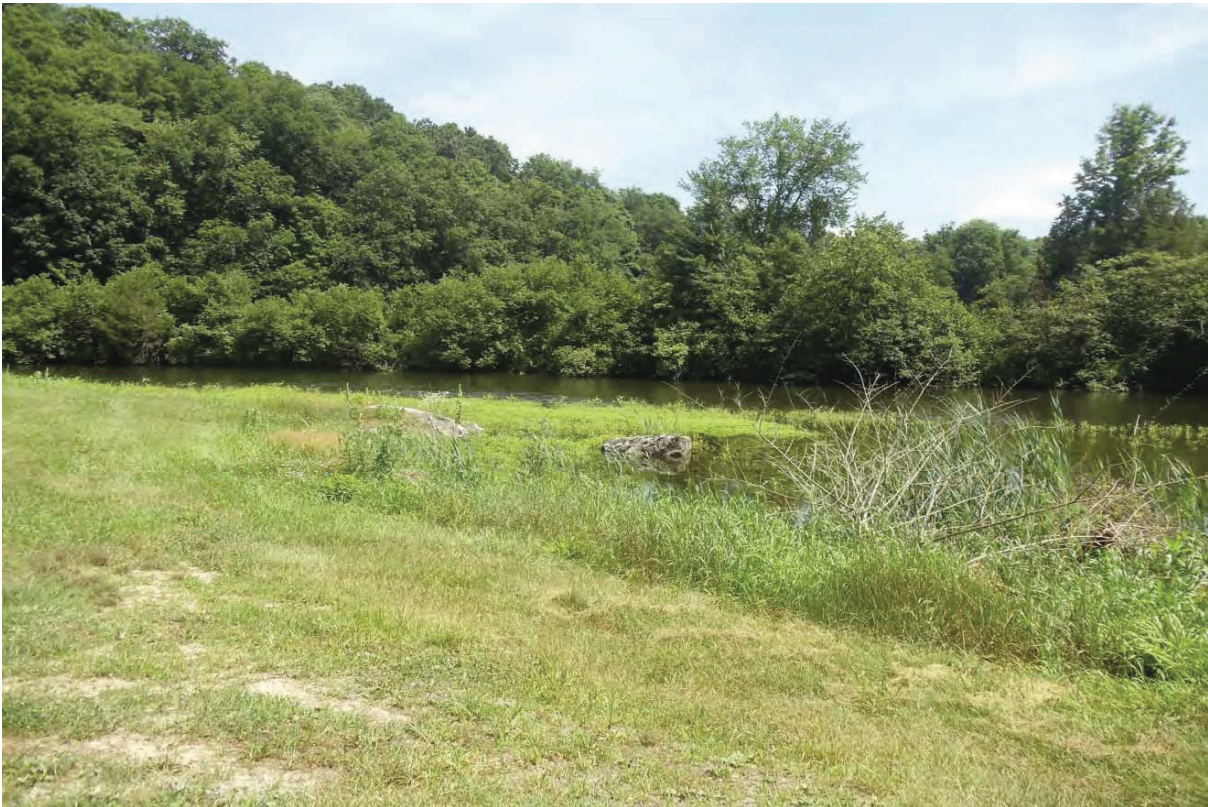
Photo 5: View of Cedar Hill Pond north bank near turn in proposed access drive to AT&T facility, looking southeast.

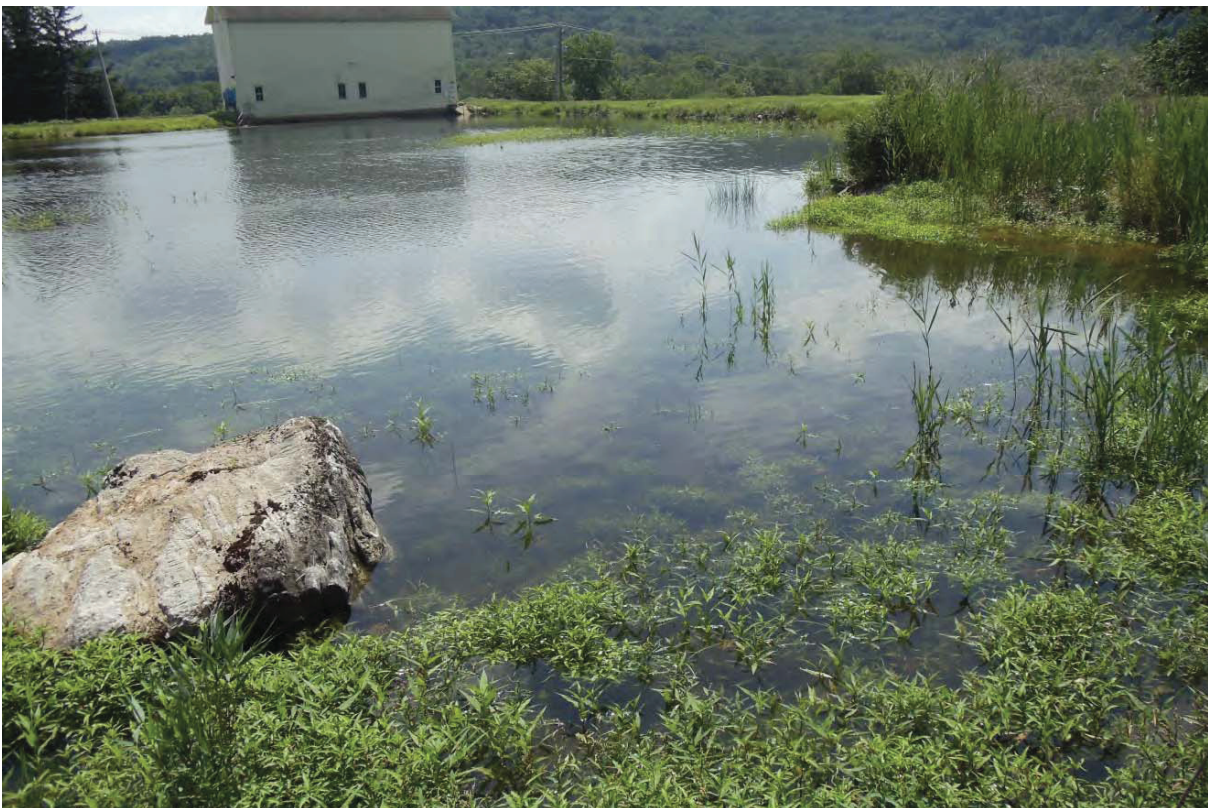
Photo 6: View of Cedar Hill Pond north bank near turn in proposed access drive to AT&T facility, looking west.
