SOUTHWEST CONNECTICUT RELIABILITY PROJECT

THE CONNECTICUT LIGHT AND POWER COMPANY

VOLUME 2: WETLANDS AND WATERCOURSES REPORT

VOLUME 3: ENVIRONMENTAL

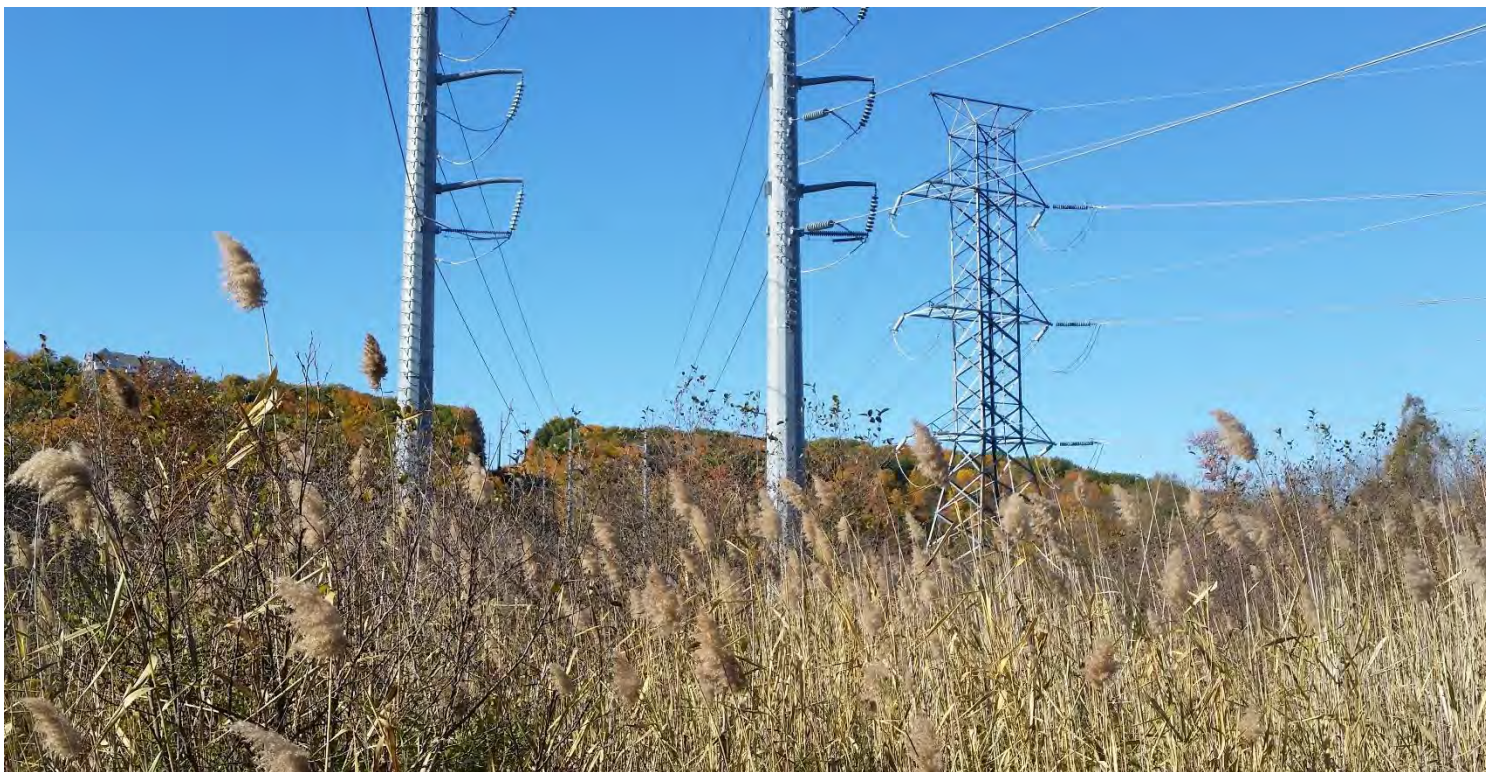
Photo #1: View of Wetland W-1 from the west side of the Plumtree Substation. Existing 321 Line Structure 10269 is shown on the right. *Facing West.*

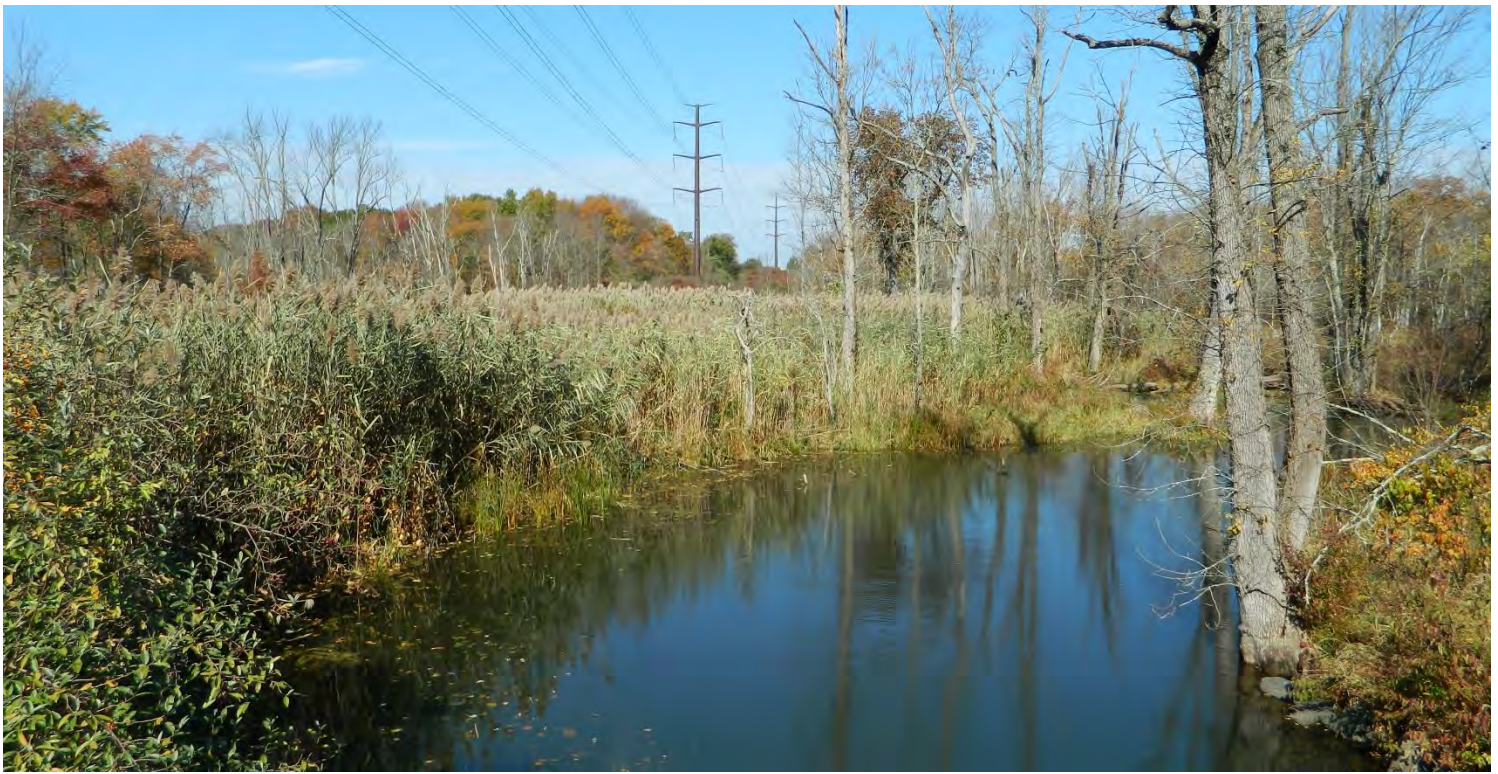
Photo #2: View of Wetland W-1 along the southern edge of the Plumtree Substation where swamp mat access is proposed. The wetland in this portion is a scrub-shrub wetland (PSS) dominated by speckled alder (*Alnus incana*) with only a few mature trees. *Facing West.*

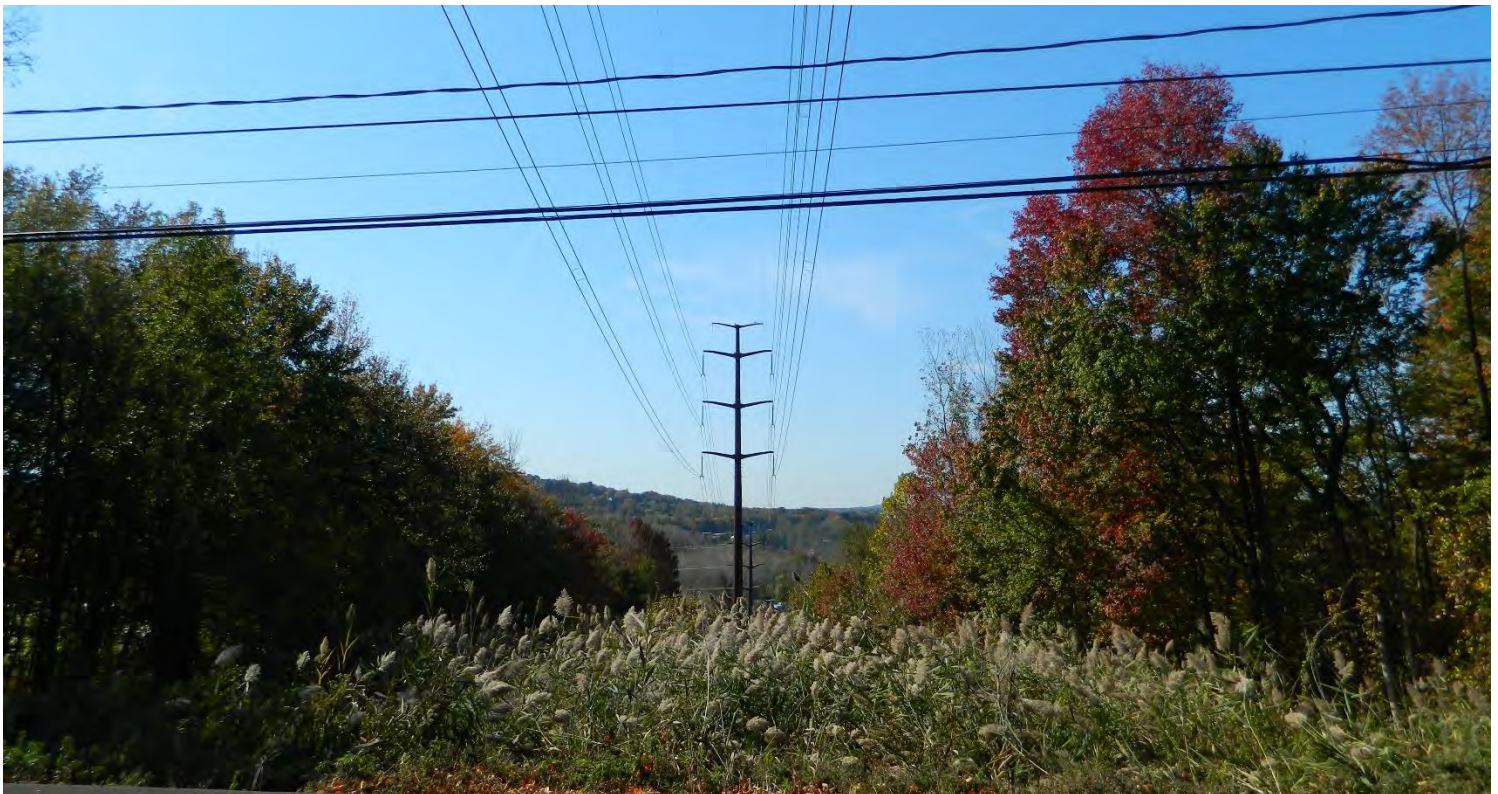
Photo #3: Wetland W-1 a palustrine emergent wetland (PEM) and Lime Kiln Brook a perennial watercourse as seen from Shelter Rock Road. *Facing north.*

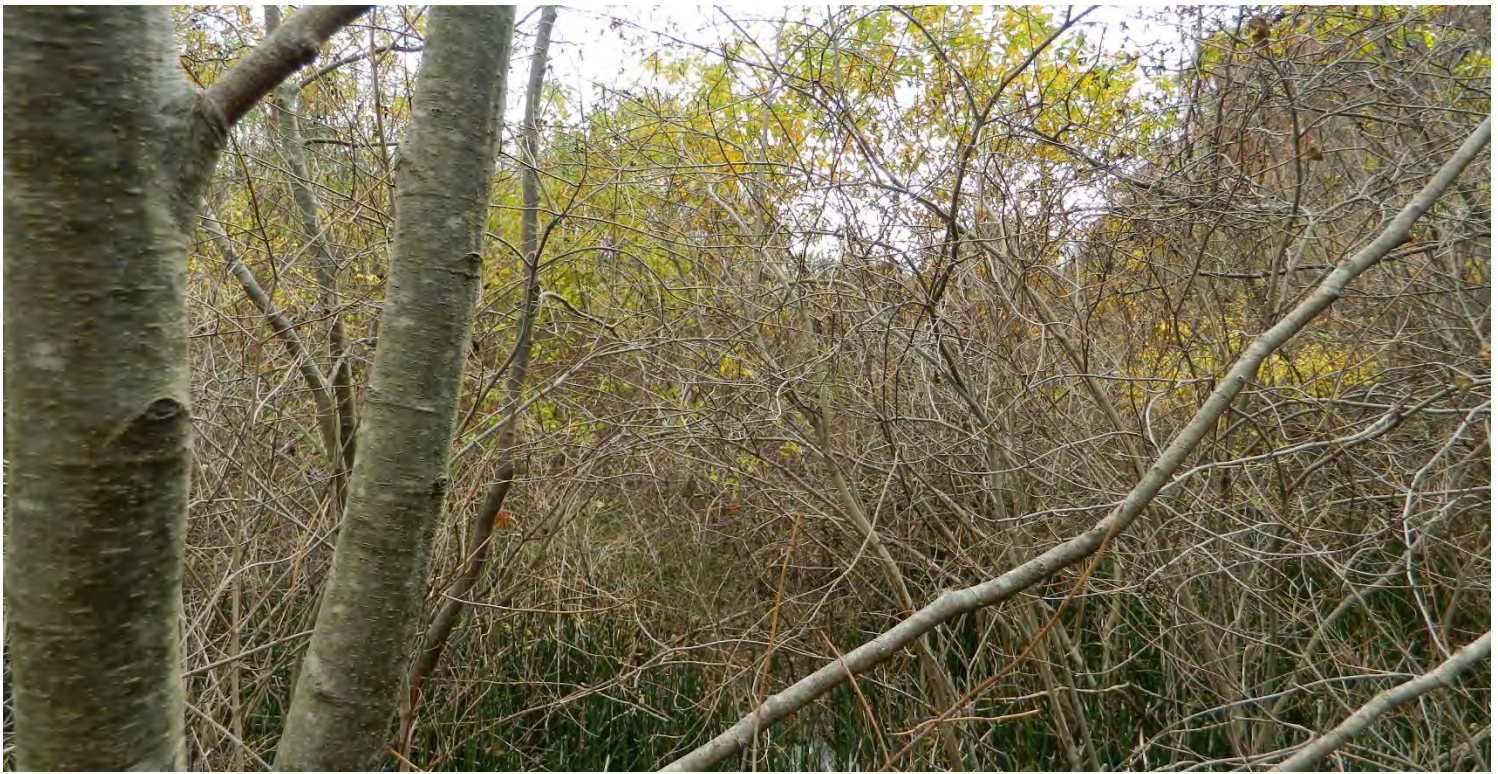
Photo #4: View of Wetland W-2 from Payne Road. W-2 is predominantly a palustrine emergent wetland (PEM) that is forested (PFO) along the northern and southern edges of the Right-of-Way. *Facing west.*

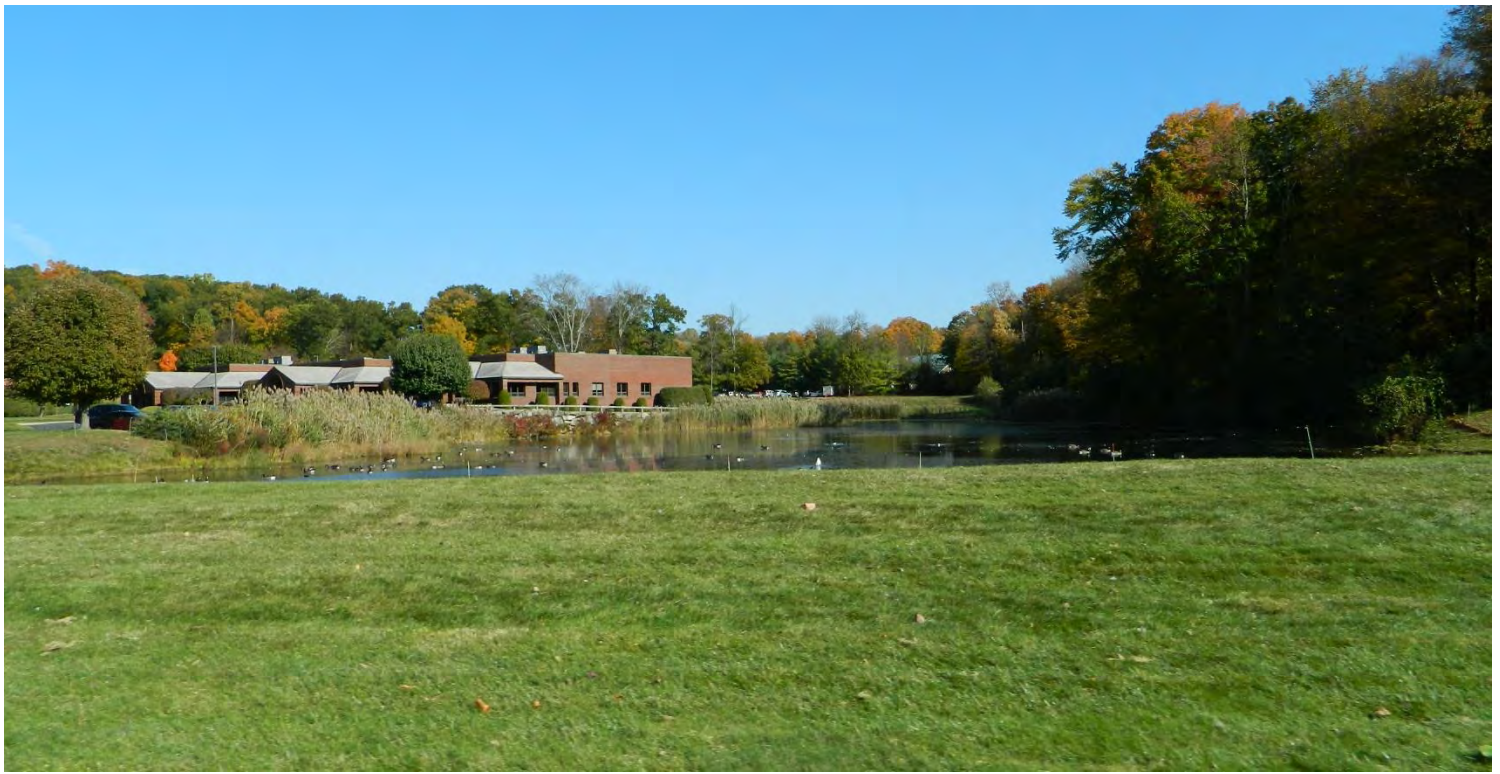
Photo #6: View of Wetland W-4 which is a palustrine emergent wetland (PEM) that is forested (PFO) on the east side of the Right-of-Way. This wetland is mowed within the emergent portion and portions of which are maintained as a man-made stormwater feature. *Facing south.*

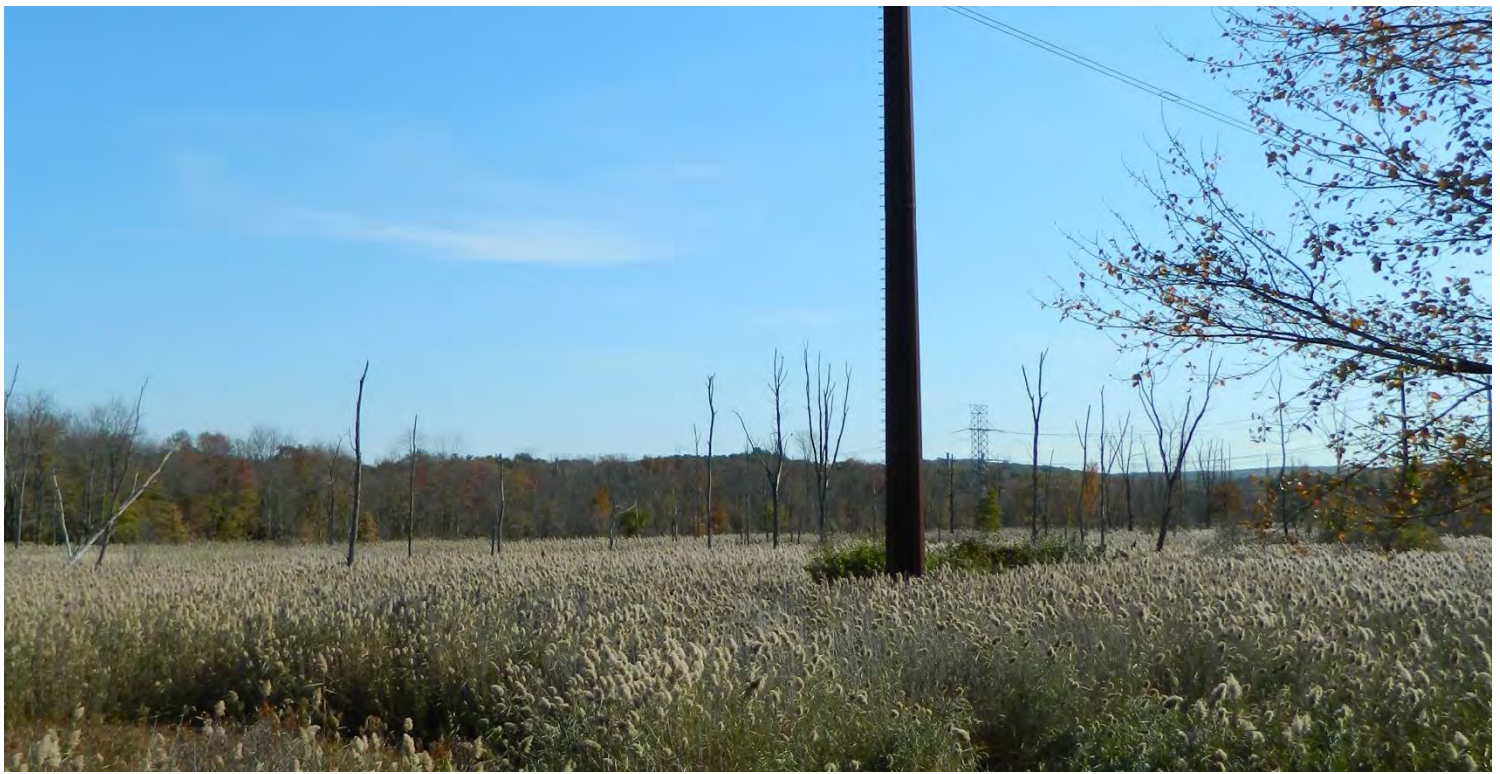
Photo #1: Palustrine emergent habitat (PEM) dominated by common reed (*Phragmites australis*). Palustrine forested (PFO) forest fragments (edge and patch fragments). This system can further be categorized as floodplain forest associated with the East Swamp Brook and Limekiln Brook wetland complex. *Facing southeast towards existing structure 10266.*

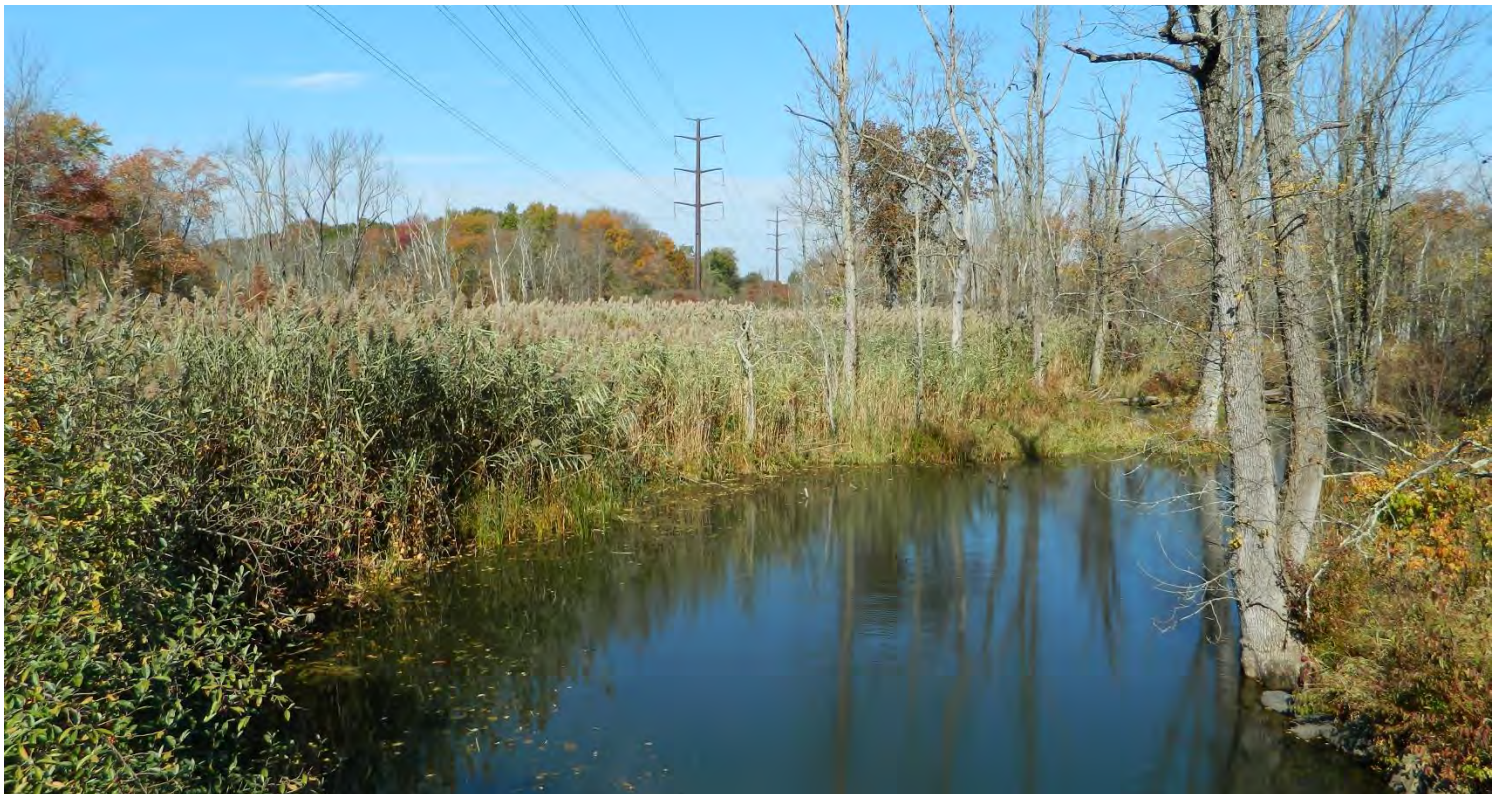
Photo #2: Palustrine emergent habitat associated with East Swamp Brook (shown above) dominated by common reed (*Phragmites australis*). Edge forest adjacent to small Core Forest (<250 acres) is present on either side and represents a palustrine forested community (PFO). *Facing north towards existing structure 10264 from Shelter Rock Road.*

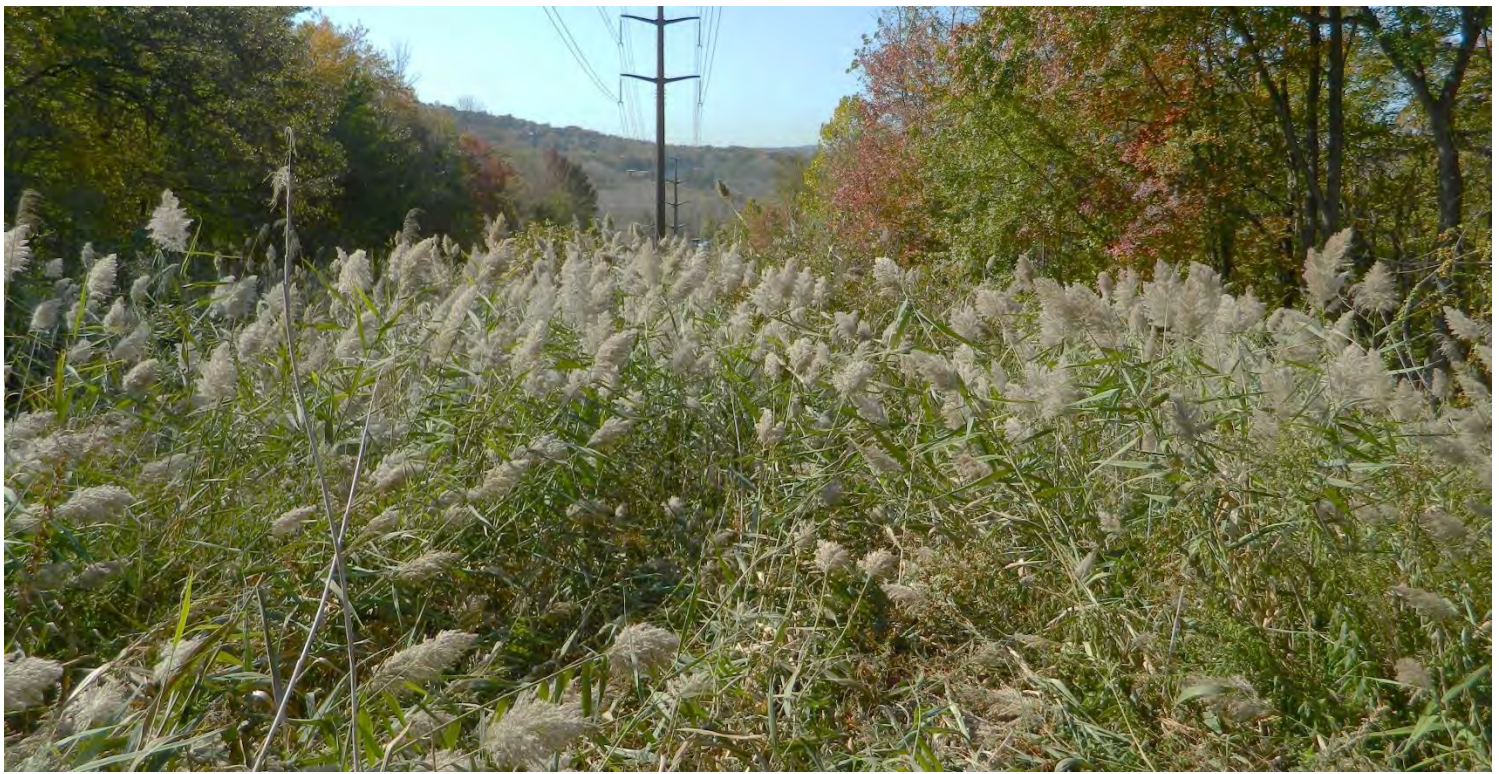
Photo #3: Palustrine emergent habitat (PEM) present within the managed portion of the ROW bordered by patch forest (PFO or upland) are typical in the residential areas from Payne Road to US-6. *Facing west from Payne Road towards existing structure 10259.*

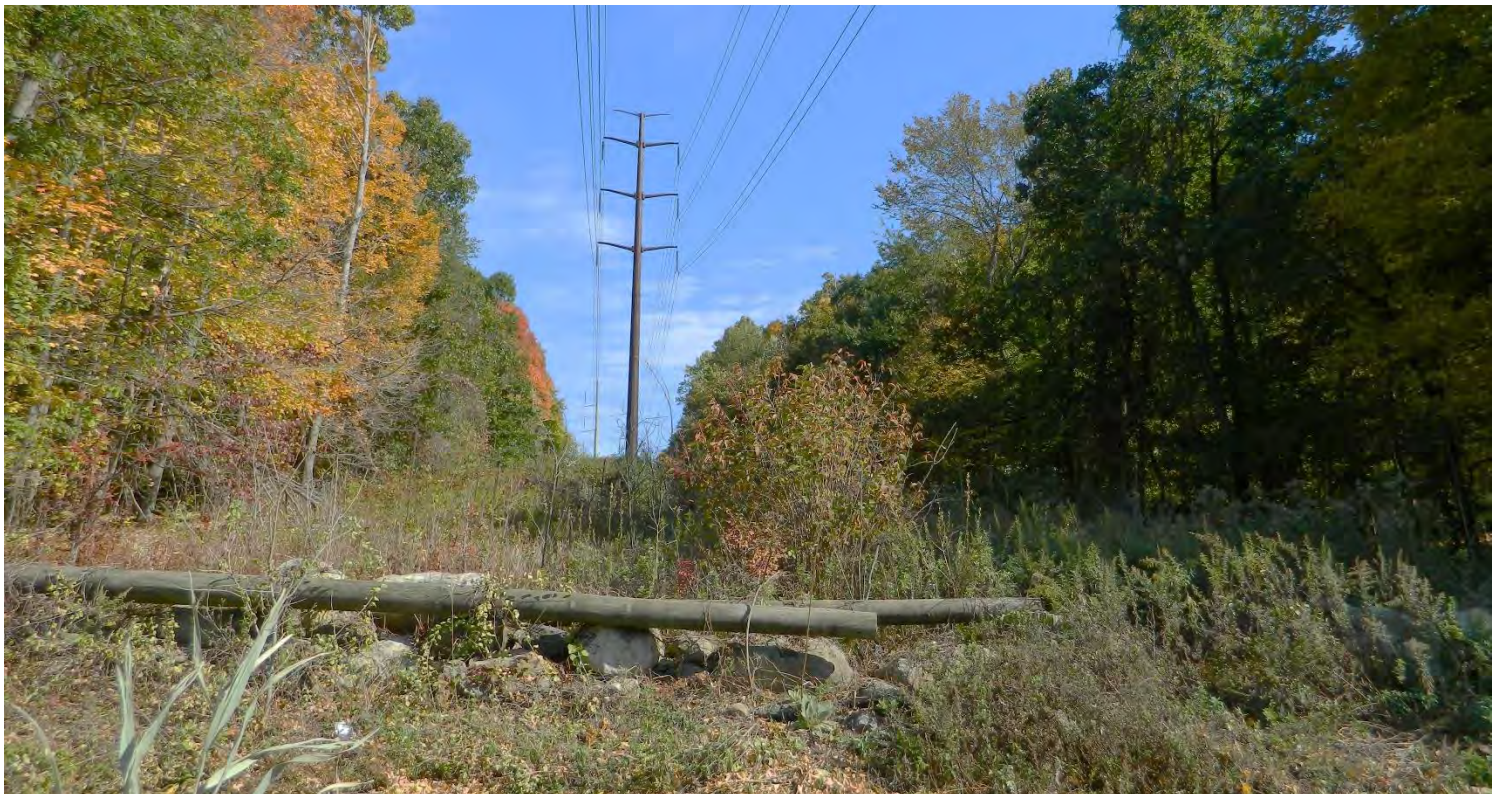
Photo #4: Scrub-shrub habitat within the managed portions of the ROW bordered by patch forest (upland forest) are typical in the residential areas from Payne Road to US-6. *Facing east from Payne Road towards existing structure 10258.*

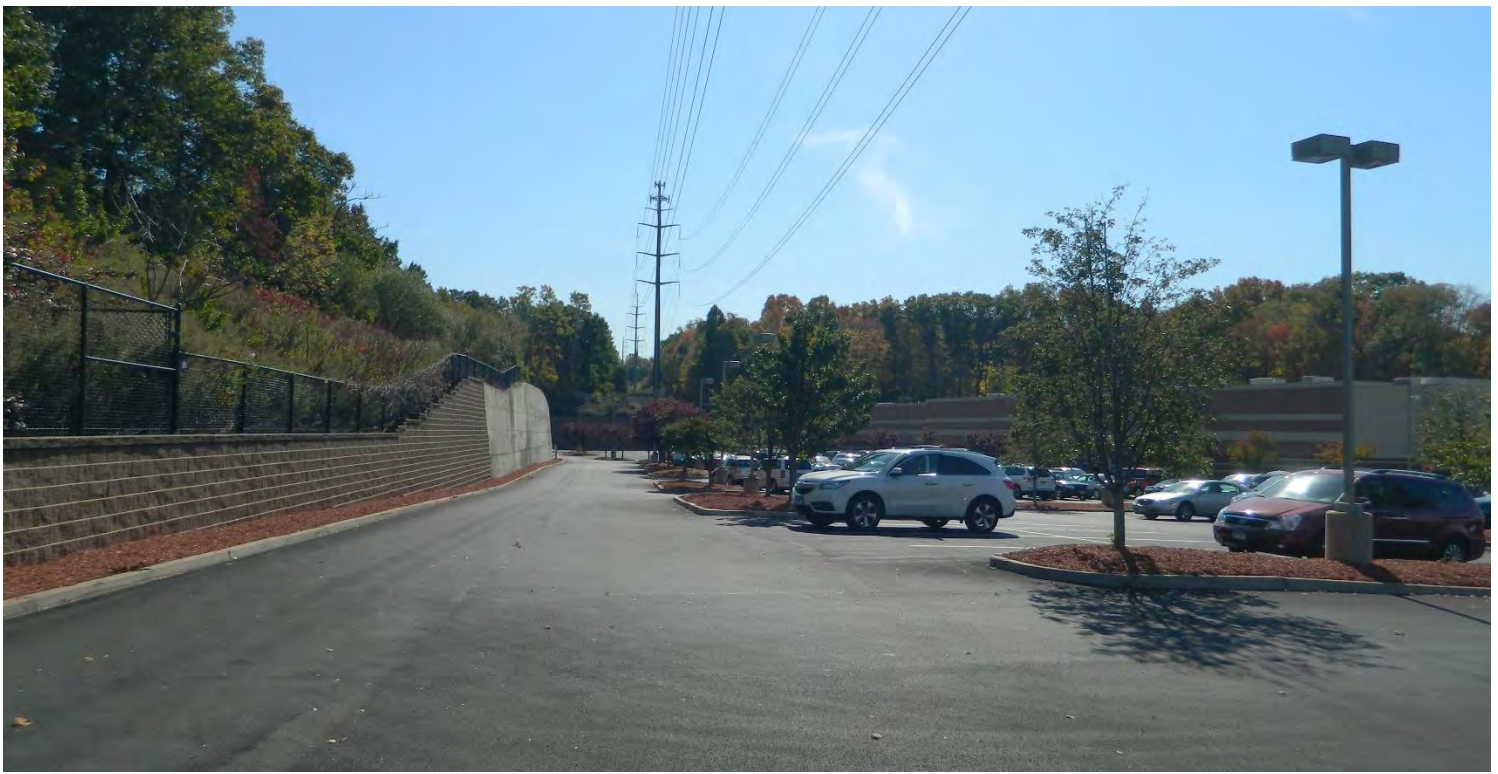
Photo #5: Urban, commercial settings are common on either side of US-6 in Bethel dominated by paved surfaces, buildings, and landscaped environments. Some sparse areas of fragmented (patch) forest is present in these areas. *Facing south from the Target parking lot towards existing structure 10255.*

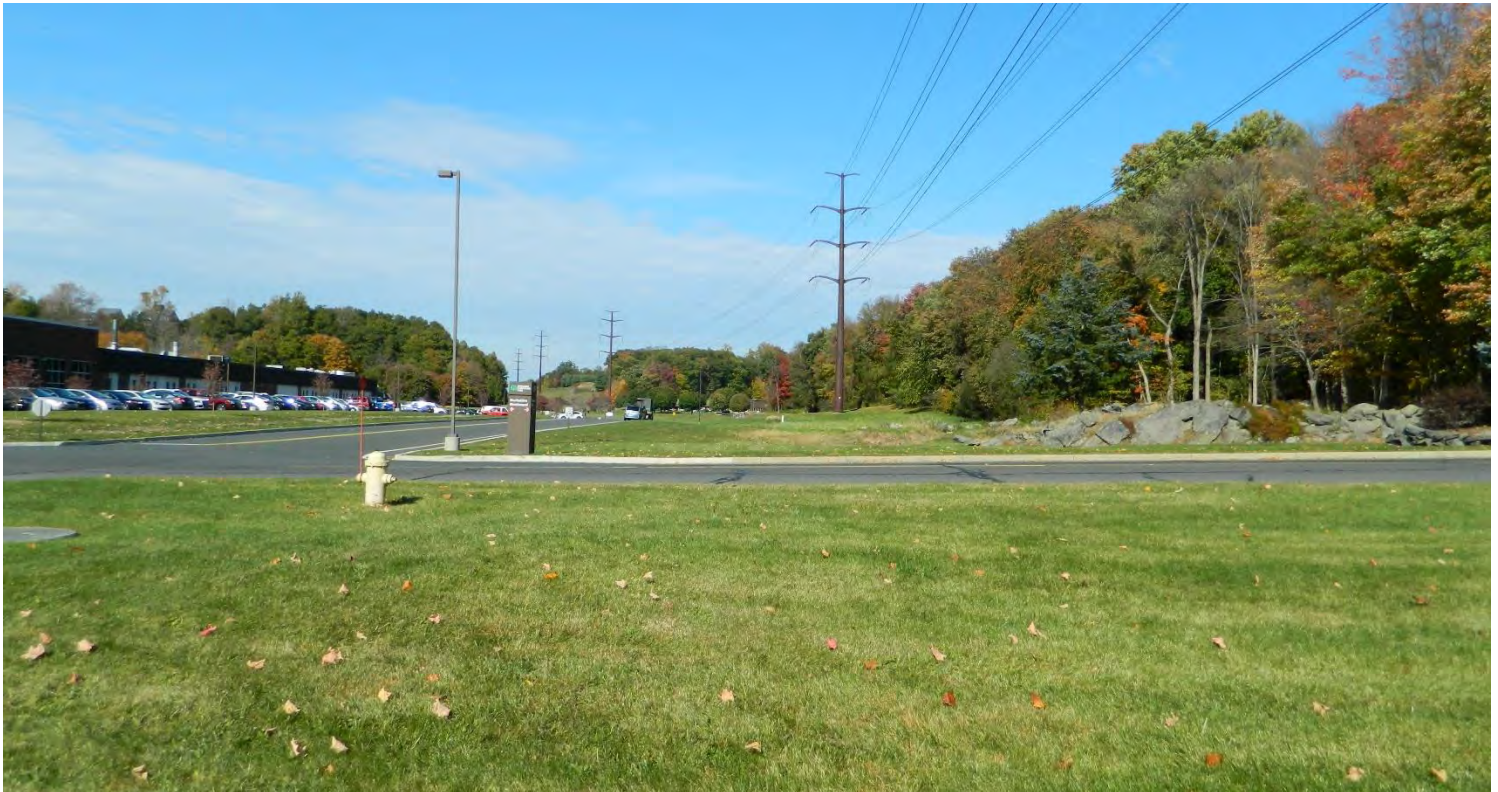
Photo #6: Commercial/industrial land uses dominate north of US-6 in Bethel. These areas consist of land cover of lawn, paved surfaces, and buildings. Forested habitat is typically only present on the east side of the ROW and is comprised of either patch forest or edge forest. *Facing north towards Berkshire Boulevard and existing Structure 10251.*

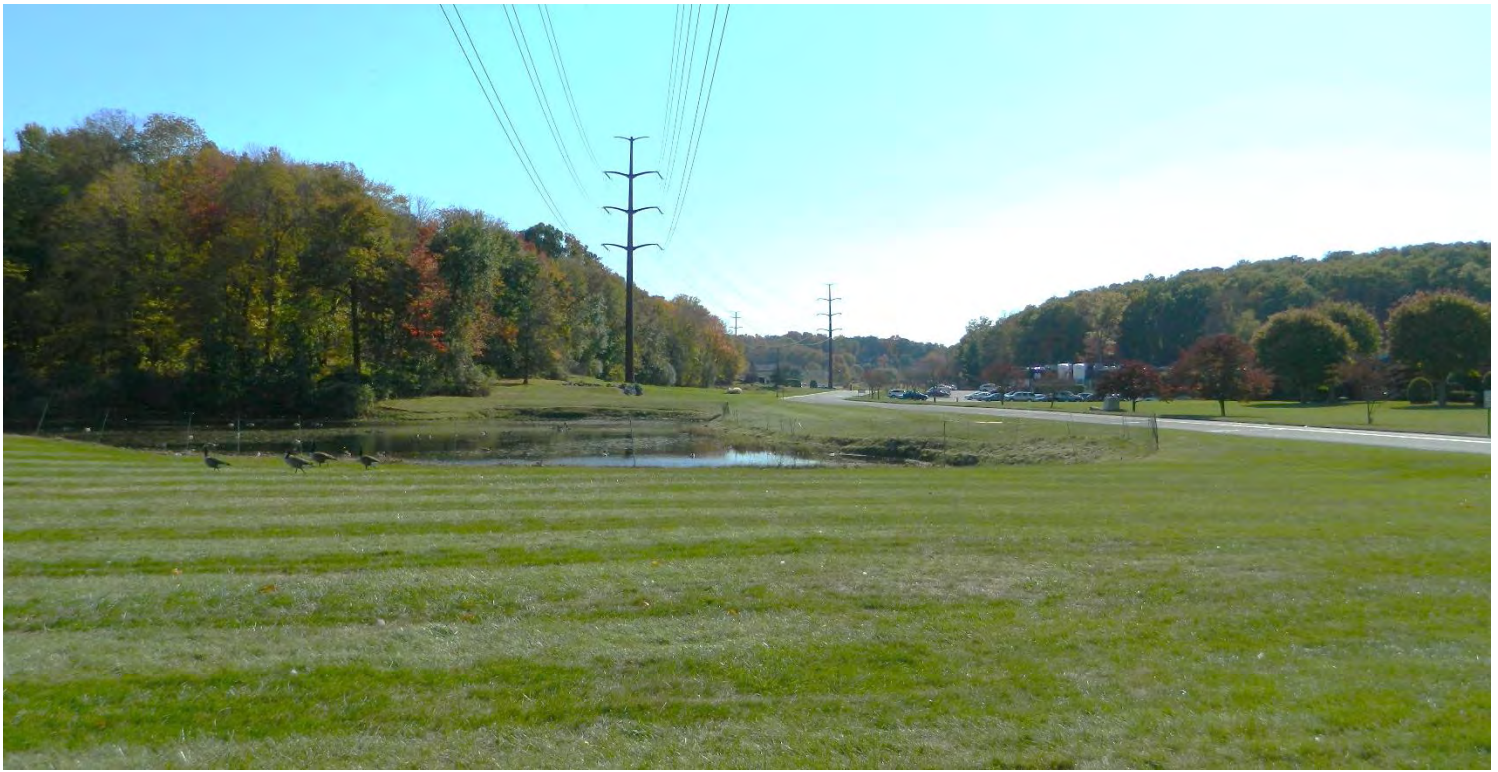
Photo #7: Open water habitat (WB-1) is suitable for Canada goose (*Branta canadensis*), as seen above. This pond is routinely mowed and maintained by the existing commercial development. Facing south from Park Lawn Drive in Bethel towards existing structure 10251.

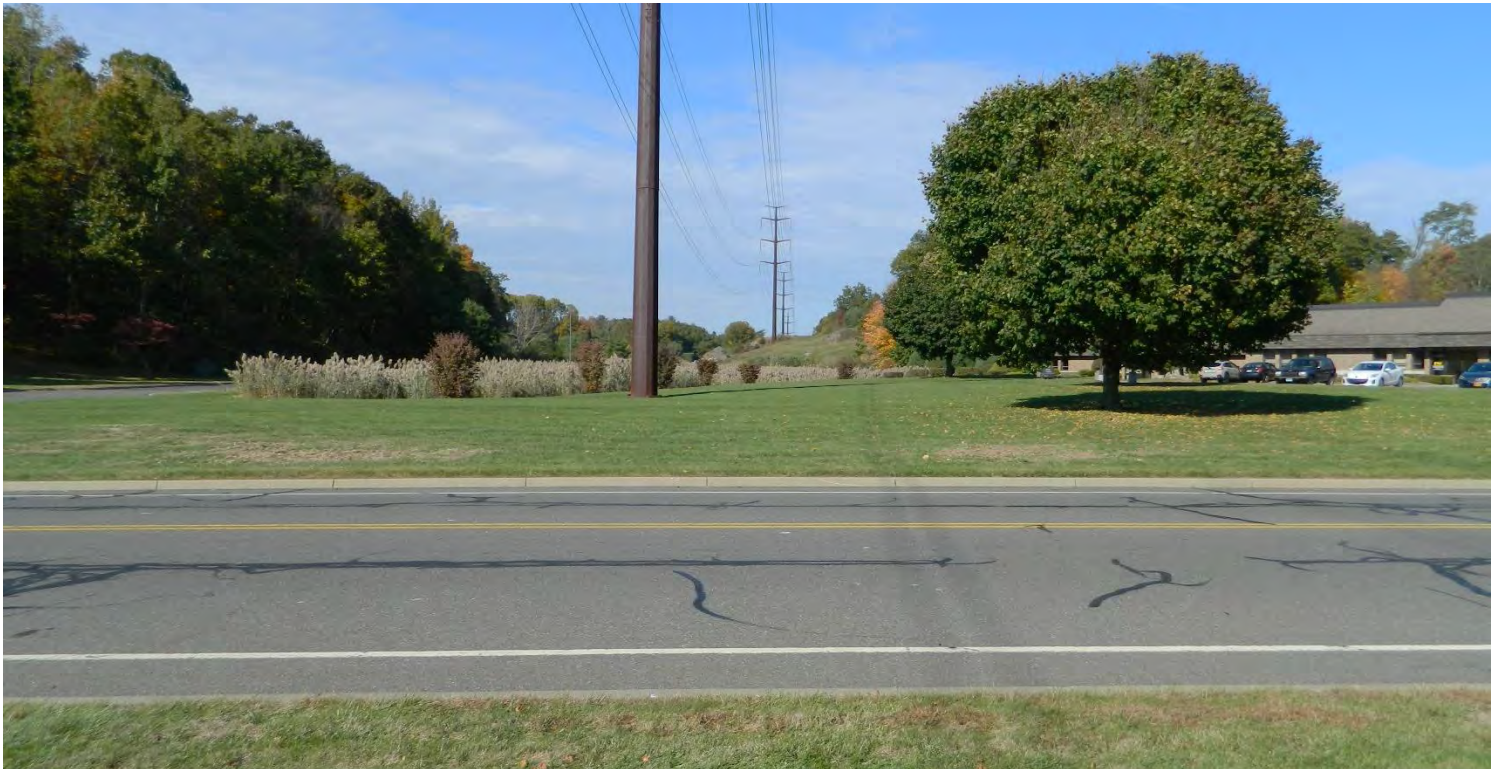
Photo #8: Palustrine emergent habitat in the commercial/industrial areas present to the north of are dominated by common reed (*Phragmites australis*) and are surrounded by a perimeter of planted juniper bushes (*Juniperus sp.*) and surrounded by lawn. The wetlands in this area are mostly armored and at least partially man made and mostly function as stormwater systems for the surrounding development. Facing north from Park Lawn Drive towards existing structure 10250.

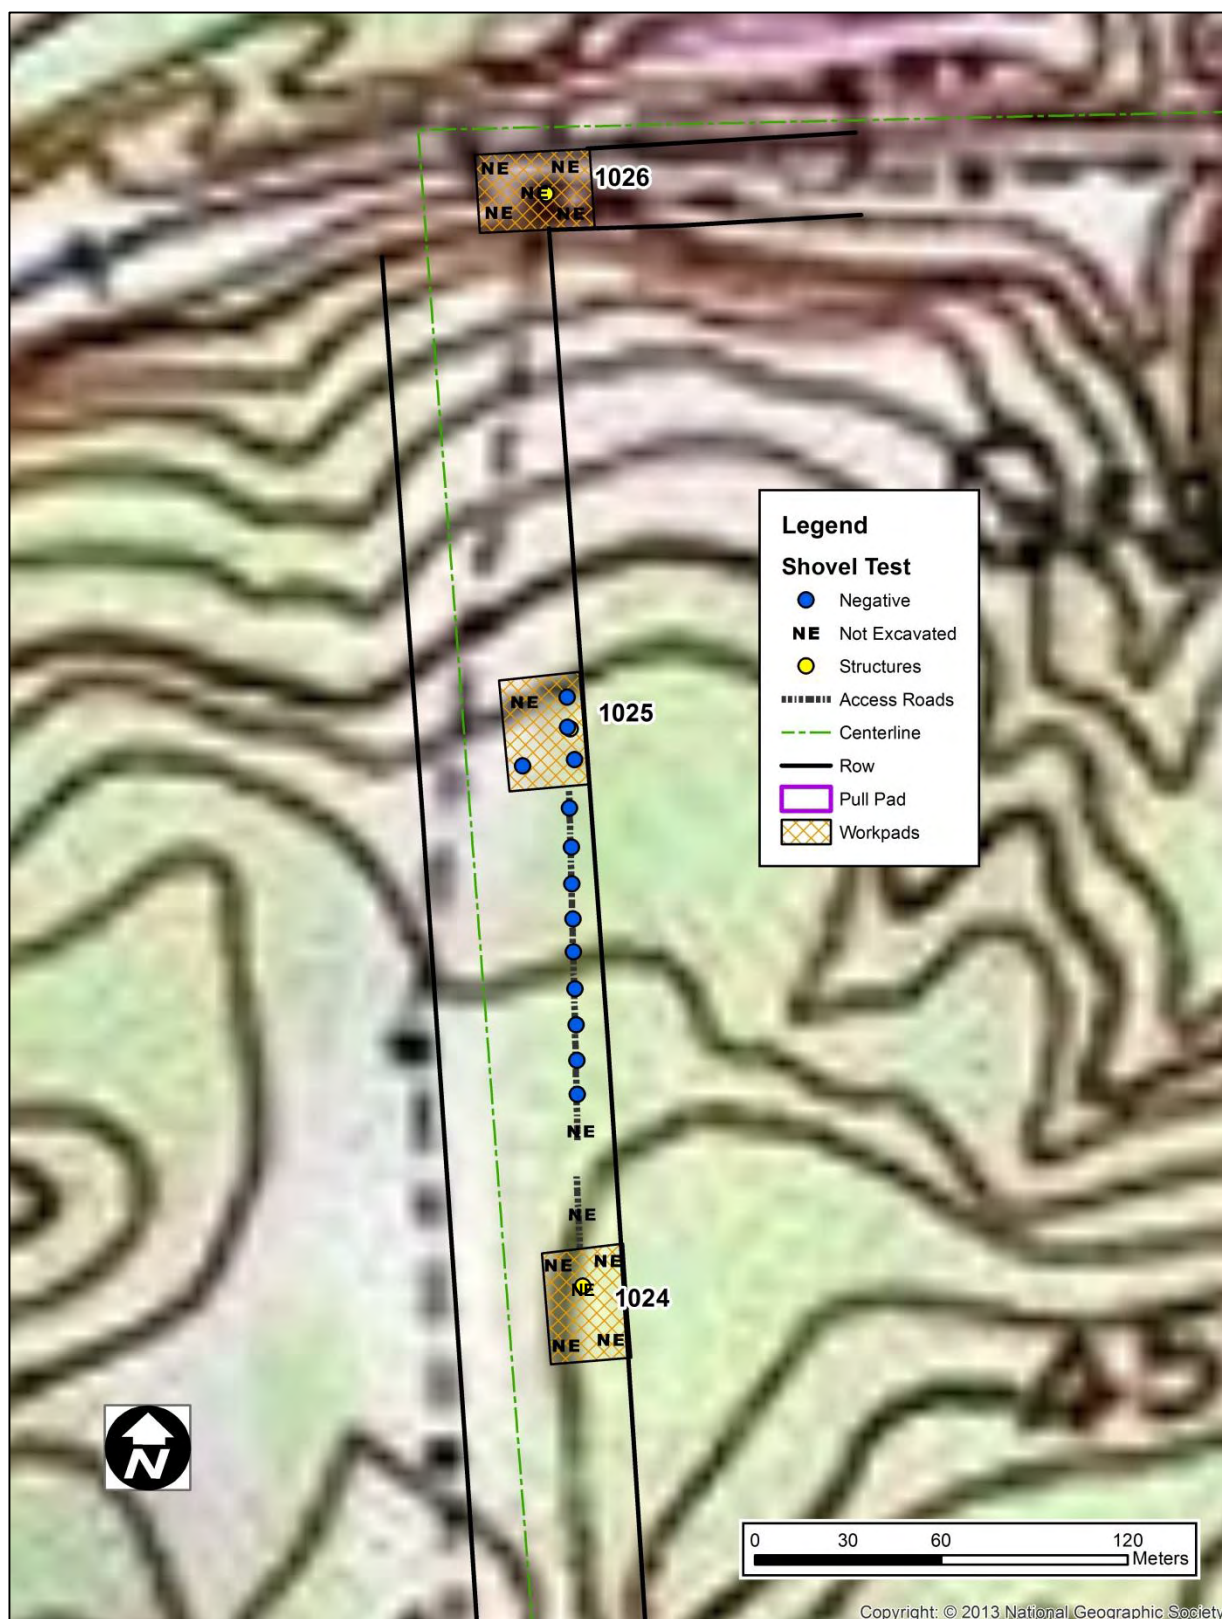
Figure 1, Sheet 2.

Excerpt from a USGS 7.5' series topographic quadrangle image showing the proposed project items associated with the Plumtree Line in Bethel, Brookfield, and Danbury, Connecticut

As mentioned above, the proposed project corridor is located in Bethel, Brookfield, and Danbury, Connecticut (Figure 1). The Areas of Potential Effect include 30 x 30 m (100 x 100 ft) work pads at Structures 1013, 1014, 1015, 1016, 1024, 1025, and 1026, three proposed pull pads in the vicinity of Structures 1015 and 1016, and proposed access roads leading to Structures 1014, 1024 and 1025. The Areas of Potential Effect are situated at approximate elevations ranging from 200 to 500 ft NGVD; they are located in areas characterized by both residential and industrial developments (Photos 1 through 13). At the time of survey, the Areas of Potential Effect were characterized by a mixture of open areas and lightly wooded areas covered with low lying brush. Despite the fact that the planned facilities are located in close proximity to existing transmission line structures, the Areas of Potential Effect were surveyed using close interval shovel testing (15 m [49.2 ft]) in an effort to identify evidence of intact soil strata and cultural deposits. Field methodologies employed during the current investigation consisted of pedestrian survey, mapping, photo-documentation, and subsurface testing throughout the Areas of Potential Effect. The details of the field methods, as well as the results of this field effort, are reviewed below.

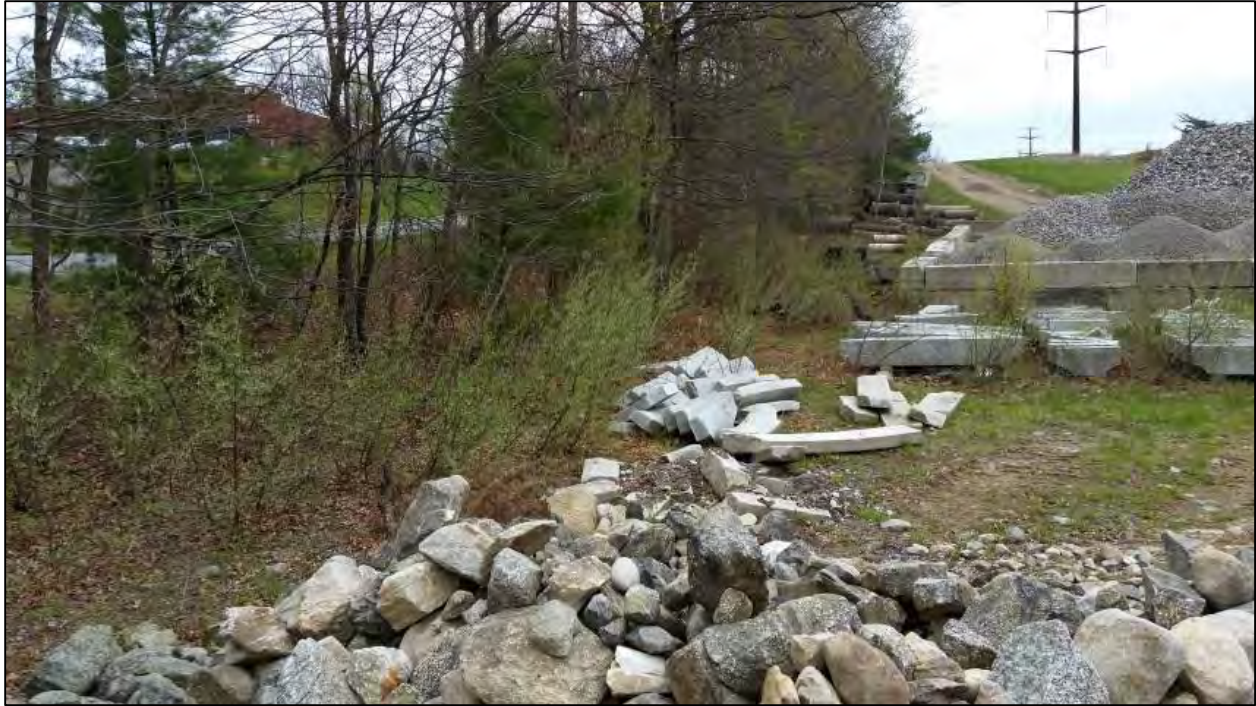
Photo 9. Overview photo of Structure 1024 location facing south (note previous disturbances in this area).

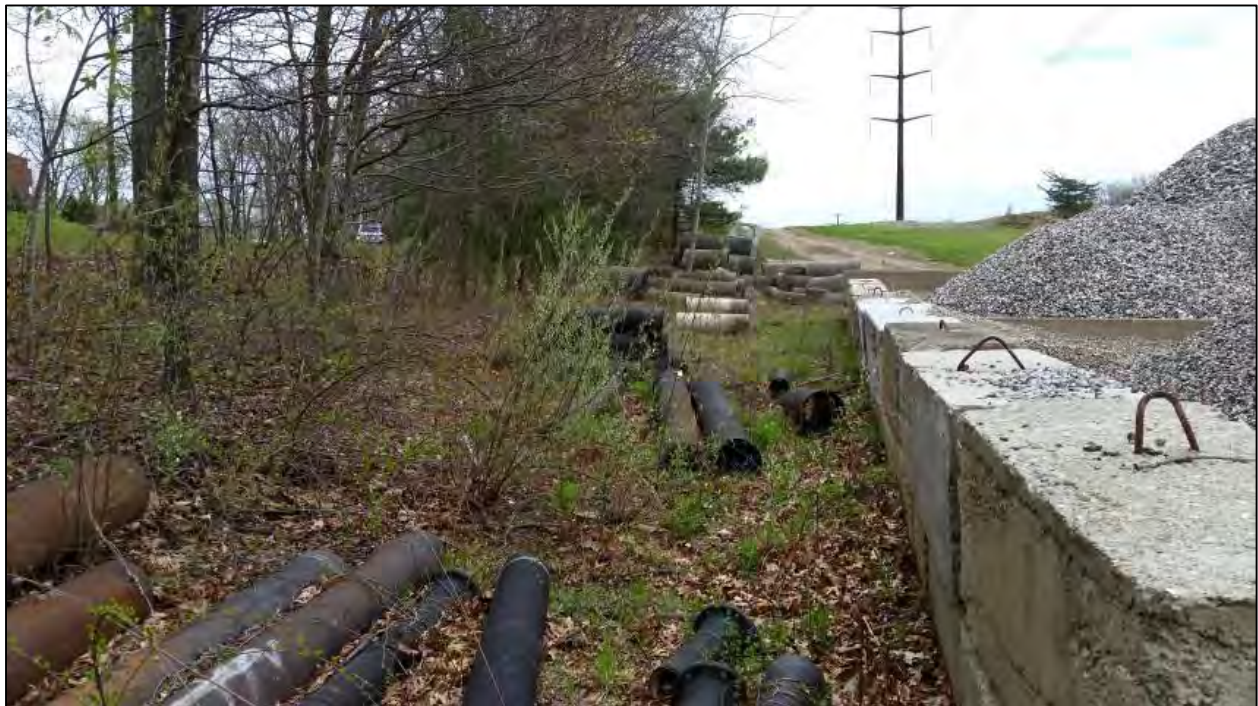
Photo 10. Overview photo of the proposed access road leading from Structure 1024 location facing south (note previous disturbances in this area).

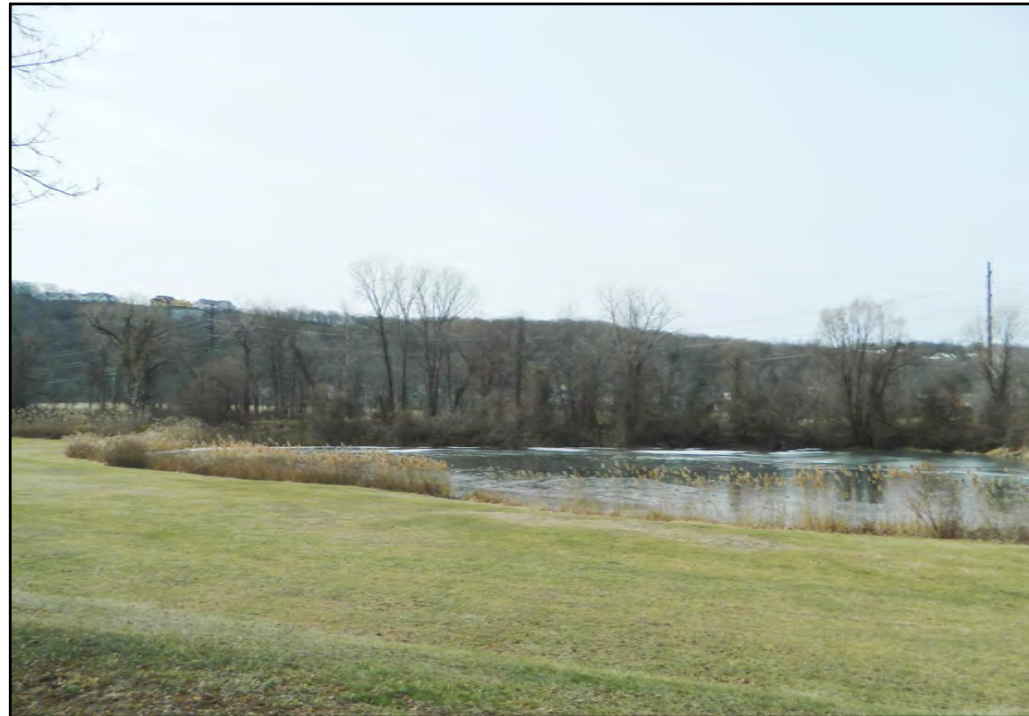
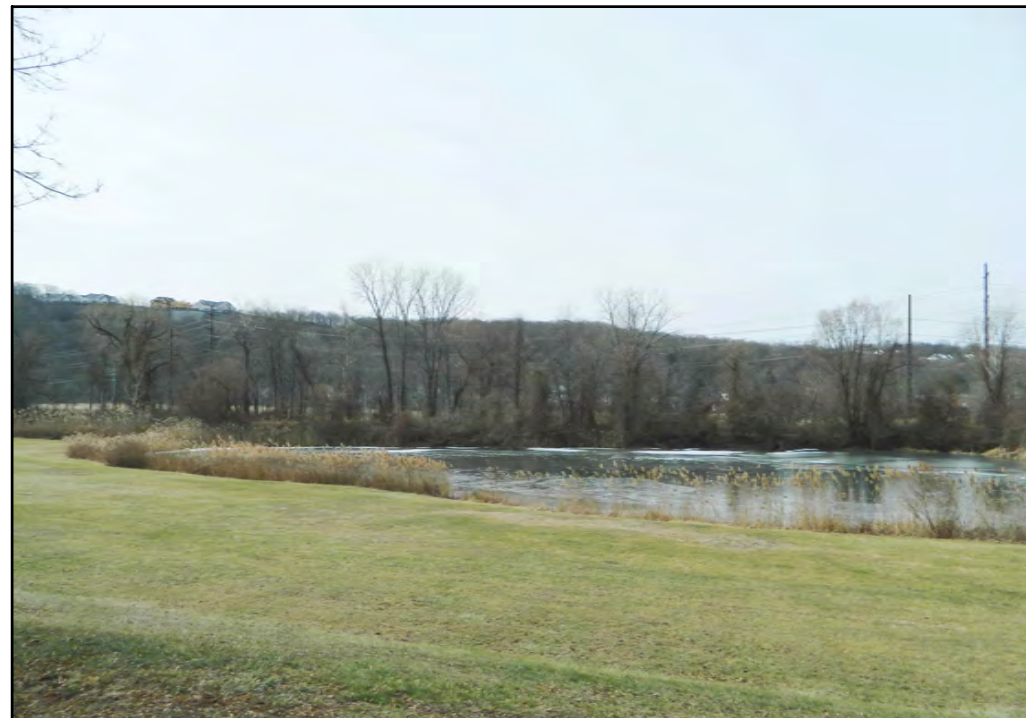
EXISTING VIEW 1

PROPOSED VIEW 1
