SOUTHWEST CONNECTICUT RELIABILITY PROJECT

THE CONNECTICUT LIGHT AND POWER COMPANY

VOLUME 2: WETLANDS AND WATERCOURSES REPORT

VOLUME 3: ENVIRONMENTAL

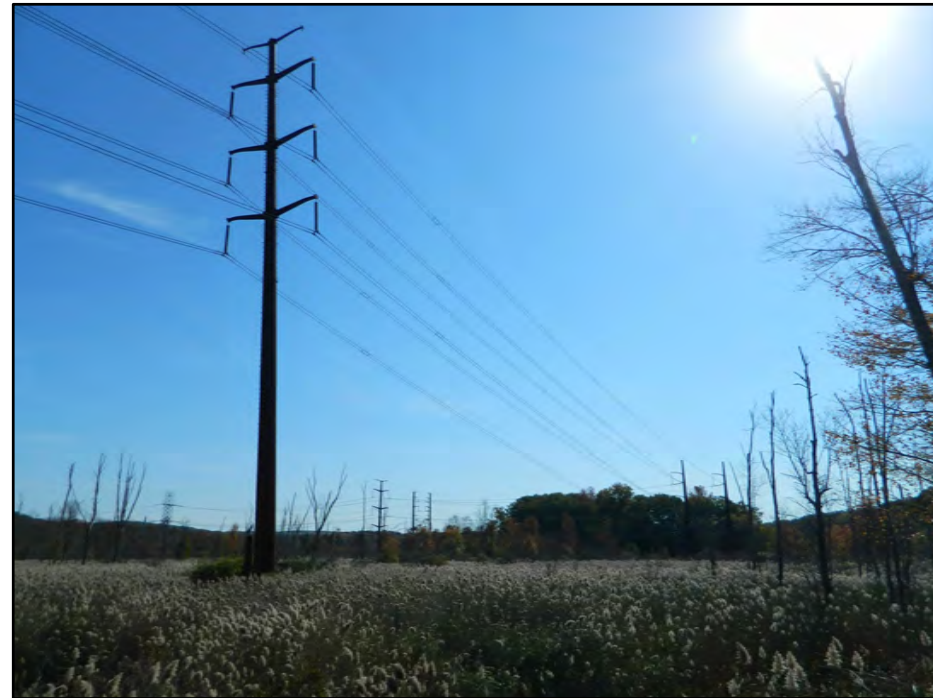
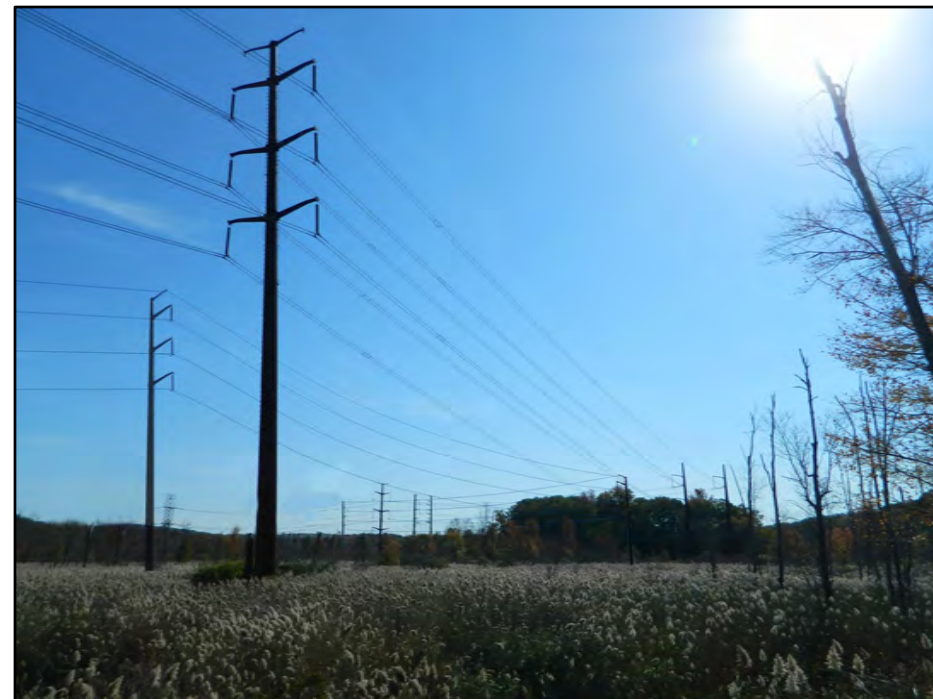
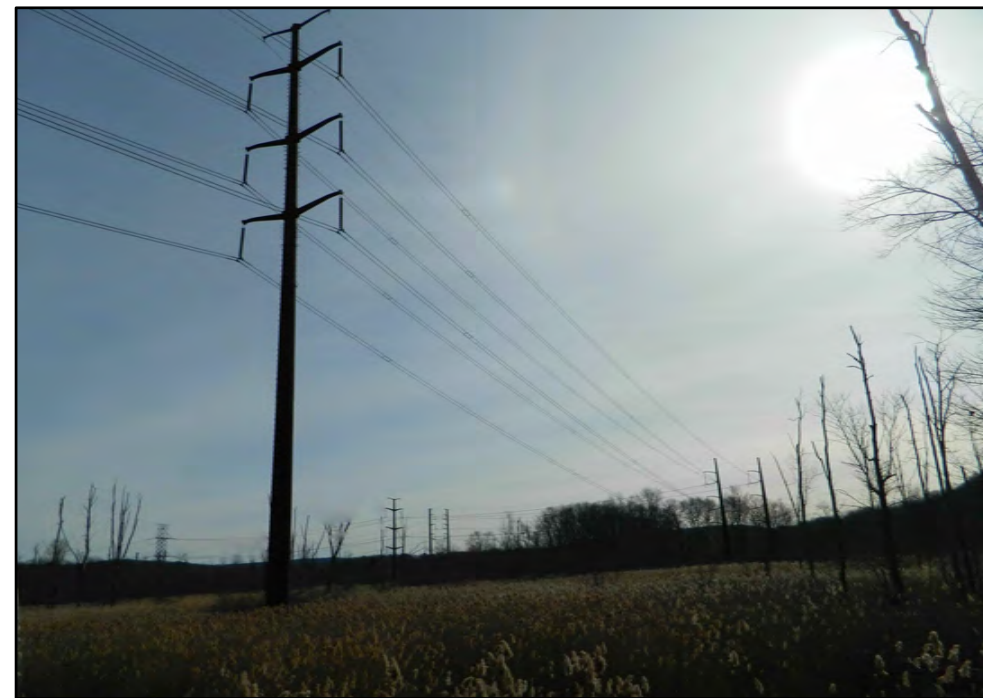
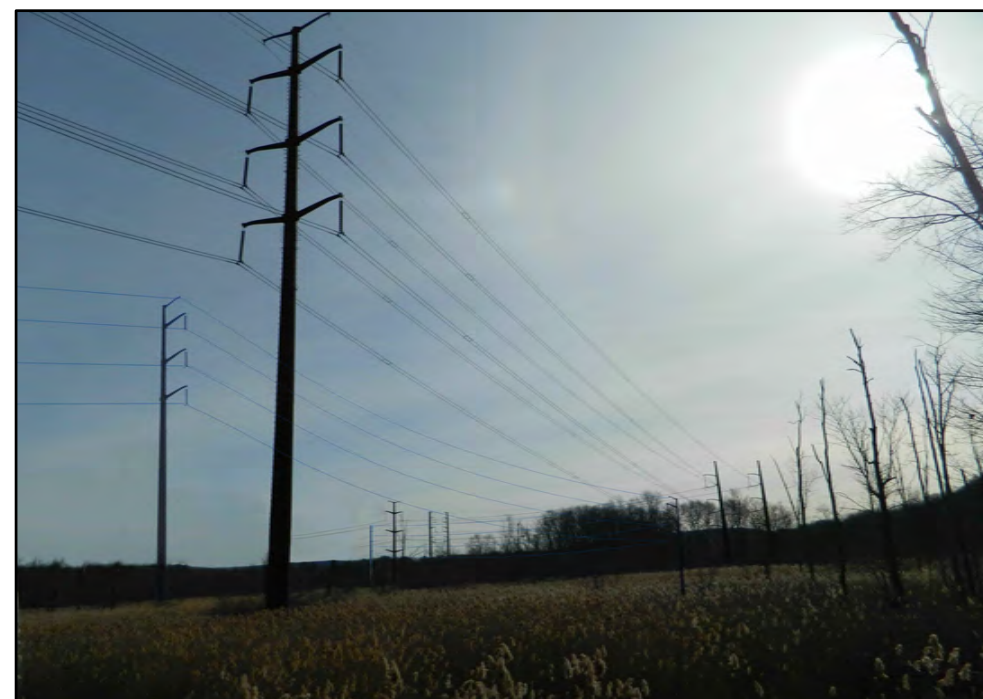
EXISTING VIEW 3

PROPOSED VIEW 3

VIEW 3 LOOKING SOUTHEAST FROM END OF LEXINGTON BLVD.

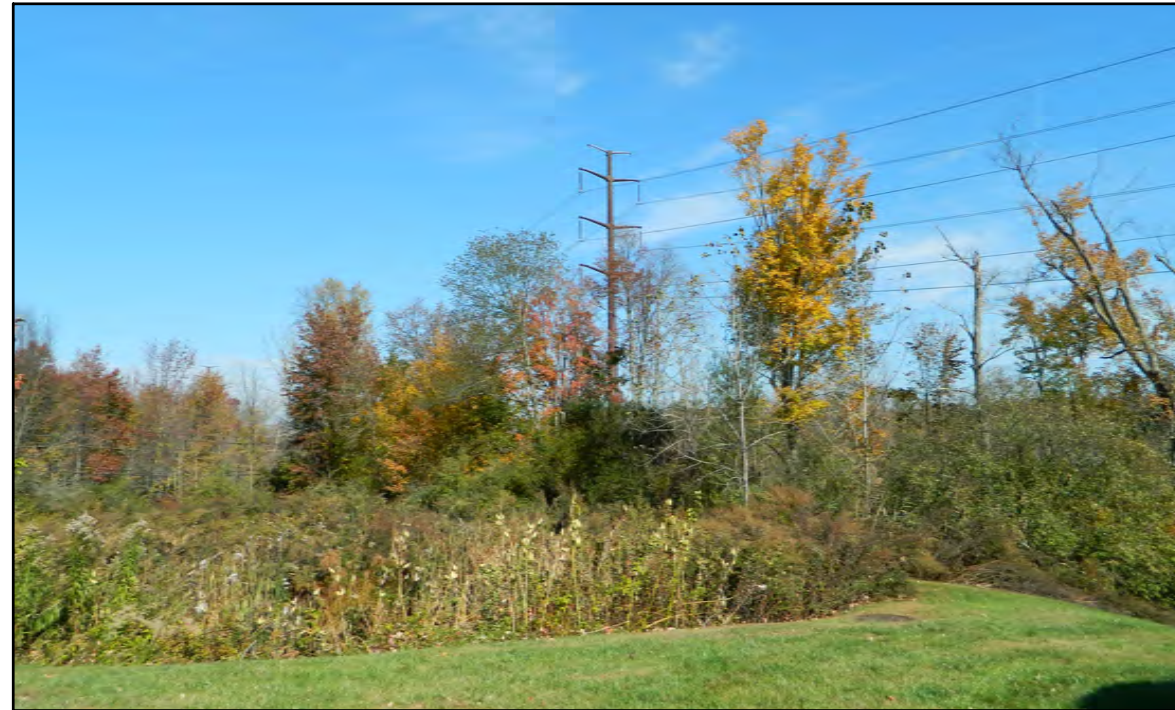
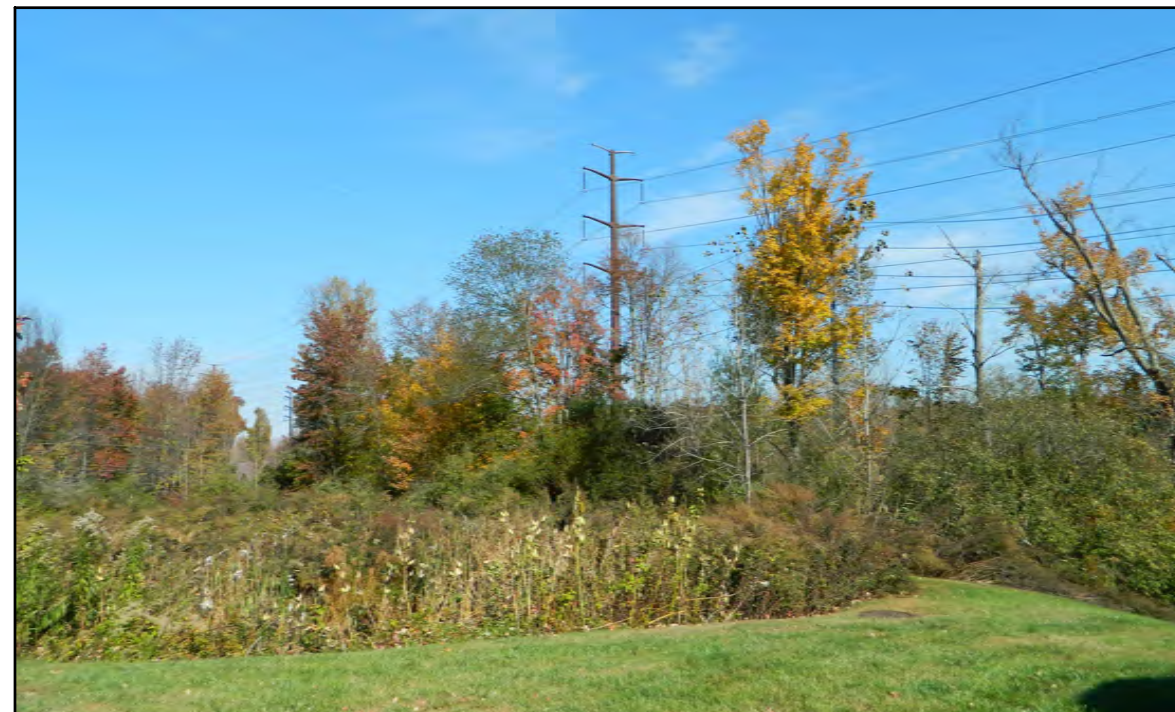
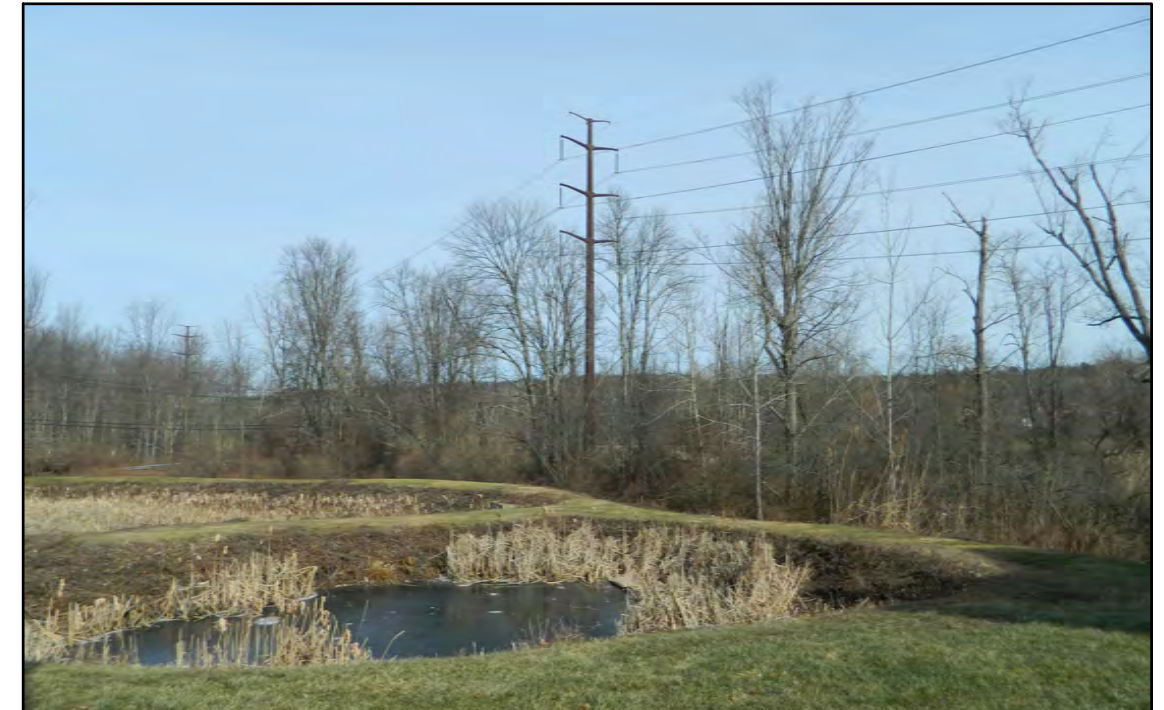
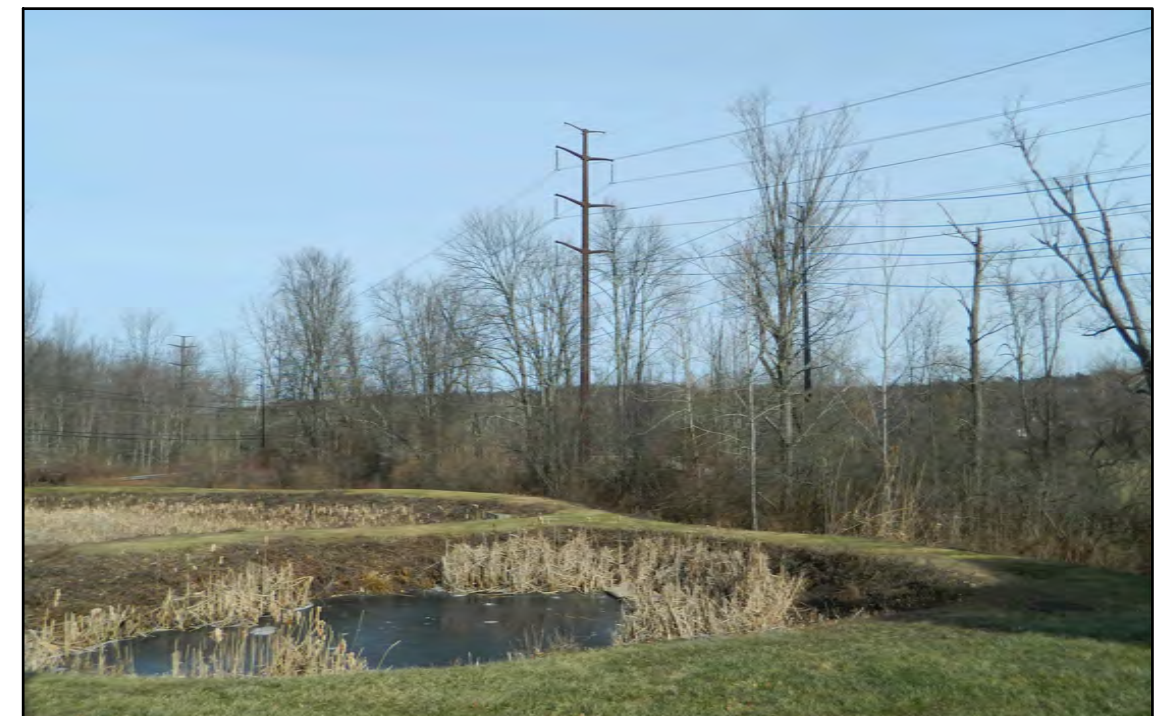
EXISTING VIEW 4

PROPOSED VIEW 4

VIEW 4 LOOKING NORTHEAST FROM RESIDENCE AT LEXINGTON BLVD.

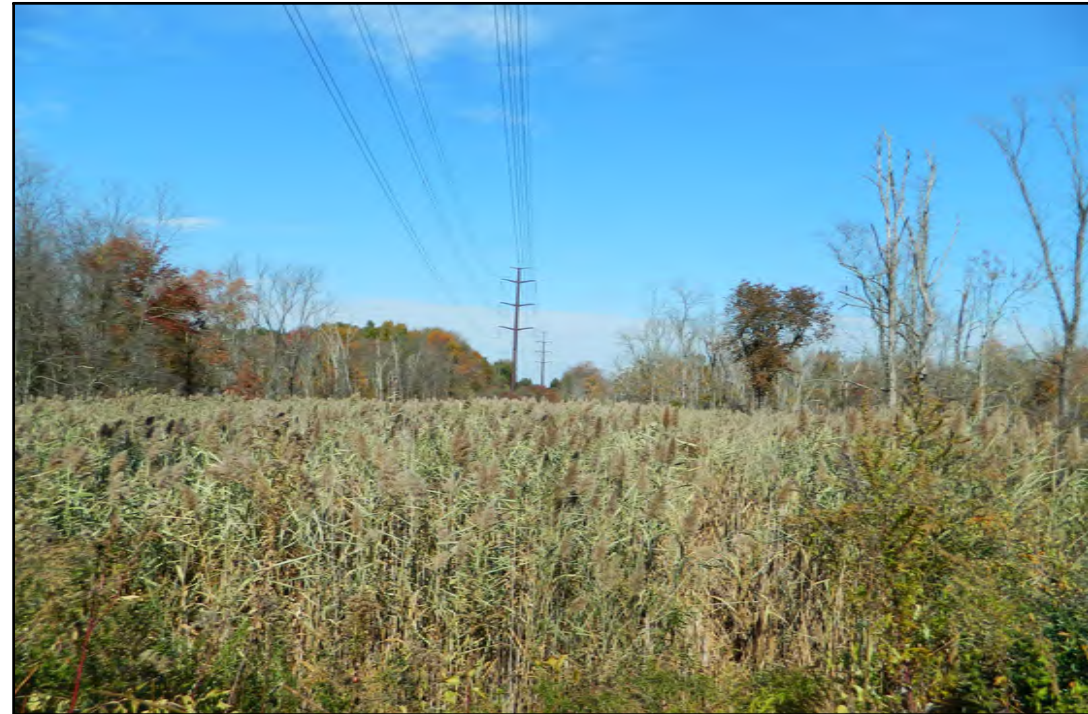
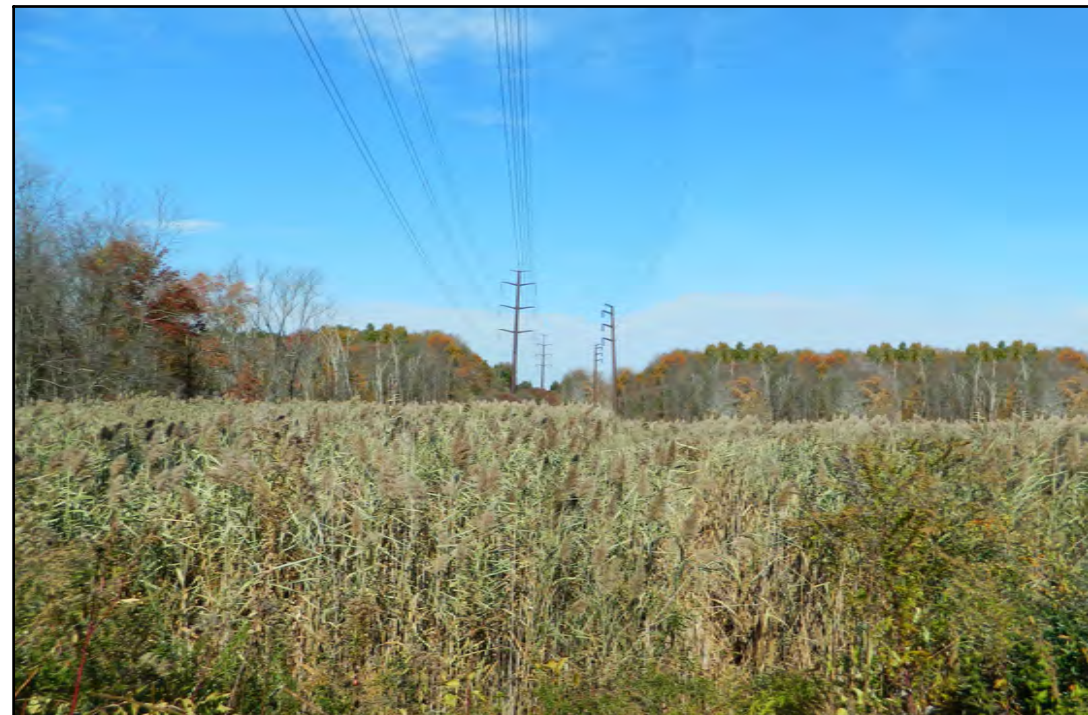
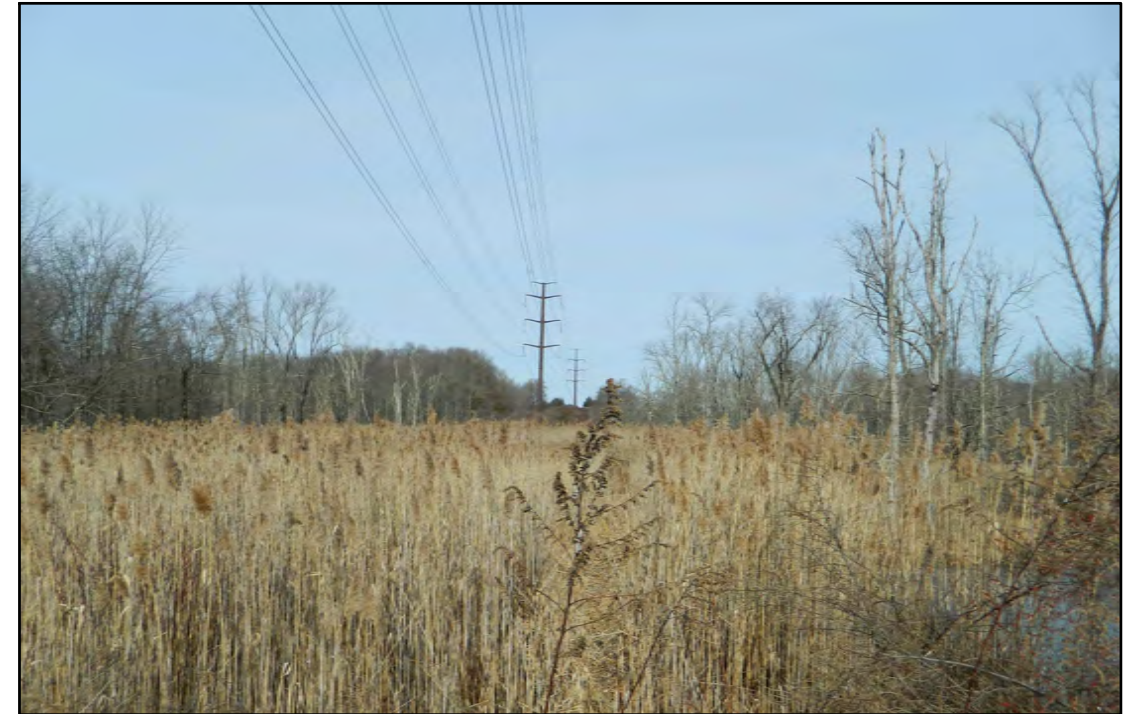
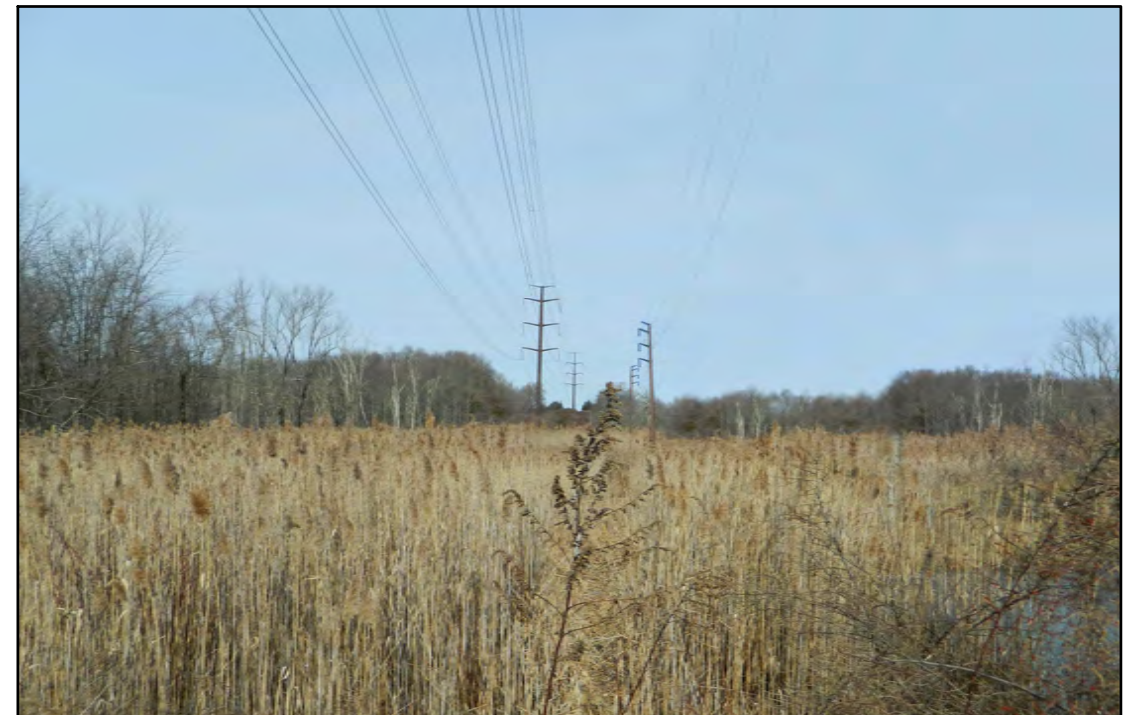
EXISTING VIEW 5

PROPOSED VIEW 5
