Morgan Brook Watershed Based Plan

Barkhamsted, New Hartford and Winchester, CT
August, 2012

Prepared by the
Northwest Conservation District
www.conservect.org/northwest

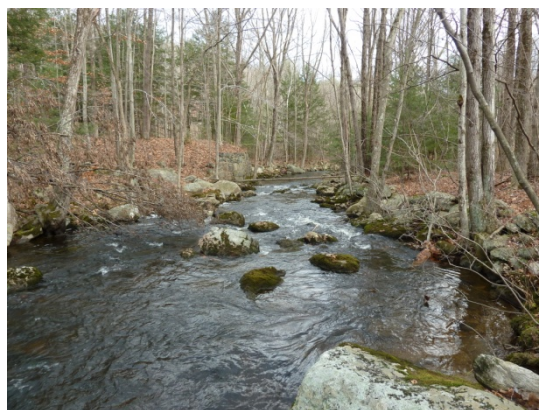
Figure 1. Typical Streamflow of Morgan Brook

The flow energy created by the moderate stream gradient allows Morgan Brook to be very efficient at carrying sediments down its stream corridor and into the Farmington River. This was confirmed by the lack of sediment deposition noted throughout the watershed.

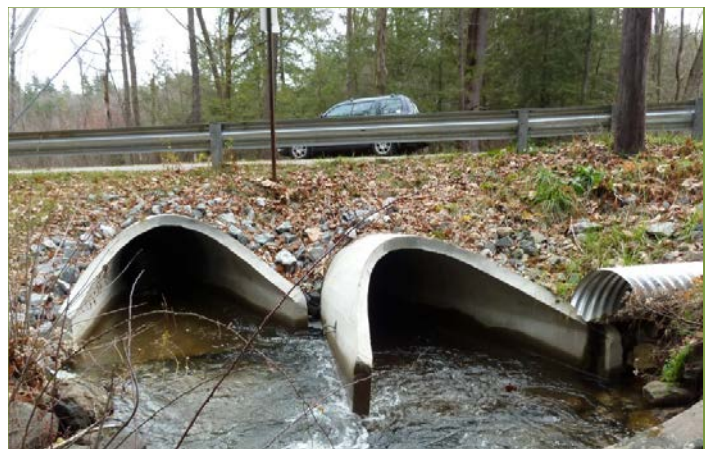
Figure 2 West Hill Road Structured Stream Crossing

Stream Crossings/Stormwater Outfalls - Most of the survey sheets describe the many road crossings in the watershed (Figure 2). Stream crossing survey sheets were completed for thirty-two locations throughout the Morgan Brook watershed (Table 4). All of the stream crossings were stable. However, most had stormwater runoff directly entering the stream from stormwater outfall pipes or by sheet flow. While no one stream crossing stood out as a problem source, collectively, untreated runoff from these locations is likely altering the water quality in Morgan Brook. After reviewing all the potential sources of bacteria and water quality degrading pollutants, stream crossing were assigned a low priority as compared to the problem areas identified by both through visual inspections and the pollutant loading analysis describe below.

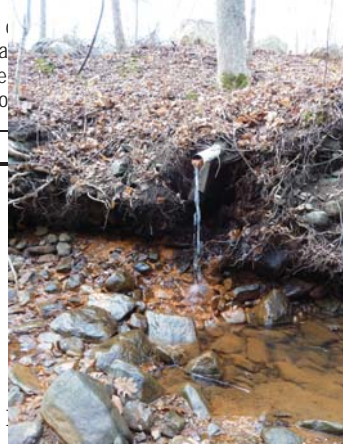
SKETCH/NOTES: Grease budding at pipe, Pipe discharge is within designated TROUT MGMNT AREA

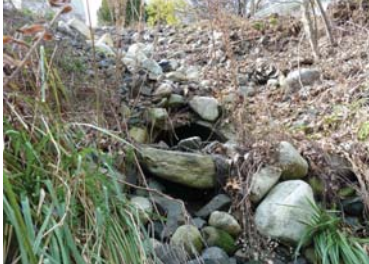
SKETCH/NOTES:
 Green Ridge Condo complex
 No stormwater renovation

Stormwater management practices appropriate for use throughout the condominium development and KFC include underground sand filters, infiltration trenches and bioretention areas. These measures are commonly used when space is limited.

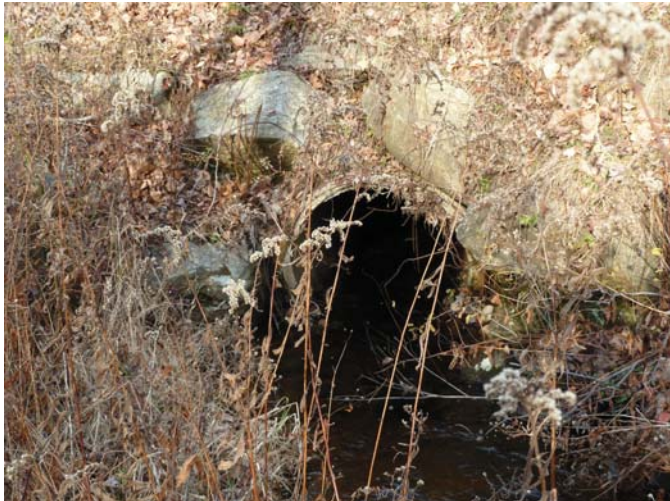
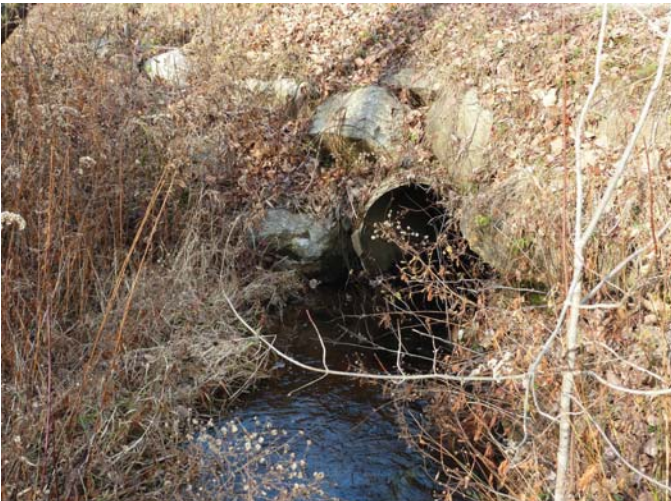
WATERSHED/SUBSHED: 4305-04-1		DATE: 11 / 18 / 2010		ASSESSED BY: SH, MM	
SURVEY REACH ID:		TIME: 2 : 20 AM (PM)		PHOTO ID: (Camera-Pic #) /# 04-1-SC-c.jpg	
SITE ID: (Condition-#) SC- C		LAT 41 ° 54 ' 0.93 " LONG -73 ° 01 ' 01.03 " LMK _____		GPS (Unit ID) R1

CONDITION: (Evidence of...) <input checked="" type="checkbox"/> Cracking/chipping/corrosion <input type="checkbox"/> Downstream scour hole <input type="checkbox"/> Sediment deposition <input type="checkbox"/> Failing embankment <input type="checkbox"/> Collected organic debris <input type="checkbox"/> Other:			CULVERT SLOPE: <input type="checkbox"/> Flat <input checked="" type="checkbox"/> Slight (2° - 5°) <input type="checkbox"/> Obvious (>5°)	UNDERSIZED? <input checked="" type="checkbox"/> No <input type="checkbox"/> Yes <input type="checkbox"/> Unsure

POTENTIAL RESTORATION CANDIDATE Fish barrier removal Fish passage Upstream storage retrofit Stream repair
 no Culvert repair/replacement Beaver deceiver/removal Other: health & safety issues

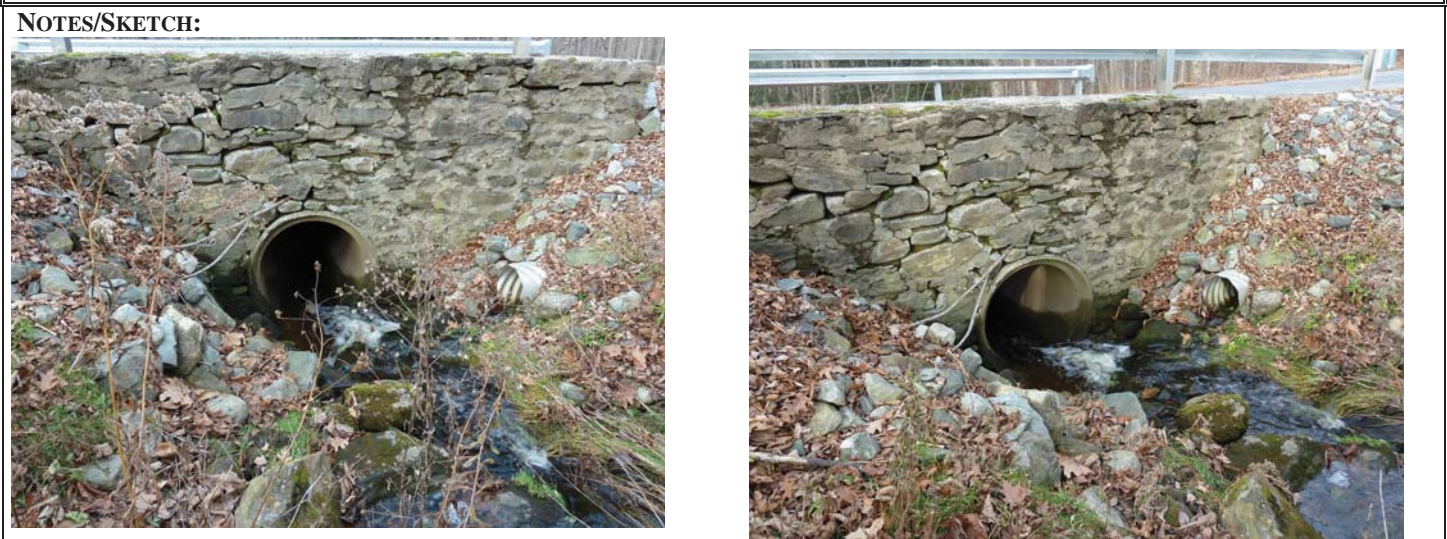
WATERSHED/SUBSHED: 4305-04-1		DATE: 11 / 18 / 2010		ASSESSED BY: SH, MM	
SURVEY REACH ID:		TIME: 3 : 12 AM/PM		PHOTO ID: (Camera-Pic #) /# 04-1-SC-e2.jpg	
SITE ID: (Condition-#) SC- E		LAT 41 ° 53 ' 49.49 " LONG -73 ° 01 ' 07.41 " LMK _____		GPS (Unit ID) R1

CONDITION: (Evidence of...) <input type="checkbox"/> Cracking/chipping/corrosion <input type="checkbox"/> Downstream scour hole <input type="checkbox"/> Sediment deposition <input type="checkbox"/> Failing embankment <input type="checkbox"/> Collected organic debris <input type="checkbox"/> Other:			CULVERT SLOPE: <input type="checkbox"/> Flat <input checked="" type="checkbox"/> Slight (2° - 5°) <input type="checkbox"/> Obvious (>5°)		UNDERSIZED? <input checked="" type="checkbox"/> No <input type="checkbox"/> Yes <input type="checkbox"/> Unsure

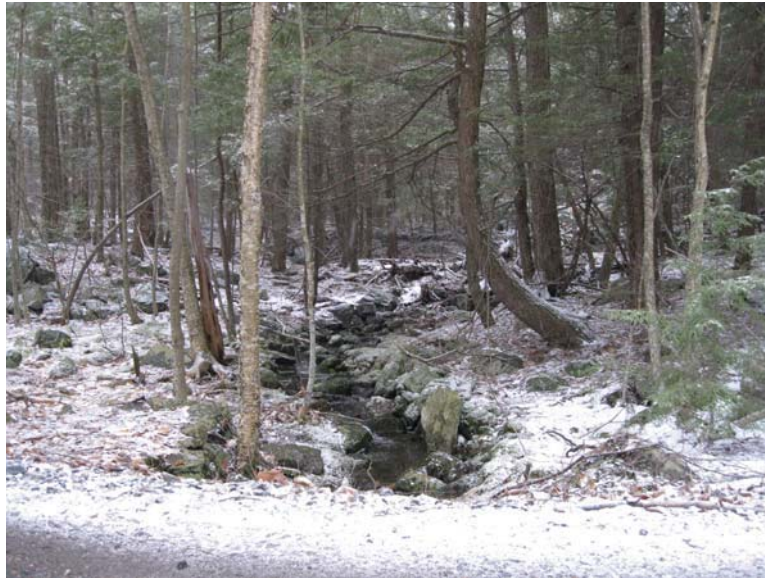
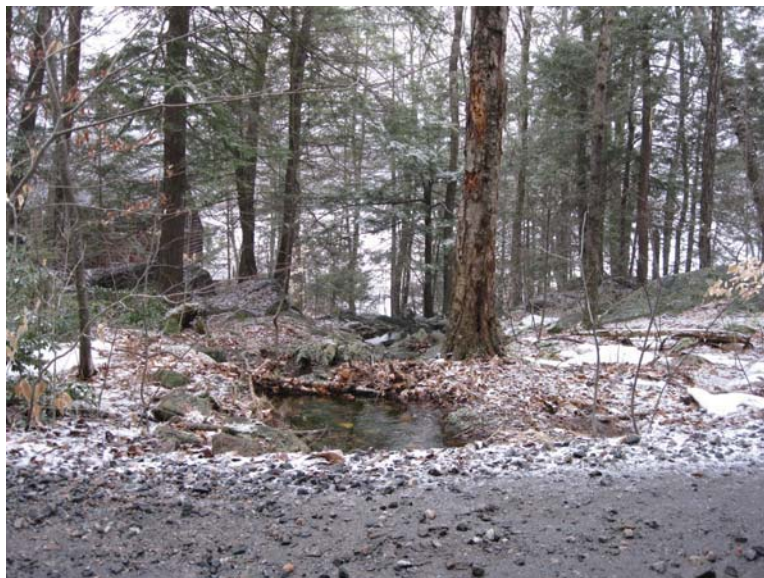
EXISTING CONDITIONS:

Stable drainage from undeveloped upland area.

Monitor and insure entrance to culverts is kept clear to prevent overtopping roadway.

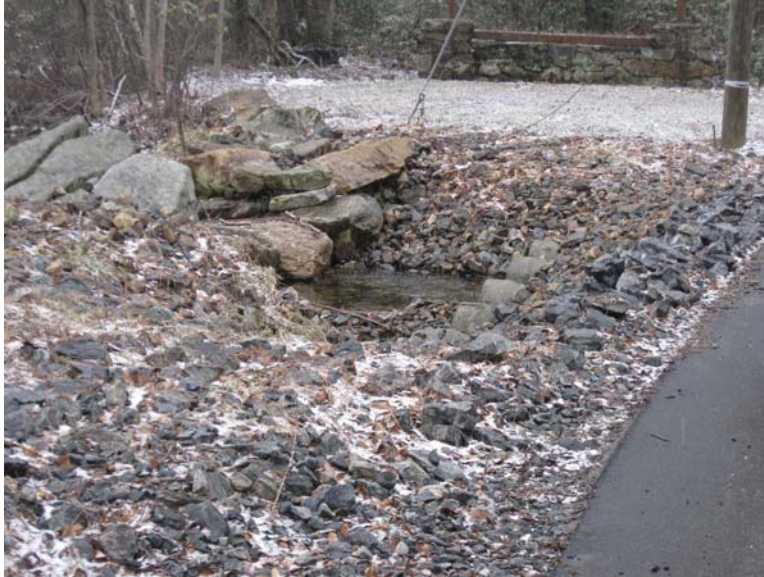
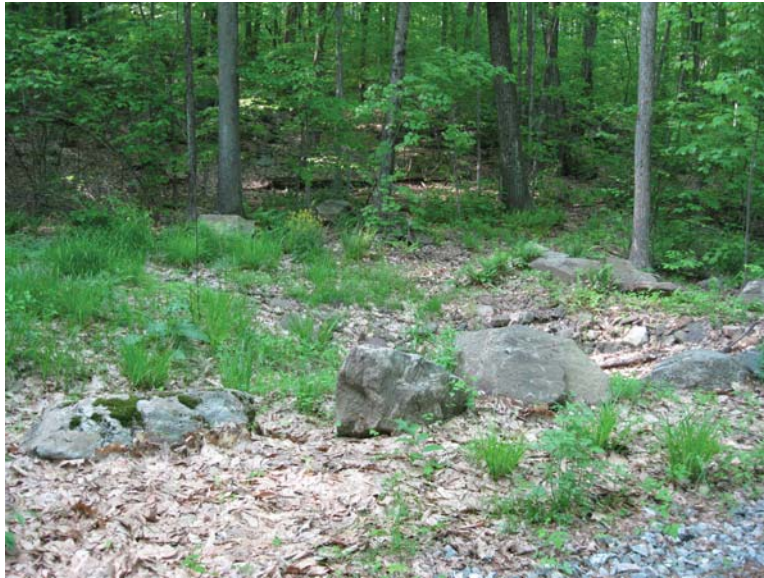
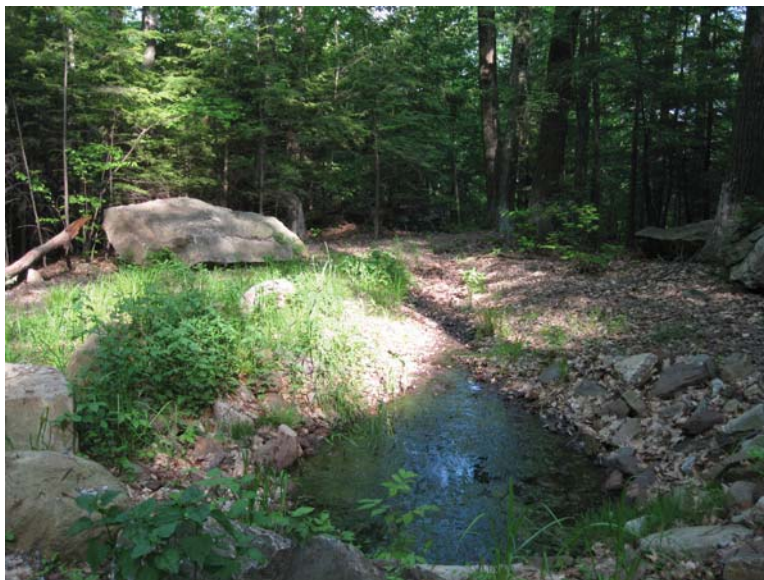
INFLOW 5

Undeveloped upland area

Nothing

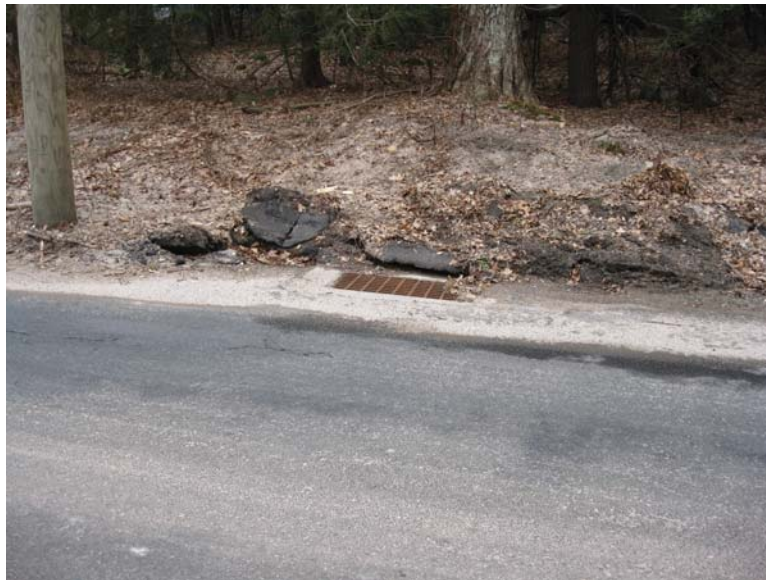
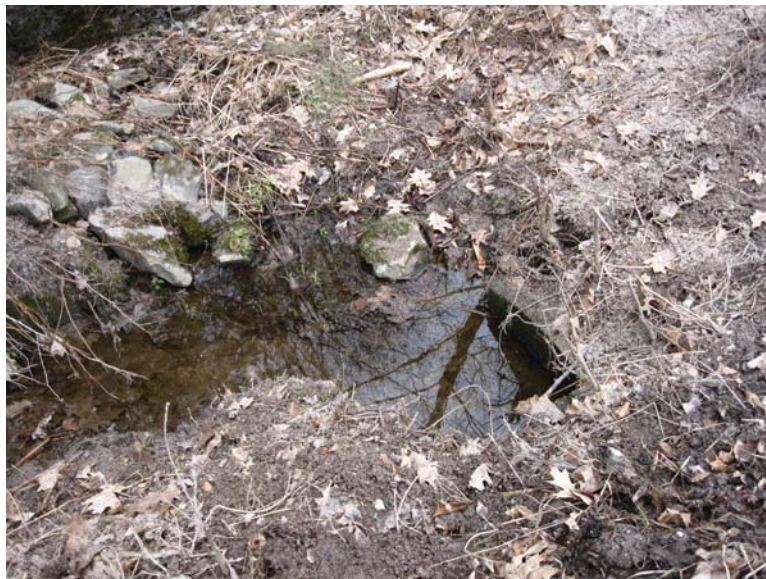
Roadside drainage through a Catch Basin (6) system into a wetland area on south side of West Hill Rd and then piped to outfall at edge of pond.

Install deep sump (2-ft min) catch basins. Regrade and vegetate roadside area to reduce exposed soil. Create a well maintained, vegetated roadside shoulder. Create roadside sediment basin for yearly cleaning. If unable to create a sediment basin (property rights or wetland issues) then install a large particle separator (equivalent of a septic tank) alongside or under the road. Particle separator could be installed on lake side of road at beginning of pipe to lake.

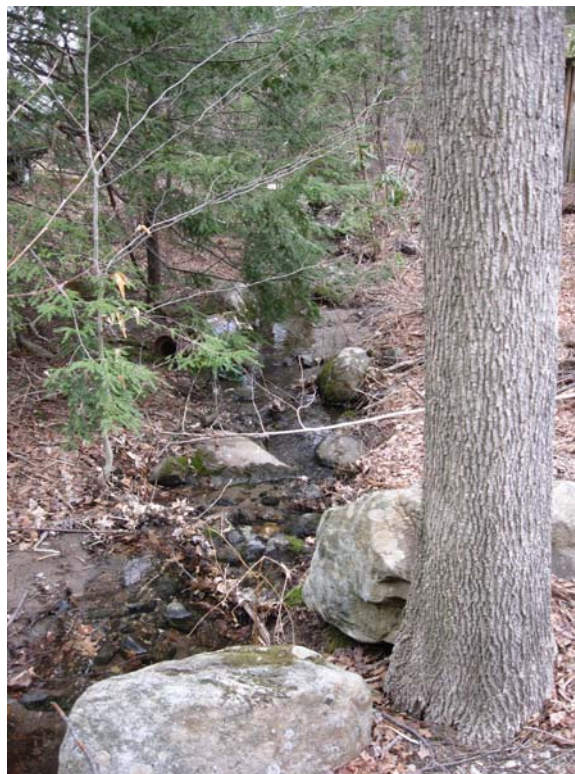
Amour roadside discharge point

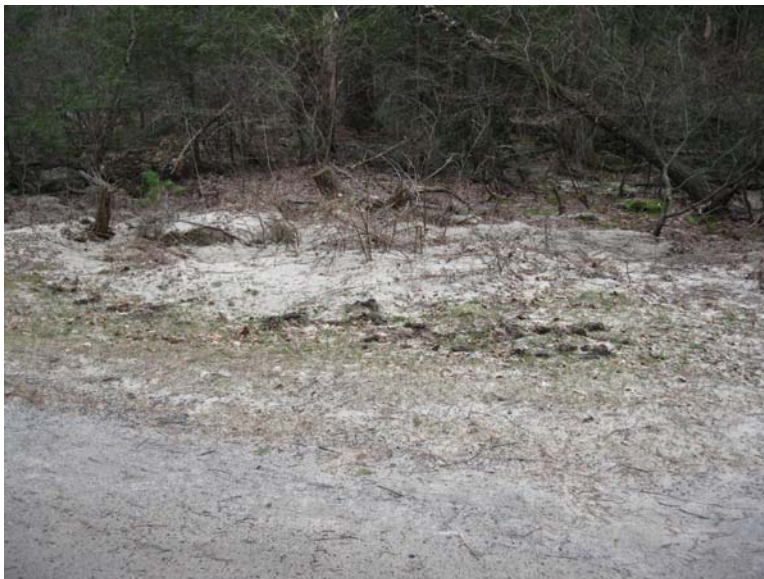
Wind Eroded Sand

Redirect parking lot runoff and create a vegetated swale along uphill side of beach area to redirect flows away from the beach.
Use coarser sand during future beach replenishments
Install silt fence or filtrex soxs along waters edge of beach during winter season.

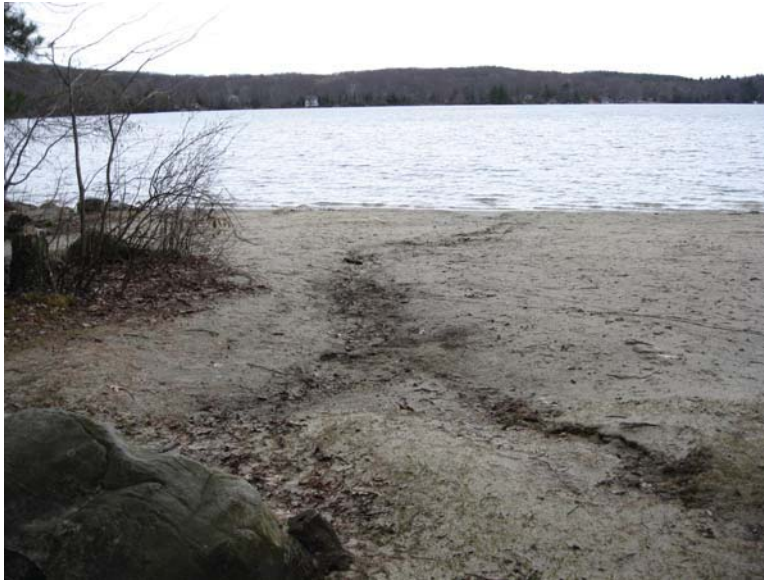
Beach Erosion

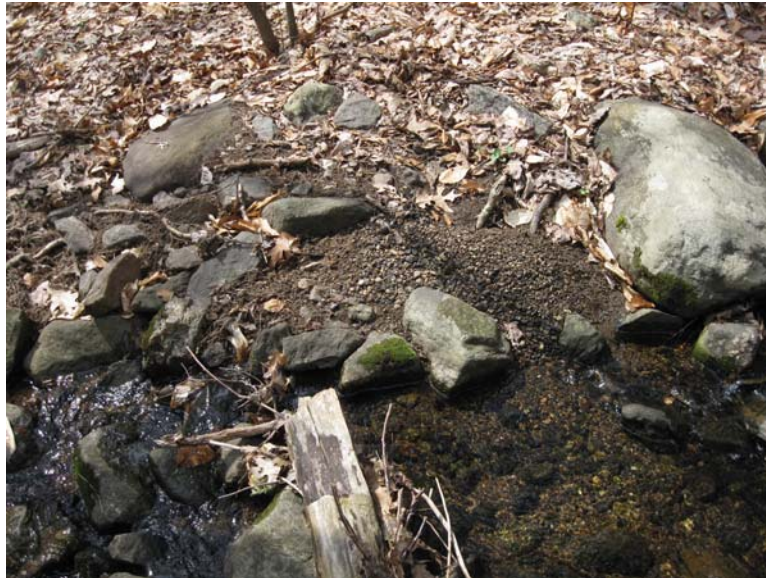
Evidence of Active Erosion that Progressively Moves Toward Pond

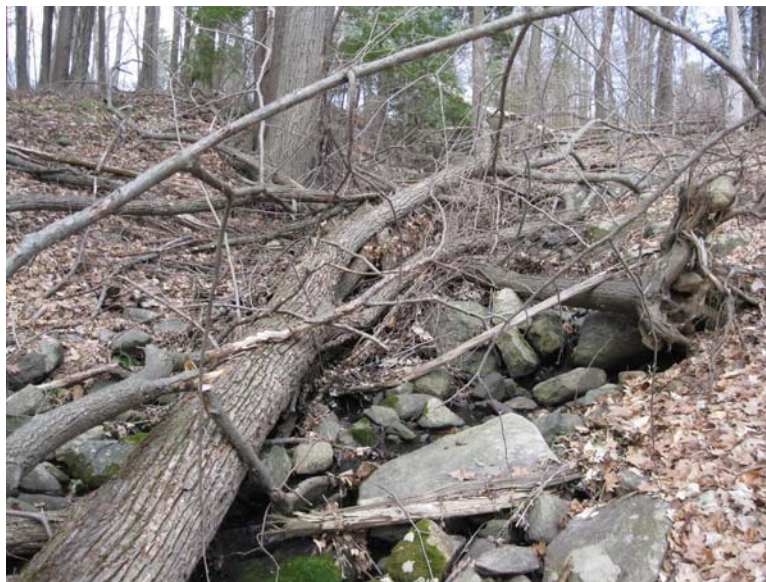
Remove Debris That Creates Dams, Forcing Flows to Erode Around Sides

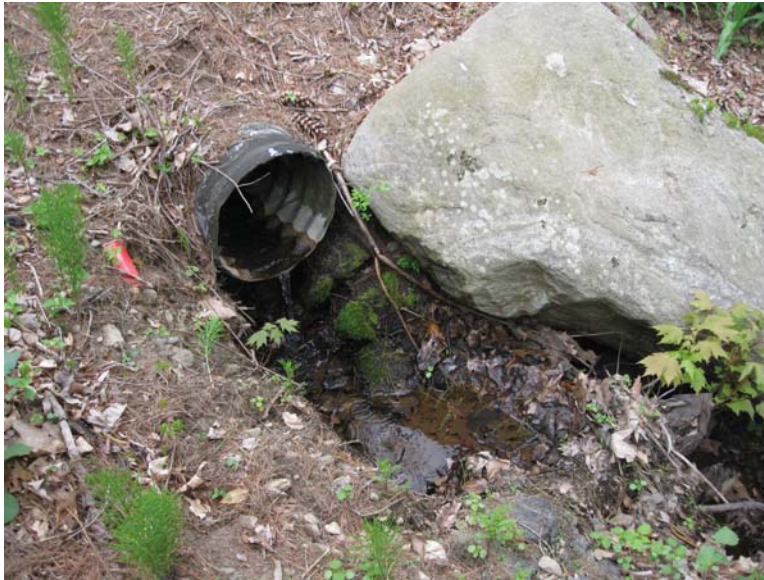
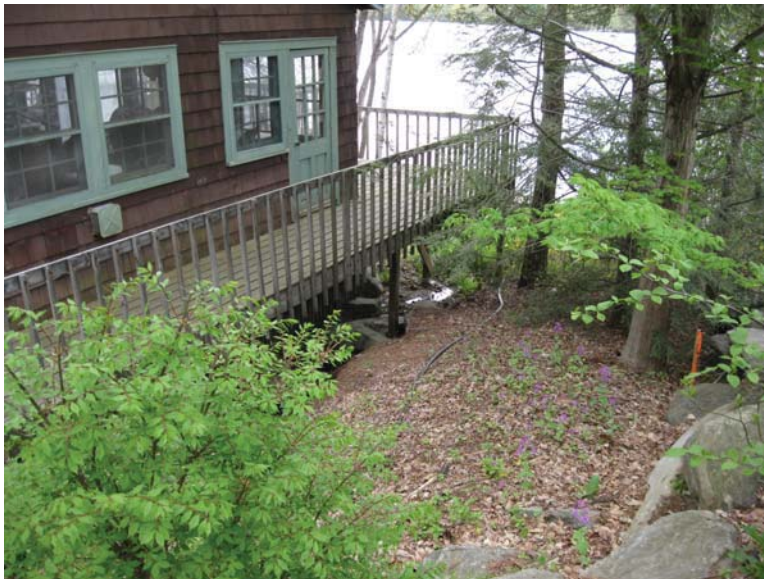
Drainage goes under existing deck & is flooding yard
Insufficient room to create stabilized channel, Will require piping

Stabilize roadside swale with vegetation or riprap, and install deep sump catch basin or large particle separator. Due to confined space, lower discharge will need to be conveyed in pipe system to outlet. It might be possible to create a small in pond sediment basin. Remove unnecessary impervious surface.

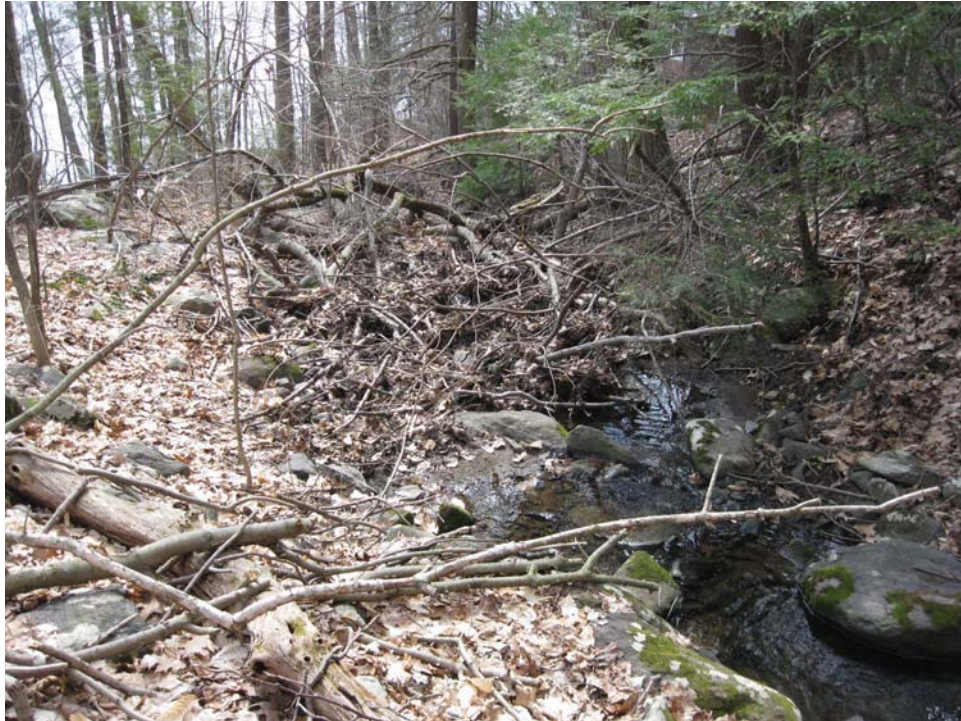
Allowing drainage channel to remain blocked by debris, creates dams and forces storm flows to create new paths, eroding material in the process

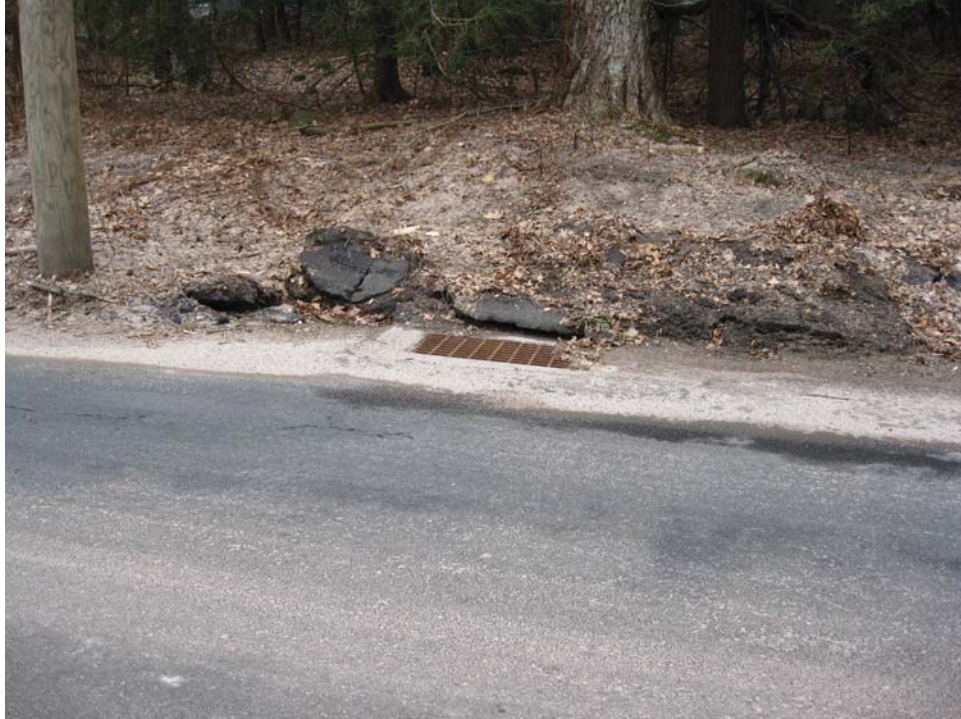
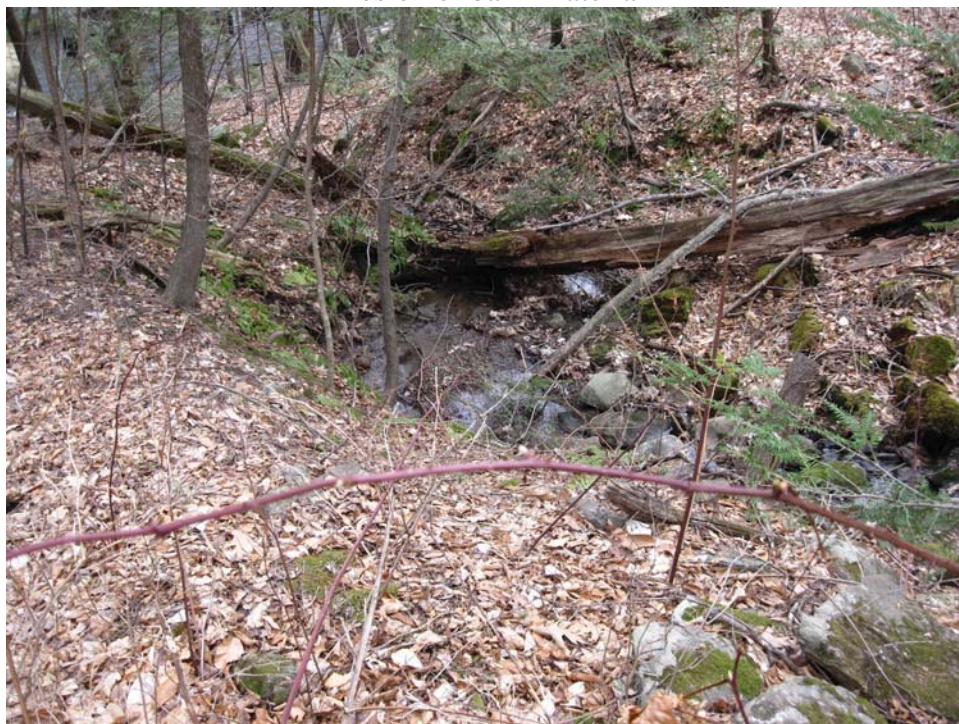
Erosion of bank material

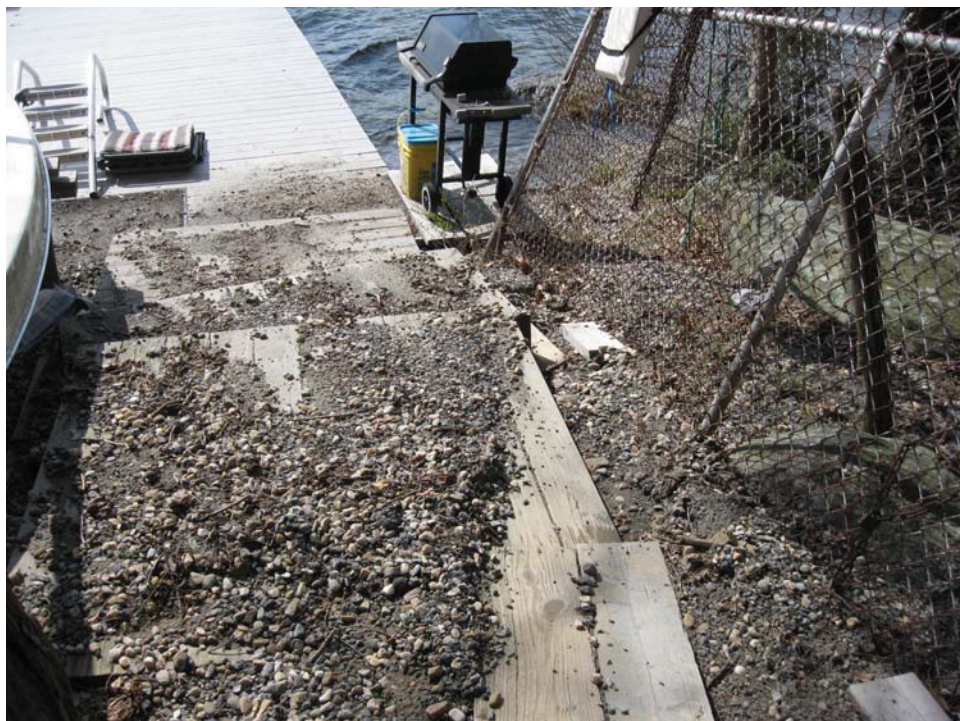
Eventually entering the Lake

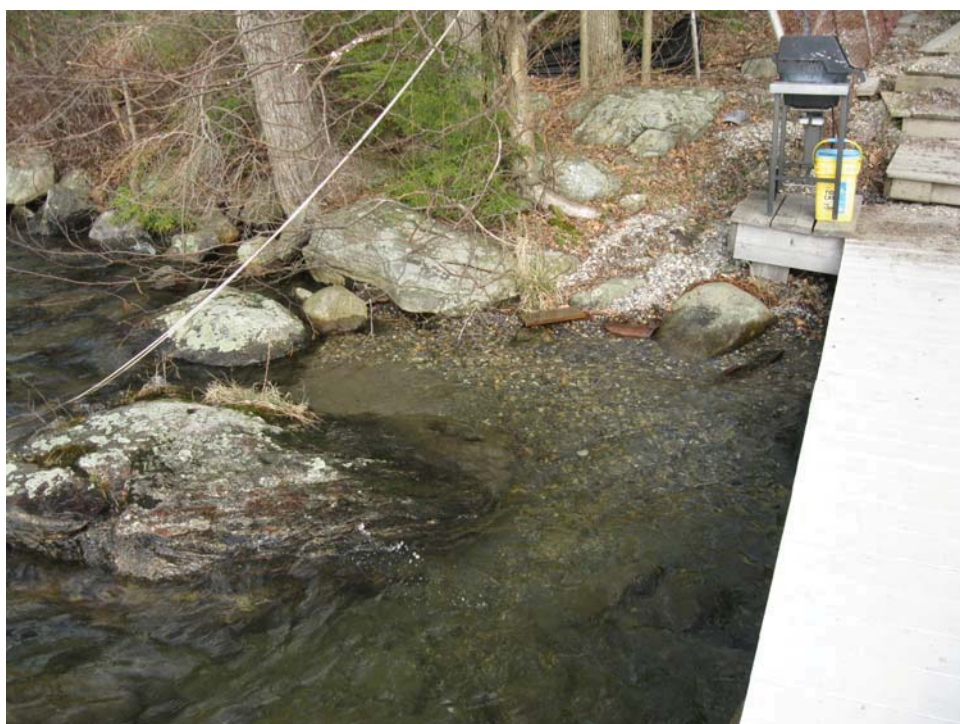
Causing infilling & vegetation growth
