Tankerhoosen River Watershed Management Plan

**Friends of the Hockanum River
Linear Park of Vernon, Inc.**

March 2009

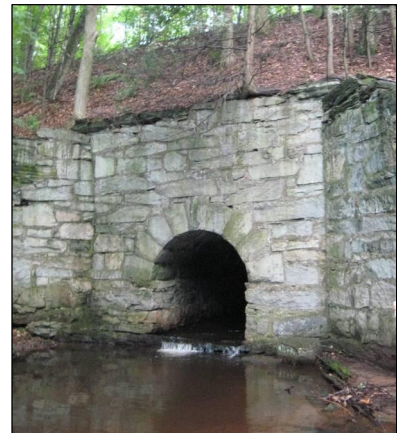
Arch-type railroad crossing (SC-02) may prevent fish passage and is suffering from downstream scour evidenced by the large pool shown in the photograph.

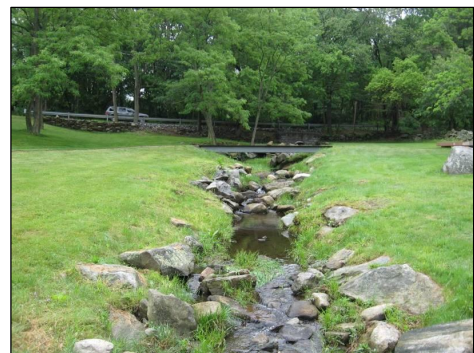
Stream segment GB-05B showing limited vegetative buffer and a small footbridge crossing the stream.

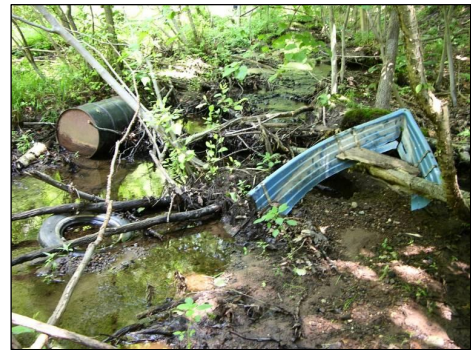
Trash and debris along Reach CB-02.

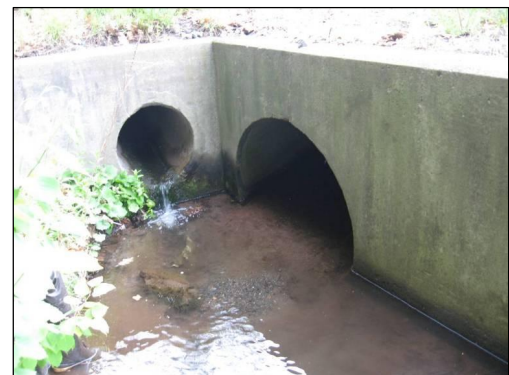
Stream crossing (SC-01) below I-84 and outfall (OT-03) along reach GBST-02.

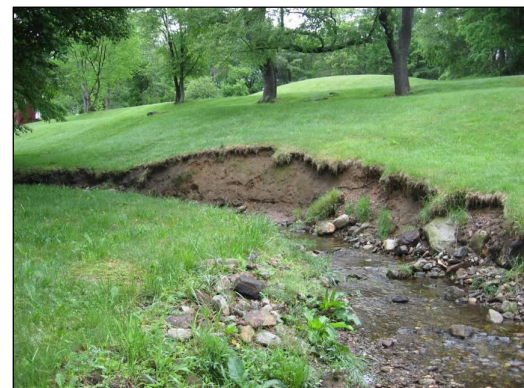
Stream segment GB-05B showing area of stream bank erosion.

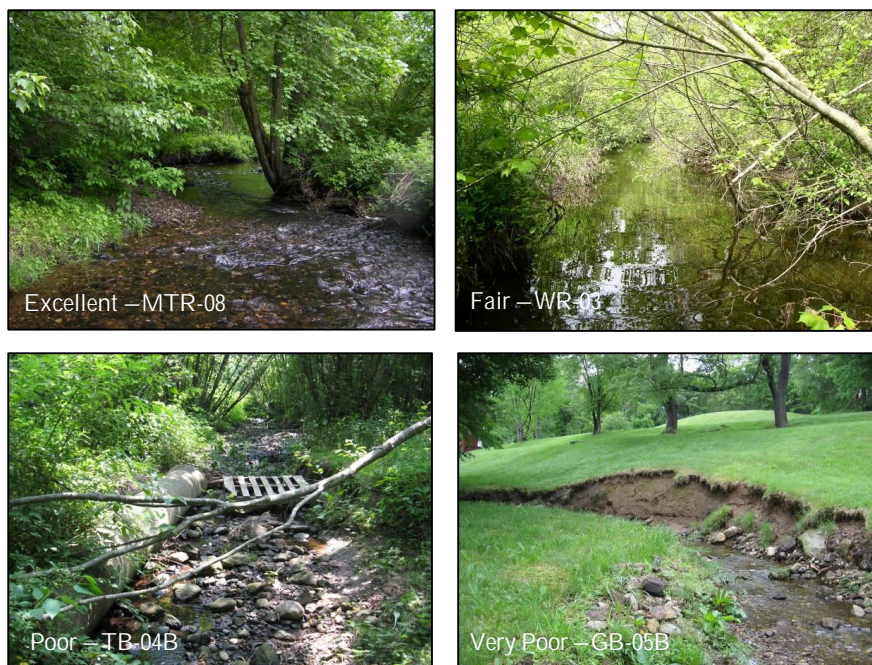
Figure 3-1. Examples of Stream Reaches in Various Classification Categories

As depicted in Figure 3-1, MTR-08 is the highest rated stream reach due to good riparian cover and bed material. WR-03 is considered fair due to the presence of invasive species within the riparian corridor. TB-04B and GB-05B are poor and very poor, respectively, because of poor channel characteristics, outfalls, stream crossings, trash and debris and lack of stream buffer and bank erosion in the case of GB-05B.

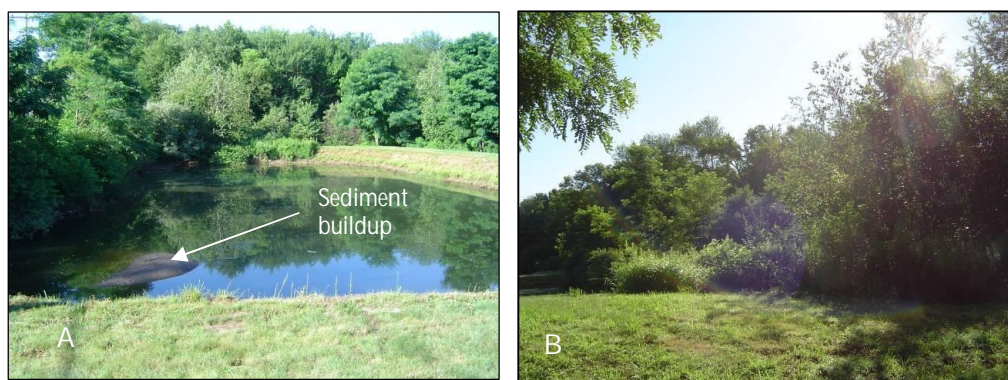
The stormwater basin that receives runoff from the Gerber Technologies facility incorporates many of the recommended elements to meet current stormwater quantity and quality design criteria. However, the basin is also in need of maintenance as demonstrated by the sediment accumulation near the center of the basin and the overgrown woody vegetation at the overflow spillway. Existing stormwater basins such as this one may also be good retrofit candidate to improve treatment effectiveness by incorporating a sediment forebay at the basin inlet, which may also facilitate routine sediment removal.

Stormwater basin at the Gerber Technologies facility on Industrial Park Road West. Sediment has built up near the center of the basin (A) and its overflow spillway is overgrown with vegetation (B).

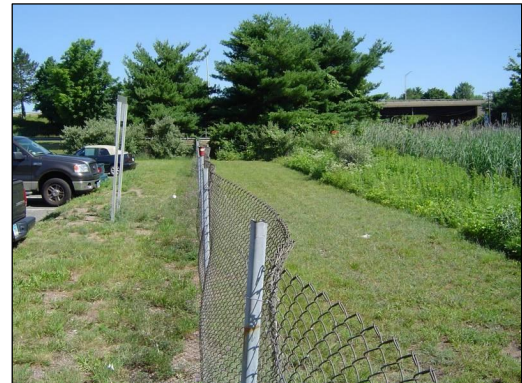
Approximately 150 vehicles were parked at the lot during the site visit, which occurred on a weekday during mid-day. The site is contains significant impervious cover and high-intensity vehicle usage and is therefore a source of automobile-related stormwater pollutants including hydrocarbons, sediment, and metals. The entire parking lot drains to a double catch basin located on the southeastern side of the lot. The catch basin discharges through a short wetland corridor and subsequently to the stream segment located upstream of Reservoir Road and Walker Reservoir East. An easily accessible grass strip exists between the paved lot and the adjacent wetland and stream corridor. This site is a potential stormwater retrofit candidate (bioretention or water quality swale) to encourage infiltration and provide additional treatment for the parking lot runoff.

The southeastern side of the Interstate 86 Exit 67 commuter parking lot showing the edge of the lot on the left side of the photograph and the wetland corridor on the right side. The center of the photograph shows the easily accessible and open area for a potential stormwater retrofit.

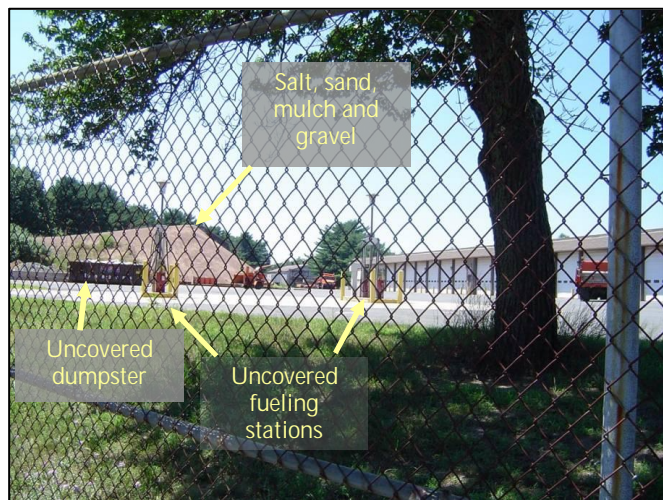
ConnDOT District #1 Maintenance Service Center, Campbell Avenue

A rolloff dumpster was observed to be overflowing and uncovered at the time of the windshield survey. Municipal and state-operated highway maintenance facilities such as this should employ source controls, pollution prevention, and stormwater treatment practices as necessary in accordance with the DEP *General Permit for Stormwater Discharges Associated with Industrial Activity*.

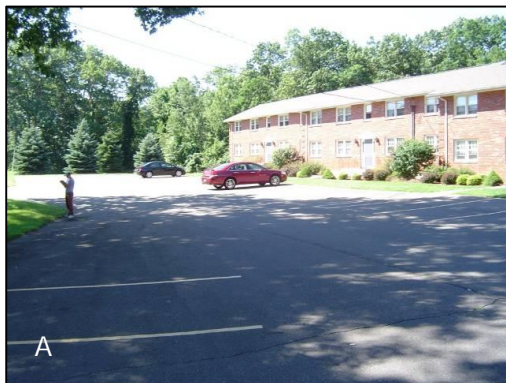
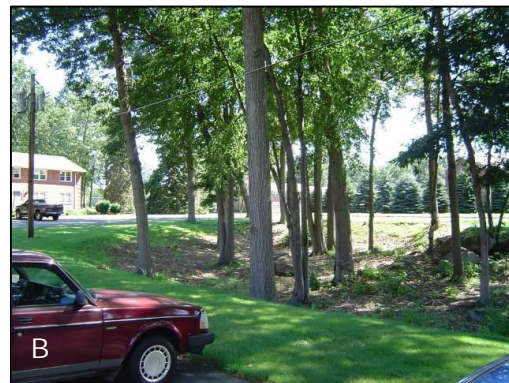
The overall pollution severity is rated as moderate due to the large amount of directly connected impervious area and potential pollutant sources from parking areas. This site is a potential retrofit candidate to reduce stormwater runoff from the site, including disconnecting downspouts from the storm drainage system and redirecting them to pervious grass areas, rain barrels/cisterns, and rain gardens. Multi-family parking lots, such as the parking lots at this complex, may also be good candidates for stormwater retrofits. The following photograph depicts an existing landscaped area adjacent to the parking lot that could potentially function as a bioretention/rain garden.

The Mount Vernon apartment complex buildings showing clean and well-maintained parking areas and landscaping (A) and a landscaped area that has the potential to be used as a rain garden (B).

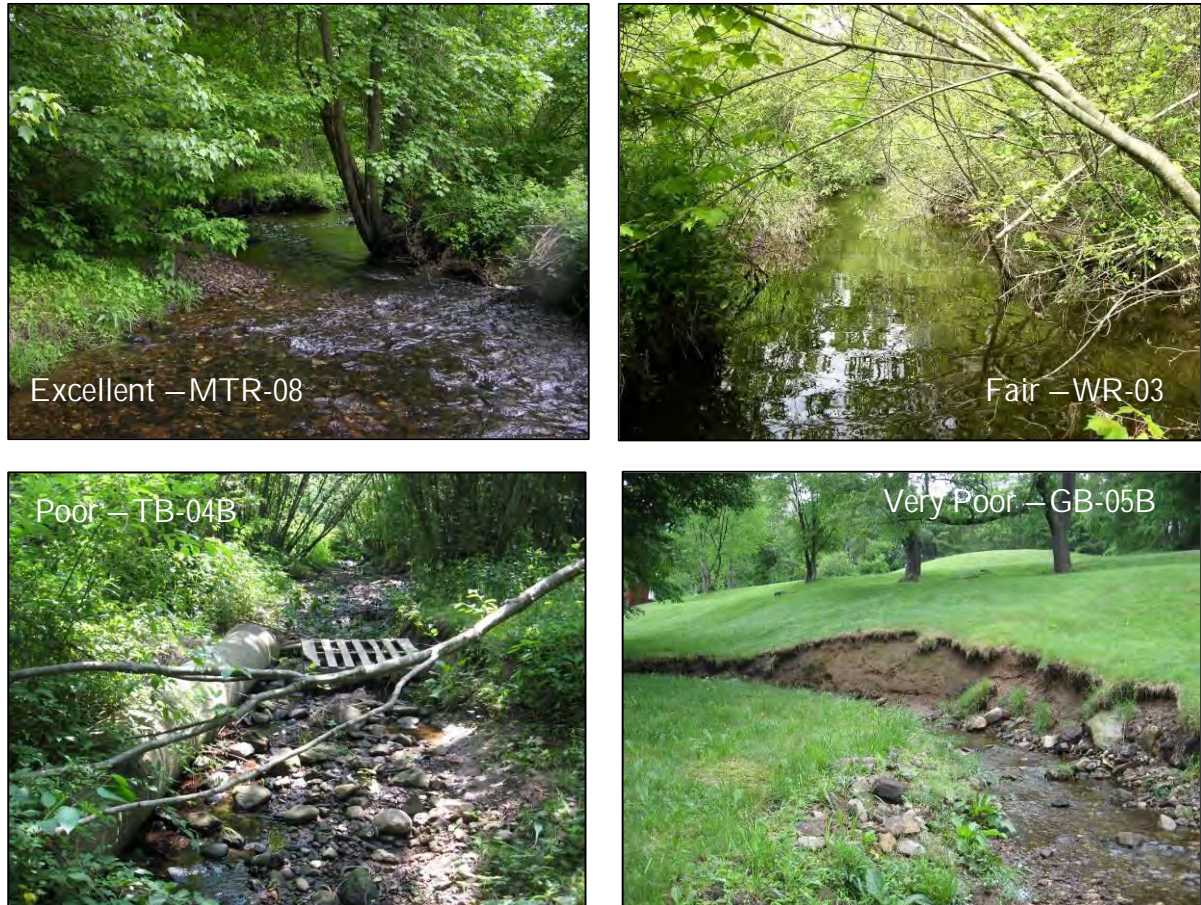
Figure 2: Examples of Stream Reaches in Various Classification Categories

As depicted in [Figure 2](#), MTR-08 is the highest rated stream reach due to good riparian cover and bed material. WR-03 is considered fair due to the presence of invasive species within the riparian corridor. TB-04B and GB-05B are poor and very poor, respectively, because of poor channel characteristics, outfalls, stream crossings, trash and debris and lack of stream buffer and stream bank erosion in the case of GB-05B.

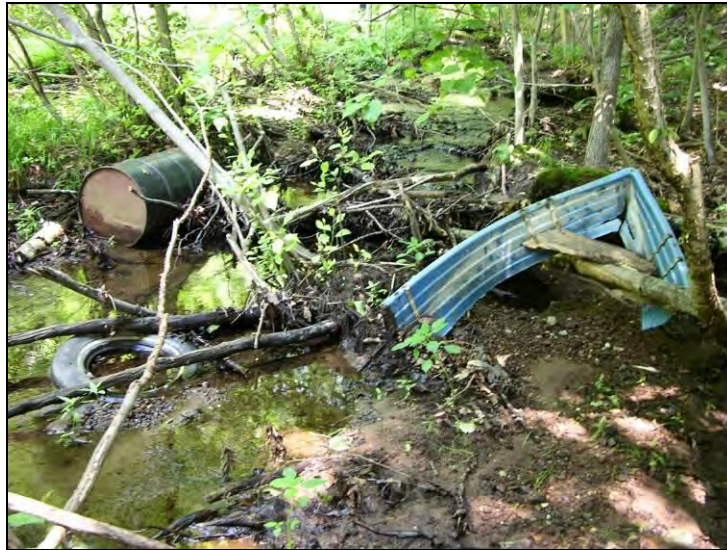
- TR – Significant quantities of trash and debris (an estimated 1 pickup truck load) were observed including tires, automotive waste, appliances and a closed 55-gallon drum of unknown contents. The debris and waste materials should be removed and disposed in accordance with applicable local, state, and federal regulations.

Trash and debris along reach CB-02

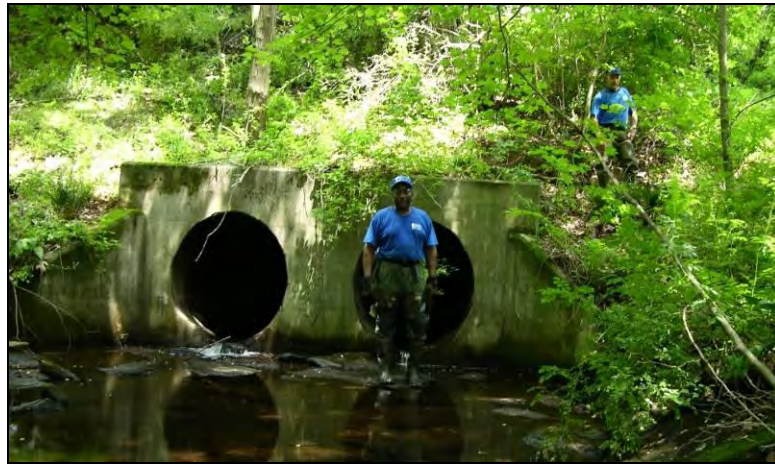
Bamforth Road crossing (perched culvert) along reach CB-03

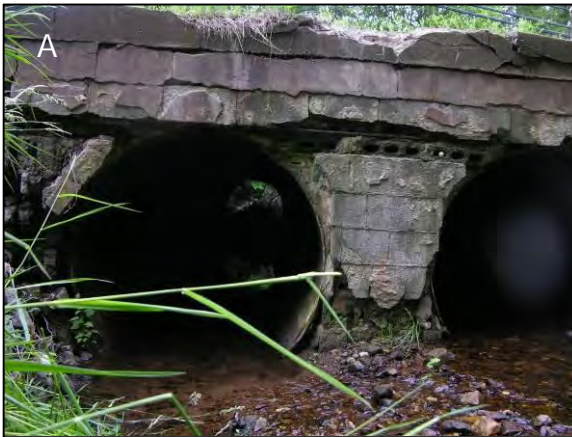
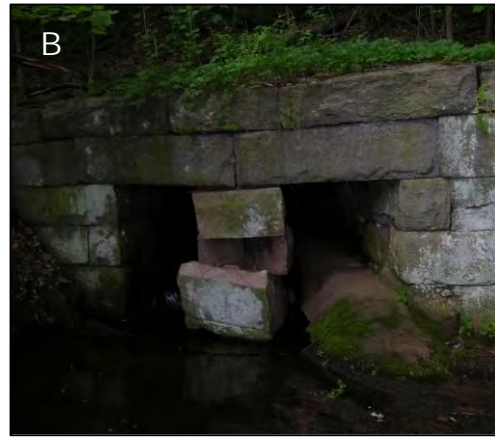
- SC –There are two road crossings and a rail crossing along this reach. The stone blocks on the outside of the Rails to Trails culvert crossing are partially dislodged and in need of repair. The Tunnel Road stream crossing has debris partially blocking the outlet of the culvert. The outlet of a concrete box culvert located north of Warren Avenue is perched approximately 14 inches above the elevation of the stream bed and is a potential barrier to fish passage. This culvert is a potential candidate for fish barrier removal to address the perched outlet.

The Tunnel Road stream crossing (A) and the Rails to Trails crossing (B).

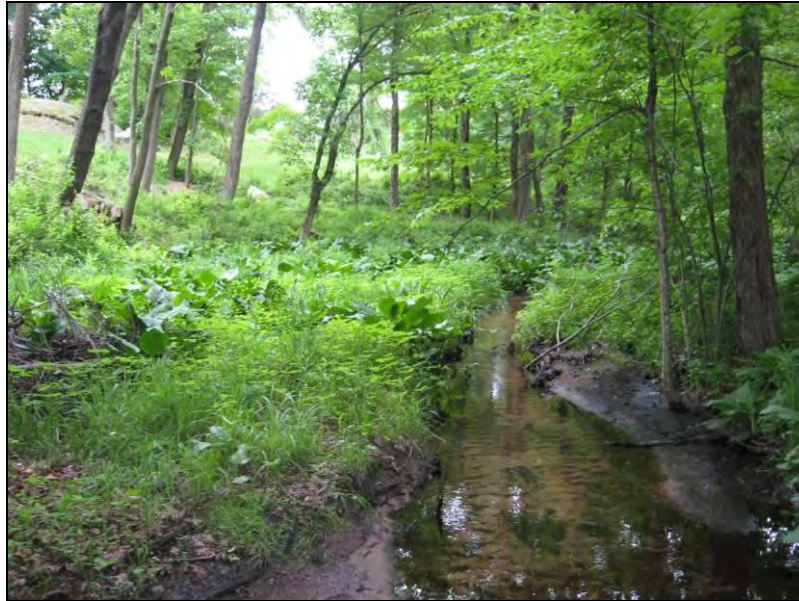
- RCH - This reach is mostly shaded with a variable bottom of generally fine material (silt/clay, sand, and gravel). In-stream habitat was marginal, and dense invasive vegetation was present on both banks. Floodplain connection was optimal, however, since the stream was not deeply incised and high flows could easily enter the floodplain.

View of reach GBST-04B

- IB - Impacted buffer was present near the downstream end of this reach. In this area, the left bank is forested, although the right bank is vegetated with turf, lawn, and shrubs. A single-family home was also located near the stream.
- SC - The upstream limit of this reach is located at Loehr Road. The stream flows below the road through a 60-inch corrugated metal pipe. The pipe was deformed at the downstream end, but the invert was inundated by tailwater, indicating that fish passage may be possible.

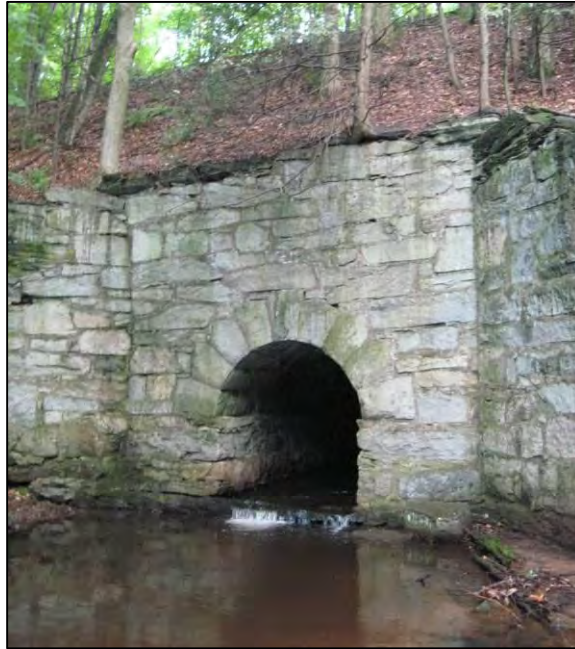
Arch-type railroad crossing (SC-02) constructed of stone and extending approximately 125 feet. The crossing may prevent fish passage and is suffering from downstream scour evidenced by the large pool shown in the photograph.

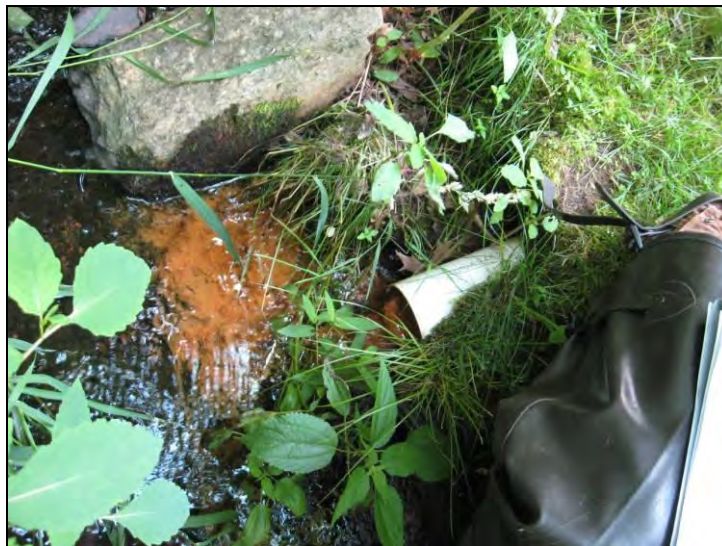
Outfall pipe originating from a residential property on the left bank of segment TB-04C.

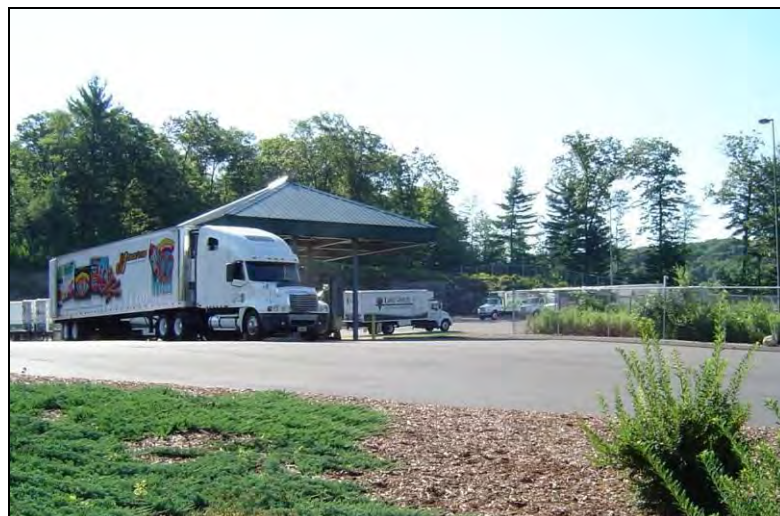
The Dari Farms distribution facility is also located in the Tolland Industrial Park on Research Way/Gerber Drive near the divide between the Gages Brook and Gages Brook South Tributary subwatersheds. The facility is estimated to be less than 5 years old, as evidenced by the facility's modern pollution prevention site design elements including a covered fueling station, no visible outdoor storage of materials, and well maintained landscaping on the grounds. Possible pollution sources to the storm drainage system are the runoff from the large impervious areas on the site (the roof and parking areas) and potential vehicle fluids from truck fueling activities and employee vehicles. It could not be determined whether stormwater is managed on-site, by the downgradient stormwater basin near the Gerber Technologies facility, or both. The site did not appear to incorporate Low Impact Development (LID) design features such as vegetated swales or parking lot bioretention. New commercial/industrial facilities with significant impervious area, such as this one, are potential candidates for on-site LID and stormwater treatment practices to reduce runoff volume and pollutant loads.

The Dari Farms Ice Cream Distribution Facility has a covered fueling station and landscaped grounds (shown in the foreground).

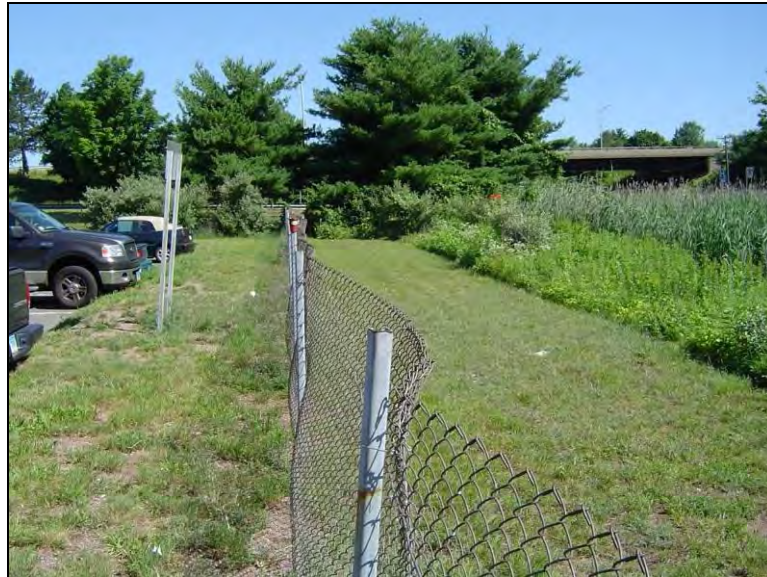
The hotspot investigation included the Connecticut Department of Transportation commuter parking lot at exit 67 of Interstate-84, which is located in the Walker Reservoir subwatershed (see stream assessment discussion in [Section 2.2.4](#)). Approximately 150 vehicles were parked at the lot during the site visit, which occurred on a weekday during mid-day. The site contains significant impervious cover and high-intensity vehicle usage and is therefore a source of automobile-related stormwater pollutants including hydrocarbons, sediment, and metals. The entire parking lot drains to a double catch basin located on the southeastern side of the lot. The catch basin discharges through a short wetland corridor and subsequently to the stream segment located upstream of Reservoir Road and Walker Reservoir East. An easily accessible grass strip exists between the paved lot and the adjacent wetland and stream corridor. This site is a potential stormwater retrofit candidate (bioretention or water quality swale) to encourage infiltration and provide additional treatment for the parking lot runoff.

The southeastern side of the Interstate 86 Exit 67 commuter parking lot showing the edge of the lot on the left side of the photograph and the wetland corridor on the right side. The center of the photograph shows the easily accessible and open area for a potential stormwater retrofit.

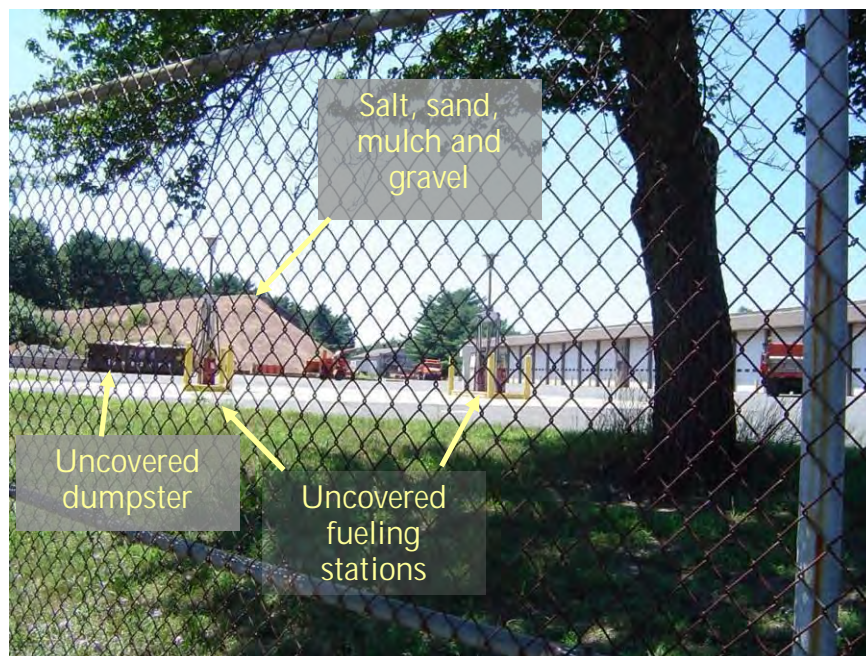
ConnDOT District #1 Maintenance Service Center, Campbell Avenue

The State of Connecticut operates a Department of Transportation Maintenance Service Center for District #1 located on Campbell Avenue in Vernon, which is located in the Lower Tankerhoosen River subwatershed. The facility has an office building, garages for vehicle storage and maintenance, a small parking lot, outdoor storage of sand, salt, gravel and mulch, and an uncovered outdoor fueling station. Vehicle maintenance activities and outdoor vehicle fueling are potential sources of stormwater pollution, in addition to the outdoor stockpile storage. A rolloff dumpster was observed to be overflowing and uncovered at the time of the windshield survey. Municipal and state-operated highway maintenance facilities such as this should employ source controls, pollution prevention, and stormwater treatment practices as necessary in accordance with the DEP *General Permit for Stormwater Discharges Associated with Industrial Activity*.

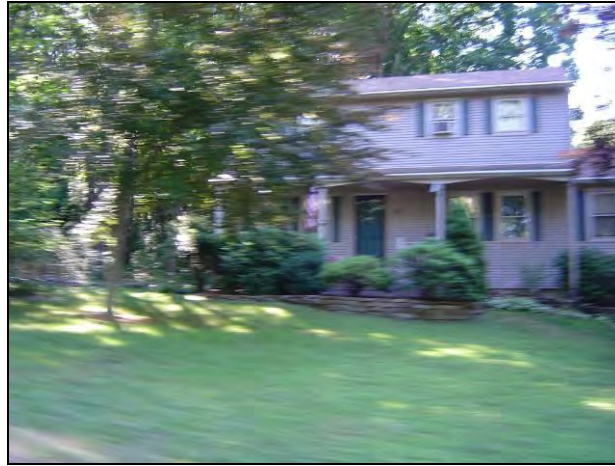
and consists of single family homes occupying approximately 1-acre lots. Most of the homes have garages and a high percentage of the lots are covered by lawn (60%) and landscaped areas (20%). The subdivision is served by traditional curb and gutter drainage. No centralized stormwater management measures were observed. Approximately three quarters of the roof downspouts are connected to adjacent pervious areas. Overall, the neighborhood was rated as having low pollution potential and limited potential for stormwater retrofits.

A typical lot in the Valley View Drive/Andrew Way neighborhood.

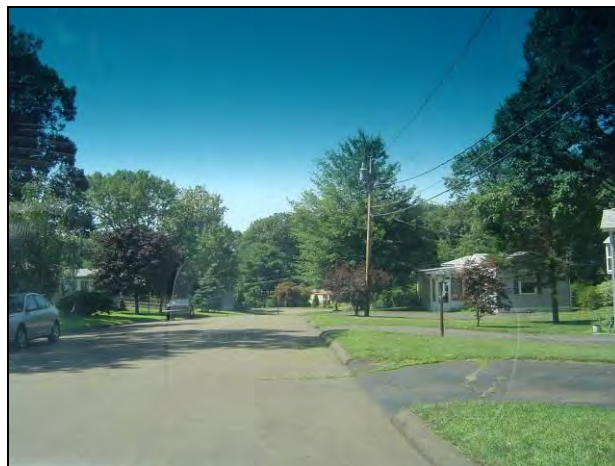
High Manor Mobile Home Park is an approximately 28-acre neighborhood located in the Clarks Brook subwatershed, situated between Route 30 and Interstate 84. The park is believed to have been developed in the 1970s. The average lot in the neighborhood has approximately 40 percent impervious cover, including the home and driveway, 40 percent grass cover, and 20 percent landscaped area. Approximately 90 percent of the homes have roof downspouts that discharge to lawns. The streets have traditional curb and gutter drainage, and storm drain inlets were observed to be clean. No centralized stormwater management measures were observed.

A street view of the High Manor Mobile Home Park showing turf lawns with some mature trees on the properties.

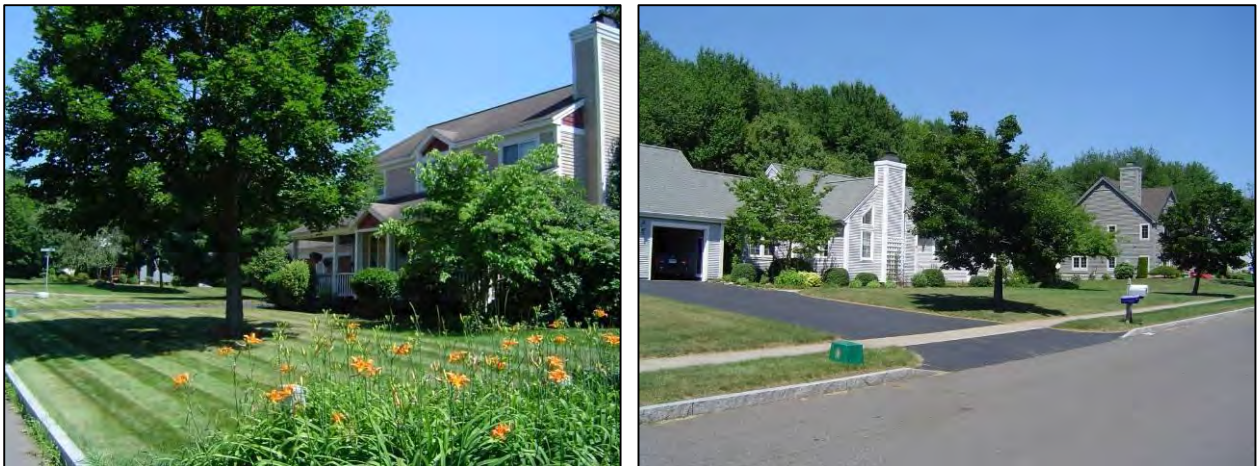
The Meadowbrook Drive neighborhood is an approximately 100-acre residential neighborhood in the northeast corner of Manchester. The neighborhood is situated in the central portion of the Tucker Brook subwatershed, and Tucker Brook flows partially through and along the north and west sides of the development (see stream assessment discussion in [Section 2.2.7](#)). The subdivision is estimated as approximately 10 years old, and the average lot size for the single family homes in the subdivision is approximately ½ acre. All of the homes have garages. The driveway, sidewalks and curb areas are clean and dry. A majority of the homes have roof downspouts that discharge to pervious lawn areas. The street storm drains are stenciled. An approximately 1-acre wet stormwater basin near the corner of Yale and Chatham Drives receives runoff from the subdivision storm drainage system. The basin outlet discharges to Tucker Brook. At the time of the inspection the stormwater basin outlet was observed to be overgrown with vegetation, and stream bank erosion was observed at the outfall to the stream. As noted in [Section 2.2.7](#), the basin appears to be in need of regular maintenance. Buffer encroachment, stream crossings, residential drain outfalls, and yard waste dumping were common in residential areas along the stream corridors in this subdivision.

Typical conditions in the Meadowbrook Drive neighborhood showing landscaping, lot sizes, and general cleanliness.

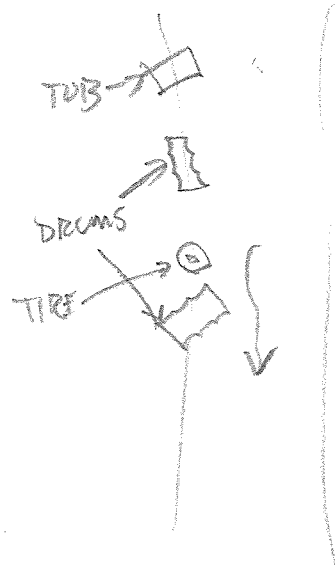
NOTES: TIRE, BATH TUB, 2 - 55 gallon drums

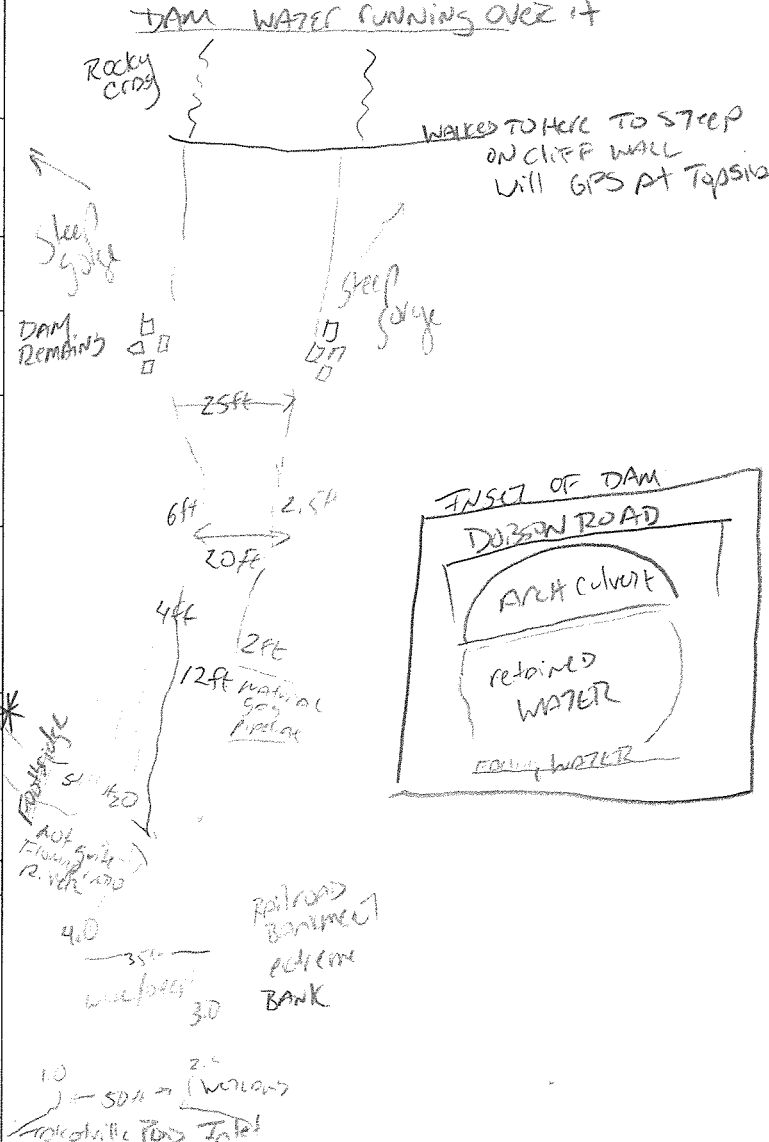
REACH SKETCH AND SITE IMPACT TRACKING

* STORM WATER CATCH BASIN FOR I-84 HIGHWAY RUNOFF
