# Watershed Field Assessment Report North Branch Park River Watershed

Connecticut Department of  
Environmental Protection

July 2010

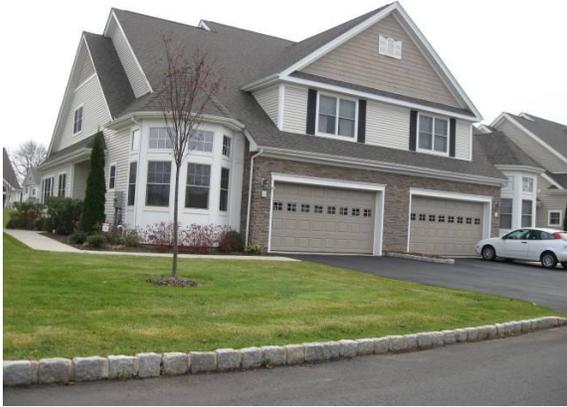
### *The Greens at Gillette Ridge*

This medium-density neighborhood consists of single-family residences and townhomes and is approximately 35 acres in size. It is located in the Tumbledown Brook subwatershed in Bloomfield and is associated with the Gillette Ridge Golf Course, which is located immediately to the south and west of the subdivision. The subdivision is approximately 5 years old and is not yet fully built-out. The existing homes are on approximately ¼-acre lots. The lots have approximately 50% impervious cover and approximately 30% grass cover, with intensive turf management

practices including lawn irrigation systems and the use of chemical fertilizers. There is no tree cover in this neighborhood since it was recently developed. The driveways, streets and catch basins are clean, dry and clear of trash, litter or organic debris such as leaves. All of the observed roof leaders are directly connected to the storm drain system despite the majority of the houses having adequate space for on-site rain gardens and rain barrels for watering of landscaped areas. This neighborhood is a good candidate for rain barrel and rain garden education programs, including environmentally-friendly residential lawn care and landscaping practices.

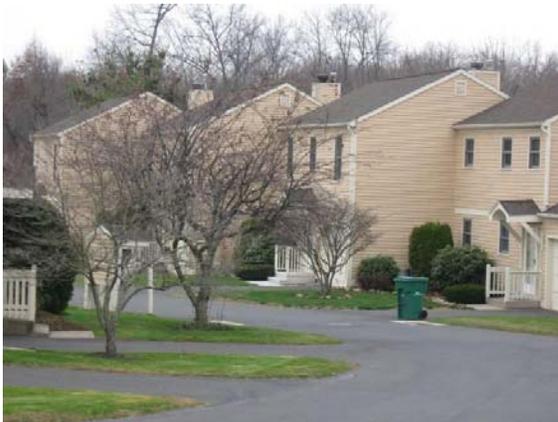
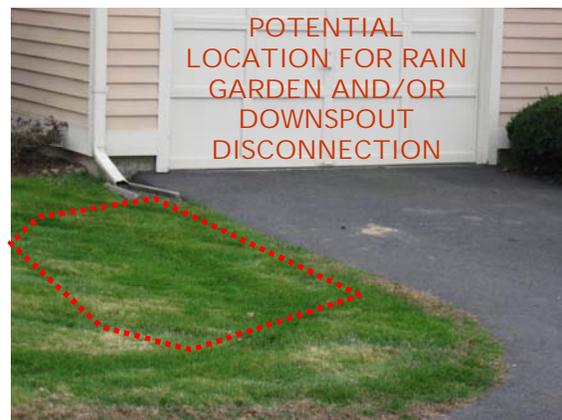
### *Mills Pond Townhouses*

Mills Pond is a townhouse complex located on Chestnut Hill Drive and Pondside Road in Bloomfield. The complex is approximately 20 years old with no evidence of infill or redevelopment. The neighborhood has some forest canopy and is surrounded by woods causing leaves and organic matter to collect in the curb and gutter street drainage system. An approximately 1-acre stormwater basin located along Pondside Road receives stormwater runoff from the complex and discharges to a tributary to Wash Brook. Approximately 70% of the roof leaders drain to the turf areas on the side of the townhouses, with the remaining draining directly to driveways. In several locations, catch basins or yard drains are located within landscaped areas. In some instances there is adequate space next to the buildings for rain gardens or to receive runoff if roof downspouts are disconnected.

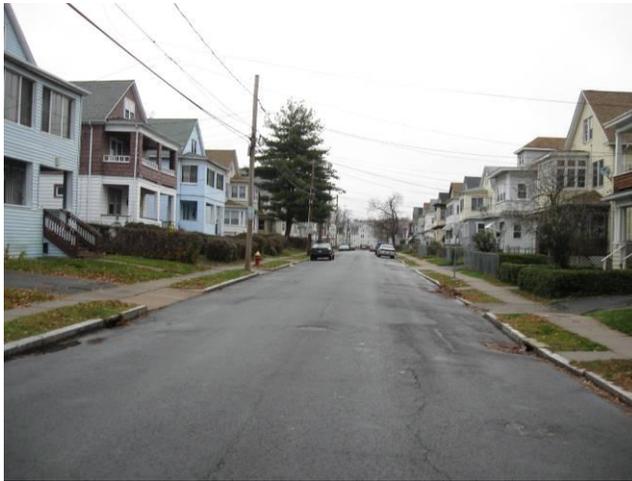
### ***Adams Street***

Adams Street is situated between Albany Avenue and the railroad line running along Homestead Avenue in Hartford. The homes on the 1/8-acre lots are two-family, and estimated to be 80 to 100 years old. The neighborhood is located within an area of Hartford serviced by combined sewers. Impervious surfaces comprise approximately 80% to 90% of the lots. Most of the roof leaders drain directly to driveways, which convey runoff to the combined sewer system, although several roof downspouts appeared to be plumbed into the residence, likely

entering the combined sewer system directly. This neighborhood is typical of many of the older, high-density residential neighborhoods in Hartford. Potential opportunities for improvements in this and other similar high-density residential neighborhoods include more frequent catch basin and storm drain cleaning (particularly for leaves), downspout disconnection, and lot-scale Low Impact Development practices and other green infrastructure practices such as green street retrofits.

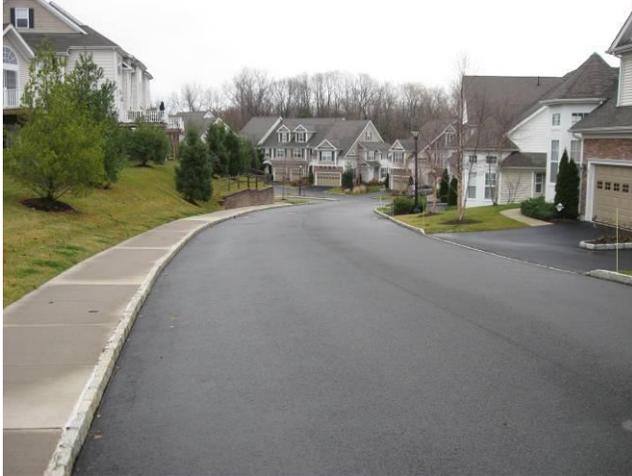
### ***Goodwin Estates***

Goodwin Estates is a West End Hartford neighborhood in the North Branch Park River subwatershed. The site is a reclaimed brownfields area that was redeveloped in 2004 with townhouses and condominiums. The development is approximately 5 years old and is believed to have stormwater management infrastructure that includes underground infiltration devices for rooftop runoff. Lawns in the neighborhood are highly managed (i.e., fertilizer usage and permanent irrigation systems). The streets and sidewalks in this neighborhood are

clean of sediment and leaves. Overall, the neighborhood has a moderate pollution rating due to intensive lawn care practices, although the restoration opportunity in this neighborhood is low. The neighborhood is a good candidate for a catch basin stenciling program.

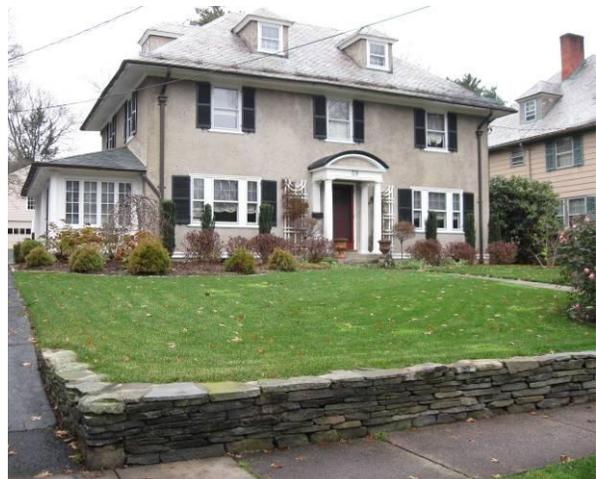
The Concord Street neighborhood is located in the North Branch Park River subwatershed in West Hartford. The ¼-acre lots are well maintained and have approximately 40-50% impervious cover, with approximately 10% of the lots consisting of landscaped planting beds, and the remaining areas consisting of grass lawns. Some lots have as much as 50% tree canopy cover given the age of the neighborhood. There are sidewalks along both sides of the tree-lined street, limiting the retrofit potential for roadside swales or bioretention.

The Concord Street neighborhood may be good candidate for rain barrel retrofits since roof leaders are likely connected directly to the combined sewer system and there are large landscaped areas that could be watered with the collected rainwater. It is recommended that the catch basins be stenciled in this area following the sewer separation along Concord Street (MDC sanitary sewer mapping indicates that sewers along Highland Street to the east and Walbridge Road to the west have been separated, while the Concord Street storm and sanitary sewers remain combined).

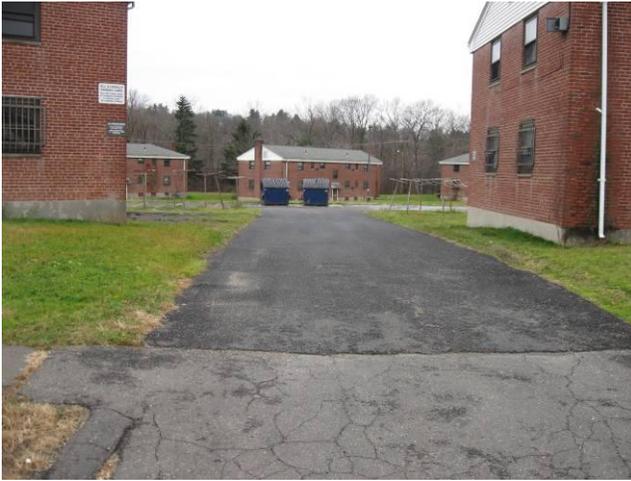
## West Brook Village

West Brook Village is a public housing development in Hartford located off of Mark Twain Drive and adjacent to the North Branch Park River. The development is mostly vacated, and the Hartford Housing Authority is reportedly working to negotiate the sale of the property. The property is utilitarian, with only the housing structures, lawns and roadways on the property with no landscape plots and a few sparse trees. Runoff from this site drains to the North Branch Park River, which is located nearby across Mark Twain Drive, without

treatment or detention. This and similar public housing developments provide opportunities for urban renewal pilot projects that could incorporate low impact development and green infrastructure elements.

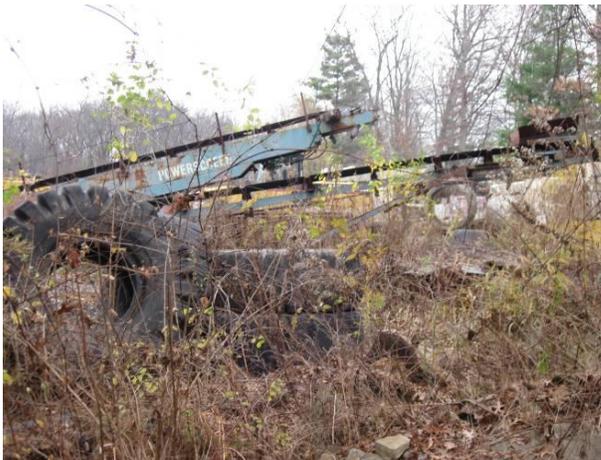
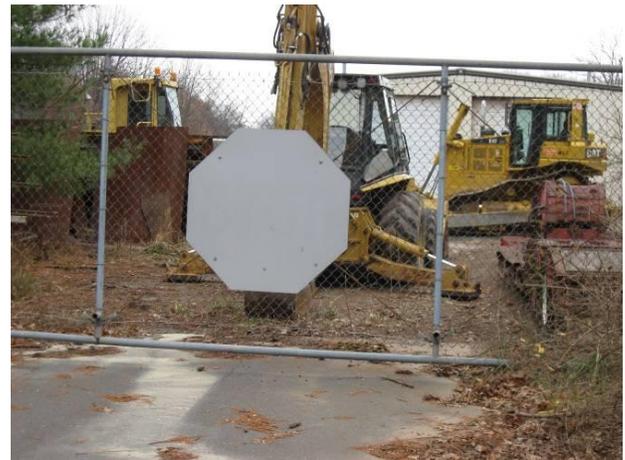
### ***Southwood Road – Used Equipment Storage Lot***

A property on Southwood Road of unknown ownership is located between the Mather Corporation parcel and the volunteer fire department building. The property is being used as machine and used equipment storage lot. The ownership of the property is unclear from the Bloomfield Assessors database since the address is unknown. Field crews could not gain access to the site for inspection, although used machinery, tires, roll-off dumpsters, loading trucks, and machine and truck parts were observed to be scattered throughout the site. The equipment and machinery is a potential stormwater pollutant source, and the site is located near a tributary of Beamans Brook. A follow-up evaluation of this site is recommended to confirm property ownership and further evaluate the site for pollution potential.

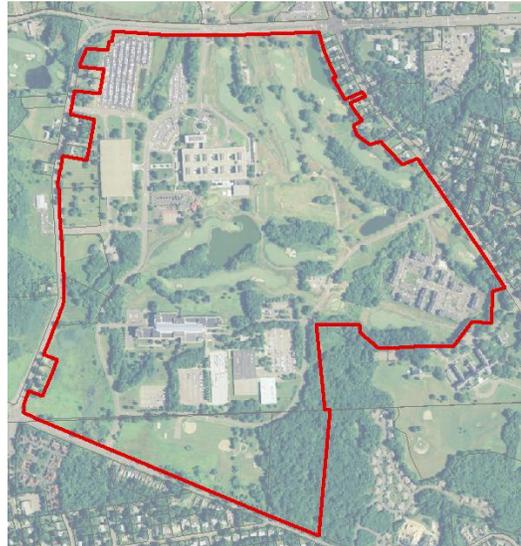
### ***Cigna Campus***

The Cigna Campus is a 304-acre parcel including Cigna, Metlife and Gillette Ridge Golf course offices. The eastern portion of the property also contains part of the Gillette Ridge Golf Course. Based on GIS mapping, there is approximately 60 acres of impervious area on the parcel, for approximately 20% overall imperviousness. Facility trash and other wastes are primarily stored and managed indoors or under covered overhangs, such as a loading dock in the rear of the Cigna building. Stormwater controls are present on the site. A parking garage associated with the Cigna building appears to drain to a constructed wetland along Hall Boulevard.

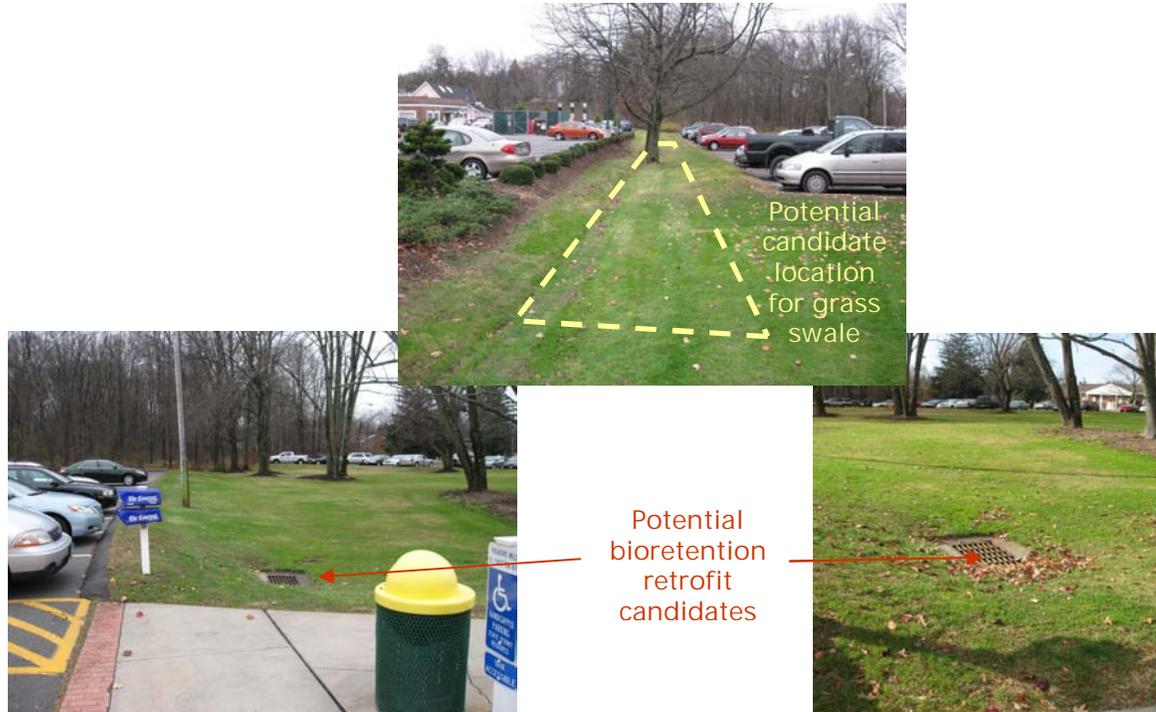
### ***Bloomfield Town Hall***

The Bloomfield Town Hall is located on Park Avenue in Bloomfield Center in the Wash Brook South subwatershed. The Town Hall is an administrative building with staff parking and no storage of fleet vehicles or on-site industrial activities. Although the pollution potential of this site is low, it is a good candidate for a demonstration stormwater retrofit project on a high-profile municipal site. The site is highly visible since it is a municipal building located at a main intersection in the Bloomfield town center. There are many stormwater retrofit opportunities at this site at locations where stormwater is currently directed toward catch basins in grassed areas or low areas downgradient of the parking lot. Additionally, there is adequate open space on the property to implement on-site retrofits such as rain gardens, vegetated swales or bioretention to treat runoff from the roof or parking areas.
