Watershed Field Assessment Report Pequonnock River Watershed

City of Bridgeport

February 2011

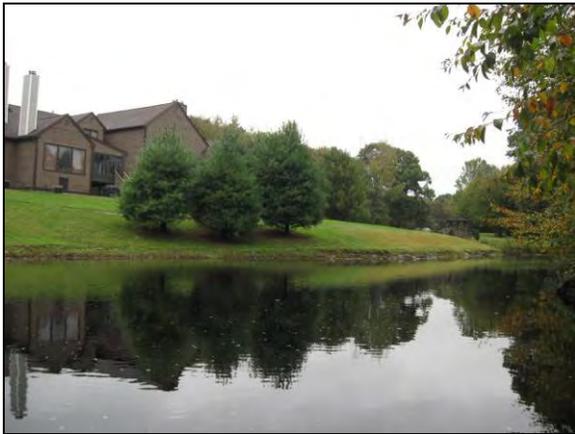
Upper West Branch Pequonnock River reach UWB-03 flows from the outlet of the lower stormwater pond at the Northbrook townhouse complex through a low-density residential area along the rear of a few residential properties. The stream crossed the rail-trail beneath a decommissioned railroad crossing which has a large downstream scour hole. The stream then flows along the edge of a private grass field, under a driveway crossing, and through a rip-rap lined channel to a small pond. The entire reach is bordered by privately-owned lands. The biggest problems in this reach are caused by the impaired buffers and channel modifications along the majority of the stream bank.

These deficiencies include rip-rap along the banks, turf planted to the stream bank, and retaining walls replacing the natural bank (one was constructed from milk crates). One residential property that abuts the stream constructed a driveway bridge over the stream for access across the property.

The lower stormwater pond at the Northbrook Townhouses marking the upstream end of UWB-03.

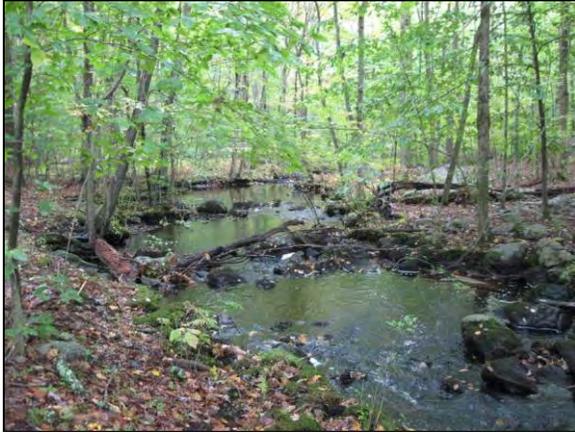
UPR-05 is considered a reference stream with excellent stream buffer distance, canopy cover, and instream habitat.

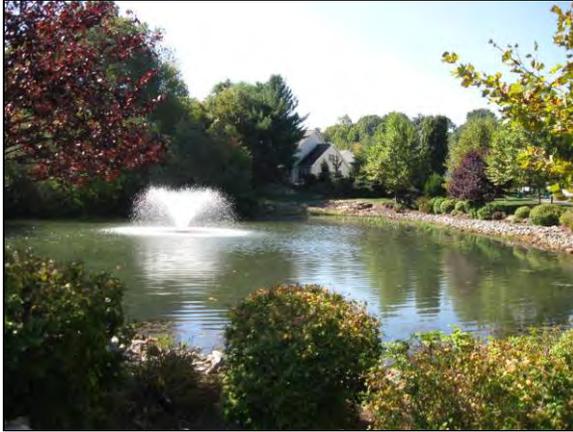
MPT-09 is rated "Fair" due to stream channelization and lack of floodplain connectivity. Another issue along this reach is the illegal dumping of household trash into the stream.

Man-made pond at the downstream end of MPT-09 at the entrance of the Governor's Ridge subdivision.

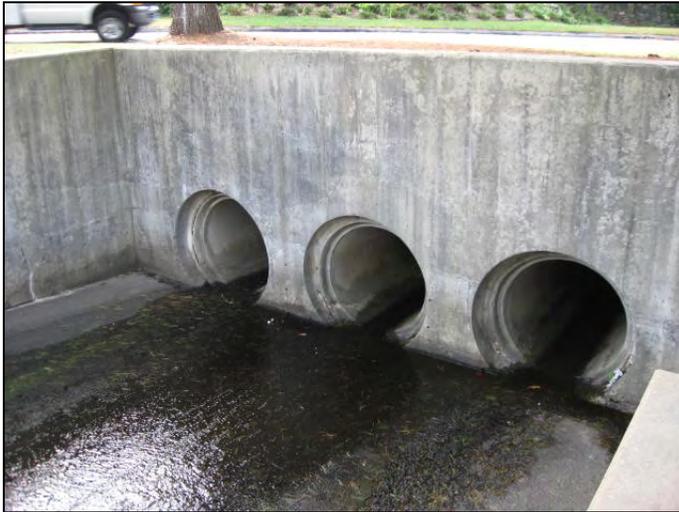
The stream enters a large wet detention pond prior to crossing Trefoil Road through three 5 foot culverts and emerges in a pool lined with concrete and gabion walls. The stream then flows through a natural channel adjacent to Spring Hill Road for approximately 500 feet before discharging to the Pequonnock River. MPT-24 is rated "Fair".

SC-01 crosses Trefoil Road in three 5 foot culverts.

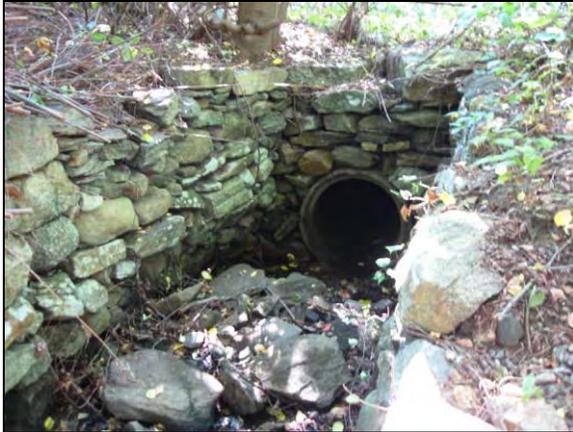
Both upstream and downstream of the bank channelization severe bank erosion is evident with undercut banks. It appears that residential land owners have attempted to secure the areas of the bank that are eroding with the addition of more stone wall, although the efforts do not appear successful. The reach is crossed by Spring Hill Road, a footbridge, and two driveways. Stream crossing SC-02 and SC-03 associated with the footbridge and the residential driveway are candidates for restoration to remove the fish barrier and stabilize the bank erosion. The overall stream conditions for reach MPT-25 is “Excellent” due to good buffer distance, canopy cover, in-stream habitat, and floodplain connection.

SC-03 is a 36" concrete culvert crossing a driveway.

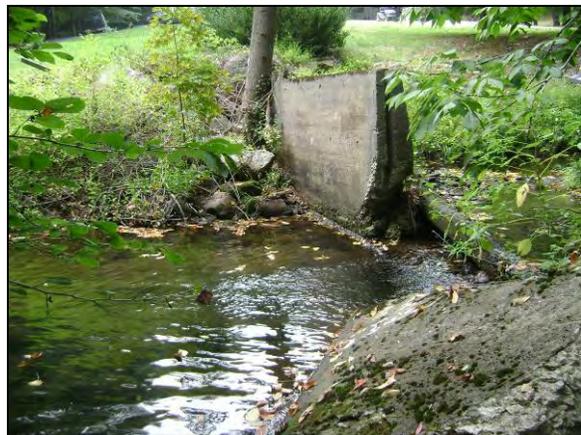
Concrete dam (SC-03)

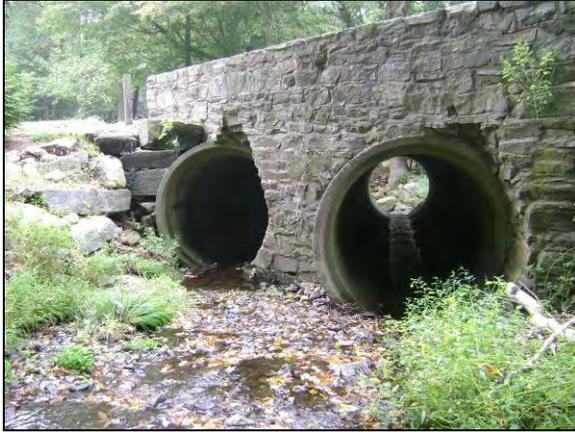
SC-01 is a twin 72-inch culvert for the stream crossing at Strobel Road, marking the beginning of the reach.

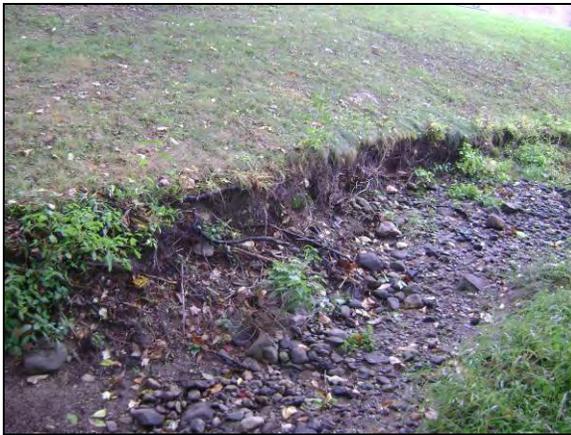
The overall rating for this reach is “Poor” due to a combination of severe bank erosion, limited vegetated buffer width, floodplain encroachment, and marginal floodplain habitat.

The stream has poor channel substrate, no vegetated buffer, and little shaded canopy cover.

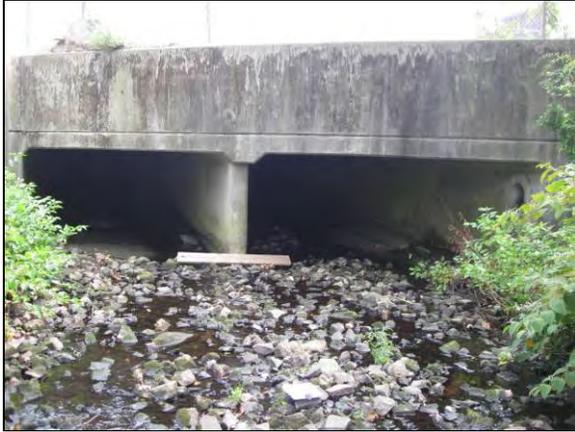
Reach ISL-02 of Island Brook is an entirely underground section of the stream conveyed in a double-box culvert approximately 15 feet wide and 6 feet in height through a dense commercial and industrial section of Bridgeport. The entrance to the culvert is at Capital Avenue and water discharges just past Route 1/North Avenue. The culvert is not necessarily a fish blockage. The reach has a rating of “No Value” since it is entirely underground, has no natural bank of floodplain, and has no in-stream or floodplain habitat value.

Reach ISL-02 is an underground culvert.

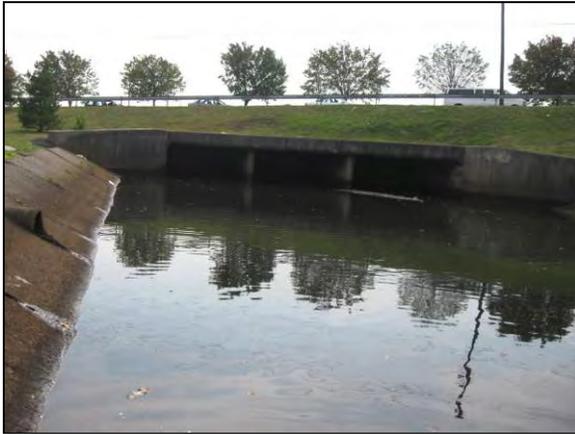
Park. The reach is rated “Poor” and given a score of “0” since the underground concrete culvert does not provide in-stream habitat or provide buffer or floodplain connection.

Reach LPR-05/06 is an underground culvert discharging at a triple box culvert in Beardsley Park.

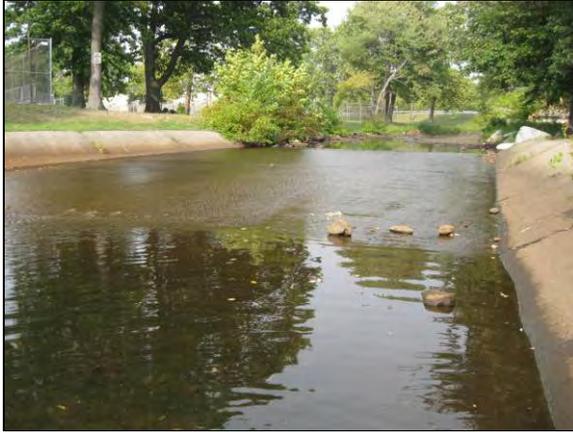
The construction of a fish apron across this concrete culverted section of the reach would allow fish passage during periods of low flow.

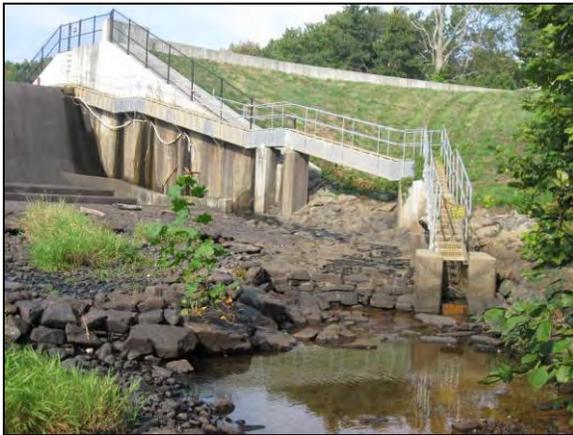
A fish ladder provides an access route to Bunnell's Pond from reach LPR-07.

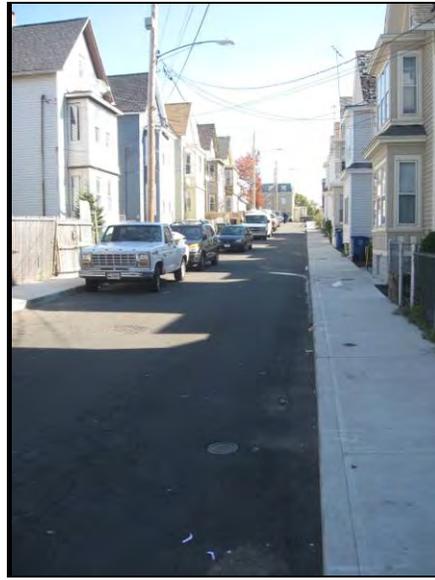
Armstrong Place has been recently paved following a sewer separation project.

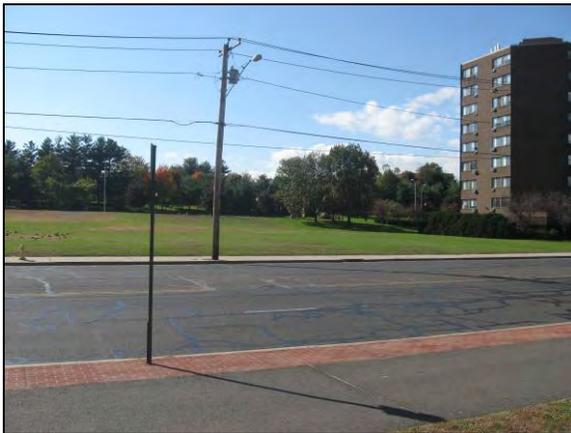
The Clifton House is a public housing building adjacent to Riverfront Park on Main and Lumber Streets. The facility has a large parking area and is surrounded by open space areas that have the potential for on-site stormwater retrofits. In addition, the property is located downgradient of a large stormwater collector line where stormwater could be diverted into a large water quality or infiltration structure.

Clifton House public housing and adjacent open space area.

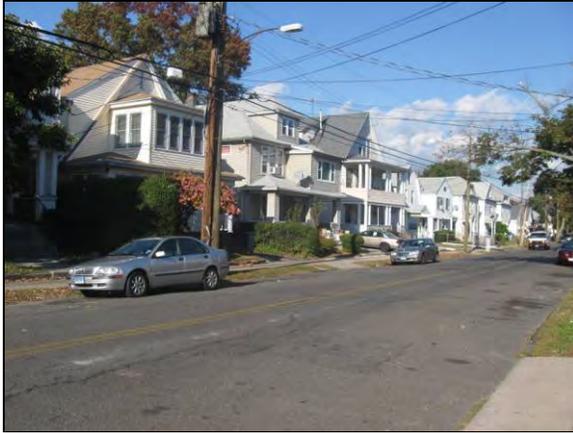
curb and gutter present along the street with many cars parked long-term on the street causing sediment, oil & grease, and trash and litter along the street. This neighborhood is a good candidate for street sweeping, and catch basin stenciling. The lawn areas are too small for rain gardens or downspout disconnections.

Garfield Avenue is a two-family housing neighborhood with evidence of long-term on-street parking.

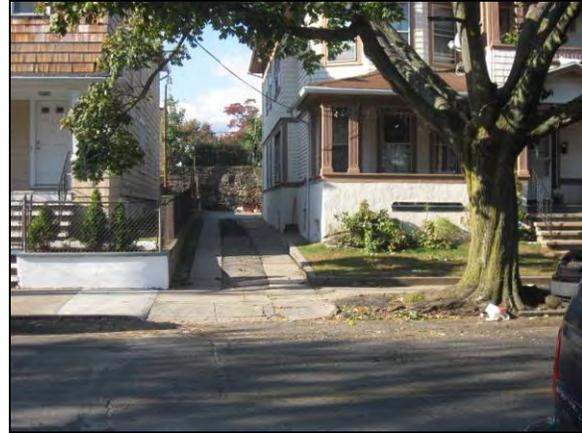
The neighborhood has a high percentage of impervious surfaces due to the small lot sizes.

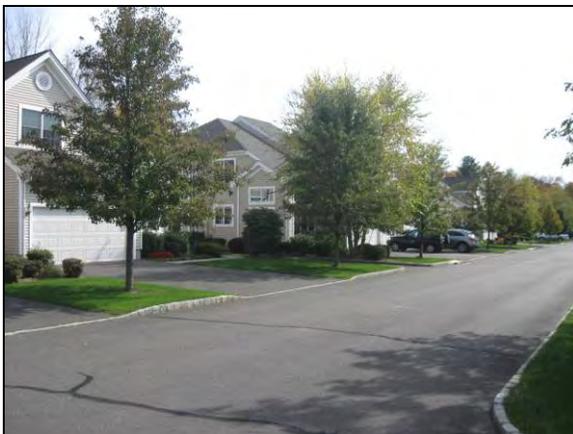
The Regency Meadows neighborhood is in the Middle Pequonnock Tributaries subwatershed along Regency Circle in Trumbull. The neighborhood is believed to have a homeowner's association. The homes are single-family attached townhouses located on 1/8-acre lots. All of the homes have basements and garages and the neighborhood is less than 5 years old. Many, if not all, of the homes have permanent irrigation systems and appear to fertilize the lawns, which may increase the contribution to non-point source pollutant runoff from the neighborhood. The downspouts are directly connected to the storm drains or sanitary sewers and there is plenty of lawn area for rain gardens. The neighborhood does have a stormwater pond, although a gully has formed in the bottom sediment causing short-circuiting through the pond. A stormwater pond retrofit is recommended to install a forebay for sediment retention. The storm drain inlets should be stenciled in this neighborhood.

Townhouses on Regency Circle are less than 5 years old and have high turf maintenance.

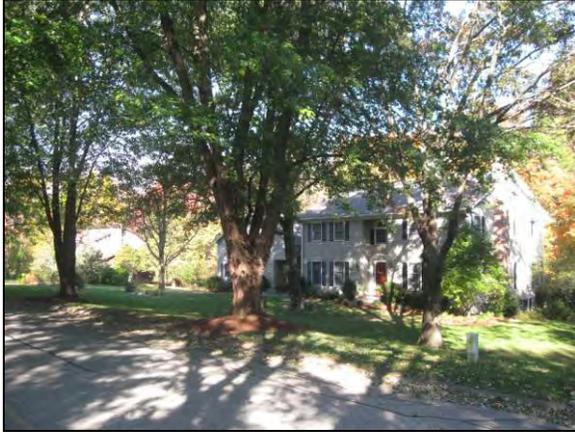
The Flint Ridge Road neighborhood is located in Monroe in the Upper Pequonnock River subwatershed. The neighborhood is estimate to be 30 years old and the homes are on greater than 1 acre lots. All of the houses have garages and basements with septic fields. There are mature trees on many of the properties. The streets and catch basins are generally clean, however they are not stenciled.

The homes on Flint Ridge Road are on greater than 1 acre lots with high turf management.

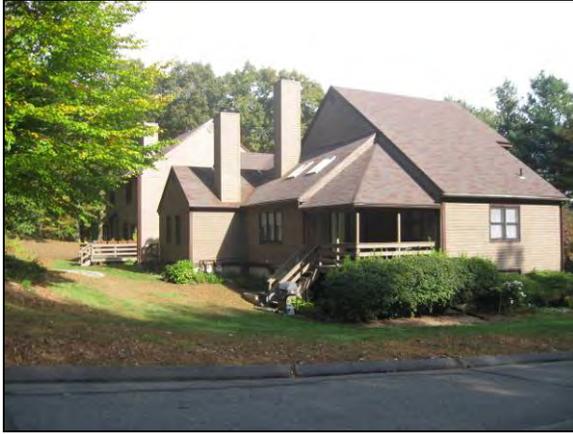
Northbrook Townhouses

Typical Northbrook townhouses.

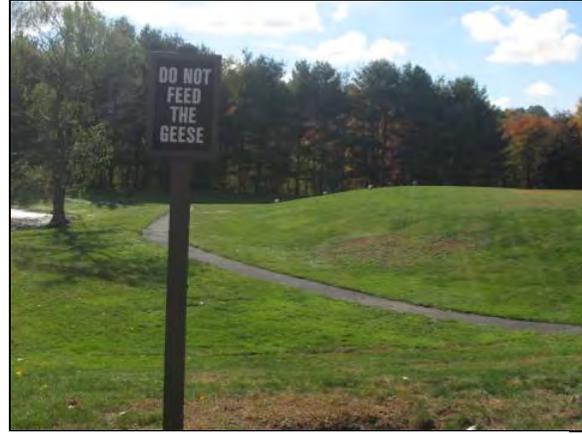
A sign discouraging wildlife feeding near a stormwater pond.

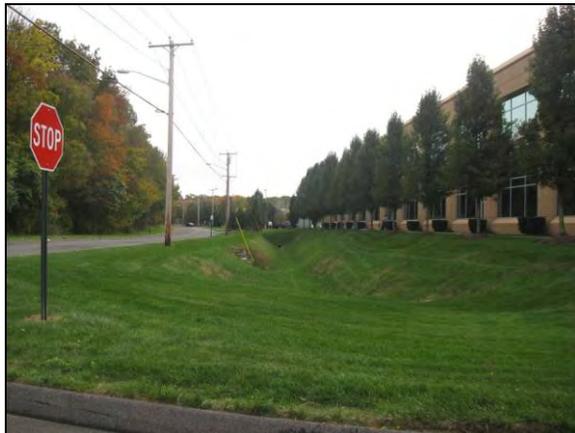
Helicopter Service – Quarry Road

Helicopter Service Inc. (HSI) is located on Quarry Road in Trumbull in the Middle Pequonnock River subwatershed close to the Pequonnock River. The parking lot has a significant amount of stored materials that are uncovered; however there did not appear to be any liquid storage items. There are loading and unloading operations at the site. It is recommended that the outdoor storage be moved to a covered location. The facility stormwater drains to a large dry detention pond along Quarry Road.

A large dry detention stormwater basin collects runoff from the site and provides water quality and quantity treatment.

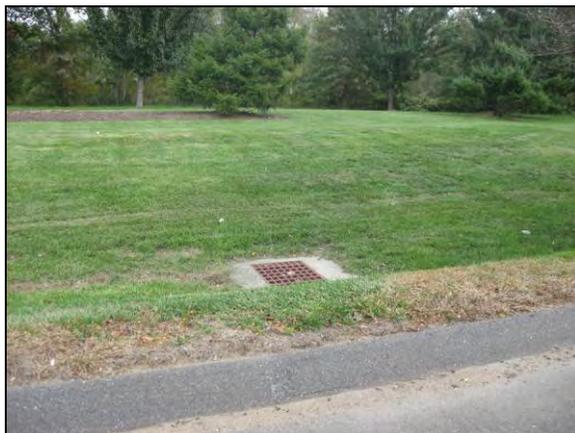
The catch basin is located in a grass swale to allow for infiltration prior to entering the storm drainage system.

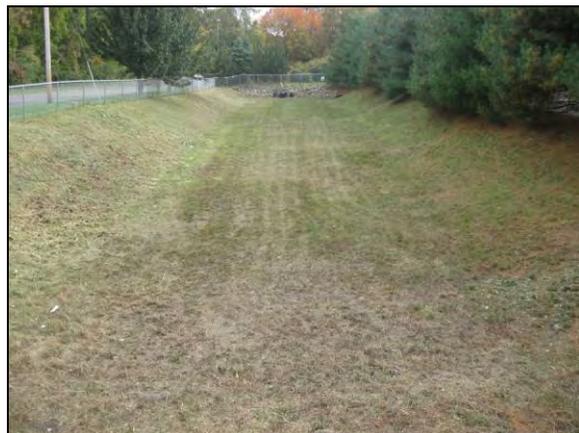
The Bow Tie Cinema is located on Quarry Road in Trumbull near the Pequonnock River. The movie theater and large parking lot are approximately 10 years old. The facility has a large dry detention basin that could be used as an example of good water quality and quantity treatment in the watershed. In addition to the dry basin, many of the catch basins are located at the bottom of grass swales to allow for some infiltration prior to entering the storm drainage system.

This large dry detention pond is a good example of water quality and quantity treatment from the Bow Tie cinema parking lots.

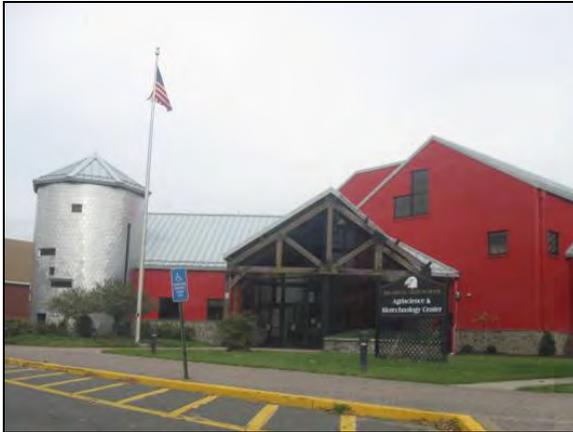
The Trumbull High School and the Regional Agriscience and Biotechnology program on Strobel Road in Trumbull is located in the Middle Pequonnock River subwatershed. The campus and ground of the two schools are large, including multiple buildings, athletic fields, parking areas, and agriculture school storage. At the time of the field visit, reconstruction of a portion of the high school was underway. The biggest potential problems at this site are the outdoor storage at the agricultural school, including farm equipment and materials, and the fertilizer runoff from the athletic fields.

The Regional Agriscience and Biotechnology program.

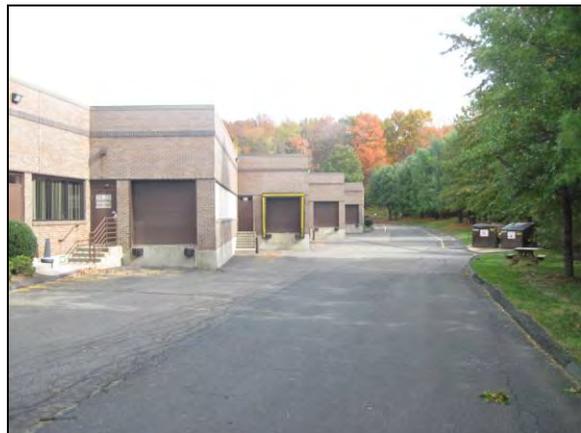
The commercial office park located at 204 Spring Hill Road in Trumbull is a potential hotspot location in the Middle Pequonnock Tributaries subwatershed due to the waste management activities, loading operations, and downspouts discharging to impervious areas. There were no observed pollution sources around the building during the site visit.

Loading and unloading operations in the rear of the facility.

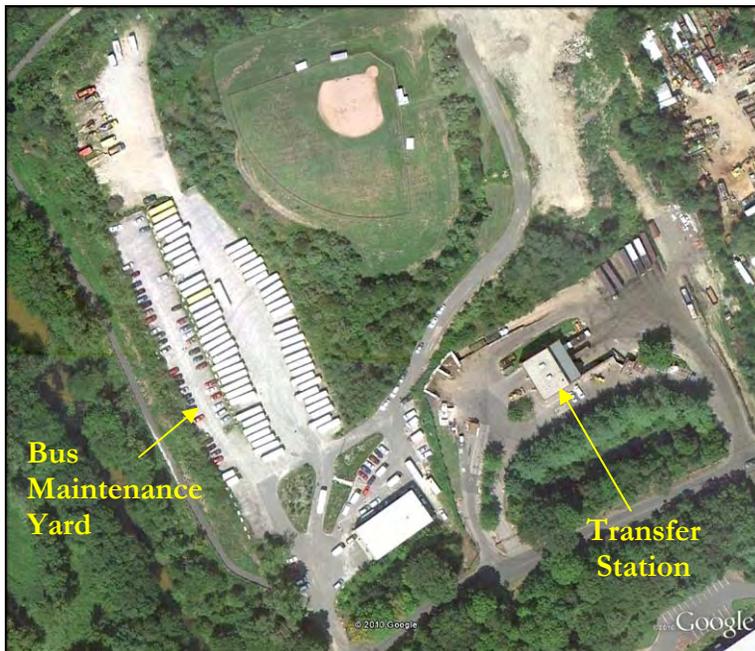
Bus Maintenance Yard & Transfer Station

The Trumbull bus maintenance yard and transfer station is located in the Middle Pequonnock Tributaries subwatershed. The facility stores approximately 100 school buses and operations include maintaining, repairing, fueling, and washing the buses. There is an uncovered fueling area. Since the field crew did not gain access to the site, the waste operations were not evaluated and should be included in future follow-up inspections.

The bus maintenance yard and transfer station are located on Spring Hill Road in Trumbull.

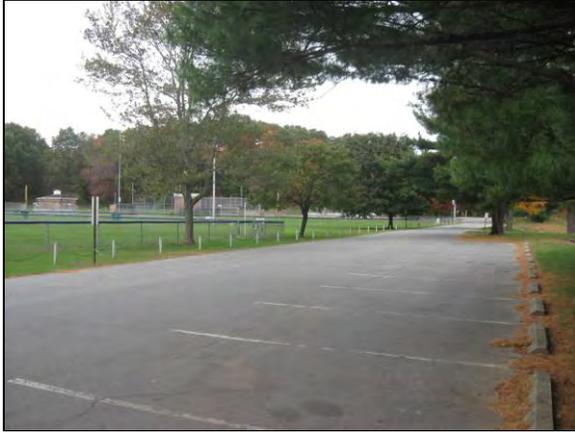
The Athletic Fields at Unity Park are located in the Thrushwood Lake subwatershed. The biggest problem for non-point source pollution at the athletic fields is the high turf maintenance practices which can contribute fertilizers to stormwater runoff. The turf at the athletic fields is irrigated and the stormwater runoff is conveyed directly to the storm drainage system. Improvements to the large-scale turf maintenance practices at these fields would improve water quality.

The runoff from a large parking lot at the athletic fields is a good candidate for a stormwater retrofit.

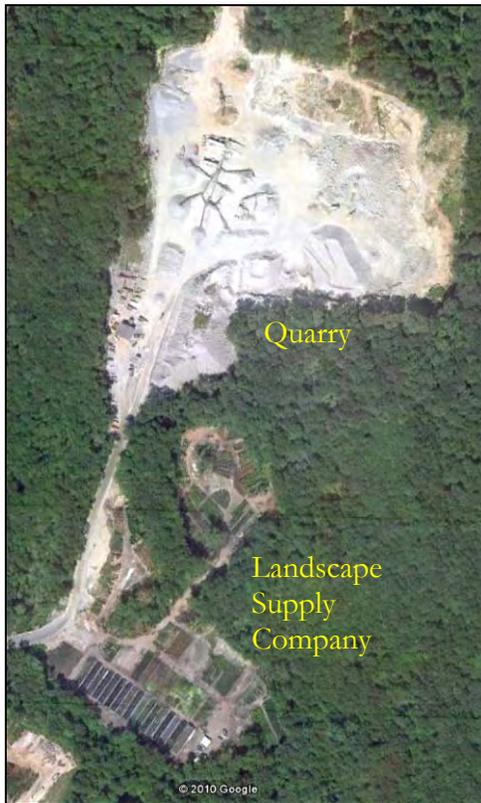
Adams Materials operates a quarry and a landscaping supply company in the Upper West Branch Pequonnock River subwatershed. Both operations are believed to support development of the new industrial buildings in the area along Enterprise Road. The operations at the quarry could not be evaluated without permission for an on-site assessment. However, it is clear that mining and loading and unloading of stone and gravel materials at this site have the potential to

influence water quality in the Pequonnock River. Follow-up should be made to determine if the site has a NPDES permit.

A quarry and landscape supply company are located on Enterprise drive and are believed to supply construction and landscaping materials to the new industrial development in the area.

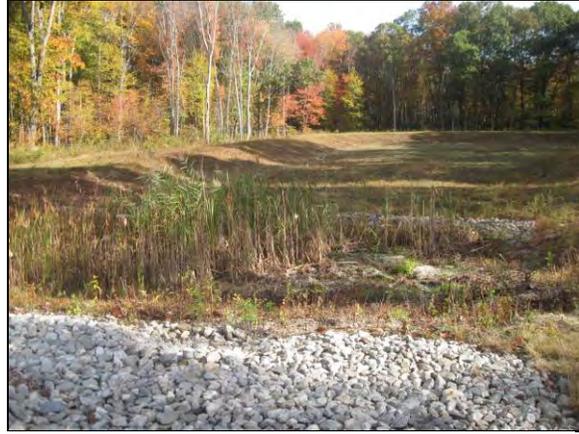
A large stormwater basin was recently constructed to treat runoff from the new and proposed industrial development along Enterprise Drive in Monroe.
