March 8, 2013

RE: Norwalk Pump Station and Tower Tank
34 Grandview Avenue, Norwalk, Connecticut
Pre-Demolition Asbestos, Lead-Based Paint and Paint Chip Survey

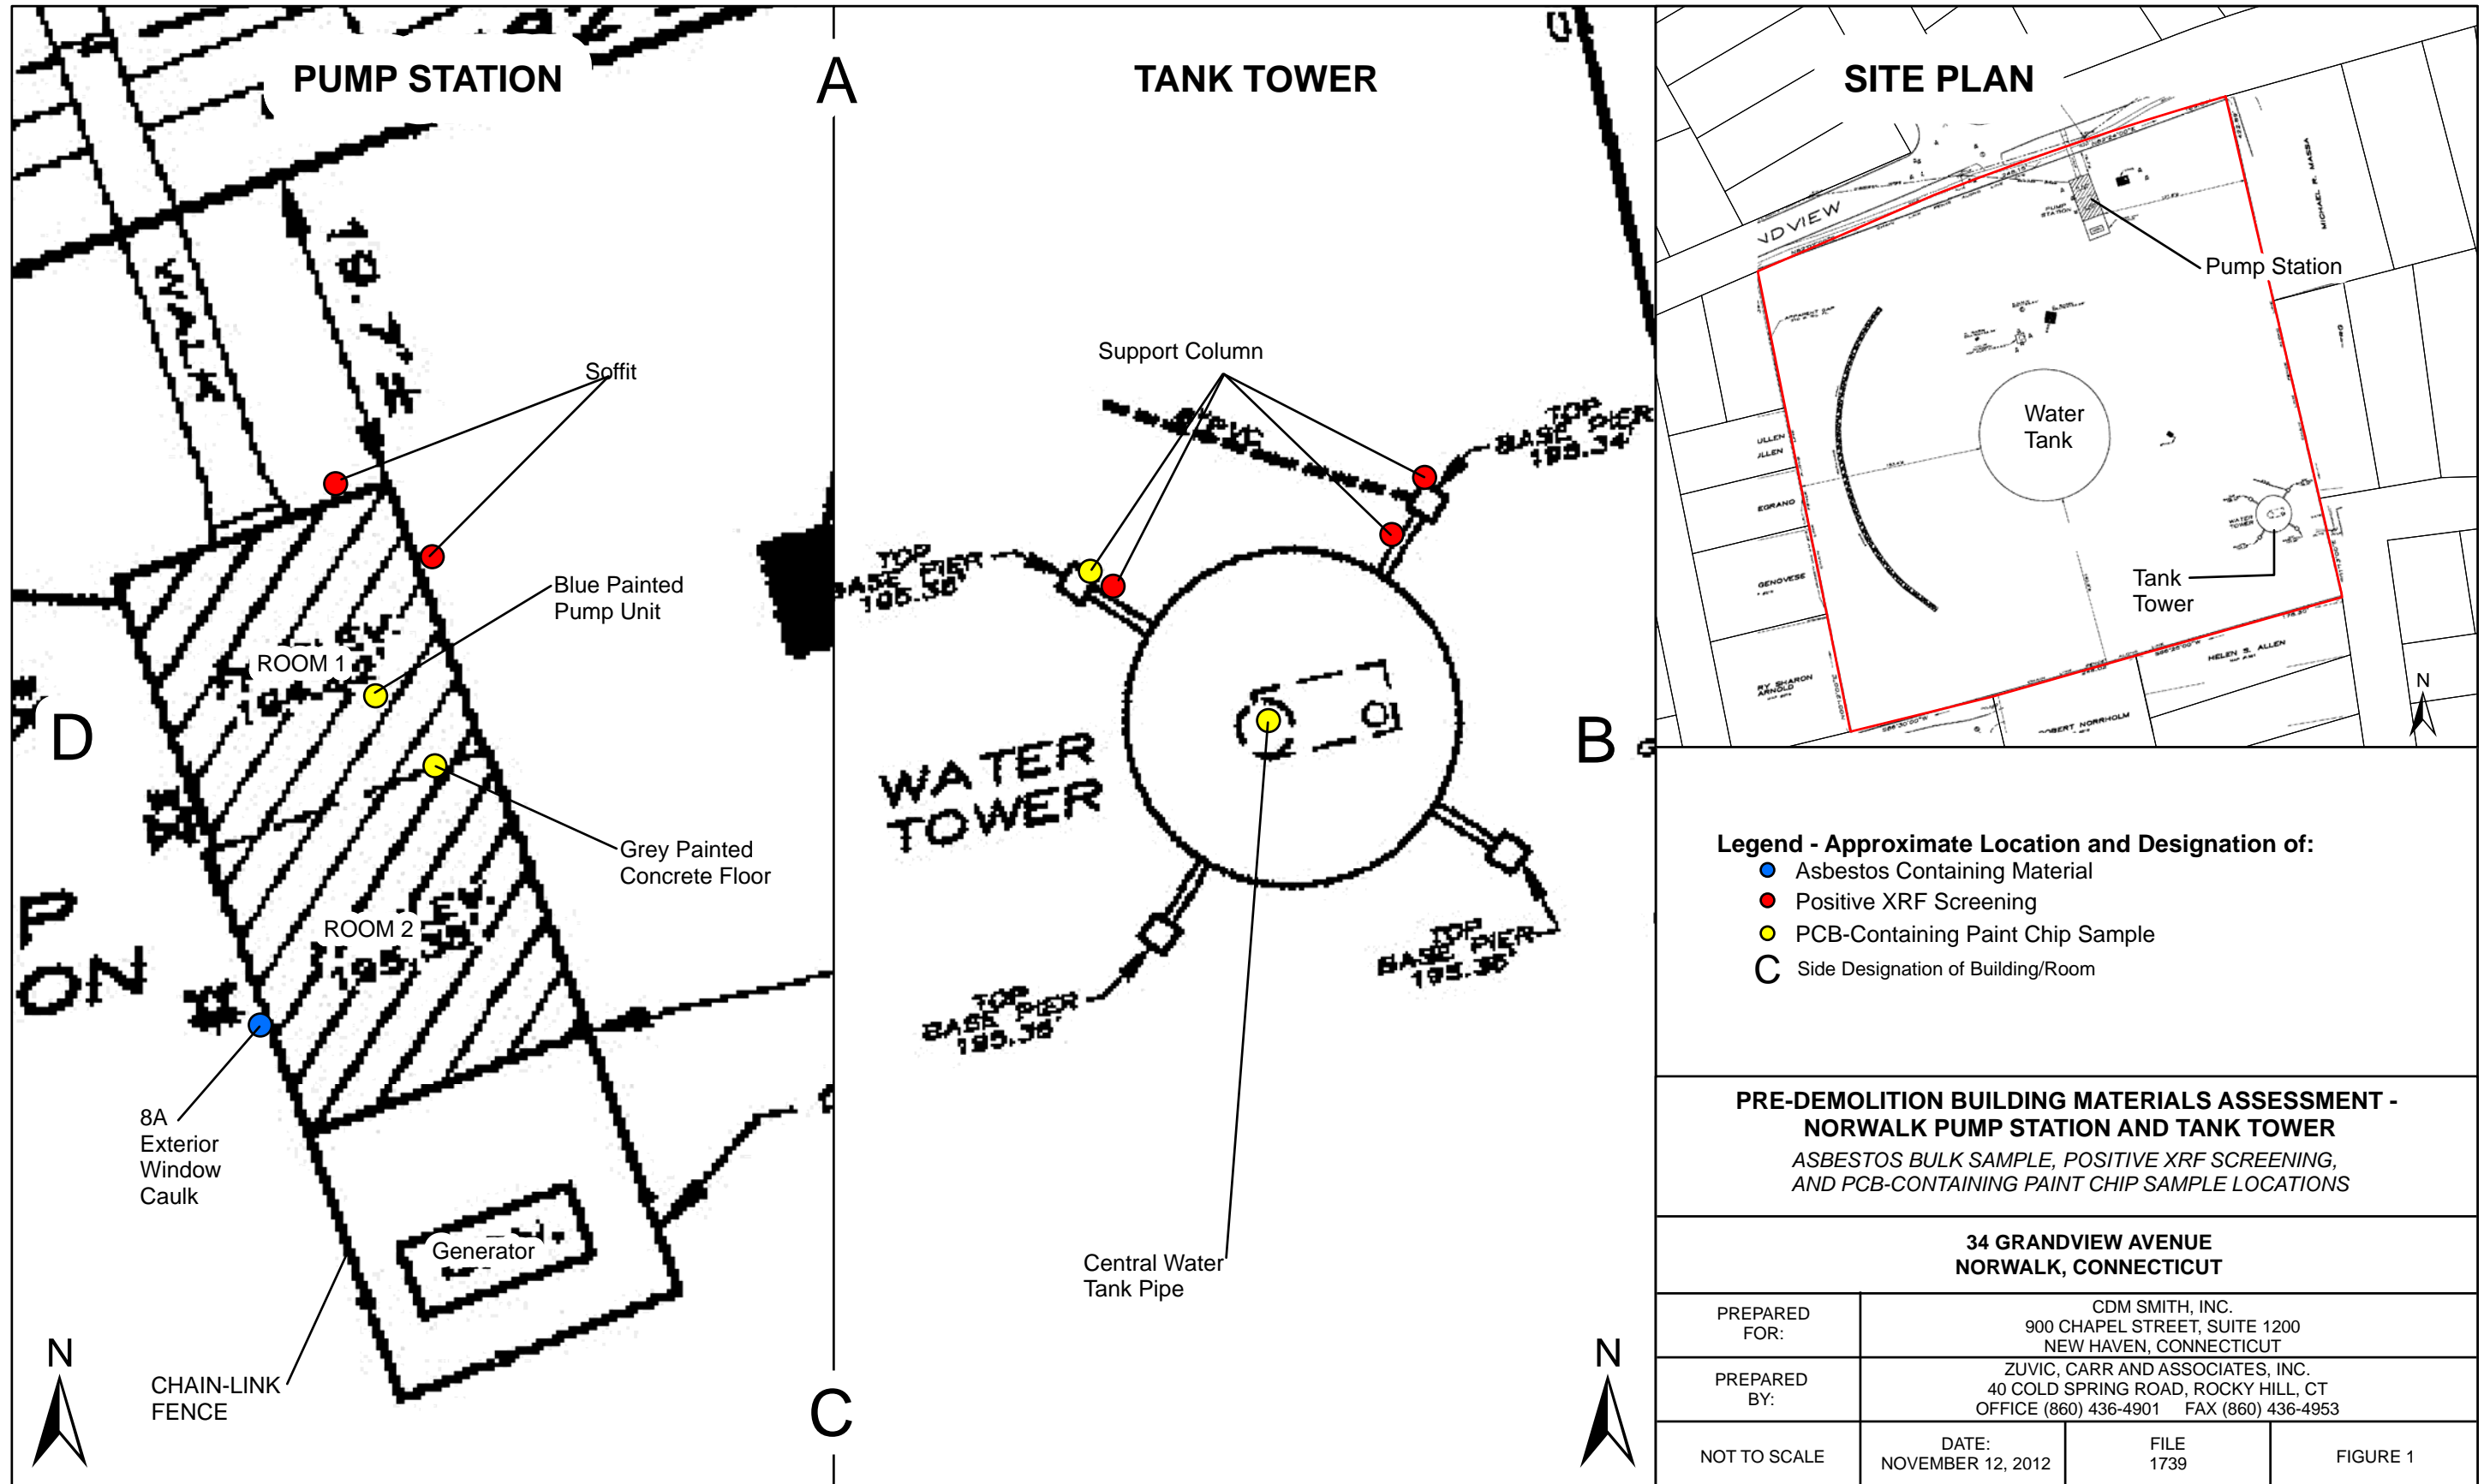
The two structures are depicted on the Site Plan, referenced as Figure 1. Photographs that were taken during the inspection are included in Appendix A.
