Memorandum

Re: Wind Colebrook South

Attached are environmental erosion and sediment control monitoring reports numbers 40 through 43 for the period July 27 through Aug 10, 2012.

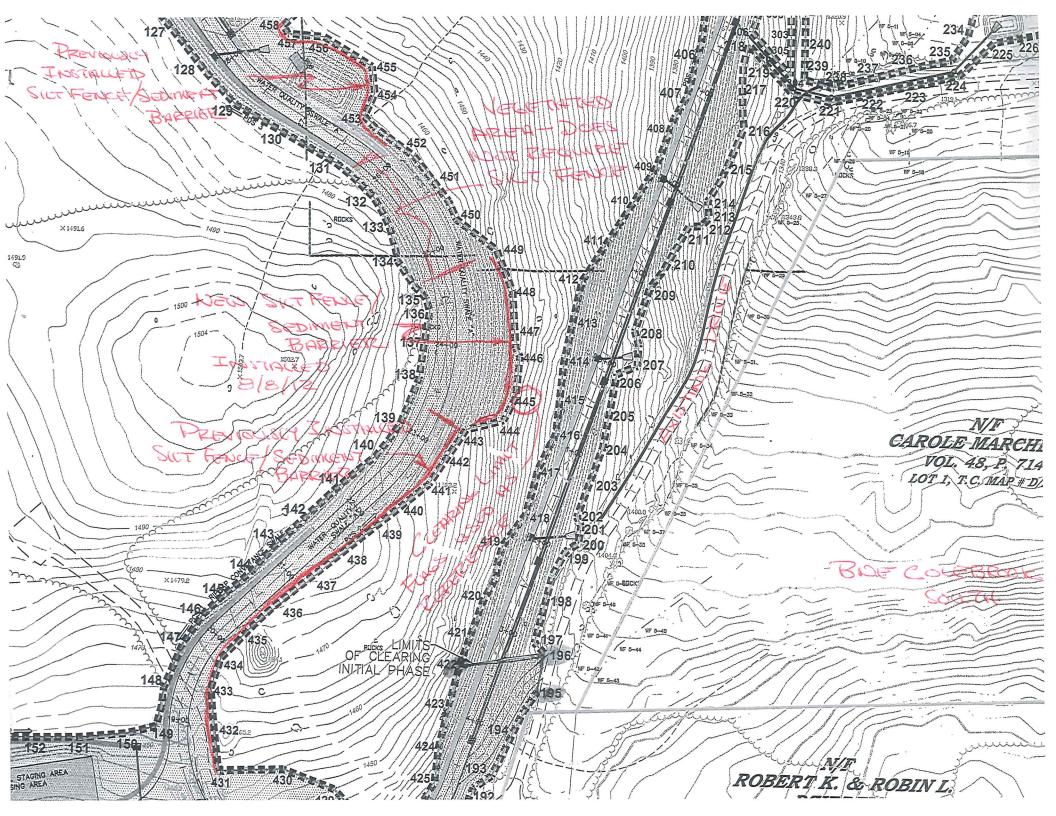
No problems or discharges were observed. Greg Zupkus installed silt fence in the area noted in previous inspection reports

Silt Fence Installed 8/8/2012
