5. **Clear cutting, tree removal, land destruction, and filling outside the easement from sites 7784 to sites 7787.**

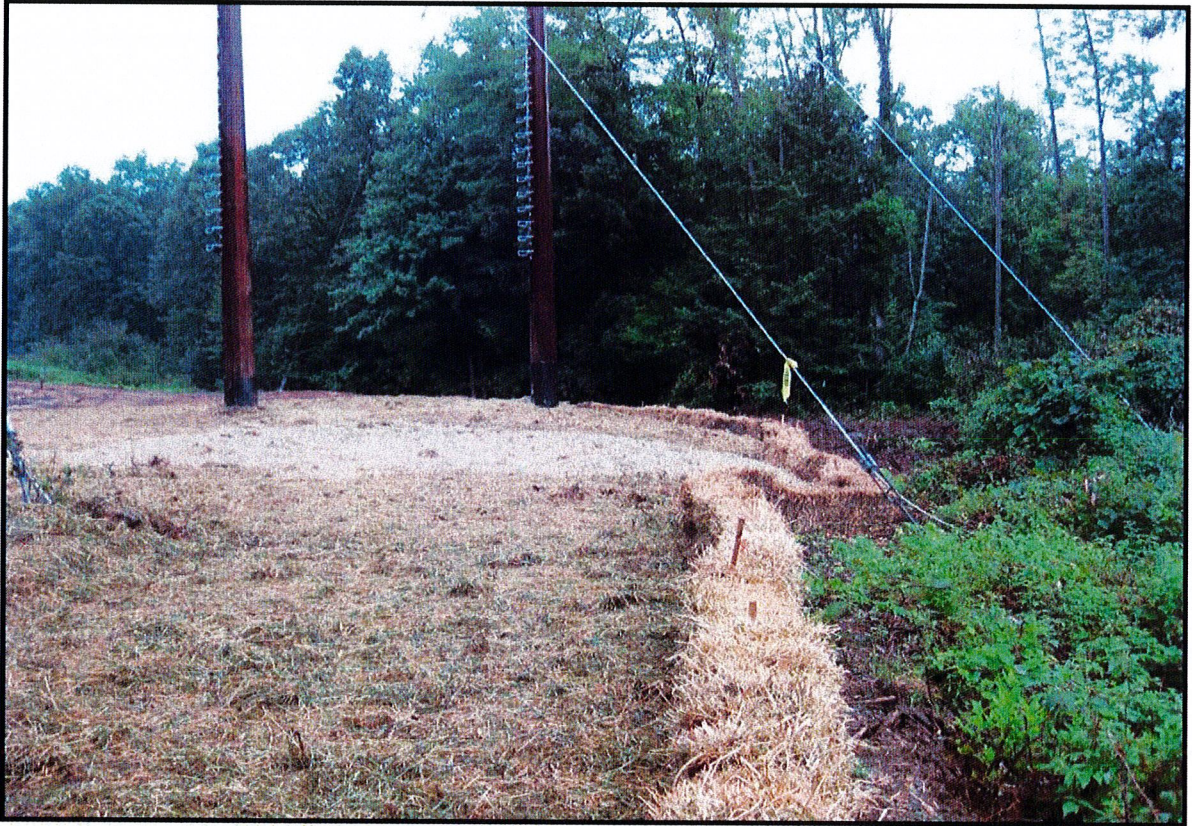
Typical view of light mulching atop unstable, seeded soils.

Notice also in this illustration from the BMPs that the existing native vegetation has been retained and is flourishing. In the easement in this case Eversource mowed down all the vegetation, right to the ground, contrary to the preservation requirements of the BMPs, and thereby “opened the door” to invasive species which have now taken over in several areas. As the owner’s environmental consultant observed: “All along the access road, mugwort swaths, ten to twenty feet wide, are dense and mature, with five-foot tall dead stems, remaining from the 2021 growing season.” At REMA 3.2.2.
