RE: **PETITION NO. 1567** - The Connecticut Light and Power Company d/b/a Eversource Energy petition for a declaratory ruling, pursuant to Connecticut General Statutes §4-176 and §16-50k, for the proposed 1637/1720 Lines Rebuild Project consisting of the replacement and reconductoring of electric transmission line structures along its existing 4.0 mile electric transmission line right-of-way shared by its existing 115-kilovolt (kV) Nos. 1637 and 1720 Lines between Grist Mill Road in Norwalk, Norwalk Junction in Wilton, and Weston Substation in Weston, Connecticut traversing the municipalities of Norwalk, Wilton, and Weston, and related electric transmission line and substation improvements.

MOTION FOR PARTY STATUS, OR ALTERNATIVELY, VERIFIED PETITION TO INTERVENE BY MR. AND MRS. PETER RUBSAM

Rubsam Property Copts Brook Habitat Assessment Wilton, Connecticut

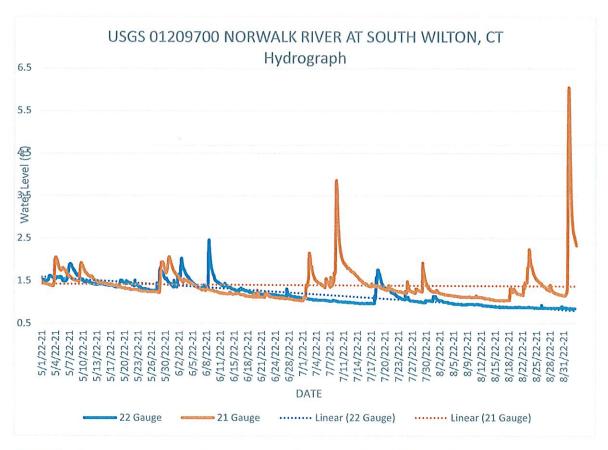
As part of the hydrologic investigation, the nearest water level and precipitation gauges were reviewed. A USGS water level gauge located on the Norwalk River (Figure 1) and precipitation data using the USDA rain gauge in New Canaan (Figure 2)¹ were reviewed to compare differences between 2021 and 2022. Summer months including May through September were the focus of the review. Table 1 shows that, on average, water levels in 2022 were lower than 2021 and, at the end of August, a decrease of ½ a foot in

Figure 1. Water levels recorded from the Norwalk River in Wilton, CT from May through September in 2021 and 2022.

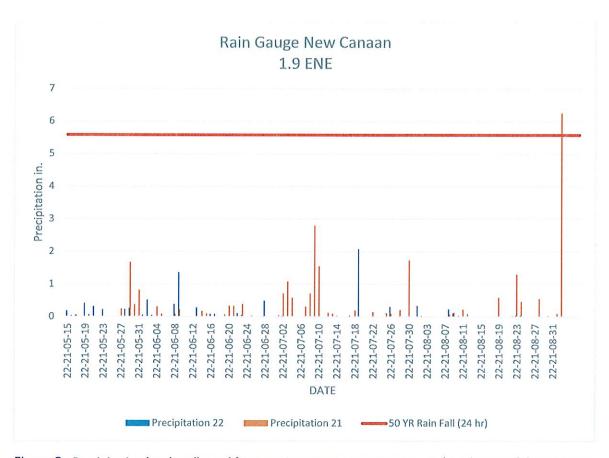
Additionally, review of the precipitation data shows that, on average between the months of May and September, precipitation was lower in 2022 than 2021. The total precipitation for 2022 was 9.88" while the total precipitation in 2021 was 26.49". There is a deficient of -16.61" in 2022 from the past year. Breaking it down further into separate months you could see that May, July, August, and September of 2021 had significantly more rain. It is worth noting that the greatest precipitation differences came in July with 8.05" less rain occurring in 2022.

Figure 2. Precipitation levels collected from a rain gauge in New Canaan, CT (3 miles away) from May to September 2021 and 2022.

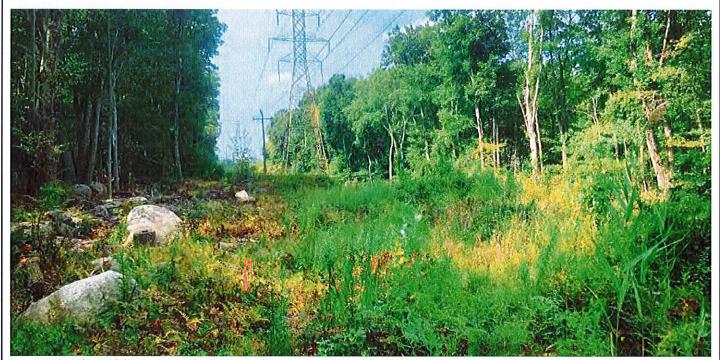
Photo 10: View of the ROW to the west of Clover Drive. Structure 944 is in the background.

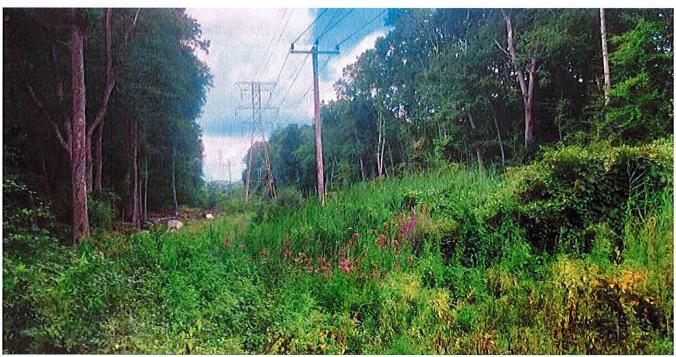
In addition, the adjacent ROW is dominated by common reed. This dominance of common reed is consistent with the pre-construction conditions of this wetland system (as demonstrated in the pre-construction (April 2020) and during construction photos [May 2021)]) that also show the thick cover of this plant species. Therefore, it is most likely that the constant seed source from the adjacent wetland (both upstream and downstream) as well as the drought conditions (preventing flow of water to wash out the establishment of common reed) likely have resulted in an increase in common reed as well as the rapid growth of native vegetation within and along the stream banks on the Rubsam's property. Standing pooled water near the culvert, sunlight, and mucky, rich organics within the stream bed allow for the perfect habitat for vegetative growth.

Photo 12: View of the ROW on the opposite side (west) of Clover Drive on August 25, 2022. Note: Structure 944 is present in the background. (Facing west)

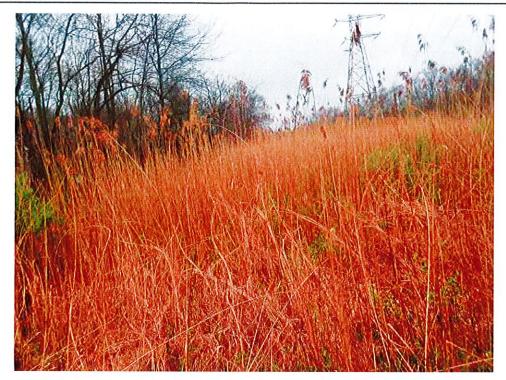
Photo 13: View of the ROW pre-construction in April 2020. The Rubsam's property is to the left and Structure 943 is in the background.

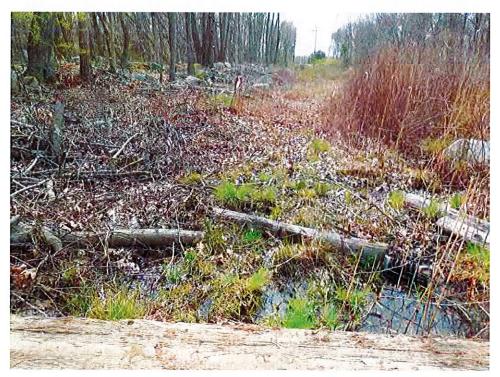
Photo 14: View of the ROW on the western side (opposite) of Clover Drive pre-construction in April 2020.

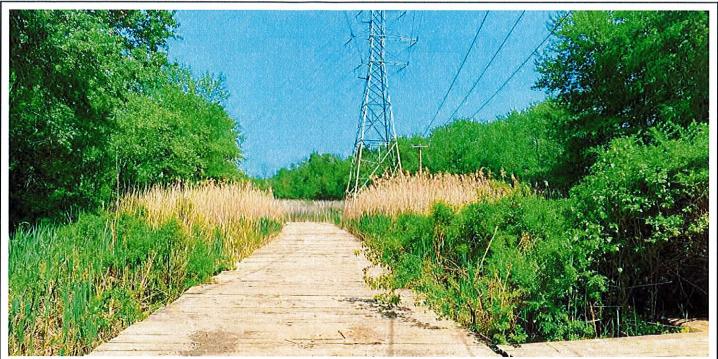
The project conducted in 2021 was temporary and did include the use of timber matting placed on top of the wetland vegetation within the ROW. Construction matting is considered a Best Management Practice (BMP) that is used to support heavy equipment and protect the wetland substrate by dispersing the weight of construction vehicles. Before and after construction is complete and the matting is cleaned and is removed, vegetation quickly returns to pre-construction conditions. In addition, Eversource, their contractors, and the BSC monitors ensured vegetative material was removed from matting, vehicles, and equipment when moving from the site and any new matting, vehicles and equipment were clear of vegetation prior to entering the site. This is consistent with Eversource's BMP Manual (Best Management

Photo 15: View of the ROW during construction in May 2021. The Rubsam's property is to the left and Structure 943 is in the background.

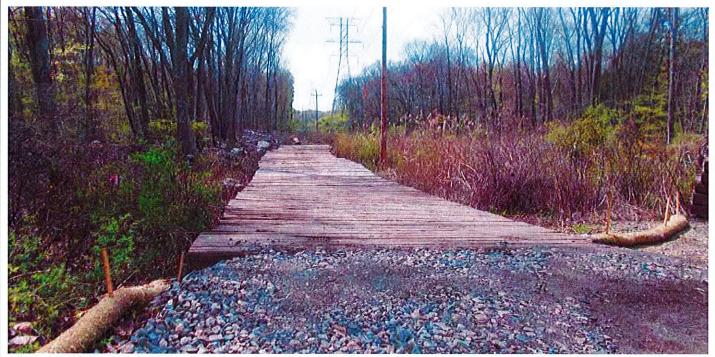
Photo 16: View of the ROW on the western side (opposite) of Clover Drive during construction in 2021. Structure 944 is present in the background.

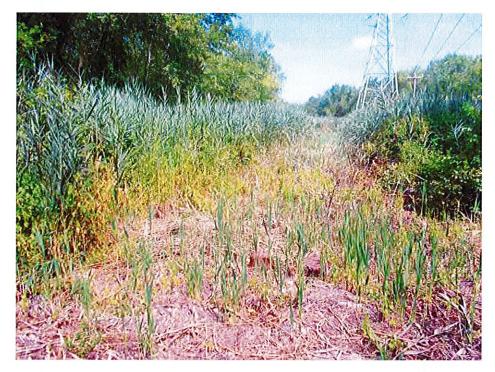
Photo 17: View of the ROW post-construction in August 2021. The Rubsam's property is to the left and Structure 943 is in the background.

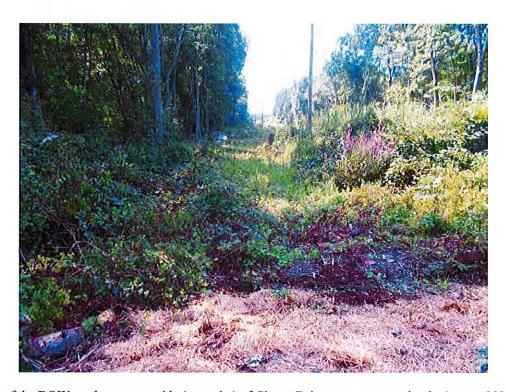
Photo 18: View of the ROW on the western side (opposite) of Clover Drive post-construction in August 2021.
