Docket No. 217 – Development and Management Plan Inspection

Northeast Utilities Service Company Certificate of Environmental Compatibility and Public Need for the construction of a 345-kV electric transmission line and reconstruction of an existing 115-kV electric transmission line between Connecticut Light and Power Company's Plumtree Substation in Bethel, through the towns of Redding, Weston, and Wilton, and to the Norwalk Substation in Norwalk, Connecticut.

Date: December 22, 2005

Location: 345kV Underground Route

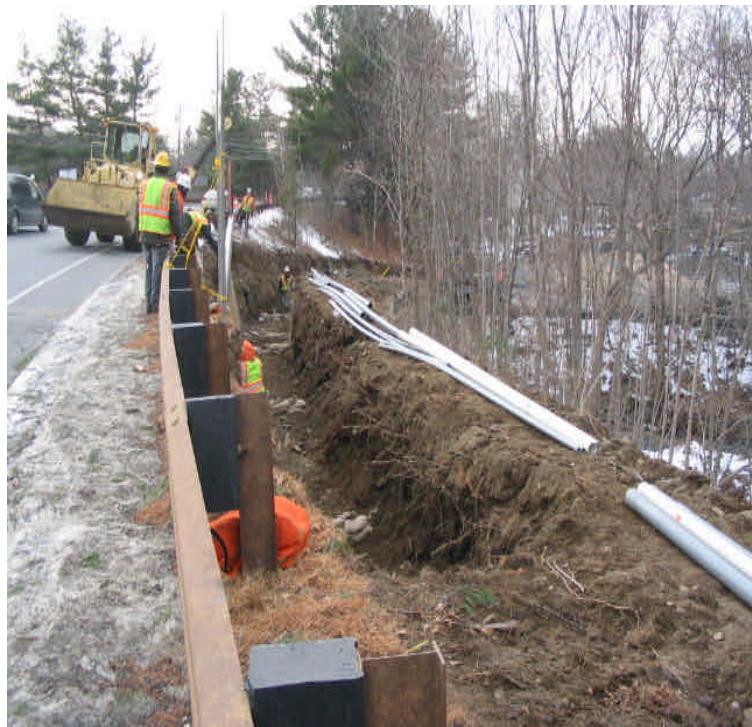
345kV (Rt 107): Photo on the left shows a view of where pipe is being installed above a bridge over the Norwalk River. Sit fence is in place at this time. Photo on the right shows a view of this work from the roadway. 12/22/05
