Docket No. 217 – Development and Management Plan Inspection

Northeast Utilities Service Company Certificate of Environmental Compatibility and Public Need for the construction of a 345-kV electric transmission line and reconstruction of an existing 115-kV electric transmission line between Connecticut Light and Power Company's Plumtree Substation in Bethel, through the towns of Redding, Weston, and Wilton, and to the Norwalk Substation in Norwalk, Connecticut.

Date: February 22 and 23, 2006

Location: Overhead Line (Composite 345kV and 115kV Gallows Hill to Archers Lane) and (345kV H-Frame Hoyts Hill to Gallows Hill)

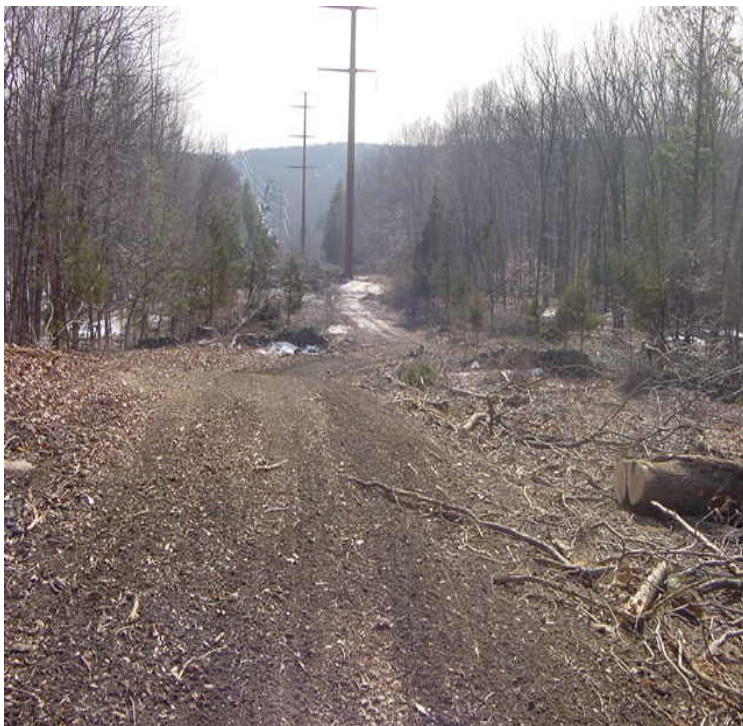
Photo on the left shows the erosion controls near the wetlands at the second structure off Gallows Hill. Sediment has been pushed over them and needs to be pulled back. Photo on the right shows the wetland crossing at the same location where silt fence is down. 2/22/06

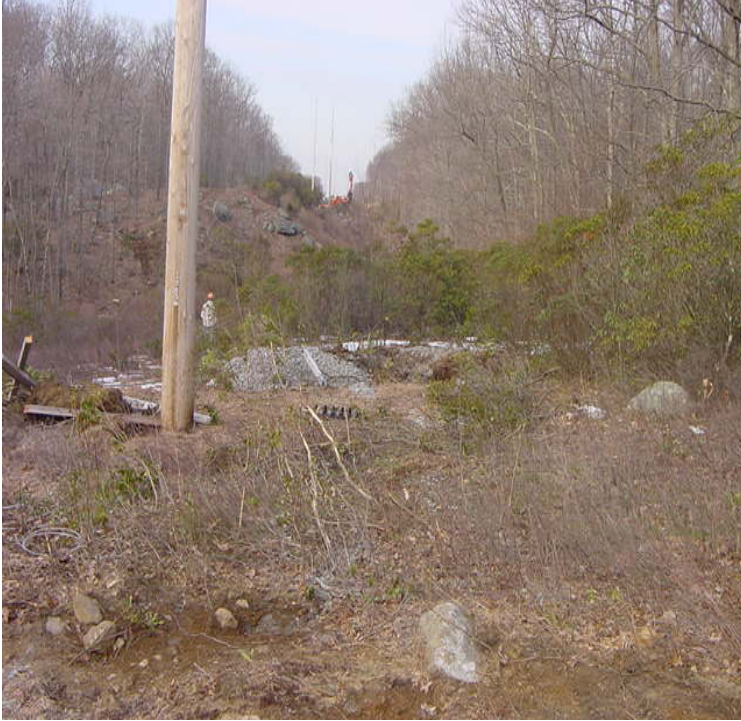
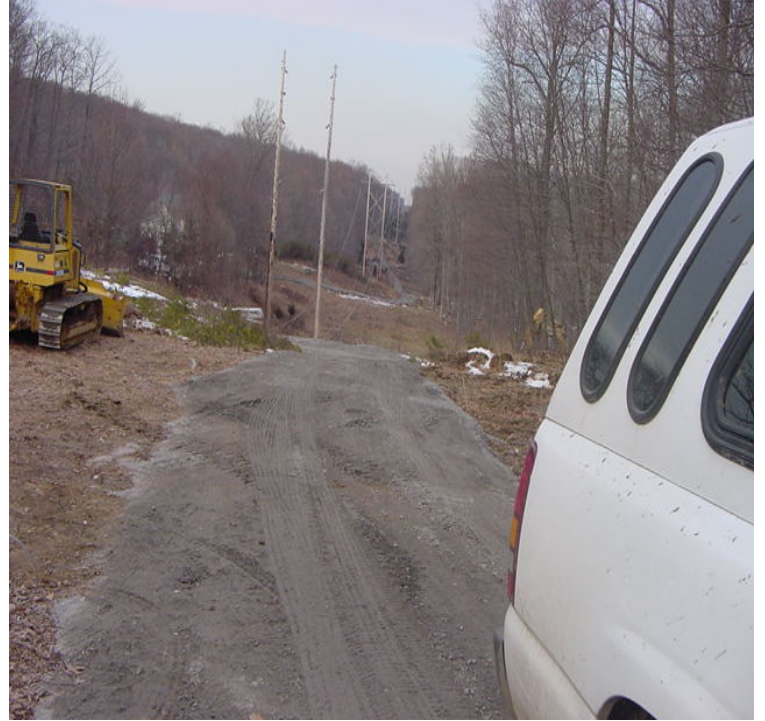
Photo on the left shows an overview of the ROW in this section where additional clearing has occurred. Photo on the right shows where wood chips were blown into the woods beyond the cleared ROW. This does not appear to be a good practice for land outside the ROW. 2/22/06

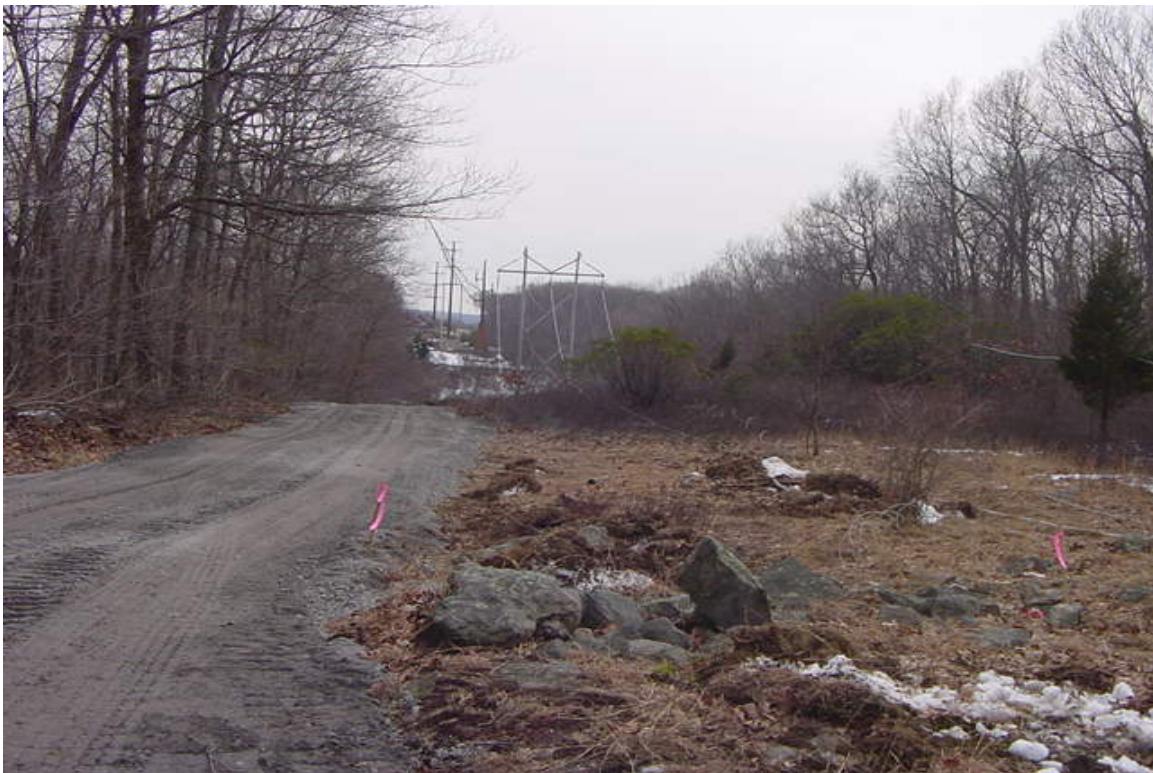
345kV (H-Frame Section): Photo on the left shows a view towards pole #21 from access off John Todd Road. Photo on the right shows the view from Costa Drive towards the access road within the ROW. 2/22/06

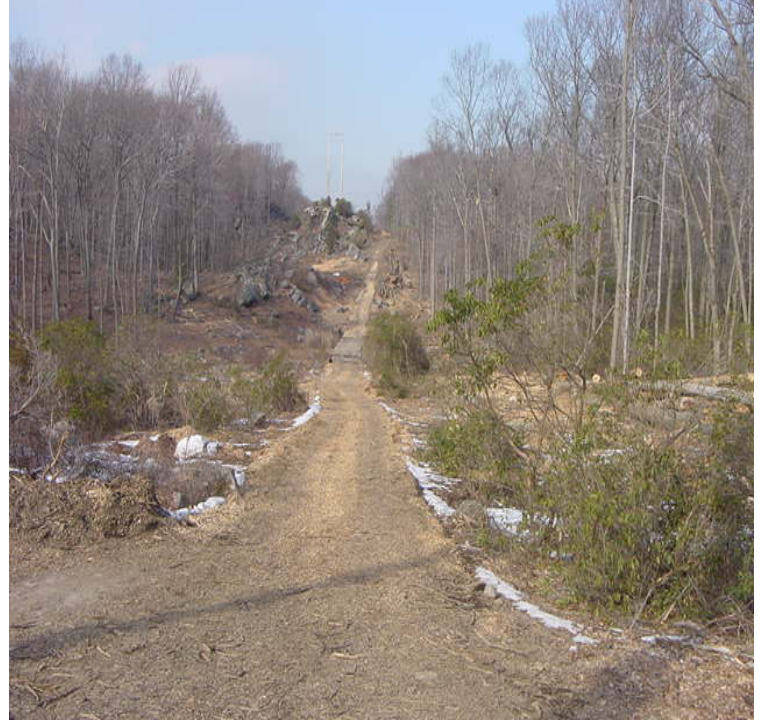
Photo on the left shows silt fence which has been installed at pole #19 now that foundation work is beginning here. Photo on the right shows the view along the access road in the Bethel Reservoir section with new wood chips in place to help stabilize. 2/22/06

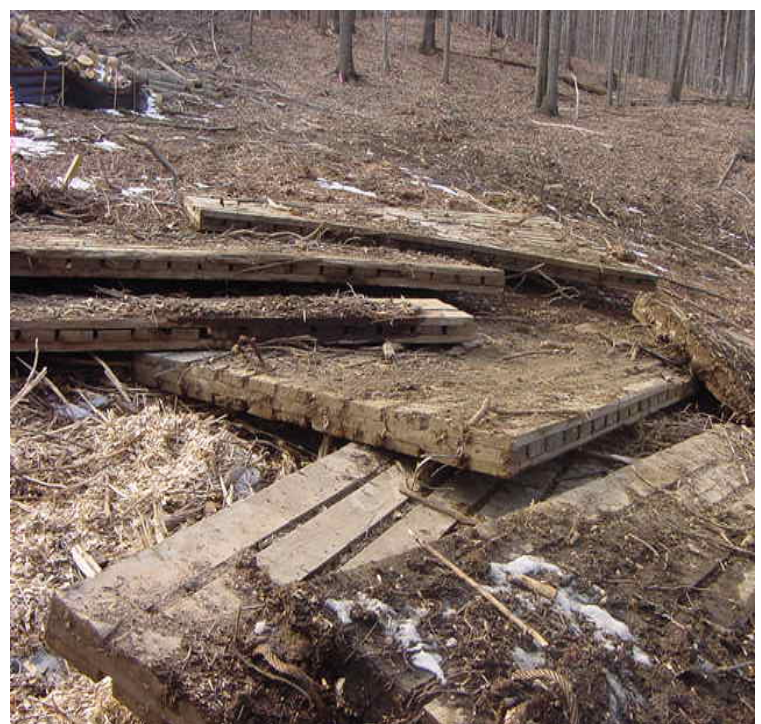
Photo on the left shows the area near the stream between poles #10 and 11 where mats have been removed. Photo on the right shows the mats stockpiled for removal. 2/22/06

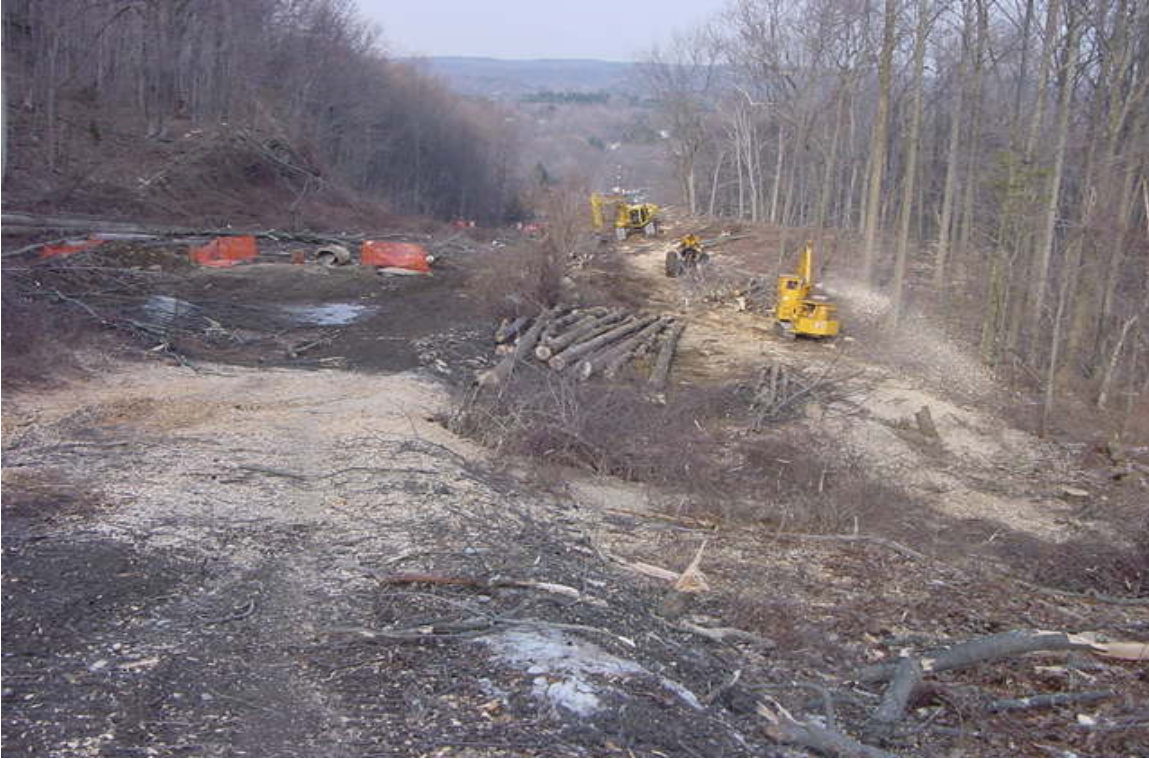
Photo shows a view of the clearing continuing in the Chestnut Ridge Rd. section. 2/22/06
