Docket No. 217 – Development and Management Plan Inspection

Northeast Utilities Service Company Certificate of Environmental Compatibility and Public Need for the construction of a 345-kV electric transmission line and reconstruction of an existing 115-kV electric transmission line between Connecticut Light and Power Company's Plumtree Substation in Bethel, through the towns of Redding, Weston, and Wilton, and to the Norwalk Substation in Norwalk, Connecticut.

Date: March 29, 2006

Location: Overhead Line (Composite 345kV and 115kV Gallows Hill to Archers Lane,
345kV H-Frame Hoyts Hill to Gallows Hill, and Norwalk Section)

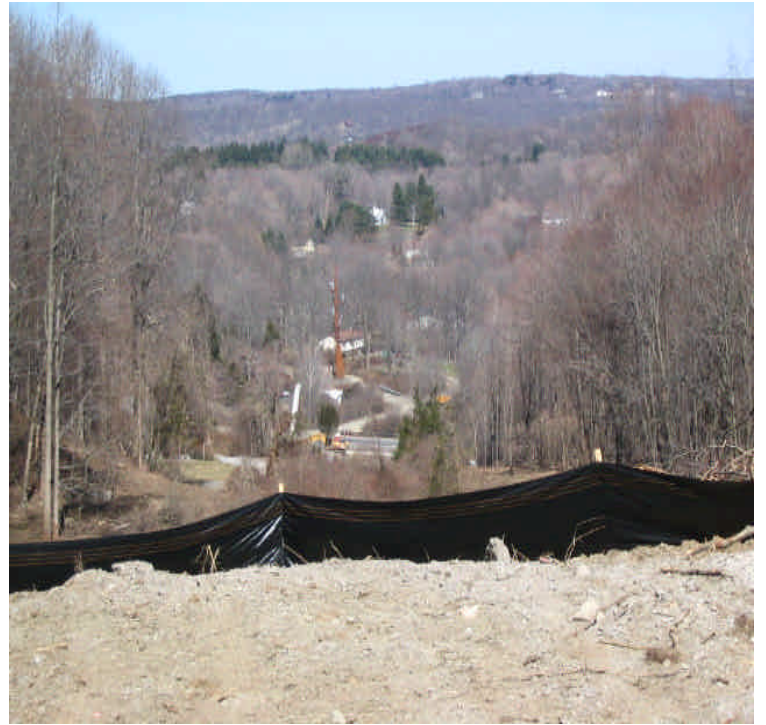
Photo on the left shows the area at structure #9 where the soil stockpile was removed. Silt fence should be maintained here until the area is stabilized. Photo on the right is a view towards Hoyts Hill from structure #2. 3/29/06.

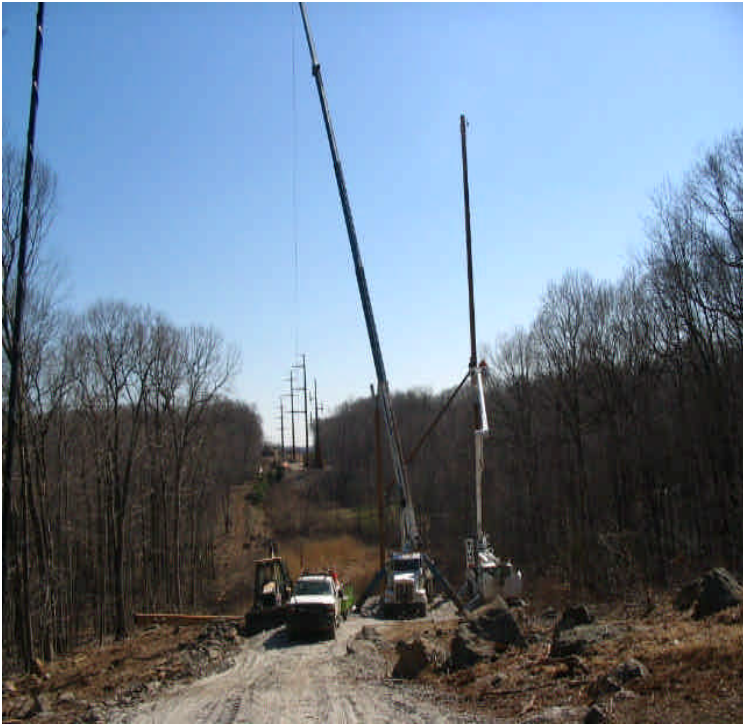
Photo on the left shows structures being installed in the area of Costa Lane. Norwalk Section:
Photo on the right shows the stone dust access road to a foundation. A concrete washout was noted here. A containment basin should be set up. 3/29/06
