Docket No. 217 – Development and Management Plan Inspection

Northeast Utilities Service Company Certificate of Environmental Compatibility and Public Need for the construction of a 345-kV electric transmission line and reconstruction of an existing 115-kV electric transmission line between Connecticut Light and Power Company's Plumtree Substation in Bethel, through the towns of Redding, Weston, and Wilton, and to the Norwalk Substation in Norwalk, Connecticut.

Date: June 14, 2006

Location: Overhead Line (Composite 345kV and 115kV Gallows Hill to Archers Lane,
345kV H-Frame Hoyts Hill to Gallows Hill, and Norwalk Section)

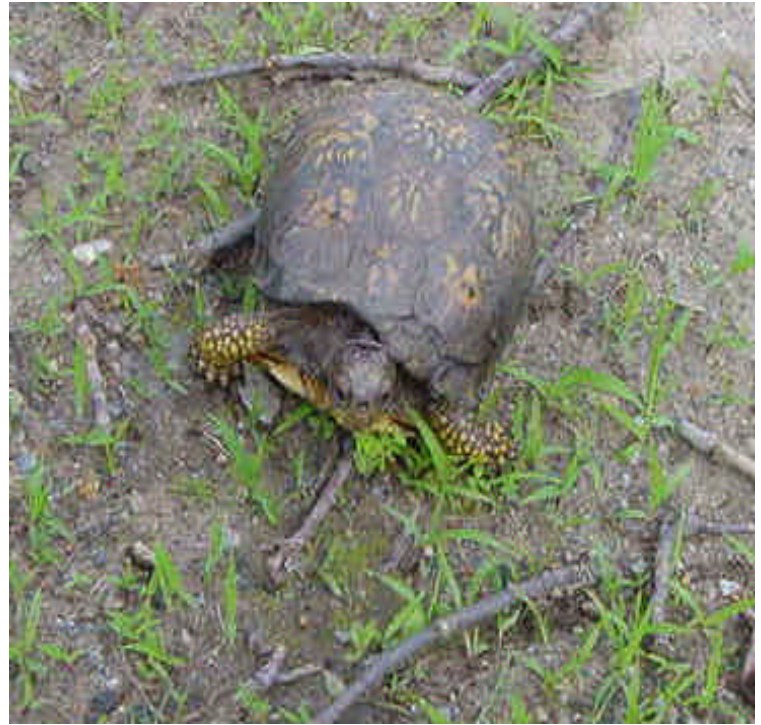
Photo on the left shows the crossing near structure #19 where silt fence was repaired. Photo on the right shows an eastern box turtle walking within the ROW off Chestnut Ridge Rd. 6/14/06.

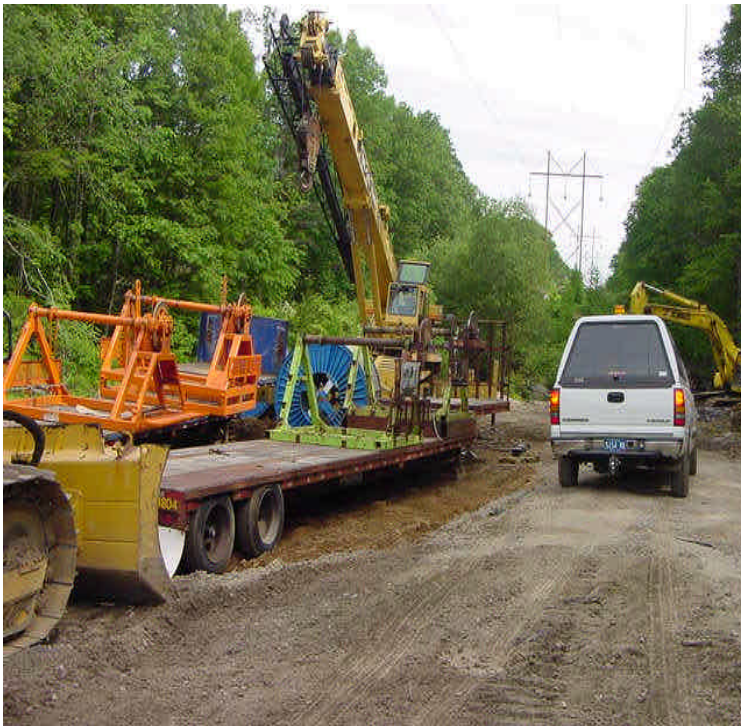
Photo on the left shows the machinery on site to pull wire in the area of John Todd Way. Photo on the right shows the separate contractor (unrelated to the project) placing fill for a driveway in the same area. This contractor is not using erosion controls. 6/14/06.

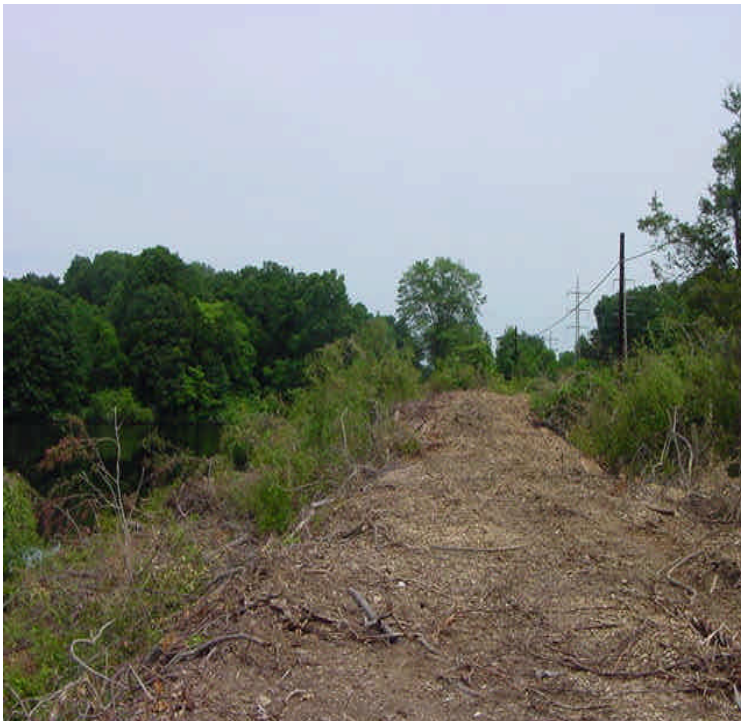
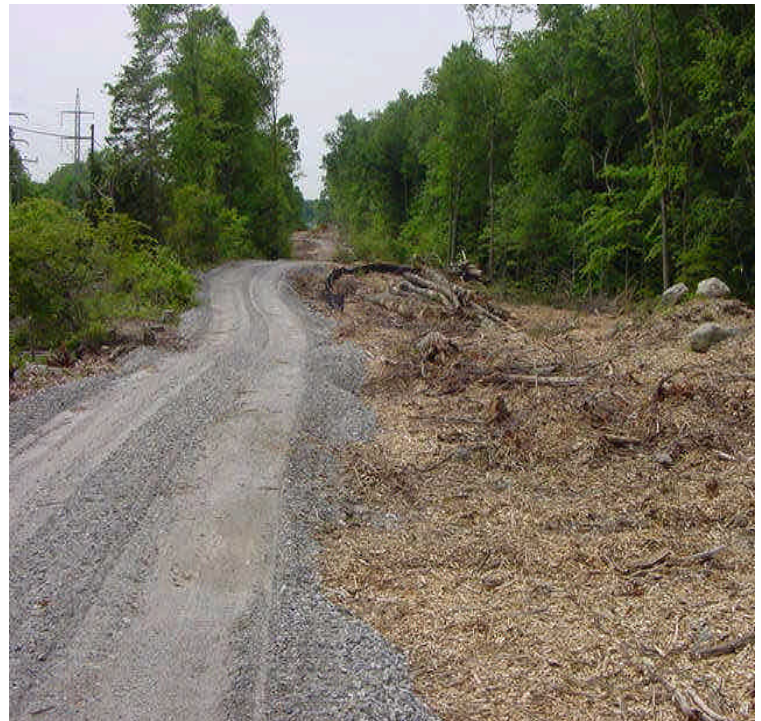
(Norwalk Section, Kent Rd): Photo on the left shows the clearing in the vicinity of the pond in the new section of ROW to the north. Photo on the right shows a view along the access road in this section. 6/14/06

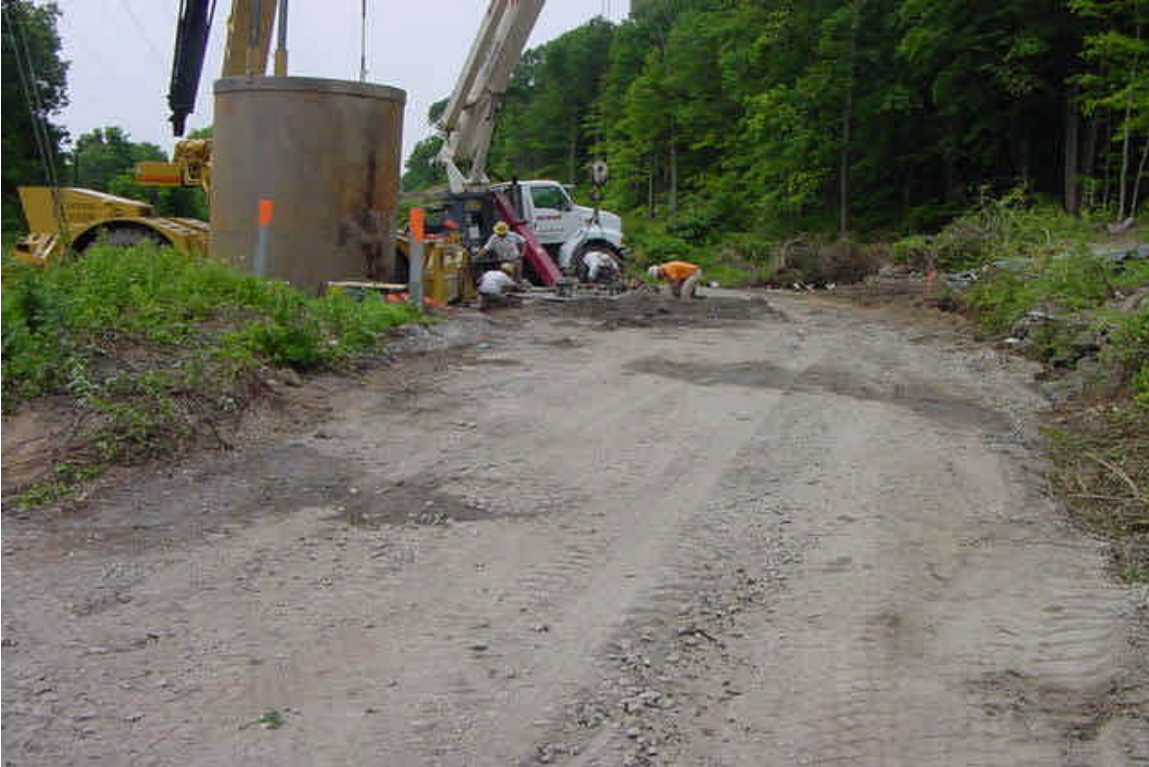
Photo shows where a structure foundation had recently been poured in the ROW section to the south of Kent Rd. 6/14/06

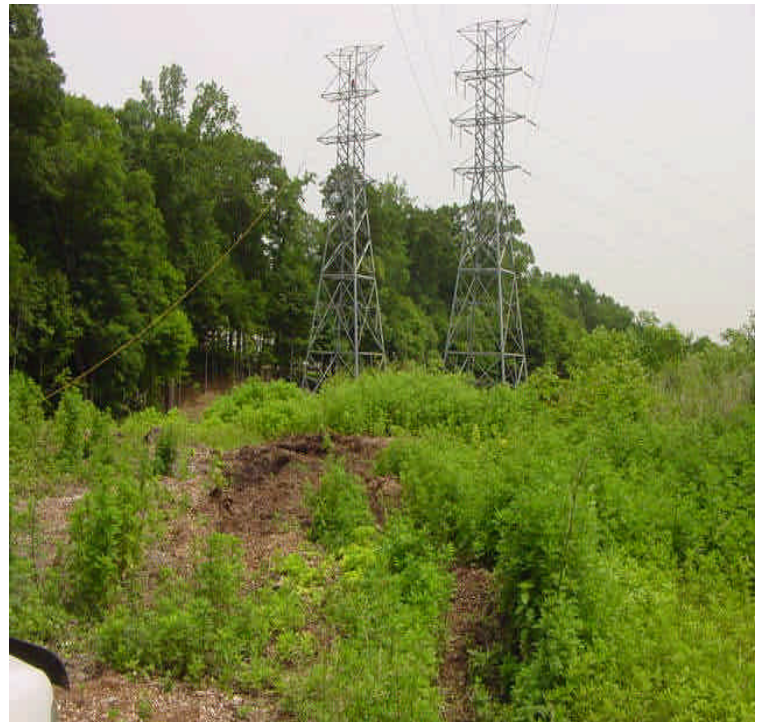
Photo on the left shows preparation to pull down old towers off North Seir Hill Rd. 6/14/06

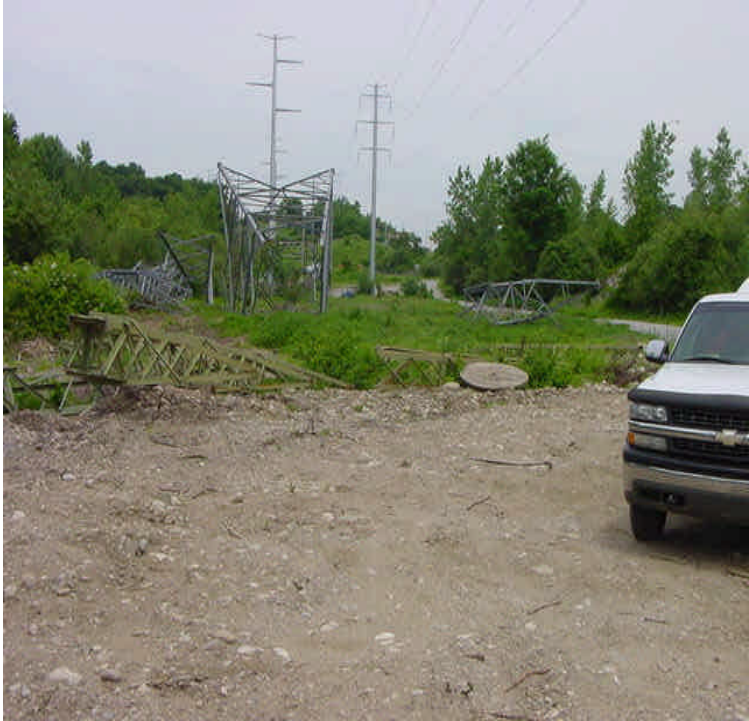
Photo on the left shows where old towers are down off Perry Ave. These will eventually be removed. Photo on the left shows silt fence to the north of Broad St at the end of the access road which should be maintained. 6/14/06
