**Docket No. 272 – Development and Management Plan Inspection**

**Segment 3 Underground Line**

**Date:** February 14, 2008

**Location:** East Devon Substation to the Housatonic River Crossing

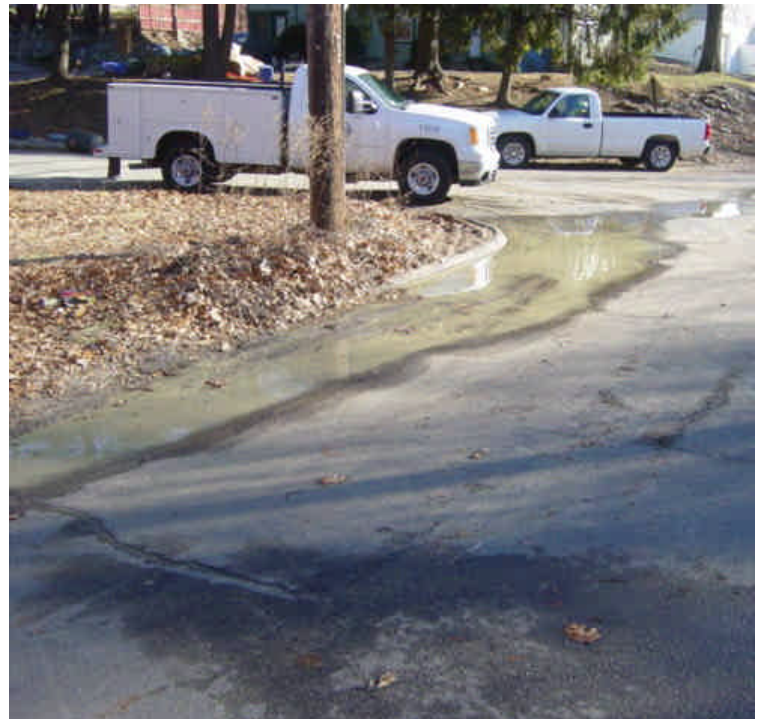
<p><b>Dewatering</b></p>	<p><b>At the time of the inspection the trench near sta. #1038 was being dewatered. The trench was being backfilled and concrete slurry had mixed with the groundwater which was being pumped down the street towards a plugged catch basin near sta. #1034. As a result, runoff was ponding along</b></p>	<p><b>The supervisor was informed of the problem and the crew agreed to vacuum out the catch basin at the end of the day. For future dewatering needs, ensure that it is contained appropriately and filtered as per the D&amp;M plan. Filtration was not observed at this location. 2/14/08</b></p>	<p><b>Needs attention.</b></p> <p><i>Supervisor was notified and catch basin will be vacuumed.</i></p>

**Trenching and backfilling activities continue along Naugatuck Ave near sta. #1037 to 1038. At the time of the inspection the trench was being backfilled. Concrete slurry had mixed with the groundwater which was being pumped down the street towards a plugged catch basin near sta. #1034. The runoff was ponding along the roadway. The supervisor was informed of the problem and the crew agreed to vacuum out the catch basin at the end of the day. Evaluate dewatering methods and ensure they are in compliance.**
