**Docket No. 272 – Development and Management Plan Inspection**

**Segment 3 Underground Line**

**Date:** July 17, 2008

**Location:** East Devon Substation to the Housatonic River Crossing

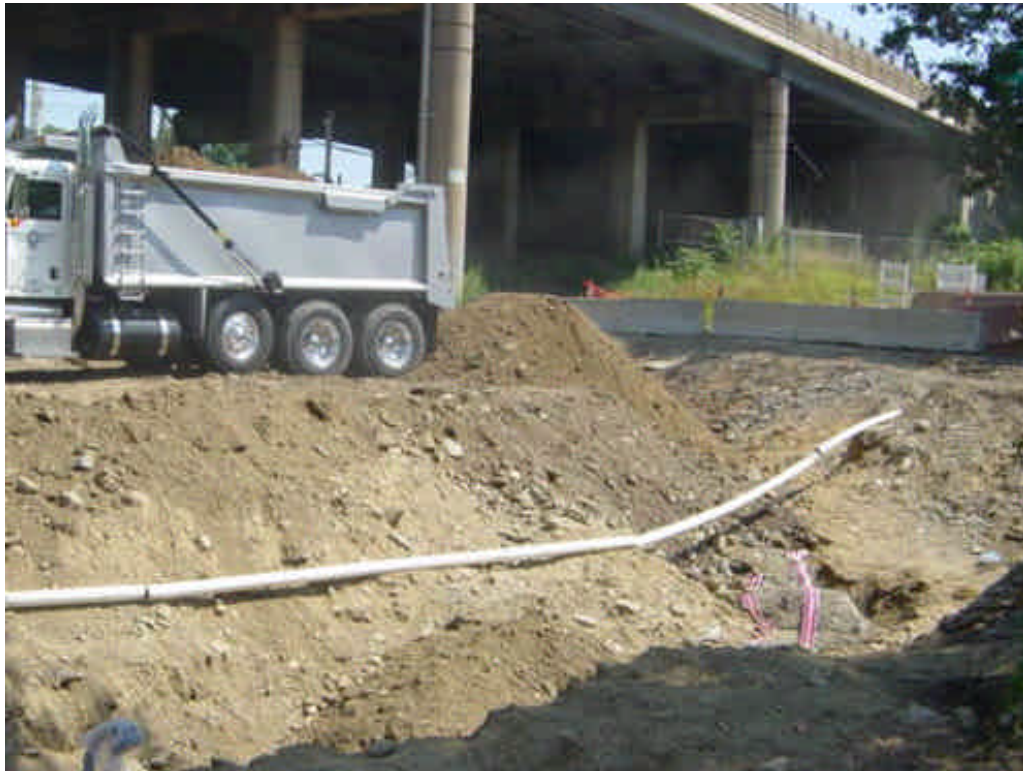
**Both circuits have been tied-in to the HDD work near sta. #1020. Backfilling was underway at the time of the inspection.**
