**Docket No. 272 – Development and Management Plan Inspection**

**Segment 3 Underground Line**

**Date:** October 16, 2008

**Location:** East Devon Substation to the Housatonic River Crossing

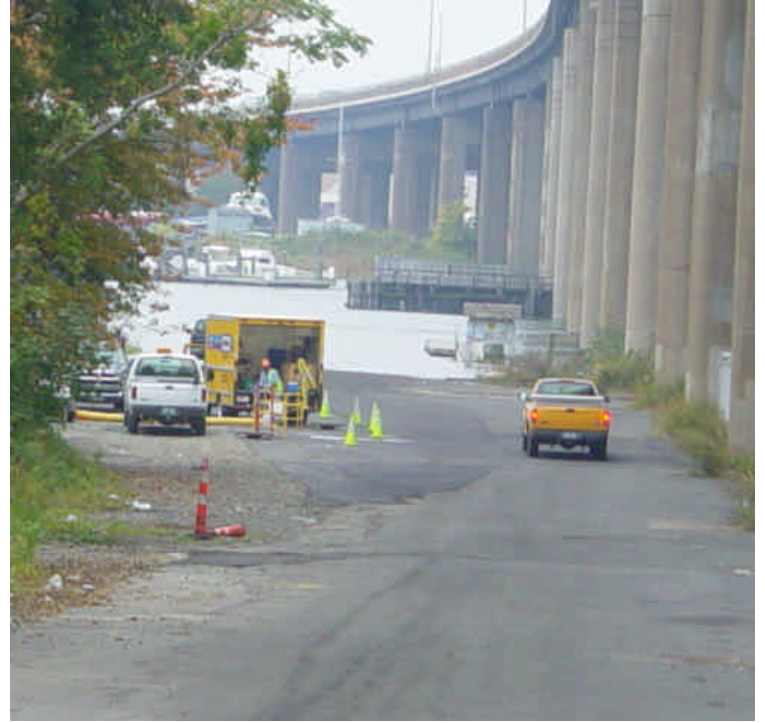
**Area near sta. #1015-1020 has been repaved as part of final restoration. Electric contractor was on site at vault #1.**
