Docket No. 272 – Development and Management Plan Inspection

Segment 4b Underground Line

Date: March 20, 2008

Location: Westport Avenue to the Norwalk Substation in the City of Norwalk

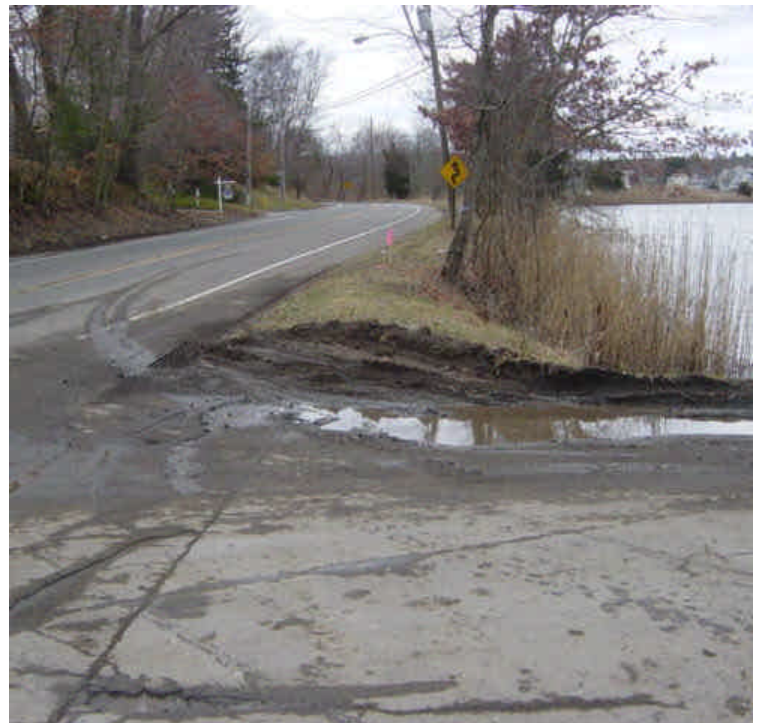
The construction entrance near the staging area on the east side of the Saugatuck River near sta. #251 is covered with mud and sediment and no longer functions. Sediment tracking was observed throughout the adjacent parking area. Heavy ruts have also formed near the corner of the access drive and Imperial Ave. The adjacent catch basin was not protected. Minor tracking was observed along Imperial Ave. but the area was being swept during the inspection. The entrance pad should be refreshed.
